**376 Gilmerton Road, Edinburgh**  
**Archaeological Evaluation & Watching Brief**  
**Data Structure Report**  
**Project 3776**

**On behalf of:** ALDI Stores Ltd

**Project Number:** 3776

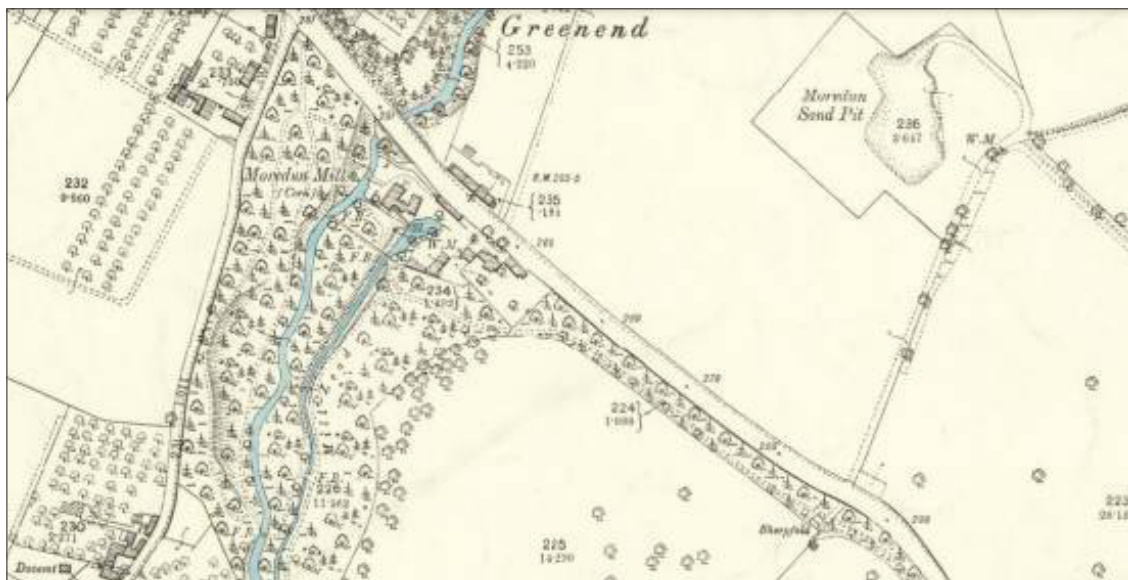
Figure 2: Moredun Mill, Mill lead and Millpond as depicted on the 2<sup>nd</sup> edition OS map published 1894.

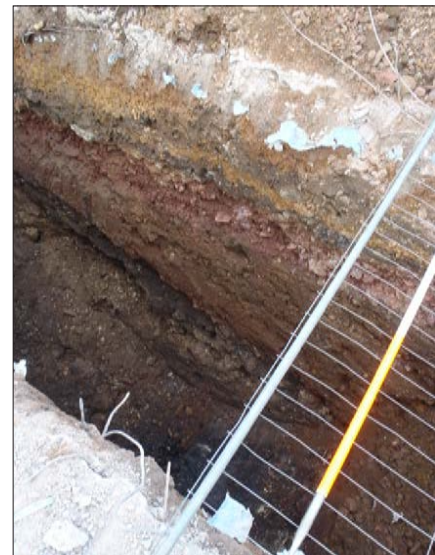
- 7.3 At the northern end of the development site by the Burdiehouse Burn below the concrete and gravel were deep deposits of infill [003] consisting of compacted mid-brown sandy silt and modern demolition debris. This was recorded in Trenches 1, 2 and 3 and measured over 4.1 m deep; the natural sub-soil was not encountered in any of these trenches.

*Plate 1: Deep infill deposit [003] in Trench 3, from the east.*

- 8.4 On both the 1892 maps Trench 3 with deep infill deposits is located within the mill dam that stored water for the mill and would confirm the interpretation of the material as later infill from when the dam went out of use. The outline for the dam is still shown on the 1908 map but it is unclear whether it was still filled with water at this time.

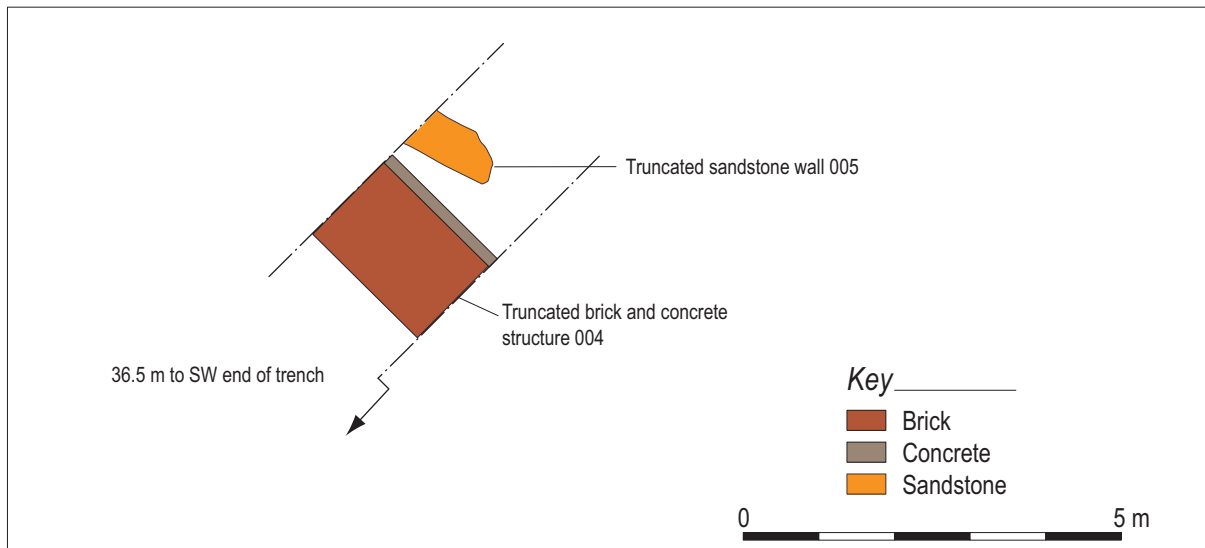
7.6 Two structures were recorded in Trench 1 (Figure 3). The first comprised a truncated concrete and brick structure [004] (Plate 2). This was rectangular in plan and measured 2 m long (width of trench) by 1.5 m wide and survived to a height of 0.24 m and continued below the east and west edges of the trench. This is likely to be relatively late in date as it was found overlying the infill deposit [003]. The second feature was revealed at a depth of 1 m from the concrete surface below the infill layer (003) and comprised a rubble wall [005] built with sandstone and lime mortar (Plate 3). The wall was aligned east to west and the section exposed was 1.2 m long and 0.5 m wide and appeared to continue beyond the trench edge to the west.

Figure 3: Plan of features recorded in trench 1.

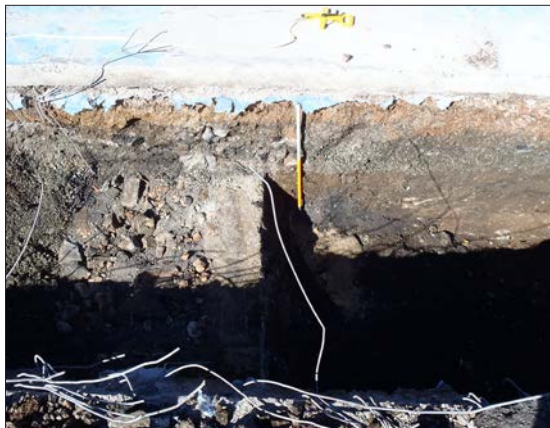
Plate 2: Trench 1, truncated concrete and brick structure [004] and truncated wall [005] at the base of 1 m ranging rod, from the east.

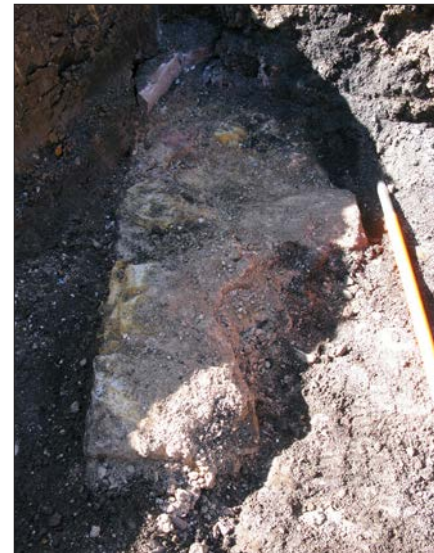
Plate 3: Detail of wall [005] in Trench 1, from the east.

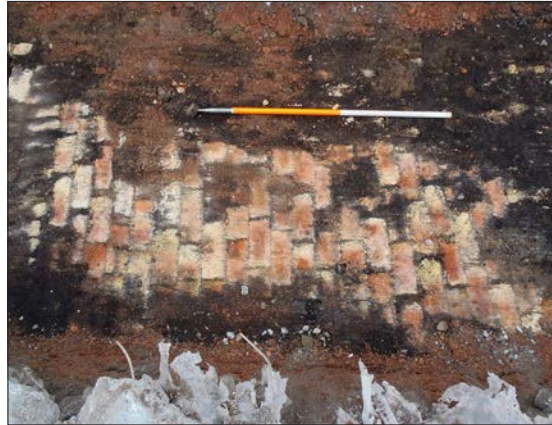
*Plate 6: Detail of brick floor [009] in Trench 7, from the north west.*

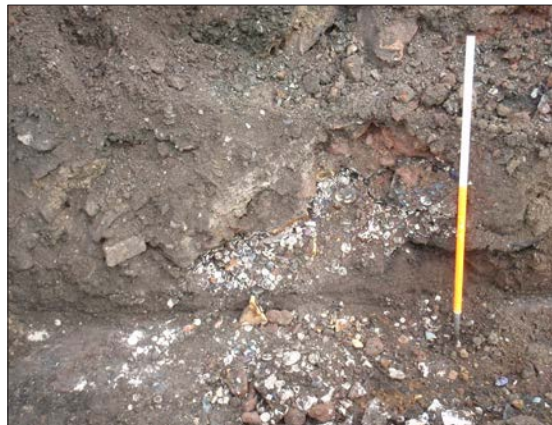
7.13 The ceramic deposit (004) was encountered within the mixed clearance material (005) as a distinct 'seam' of material, extending for 2.4 m length x 0.96 m depth. This comprised almost entirely of ceramic material, mostly small items such as buttons, small painted discs, small tiles and some bottle fragments along with various clay spacers; a selection of these were retained as small finds 01-16. Some of these were partially painted and unglazed; two have maker's stamps which read 'Holyrood Pottery'. At least some of the finds recovered appear to belong to the 'Biscuit Ware' blanks range of small objects which were sold for amateur painting and could be returned to the pottery for firing (eg sf 01, 02, 03, 04, 06, 12), while others appear more professionally finished (eg 05, 09, 13).

Plate 11: West facing section of ceramic deposit (004).

- 8.9 Research indicates that the ceramic material (004) originates from the Holyrood Pottery, which was founded by the Scottish artist Henry Taylor Wise and operated between 1917-27 in premises at Boroughloch in Edinburgh. These ceramics were likely deposited not much later than this; the stratigraphy indicates that this pre-dates the upper deposit (002) which all the structural features encountered are constructed on. The reason for the deposition of the material is unclear; it is possible given the mixed nature of the material in terms of glazed/unglazed state, quality of painting, presence of spacers etc that it was originally cleared from the ceramic works itself after it's closure in 1927. However, given the nature of the material and the fact that at least some of the pieces may have been for 'amateur' painting, there is also a possibility that the material had been purchased for craftwork elsewhere and cleared from another location. No evidence of any structural debris or burnt kiln material related to the ceramic was apparent.

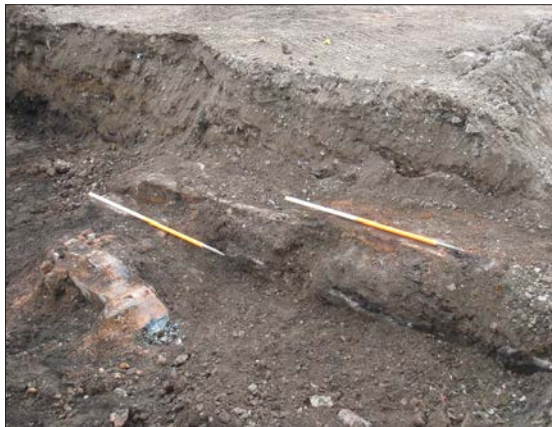
- 7.15 Two brick wall structures were encountered. The brick wall [006] comprised of bonded bricks with a thick cement foundation, extending for 12.35 m NE/SW, with a 3.4 m NW/SE return at the north extent, and surviving to a height of 0.45 m including three courses of brickwork and the foundation. ‘White Hill’ stamps were visible on the bricks, indicating their production at the former Whitehill Brickworks at Rosslyn. The feature was truncated to the SW, appearing to originally extend further than the surviving section, and was encountered at 0.45 m below existing ground level.

Plate 12: W facing elevation of [006] at return, with collapse.

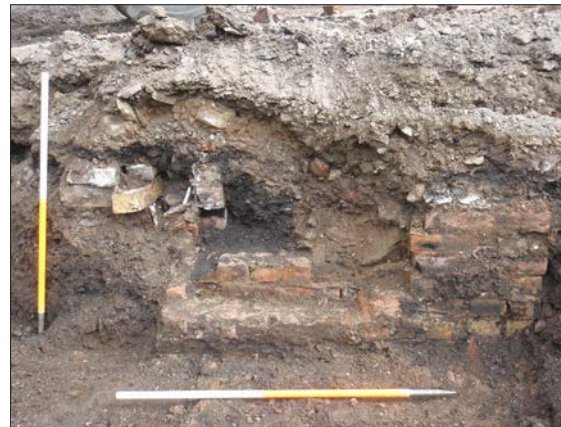
- 7.16 The small brick structure [011] was visible only in the west facing section of the trench towards the NE extent, with the W elevation protruding only slightly into the trench area itself. This comprised of bonded brickwork, measuring 1.50 m in width x 0.57 m in surviving height, with seven courses of brickwork visible. The structure appeared to be demolished at the upper level, and was encountered at 0.32 m below existing ground level. Ceramic drainage was visible in an area of disturbed brickwork; although the extent is unknown, the size of the structure and the presence of drainage imply that this may be a possible utility or basement structure.

Plate 13: W facing elevation of [011].
