376 Gilmerton Road, Edinburgh
Archaeological Evaluation & Watching Brief
Data Structure Report
Project 3776

On behalf of: ALDI Stores Ltd

Project Number: 3776

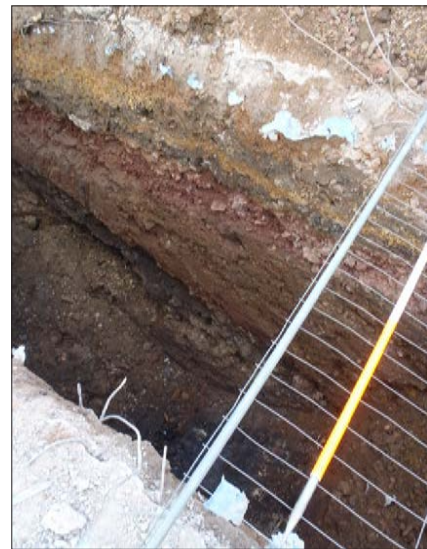
- 7.3 At the northern end of the development site by the Burdiehouse Burn below the concrete and gravel were deep deposits of infill [003] consisting of compacted mid-brown sandy silt and modern demolition debris. This was recorded in Trenches 1, 2 and 3 and measured over 4.1 m deep; the natural sub-soil was not encountered in any of these trenches.

Plate 1: Deep infill deposit [003] in Trench 3, from the east.

- 8.4 On both the 1892 maps Trench 3 with deep infill deposits is located within the mill dam that stored water for the mill and would confirm the interpretation of the material as later infill from when the dam went out of use. The outline for the dam is still shown on the 1908 map but it is unclear whether it was still filled with water at this time.

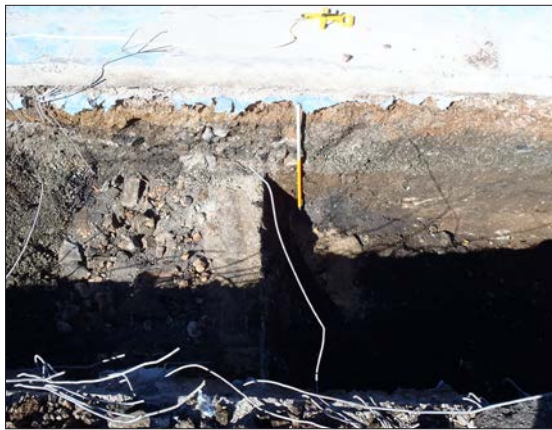
7.6 Two structures were recorded in Trench 1 (Figure 1). The first comprised a truncated concrete and brick structure [004] (Plate 2). This was rectangular in plan and measured 2 m long (width of trench) by 1.5 m wide and survived to a height of 0.24 m and continued below the east and west edges of the trench. This is likely to be relatively late in date as it was found overlying the infill deposit [003]. The second feature was revealed at a depth of 1 m from the concrete surface below the infill layer (003) and comprised a rubble wall [005] built with sandstone and lime mortar (Plate 3). The wall was aligned east to west and the section exposed was 1.2 m long and 0.5 m wide and appeared to continue beyond the trench edge to the west.

Plate 2: Trench 1, truncated concrete and brick structure [004] and truncated wall [005] at the base of 1 m ranging rod, from the east.

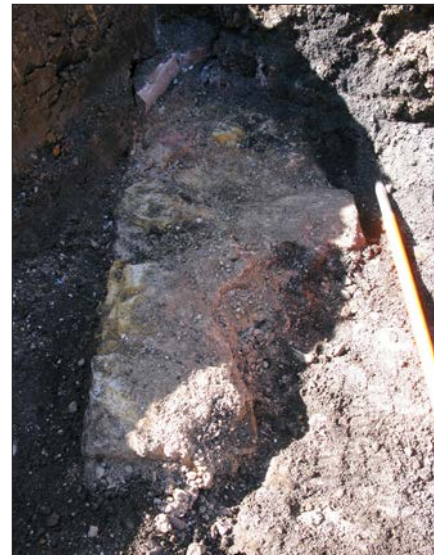
Plate 3: Detail of wall [005] in Trench 1, from the east.

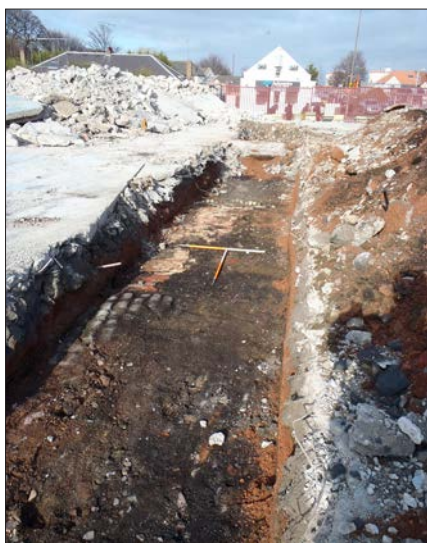
7.7 A series of floor surfaces were recorded towards the north east end of Trench 7 at a depth of 0.7m from the present concrete surface (Plate 4). These consisted of a cobbled surface [008] (Plate 5), a brick floor [009] (Plate 6) and a gravel surface [010]; the gravel possibly laid to replace areas of degraded brick flooring (Figure 4). All these surfaces were covered by a layer of coal dust [011].

Plate 4: General view of surfaces recorded in Trench 7, from the south west.

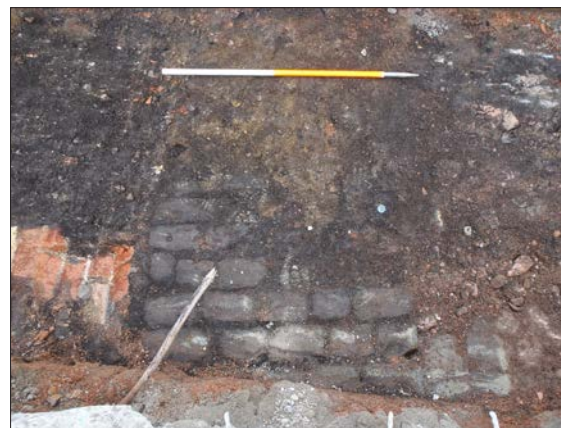
Plate 5: Detail of cobbles [008] in Trench 7, from the north west.

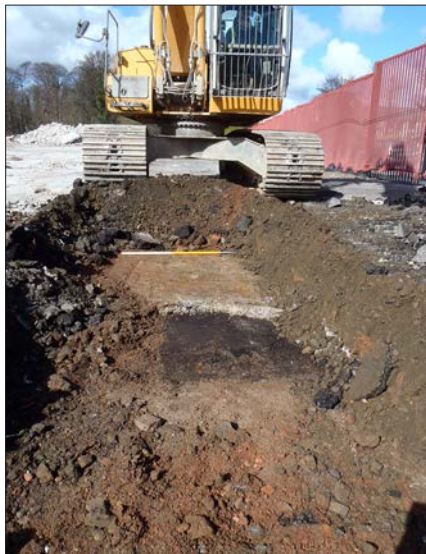
7.8 Fragments of concrete and mortar surfaces were visible towards the south east end of Trench 10 (Figure 5). A roughcast concrete surface [012] 0.09 m thick was found overlying a mortar screed [013] which was covered with a dark grey shale like substance (Plate 7). These surfaces were visible covering an area 2.1 m long by 2 m wide and appear to continue beyond the trench edges to the south, north and west. Part of the present concrete surface was left in situ within this trench to facilitate access to the site through the central gate.

Plate 7: Roughcast concrete floor [012] overlying a mortar screed [013] in Trench 10.

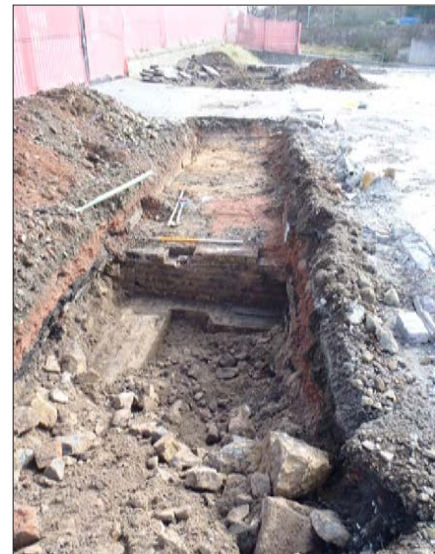
7.9 Towards the north west end of Trench 10 a brick built structure was recorded (Plate 8). This comprised two brick walls, [014] and [017], forming the north-west and south-east limits of the structure. Two brick piers [015], one aligned north-east/south-west abutting the north west facing elevation of brick wall [014], the other aligned north-west/south-east (Plate 9), probably continued on to abut the south east facing elevation of wall [017] at the north west end of the structure (Plate 10). The structure was built on top of a concrete floor or foundation [016] at the south east end. The overall dimensions of the exposed structure was 7.5 m long by 2 m wide and appeared to continue beyond north and south trench edges and the walls and foundations survived to a height of 1.3 m.

Plate 8: General view of brick built structure area in Trench 10, from the north west.

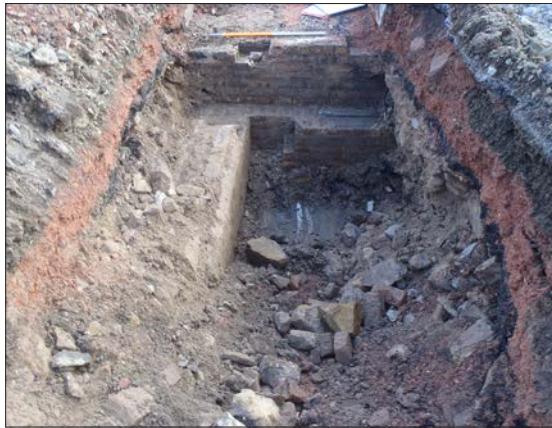
Plate 9: Concrete floor [016] at the base of brick piers [015], from the north west.

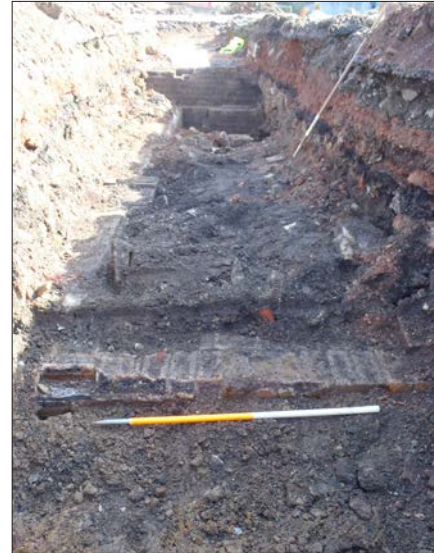
Plate 10: Brick wall [017] forming the north west limit of the brick structure, from the north west.

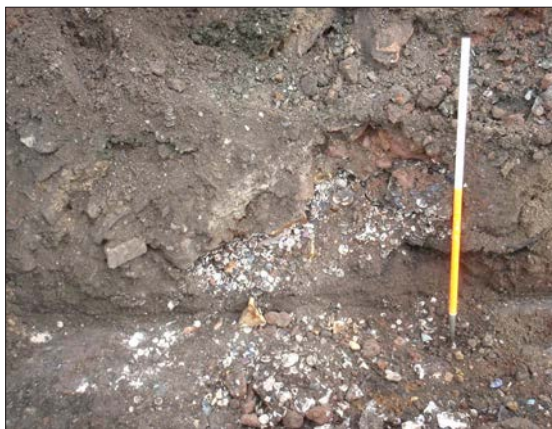
7.13 The ceramic deposit (004) was encountered within the mixed clearance material (005) as a distinct 'seam' of material, extending for 2.4 m length x 0.96 m depth (Plate 13). This comprised almost entirely of ceramic material, mostly small items such as buttons, small painted discs, small tiles and some bottle fragments along with various clay spacers (Plates 11-12). The depth of the trench at more than 2 m at this point made access to the deposit itself impossible; even the trench edge here was unstable due to the loose made deposits rendering any retention problematic. However, a small selection of objects was retained as a representative sample of the different objects present. A drawing was also made of the deposit in section, as measured from the top of the trench, to demonstrate the size of the deposit (Figure 6); a relatively substantial amount of material can be seen to remain in situ on both sides of the trench. The extent of this is unknown, however this would appear to be a relatively localised deposit given that it was not noted within either of the nearby evaluation trenches 1 or 3.

Plate 13: West facing section of ceramic deposit (004).

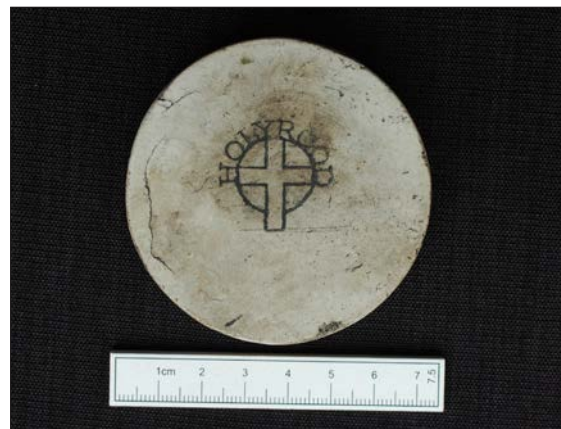
7.14 Of the objects retained some were partially painted and unglazed; two have maker's stamps which read 'Holyrood Pottery' (Plate 14). At least some of the finds recovered appear to belong to the 'Biscuit Ware' blanks range, a name given by the pottery to a range of small objects (Holyrood Art Pottery, www.htwyse.info), which were sold for amateur painting and could be returned to the pottery for firing (eg sf 01, 02, 03, 04, 06, 12; Plates 15 & 16), while others appear more professionally finished (eg 05, 09, 13; Plate 12).

Plate 14: Holyrood stamp on the back of a small glazed disc, sf 1.

- 8.9 Research indicates that the ceramic material (004) originates from the Holyrood Pottery, which was founded by the Scottish artist Henry Taylor Wise and operated between 1917-27 in premises at Boroughloch in Edinburgh (Holyrood Art Pottery, www.htwyse.info). These ceramics were likely deposited not much later than this; the stratigraphy indicates that this pre-dates the upper deposit (002) which all the structural features encountered are constructed on. The reason for the deposition of the material is unclear; it is possible given the mixed nature of the material in terms of glazed/unglazed state, quality of painting, presence of spacers etc that it was originally cleared from the ceramic works itself after it's closure in 1927. However, given the nature of the material and the fact that at least some of the pieces may have been for 'amateur' painting, there is also a possibility that the material had been purchased for craftwork elsewhere and cleared from another location. No evidence of any structural debris or burnt kiln material related to the ceramic was apparent.

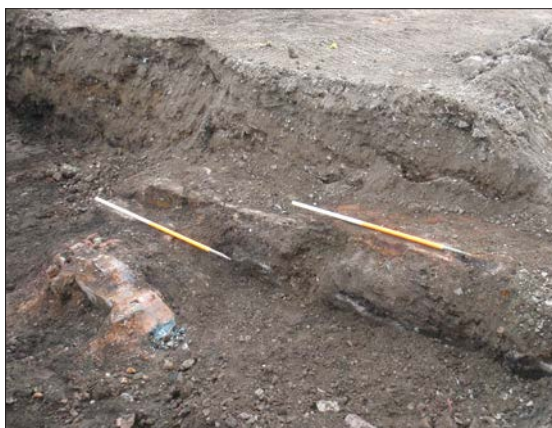
- 7.16 Two brick wall structures were encountered. The brick wall [006] comprised of bonded bricks with a thick cement foundation, extending for 12.35 m NE/SW, with a 3.4 m NW/SE return at the north extent, and surviving to a height of 0.45 m including three courses of brickwork and the foundation. 'White Hill' stamps were visible on the bricks, indicating their production at the former Whitehill Brickworks at Rosslyn. The feature was truncated to the SW, appearing to originally extend further than the surviving section, and was encountered at 0.45 m below existing ground level.

Plate 17: West facing elevation of [006] at return, with collapse.

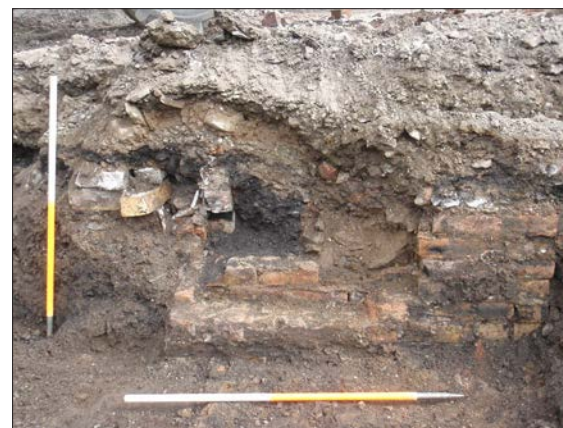
- 7.17 The small brick structure [011] was visible only in the west facing section of the trench towards the NE extent, with the W elevation protruding only slightly into the trench area itself. This comprised of bonded brickwork, measuring 1.50 m in width x 0.57 m in surviving height, with seven courses of brickwork visible. The structure appeared to be demolished at the upper level, and was encountered at 0.32 m below existing ground level. Ceramic drainage was visible in an area of disturbed brickwork; although the extent is unknown, the size of the structure and the presence of drainage imply that this may be a possible utility or basement structure.

Plate 18: West facing elevation of [011].
