Preston Mill Building Recording Watching Brief Data Structure Report Project 4193

Data Structure Report

On behalf of: The National Trust for Scotland

Project Number: 4193

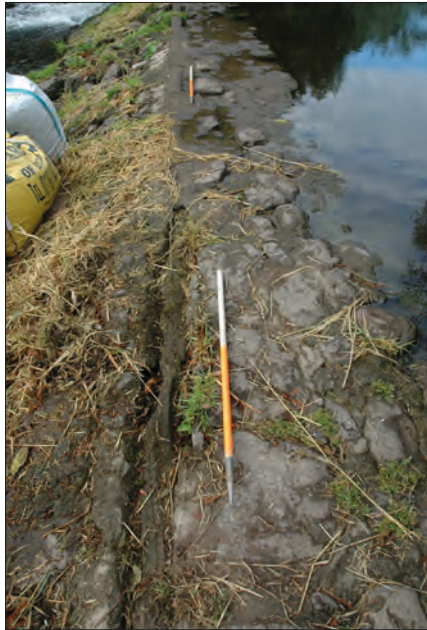
Plate 3: Degraded timber beam 002 left of near ranging rod with later replacement concrete blocks 003 left of far ranging rod, from the NE.

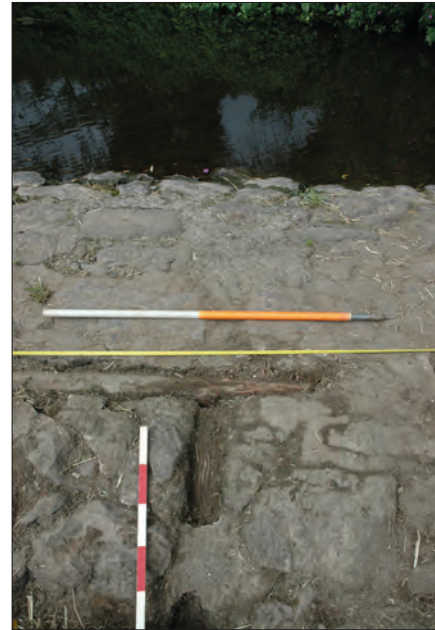
Plate 4: Partially obscured degraded timber beam 002 below horizontal ranging rod and partially obscured degraded diagonal bracing timber beam 007 to right of vertically positioned ranging rod, from the SE.

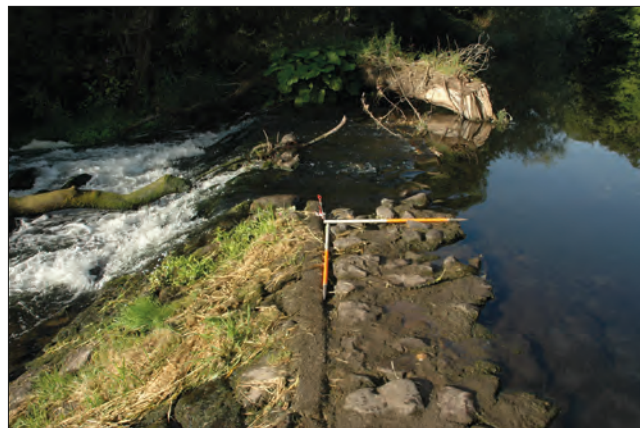
- 7.2.3 Around the centre of the weir a large section of the structure had been breached and much of the stone fabric washed away.
- 7.2.4 The south-east section of the weir was not initially accessible due to fallen trees, branches and vegetation including Giant Hogweed and access to the south bank of the river was restricted. As

Plate 5: Breached section of the weir with thick roughcast concrete screed 004 consolidating the top of weir, from the NE.

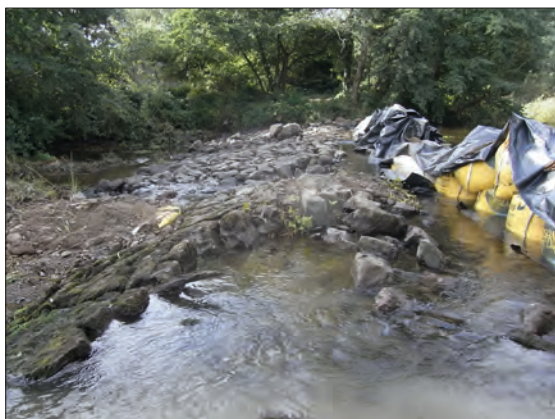
- 7.2.5 The south-east section is quite different in terms of construction from the north-east section, the weir is much broader (approximately 4m) and the spillway is not so steep. The crest of the weir is marked by a straight kerb made from roughly squared stones although the channel with the timber beam was only observed at the other side of the breach in the weir. The weir and slipway in the south-east section is built from much larger stones and boulders and is of a looser construction with little attempt to form a flat surface or face although the overall dimensions are quite uniform. This section does not appear to have had the same level of recent repairs as there was no evidence for the concrete blocks or roughcast concrete screed. Some of the larger and more irregular stones may be the result of attempts to repair or heighten the weir by dumping stones over the existing structure and there are local accounts of this taking place.

Plate 6: south-east section of the weir clear of vegetation, from the NE.

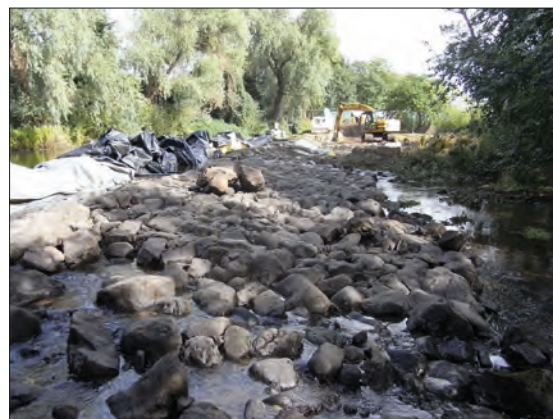
Plate 7: south-east section of the weir clear of vegetation, from the SE.

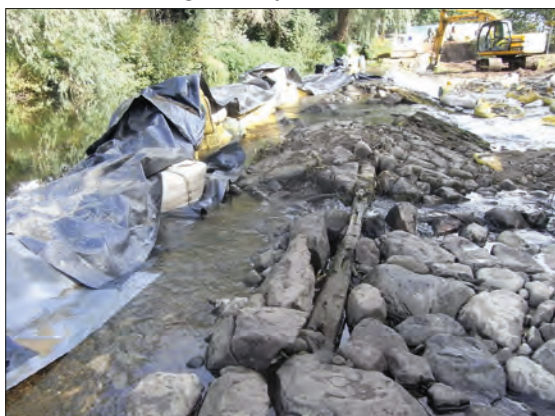
Plate 8: central area of the weir with the timber beam still in place, from the SE.

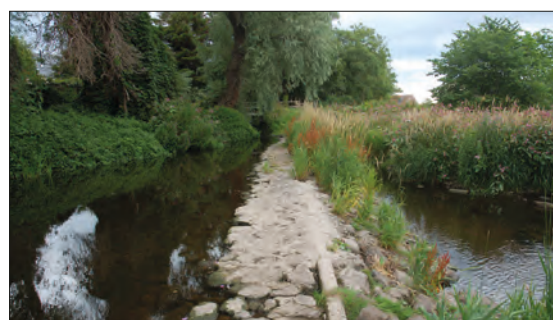
Plate 9: south-east section of the weir after consolidation work.

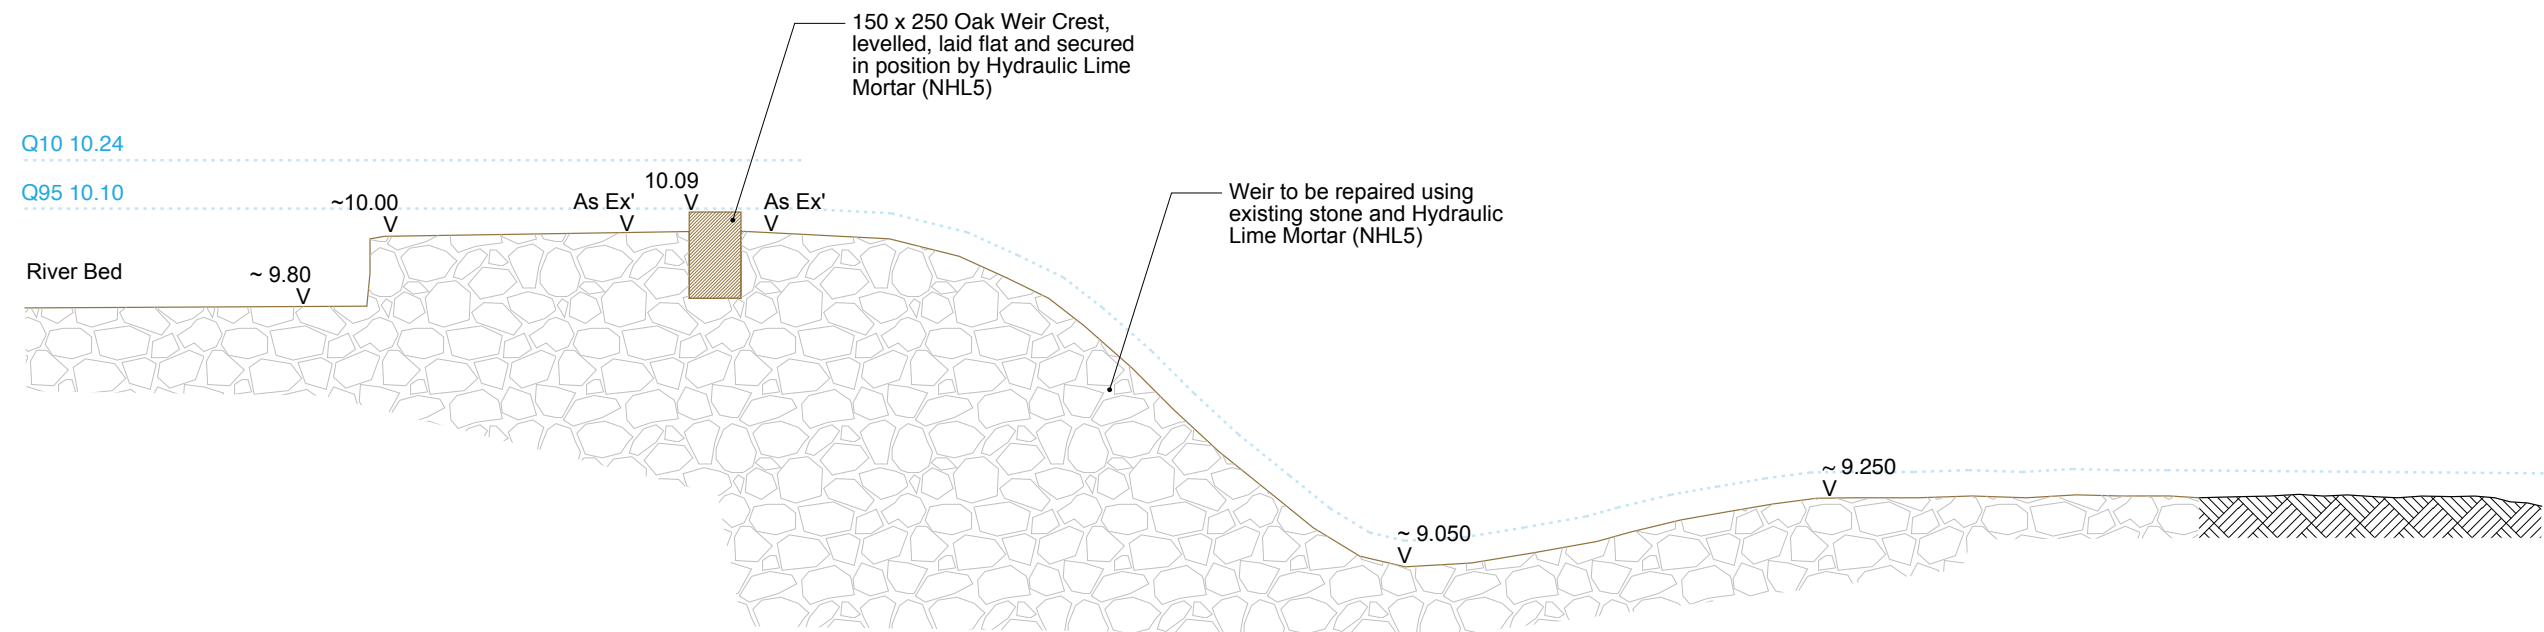
Typical Section showing Weir Rebuild / Repair - Profile Type 1

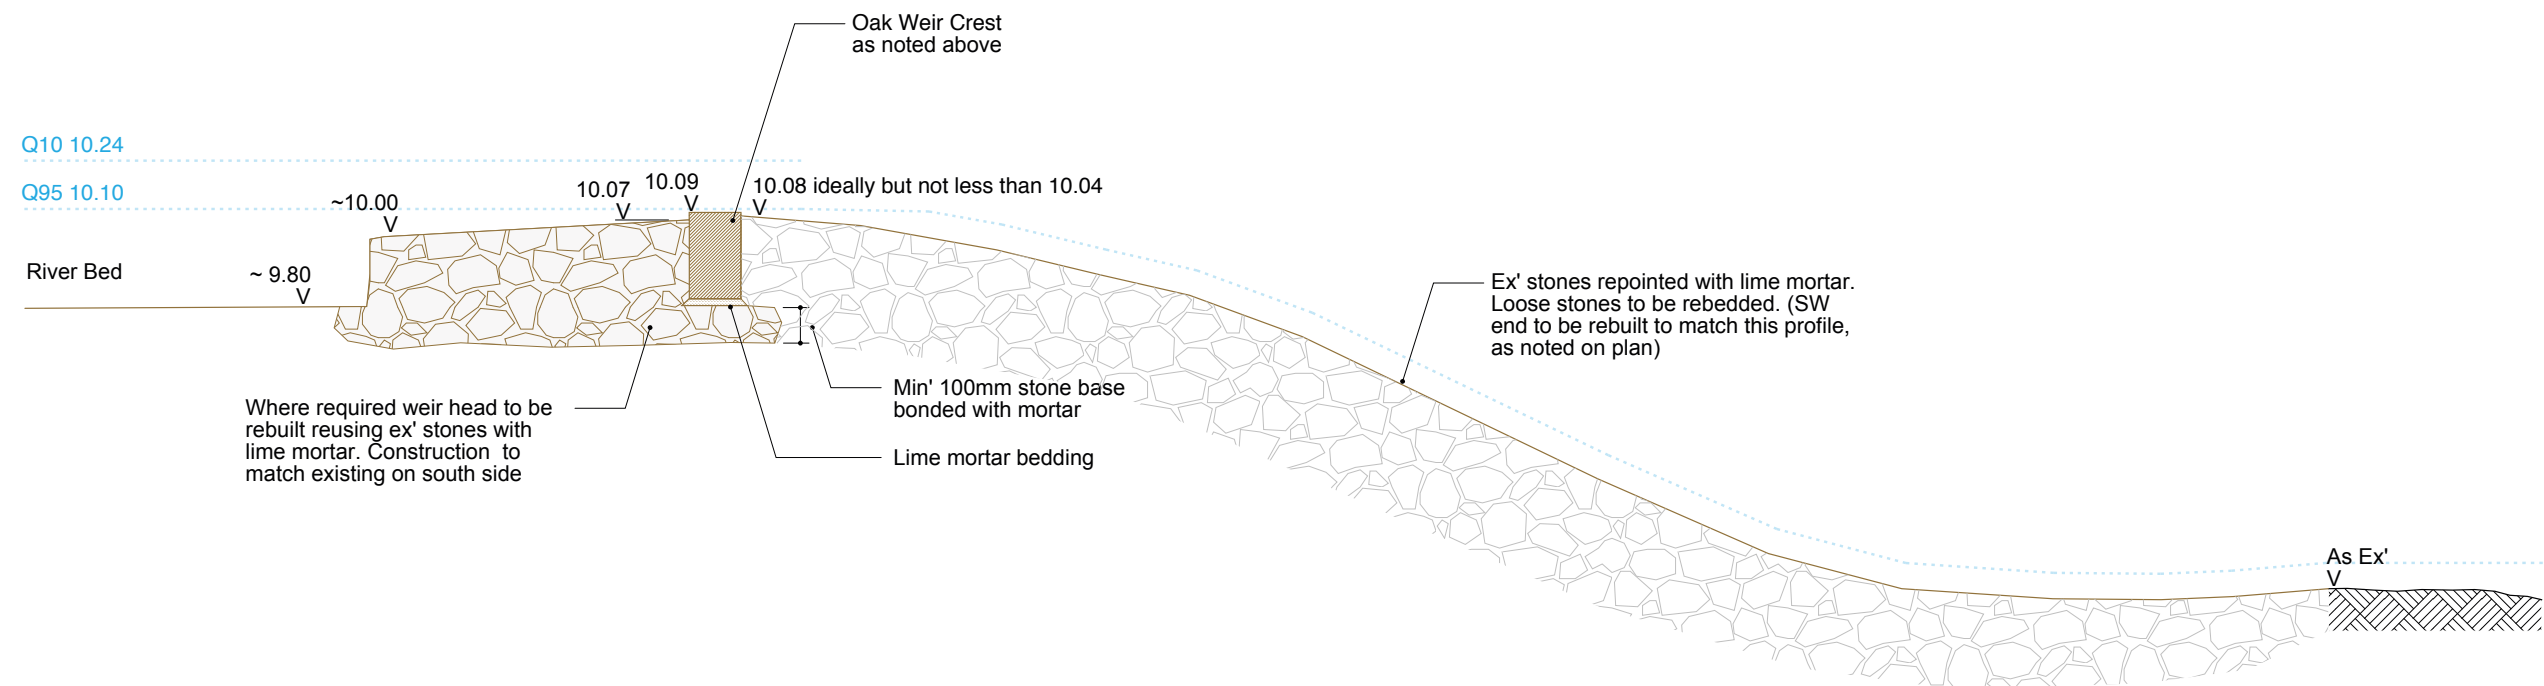
Typical Section showing Weir Rebuild / Repair - Profile Type 2
