Castle Street, Dumbarton
Archaeological Watching Brief and Evaluation
Data Structure Report
Project 4151

On behalf of: West Dunbartonshire Council

Project Number: 4151

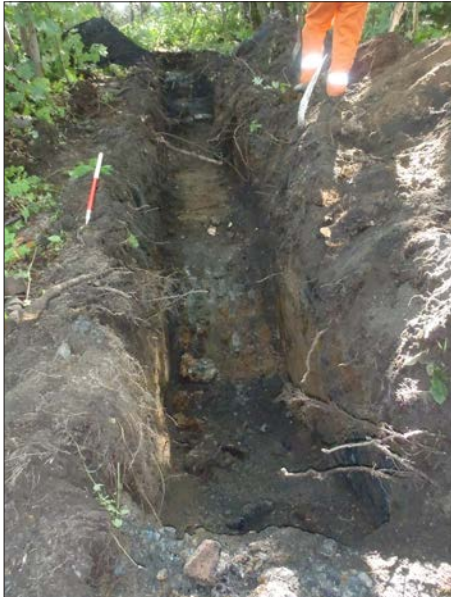
- 7.3.1 Within the north eastern area of the site, a total of three exploratory/evaluation trenches were opened. Trench H was located near the northern boundary wall and extended for 12 m (Figure 1). Within this trench two sections of red brick wall foundations (context 006 and 007) were exposed (Plate 1). Within the trench, the subsoil (context 008) was found to be highly contaminated with

significant levels of cyanide, a derivative of the gas works that once occupied this section of the site. As a consequence the developer instructed that the trench was immediately closed for health and safety reasons.

Plate 1: General photograph Trench H, facing east.

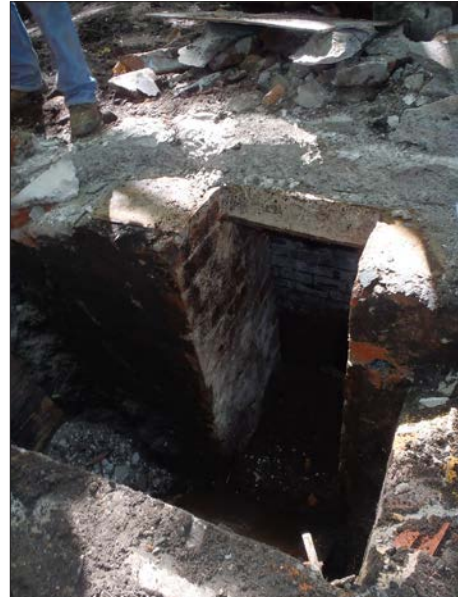
Plate 2: Opened entrance into possible air raid shelter, facing south.

- 7.3.3 Prior to arrival on Site, a concrete structure that appeared to be an air raid shelter had been uncovered within the wooded area, to the immediate north of the car park. The shelter was L-shaped in plan with four air holes along the roof and measured approximately 6.5 m by 5 m and 2 m wide. As a means of verifying the structure was an air raid shelter and to gain entrance, attempts were made to break open one of the corners of the structure, however the thickness of the bricks and concrete meant this was unachievable. The entrance to the shelter had previously been located, exposed and backfilled. As this was the most practical entrance to the shelter it was re-excavated and the steel doors opened. The entrance and interior to the shelter was found to contain a number of glass bottles as well as make-shift cooking facilities.

There was no datable material within the shelter, therefore it could date to the Second World War or potentially associated with the nearby gas works. Due to the reduction in height of the ground levels for the new development, the air raid shelter will be partly reduced in height and the interior filled with hard core or another suitable material.

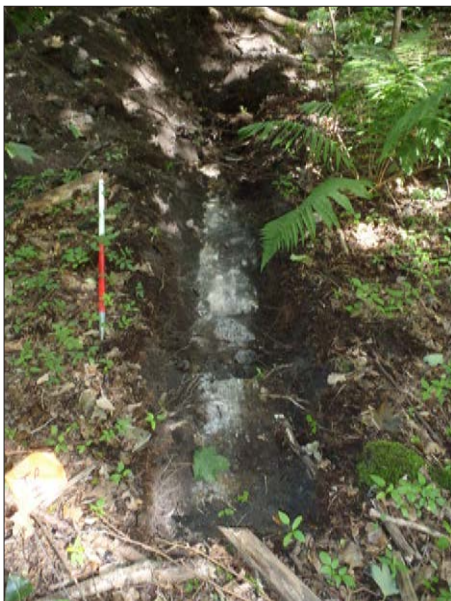
- 7.3.2 To the east of Trench H, two further trenches were machine excavated (Trench I and J; Figure 1) as a means of defining the extent of the contaminated soil. Both of these trenches uncovered a concrete skin (context 010) immediately below the layer of woodland leaf litter (context 005).

Plate 3: General photograph Trench I.

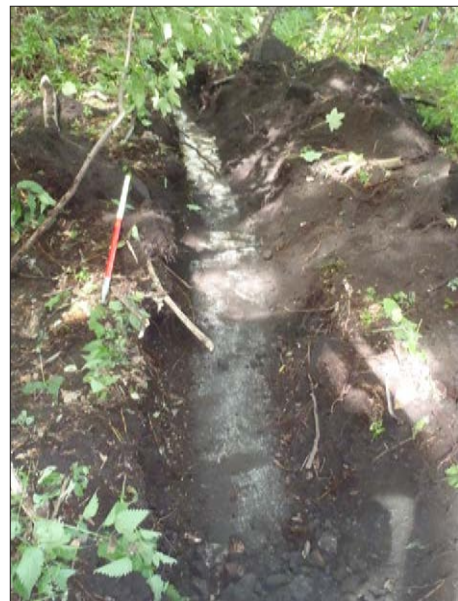
Plate 4: General photograph Trench J.
