Kilfinan Parish Church, Argyll & Bute Archaeological Watching Brief: Data Structure Report Project 4043

Kilfinan Parish Church, Argyll & Bute
Archaeological Watching Brief: Data Structure Report

Project Number: 4043

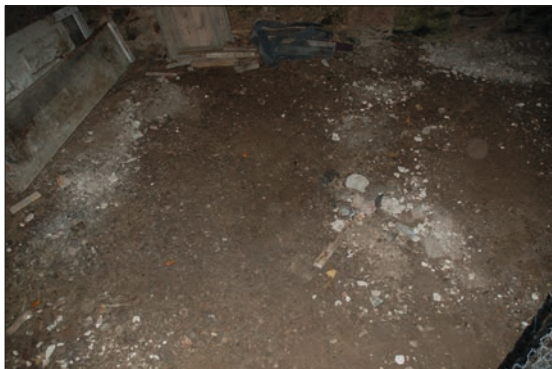
- 7.1 The total area of the watching brief measured 4.5 by 5.3 metres. The existing floor in the Lamont Aisle was a mixed deposit (Context 001) comprising rubble, sand and gravel with modern material such as plastic cabling (Plate 1). This deposit was removed, under close archaeological supervision, to the required depth of 350 mm by contractors Paul Morley & Son Ltd. Some 150 disarticulated human bones and five pieces of masonry were found distributed throughout the floor deposit.

Plate 1: Pre-excavation view of the Lamont Aisle.

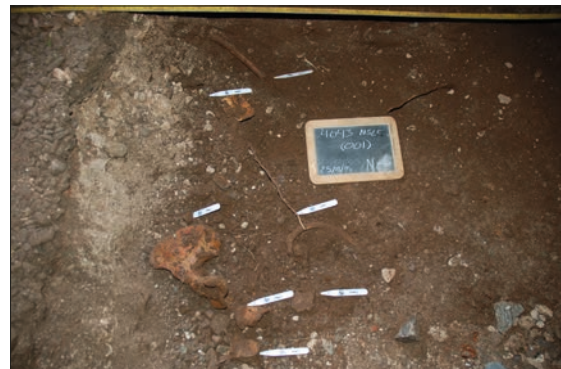
Plate 2: Small Finds 80 to 85 in situ.

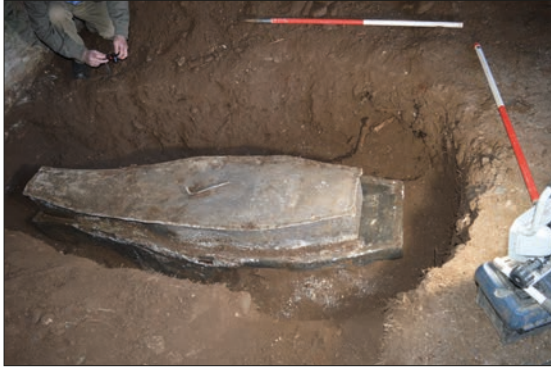
- 7.5 The two lead coffins were located opposite the entrance door to the Lamont Aisle and south of its east window. They were both orientated east-west, with the head end towards west following Christian tradition. The first one (coffin one) was placed on top of the second coffin (coffin two). Slight traces of burial soil were observed between them both, suggesting that they might have been buried at the same time or that care was taken to remove any grave soil deposited on top of coffin two prior to placing coffin one on top (Plate 3).

- 7.6 Coffin one, measured 1.815 m in length by 0.23 m height and was 0.47 m at its widest point. It was 0.29 m wide at the head end and 0.22 m wide at the foot end. Its lid was domed and presented no decoration or coffin furniture that could aid determining its date. It had caved-in at the centre as well as on both sides around the bottom half. A crack was present at the south side of the foot end, just under the lid, possibly as a result of some collapse of the walls. Some of the welded joints at the centre of the coffin and foot end were missing too. This probably led to the breaking of the seal and exposure to the air of any remains present inside the coffin.

Plate 3: Both coffins exposed.

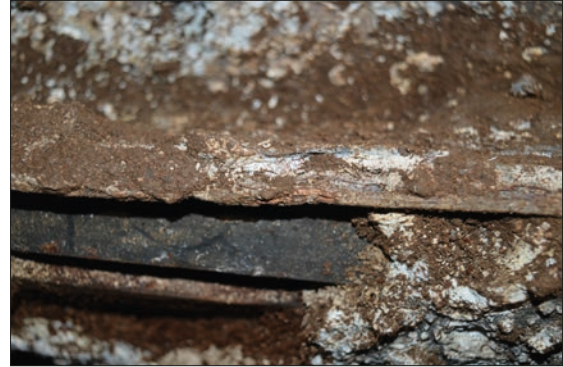
- 7.7 Coffin two was much bigger in size at 2.09 m in length by 0.63 m at its widest point, 0.38 m wide at the head and 0.3 m wide at the foot end. This coffin was not fully exposed due to the nature of the excavated space. Contrary to coffin one, a painted black frame, 80 mm thick, was present at the top of the coffin. Starting after the welded joint, it outlined the entirety of the coffin. Due to the placement of coffin one on top of it and the resulting lack of visibility, no other decoration/inscriptions were observed.

Plate 4: Inner wood and metal detail in coffin two.

- 7.8 While welding was observed on both coffins' covers, the construction techniques varied. Coffin one's vaulted lid was made of a separate wider lead sheet with the coffin shell folded over the lip and welded in. The welding job was much cruder than in coffin two. Coffin two's lid was same size as its shell and it was not vaulted, giving a uniform trapezoidal appearance to the coffin's profile. Damage due to corrosion at both top edges, revealed a possible metal framed inner wooden shell. (Plate 4: Inner wood and metal detail in coffin two)

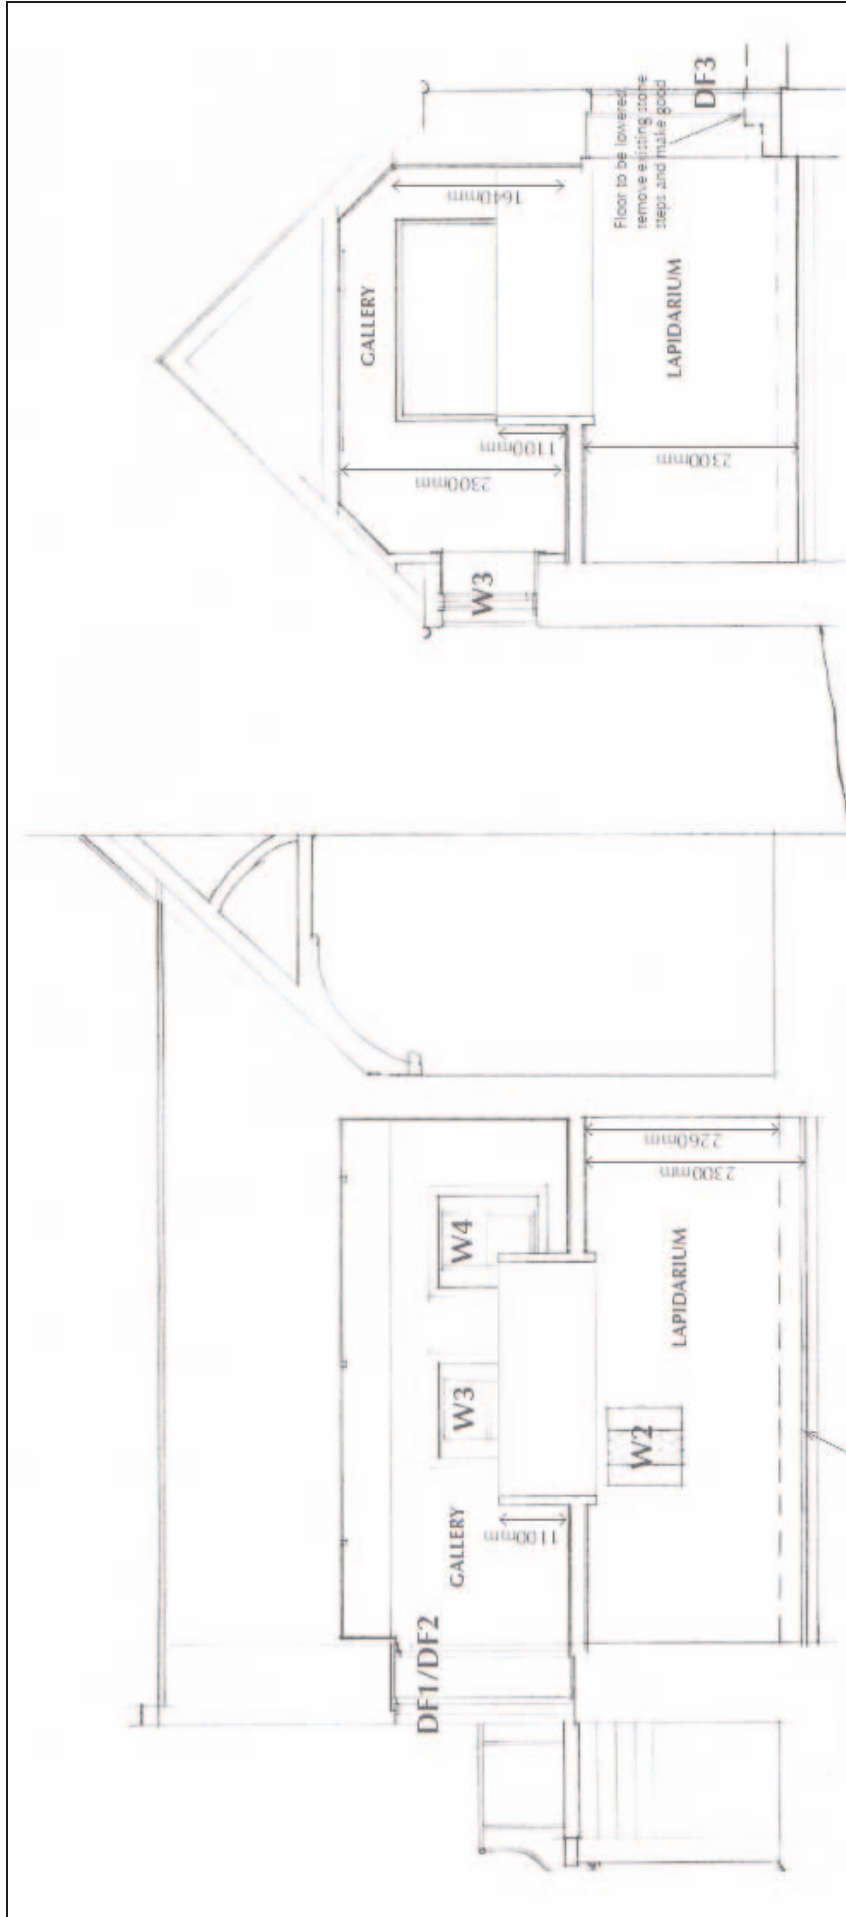
Figure 1:
Lapidarium alterations- reduction of current floor level by 350 mm

- 6.5 The scope of the watching brief will include archaeological monitoring of any ground-breaking interventions associated with the development to ensure that no significant archaeological remains are disturbed, without first being recorded. The watching brief will include the monitoring of all topsoil and/or over-burden stripping operations by machine or by hand-tools. The present floor level of the Lapidarium will be reduced by 350 mm (Figure 1).
