Largs Bowling Club: Geophysical Survey Data Structure Report Project 4255

Largs Bowling Club: Geophysical Survey Data Structure Report

On behalf of: Largs Bowling Club

Project Number: 4255

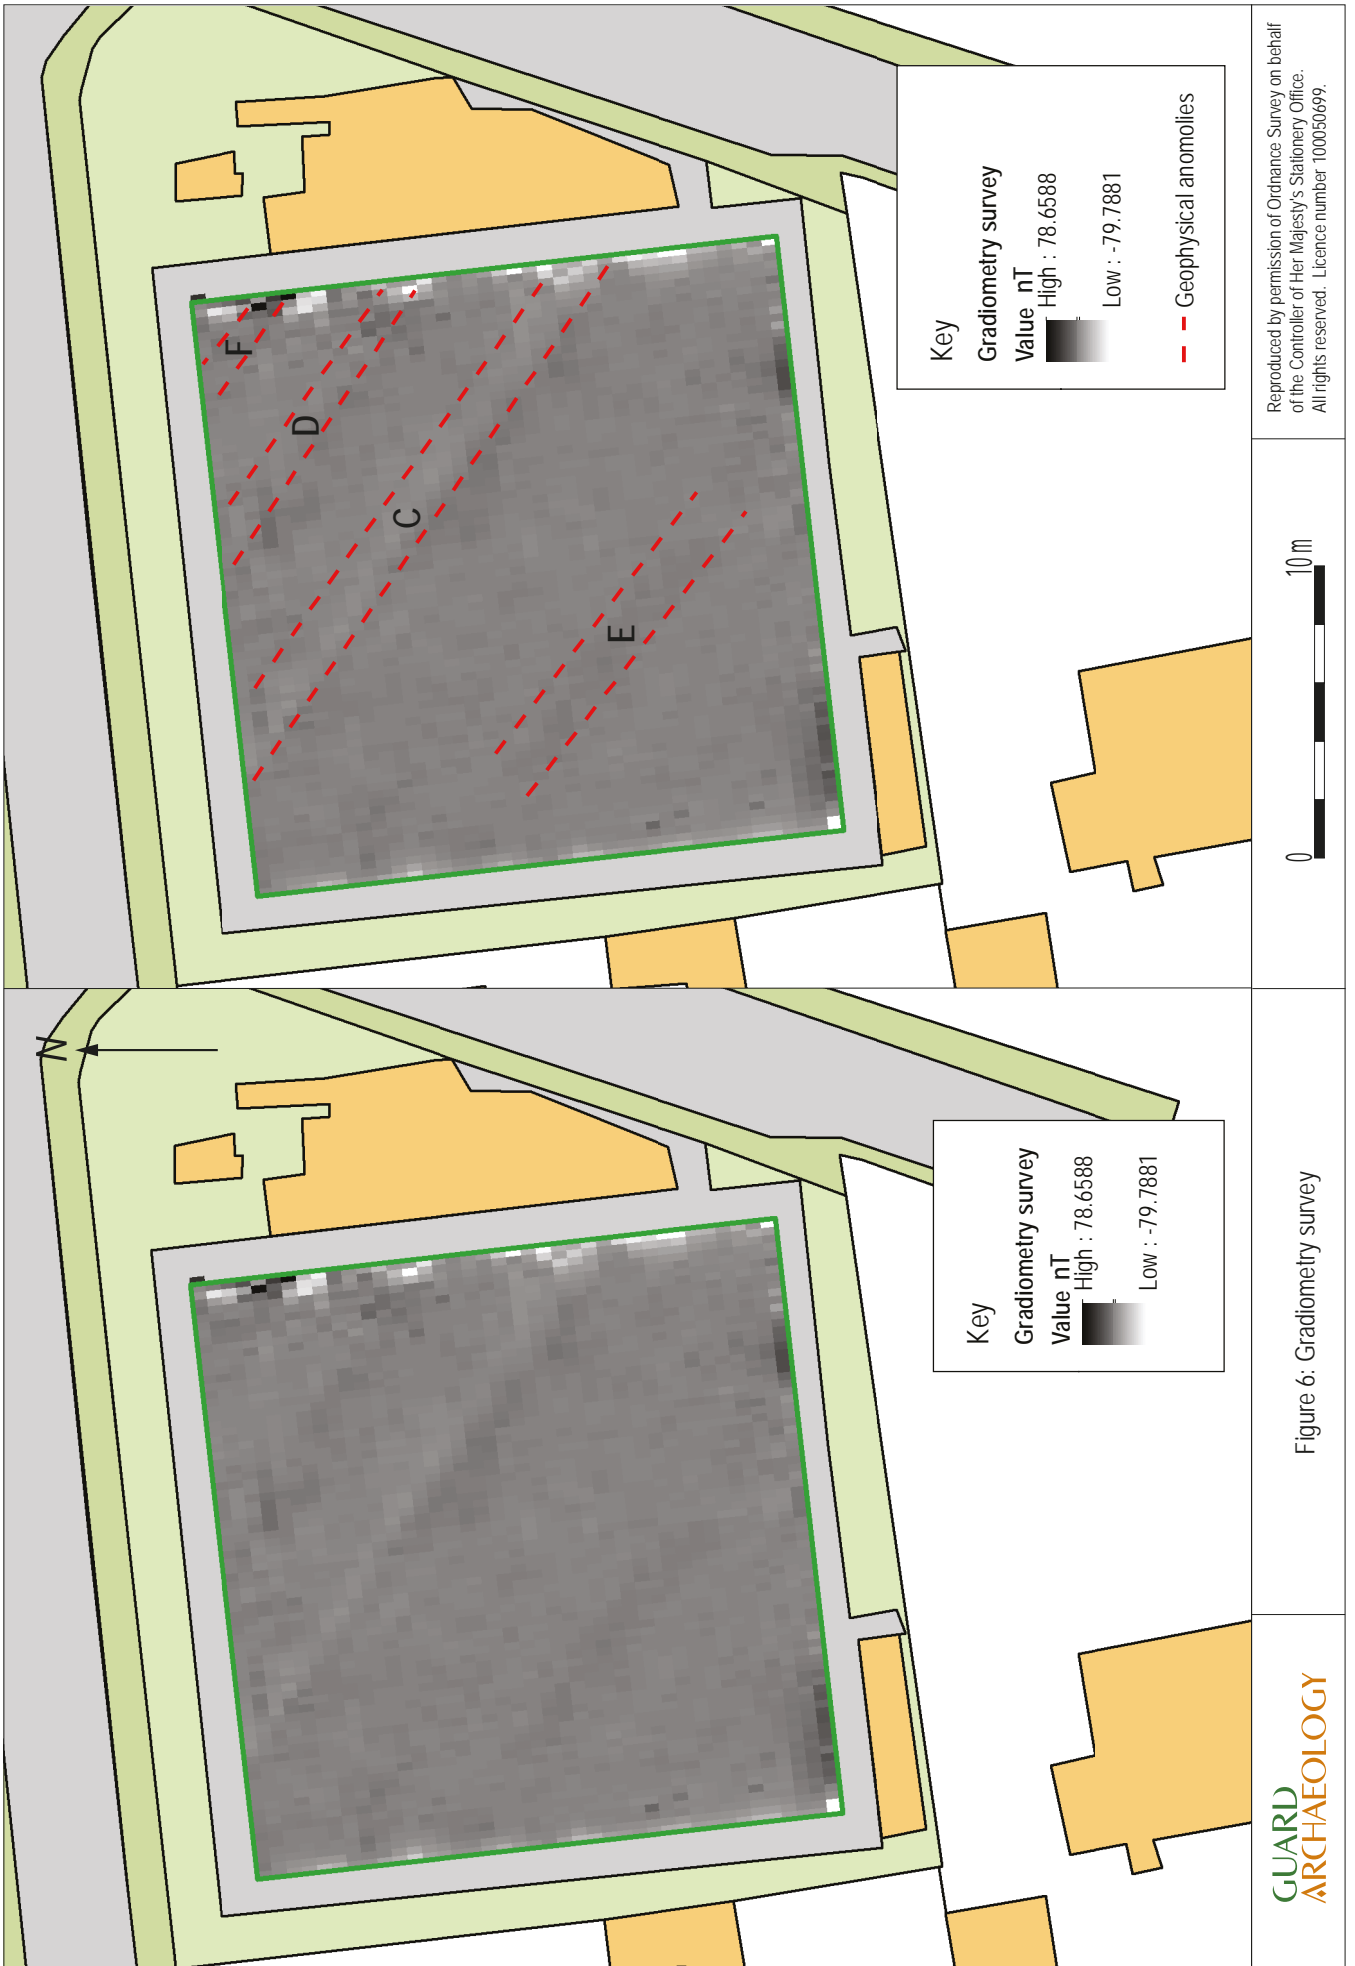
7.4 The gradiometry survey (Figure 6) identified three linear anomalies, all of which are aligned south-east to north-west across the bowling green (Anomalies C, D and E). The most distinct of these is Anomaly C, which is at least 34 m long and up to 1 m wide.

7.5 Anomaly D is a more subtle feature lying to the north-east of Anomaly C. It is visible for about 15 m and, like Anomaly C, is about 1 m wide.

7.6 Anomaly E is also a more subtle feature, and is located to the south-west of Anomaly C. This linear feature is about 17 m long and about 0.5 m wide.

7.7 A possible fourth linear anomaly (Anomaly F) may lie at the north-east corner of the bowling green, but is masked by magnetic disturbance in that area. This disturbance, which is also found on the west, south and east sides of the area surveyed, is indicative of the presence of metal, and is almost certainly caused by modern infrastructure associated with lighting around the green.

8.3 Anomaly C and, to a lesser extent, Anomalies D and E have the appearance of negative-cut features. The combination of slightly negative and slightly positive readings along the course of Anomaly C indicates some disturbance of the soil, with the in-fill material having marginally different magnetic properties to the surrounding soil. The geophysical signature of ditches can consist of one or more linear bands where the readings recorded over the ditch cut are noticeably different to those recorded on either side of the ditch. Depending on the nature of the ditch fill, the readings over the ditch cut can be more strongly positive or negative than the readings over the surrounding soil.

- 8.4 The morphology of Anomalies C, D and E strongly suggests that these are cut features lying at a depth of about 0.5 m to 0.75 m below the surface of the bowling green. The linear features are not equidistant, as C lies about 10 m north-east of E, and D is located about 7 m north-east of C. The features do, however, create a fairly regular pattern across the bowling green, and are of similar enough dimensions to suggest that they are all related.

- 9.1 The surveys identified three linear anomalies (Anomalies C, D and E) at Largs Bowling Green that have the characteristics of cut features. While it is very likely that these are cuts for drainage channels, the fieldwork could not positively establish this. No evidence for ceramic, or other types of pipe, was recorded within these channels, although their presence cannot be ruled out.
- 9.2 Should the linear anomalies prove to be drain cuts, they may be draining into Douglas Street or Brisbane Road. Intrusive work would be required in order to further investigate any of the geophysical anomalies.
- 9.3 The remaining anomalies recorded by resistivity (Anomalies A and B) do not represent sub-surface features, but are most probably a reflection of the soil composition over the extent of the bowling green.
