## Ardnaw Barn B, Kilmory Archaeological Watching Brief Data Structure Report Project 4257

## **Ardnaw Barn B, Kilmory, Archaeological Watching Brief Data Structure Report**

**Project Number:** 4257

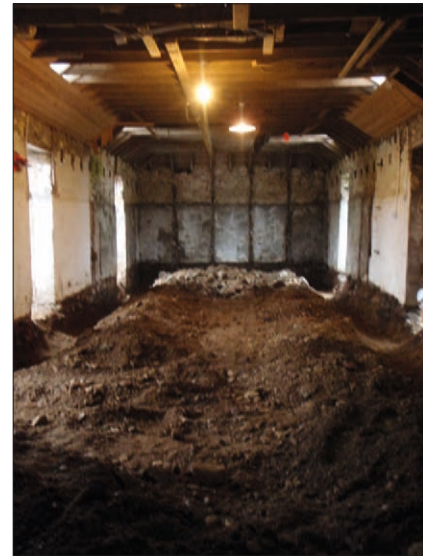
Plate 1. South end of barn showing drains.

7.1 Barn B measured approximately 18.7 m by 5.8 m. The interior deposits within Barn B were reduced by a depth of between 300 – 400 mm, removing the cobble floor surface (contexts 001 and 002) and the underling bedding material (context 002). This exposed a less stony and gravelly course sand (004). Context 004 was subsequently removed, revealing a loose, mid to dark brown, sandy soil (005). Around the internal walls of the barn a narrow channel measuring between 500 mm and 600 mm wide was excavated to a depth of 150 mm to accommodate services within the barn. No archaeological deposits were noted, see Plate 1.

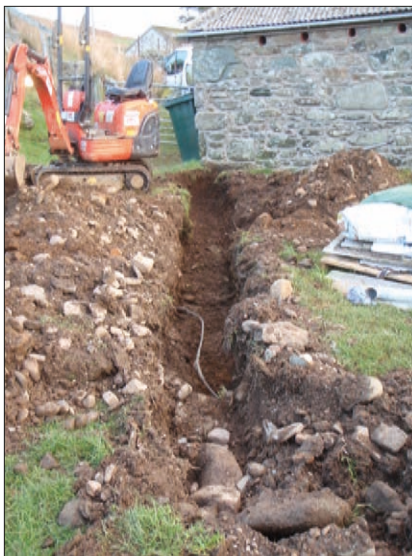
Plate 2. North west soakaway, post excavation.

7.3 During the course of the watching brief no features of archaeological significance were encountered, see Plates 2 and 3.

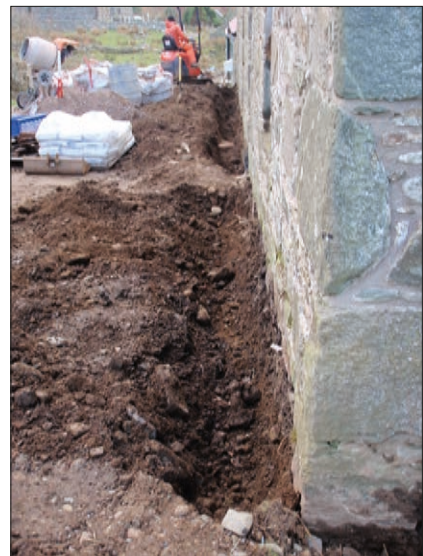
Plate 3. Trench along the east facing wall of barn B.

7.2 Externally a series of service trenches were excavated along the eastern, southern and western walls of Barn B. The trench along the eastern wall measured approximately 18.7 m long, 0.7 m wide with a maximum depth of 0.5 m. The trench along the southern wall measured 5.8 m long by 0.7 m wide with a maximum depth of 0.5 m. The trench along the western wall measured approximately 18.7 m by 0.5 m wide and 0.5 m deep. Extending from the western trench, two additional trenches were excavated as soakaways. The north-western soakaway trench measured 7.6 m by 0.5 m by 0.9 m and extended in a south westerly direction. The southern soakaway measured 6 m by 0.5 m by 0.8 m and extended in a westerly direction.
