## Wide Close, Lanark, Archaeological Watching Brief Data Structure Report Project 4183

**On behalf of:** South Lanarkshire Council

**Project Number:** 4183

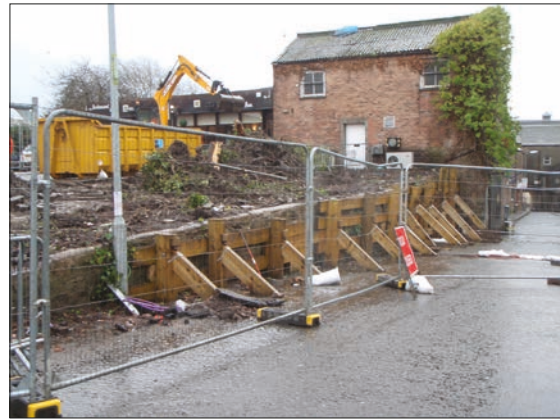
Plate 1: Shored wall.

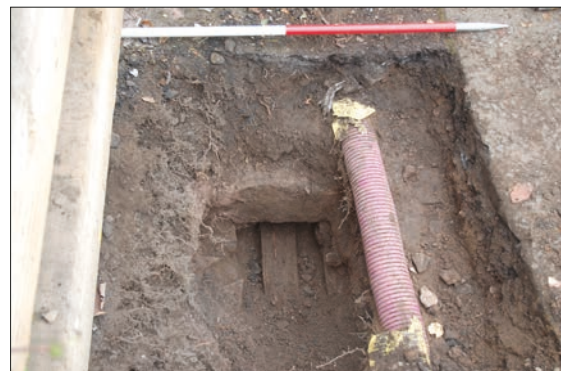
- 7.1 Five small site investigation pits were excavated prior to remedial works commencing. All contained building debris layers with pits 1 – 3 also containing service pipes and their associated backfills. No archaeological features or deposits were located in any of the pits although the foundations of several modern brick and stone walls were encountered. A possible stone-lined drain was also encountered in trial pit 1 (plate 2). Trial Pit 1 measured 1.66 m x 1.1 m x 0.68 m and contained a possible culvert or service trench running alongside the foundations of the retaining wall in a north/south direction. This feature had side walls constructed of rubble and a sandstone capstone 1005 measuring 200 mm thick. No bonding materials could be seen. Under the capstone was a 30 mm wooden plank covering a metal service cable. Trial pit 2 measured 3 m x 0.63 m x 0.84 m and contained the remains of an inspection hatch 2006 for a cast ceramic pipe measuring 250 mm in diameter. Trial Pit 3 measured 2 m x 0.95 m x 0.84 m and contained the foundations for the retaining wall 3008; a clay/rubble levelling layer 3004 with flat sandstone blocks 3009 underneath and a secondary, single skinned, sandstone wall with a sandy lime mortar bond 3007. Trial Pit 4 measured 2 m x 2 m x 1.85 m and contained the demolition material from the interior of the tannery building, including a single skinned brick wall with bricks stamped 'COLTNESS'. This brick was manufactured at a brickworks based in Carluke which operated from the late nineteenth century through to the 1960s ([www.scottishbrickhistory.co.uk](http://www.scottishbrickhistory.co.uk)). Trial Pit 5 measured 4.5 m x 2.5 m x 0.9 m containing the remains of a singled skinned brick wall with a 20 mm thick concrete render on its north face.

Plate 2: Trial Pit 1.

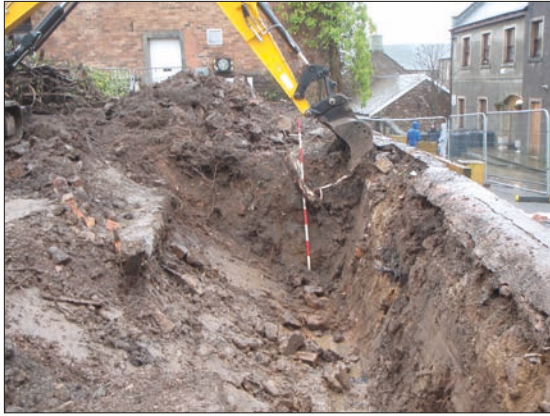
- 7.2 Ground breaking during the main phase of work revealed no features or deposits of archaeological interest. The site appeared to be dominated by layers of demolition debris (plates 3 and 4) containing remnants of the demolished Tannery building 001. The thickness of this deposit ranged between 2.9 m at the southern end of the site and 0.8 m at the northern end where it was not fully exposed due to the required construction level being shallower. The area included modern brick and concrete foundations for internal walls, sandstone walling, burnt timbers and concrete flooring. At the southern end and along the retaining wall was found a large rectangular door slab (plate 5) probably representing an earlier doorway which was later walled up. The lowest foundation stones of the wall were large in size and measured 0.7 m x 0.5 m with a depth of 0.11 m.

*Plate 3: Removal of overburden.*

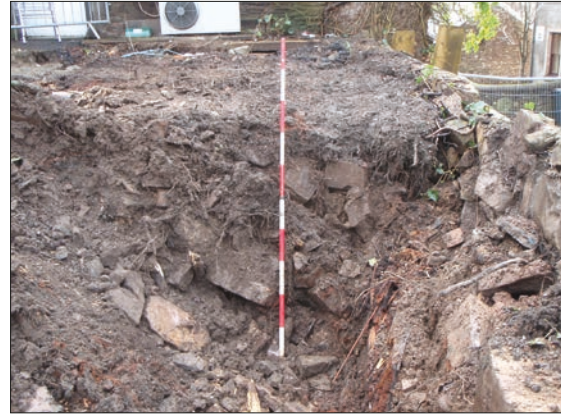
*Plate 4: Demolition material behind wall.*

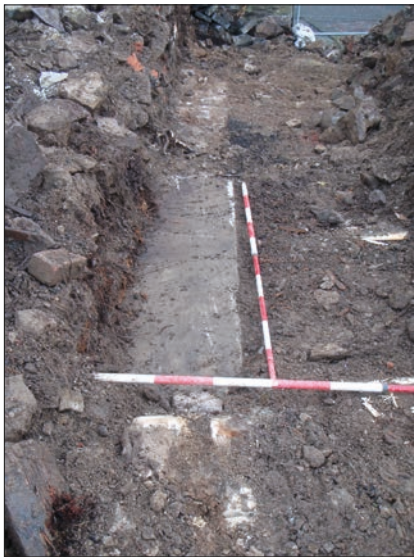
*Plate 5: Door slab.*

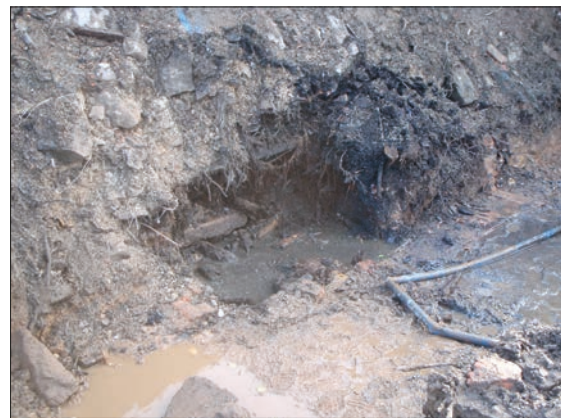
- 7.3 Also found during excavation work were two large voids within the rubble. The void closest to the southern extent of the wall is the possible remains of an oil tank (plate 6), whilst the void closest to the walls northern extent is constructed of brick with concrete capping although its purpose is unknown. However, it is more than likely associated with the Tannery which previously occupied the site.

*Plate 6: Possible oil tank.*

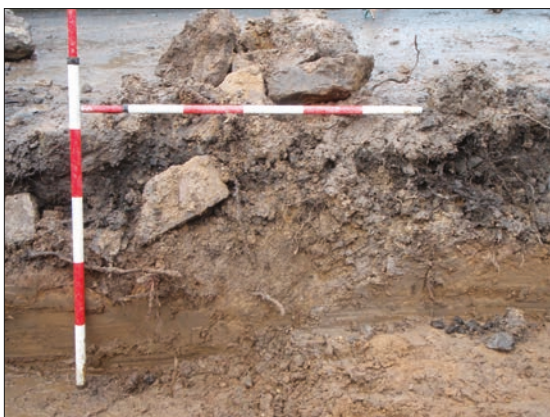
- 7.4 Located immediately below the demolition rubble was light brown/pink silty clay subsoil 002 (plate 7). This was encountered in most of the trench except the last 8 m from the north due to the required construction level depth being shallower at this end and the subsoil not exposed.

*Plate 7: Subsoil depth below present ground level.*

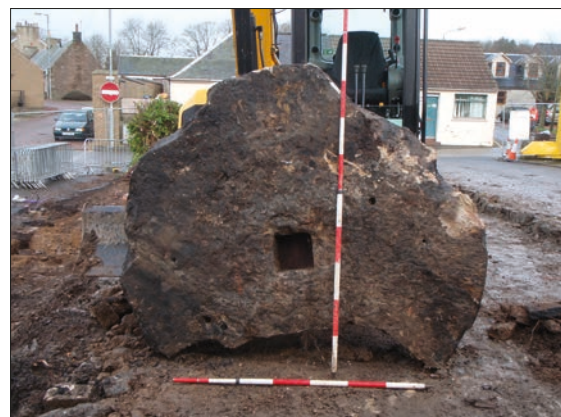
*Plate 8: Mill stone.*

- 7.5 During excavation work a large mill stone (plate 8) which measured 1.9 m x 1.9 m x 0.15 m was encountered within the building debris deposits. It appeared to be broken in several areas and its outer circumference was irregular in shape. The internal eye hole was roughly rectangular with a rebate edge and measured 0.2 m x 0.22 m. The eye had been covered with a square of slate which had then been cemented over suggesting the mill stone had been re-used for an unknown function.
