**St Mary's Hall, Biggar
Data Structure Report
Project 4291**

On behalf of: Biggar Kirk

Project Number: 4291

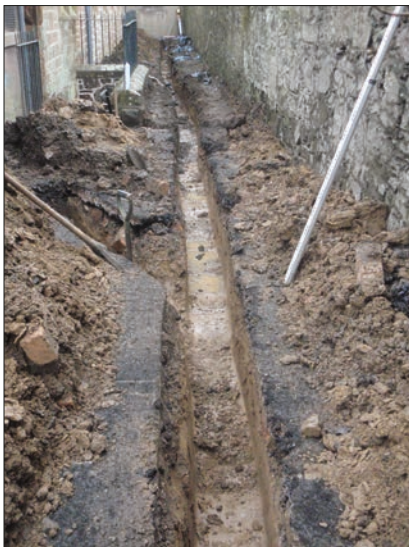
- 7.1 A total area of around 18 m² was stripped of topsoil to reveal various overburden deposits and a sterile subsoil (Figure 1). Within the northern and eastern drainage trenches the upper deposits consisted of a modern gravel surface 001 to the west and asphalt 004 to the east (Plate 1). Gravel 001 sat above a grey black mixed silt with sand, ash and dross material which was 0.1 m in depth, while asphalt 004 mostly sat above a mixed grey brown silt 005 with frequent bricks and cement bonding fragments which may have been the remains of a former yard pre-dating the asphalt or else simply collapse material. Sterile sandy clay subsoil 002 with occasional small pebbles and black mineral flecks was revealed across most of the area directly below the upper recent deposits, with no evidence of former topsoil present. The excavated depth for the drainage was between 0.45 m and 0.65 m, and frequent former services such as copper piping and ceramic drains were present towards the east, truncating the subsoil below.

Plate 1: Northern drainage trench, from the east.

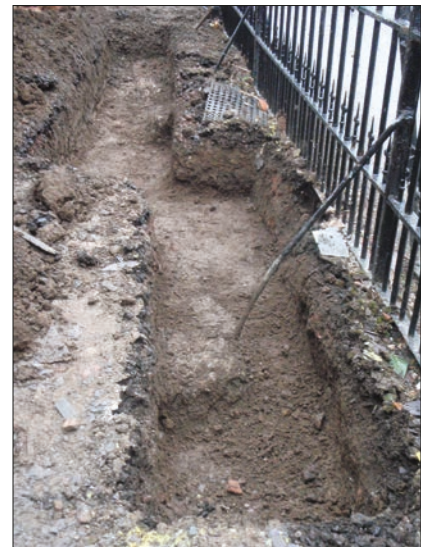
Plate 2: Southern foundations, from the west.

- 7.2 The exception to this was within the southern trench for the retaining wall foundations (Plate 2). Here asphalt 004 sat above a mixed grey brown silt 006 which contained frequent slate, stone and cement fragments. This was likely disturbed redeposited material from the construction of the extension to the existing hall and was later twentieth century in date. Subsoil was not reached within this trench, at a depth of 0.4 m.

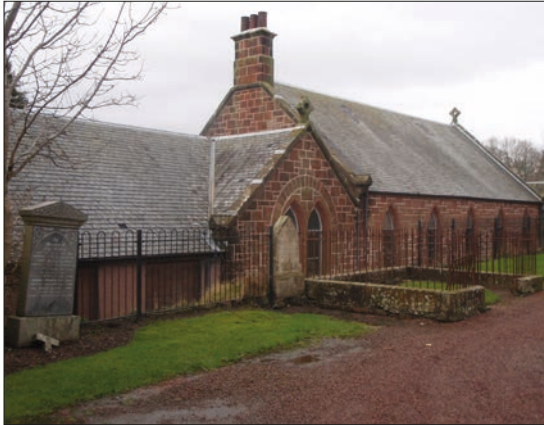
Plate 3: St Mary's Hall from and adjacent gravestones, from the north-east.

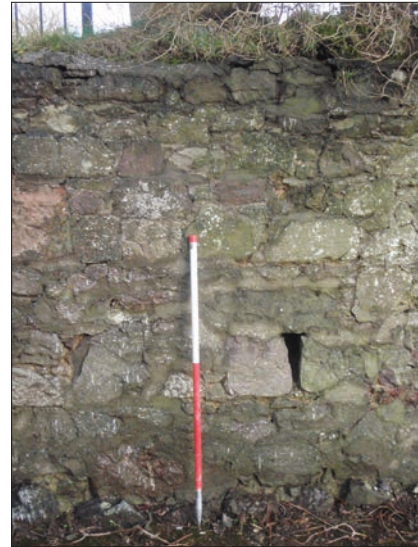
Plate 4: Retaining wall at the churchyard, showing depth of St Mary's Hall site.

- 7.3 A likely explanation for the lack of any indication of a former topsoil or upper deposits may be due to the fact that the hall itself sits at a depth of around 2.1 m below the adjacent churchyard to the north, bounded by a retaining wall running the length of the property along this side (Plate 4). The church itself does sit on a raised knoll, however clearly a certain amount of cutting must have occurred to create the flat ground on which the adjacent hall is located and it is likely that this may have removed any archaeological remains which predate the hall. The construction processes involved in the building of the hall are likely to have caused significant disturbance to the areas observed given their proximity to the building footprint. The hall has a basement level which must have required substantial excavation, with this depth likely reaching at least 5 m below the current level of the adjacent churchyard. This indicates that the subsoil level observed has likely already been substantially truncated.

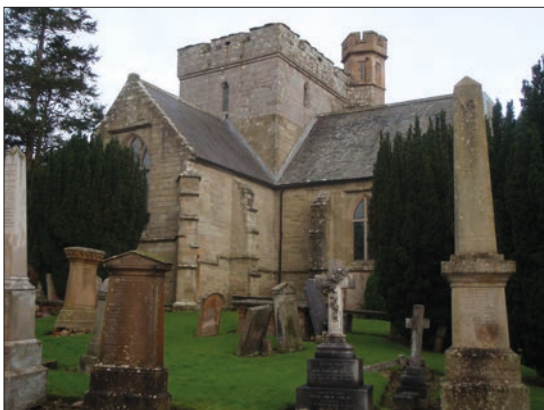
Plate 5: Biggar Kirk, from the south-east.

- 8.2 Although the current Biggar Church dates to the mid sixteenth century (Plate 5), the grave stones at this side of the churchyard adjacent to the site of the hall date to the mid nineteenth century (Plate 6). The St Mary's Hall was not constructed until very late in the nineteenth century or the early twentieth century, being present on the Ordnance Survey 1911 25 inch edition, but not on the 1897 edition, meaning that these existing marked burials within the churchyard took place prior to construction of the hall and any associated ground disturbances. However the churchyard boundary is present on the earliest 1864 Ordnance Survey map of the area as similar, if not slightly to the north of the existing boundary, suggesting that it is unlikely that any Later Historic burials or other features directly associated with the church were likely disturbed during this. The layout on this earlier map suggests that the land was still in use on the site of the later St Mary's Hall and along the length of the existing North Back Road as long thin cultivated or pasture strips. These strip likely reflect the earlier Medieval burgh plots of the town suggesting that the church grounds have not ever extended this far. Any remains related to the layout of these plots has likely been destroyed during the construction and extension of the Hall.

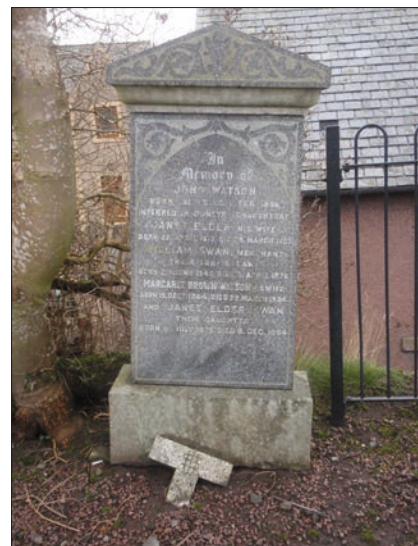
Plate 6: Gravestone at the edge of the Church and Hall boundary; earliest date is 1866.
