**Lanark Road, Carlisle  
Data Structure Report  
Project 4334**

## Lanark Road, Carluke Data Structure Report

**Project Number:** 4334

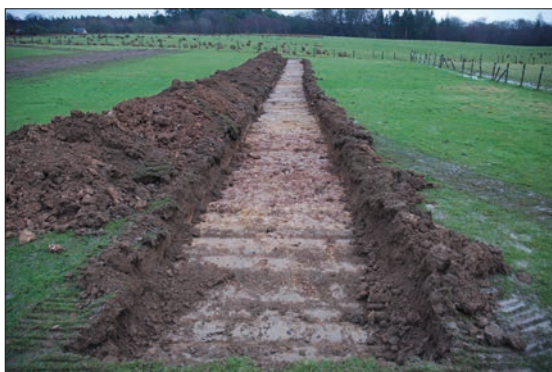
7.1 During the course of the evaluation 29 trenches were excavated across the area. Topsoil was a dark brown grey loam with small stones and roots around 0.3 m in depth across the area, and was frequently waterlogged at the surface. For the majority of the area this sat directly above subsoil which was generally a light pinkish grey orange beige sandy clay with frequent stones. Frequent plough scarring was visible in this. Occasionally a mid brown grey silt clay intermediate deposit was present within natural undulations or at slight topographic break of slope areas. This was between 0.15 m – 0.2 m in depth, but was only occasionally present.

Plate 1: North-west facing section of Trench 19.

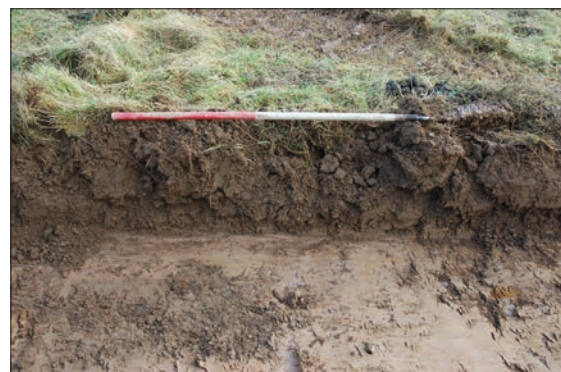
Plate 2: Trench 9 from the north-west.

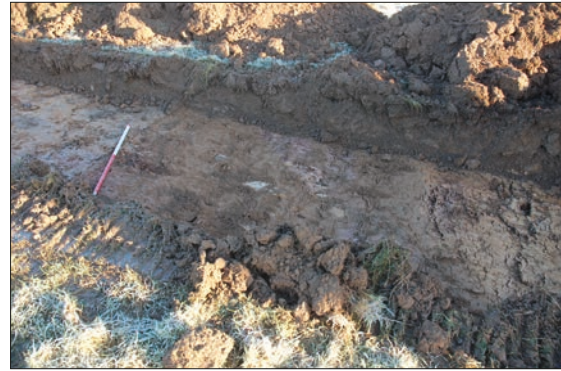
7.2 Apart from what would appear to be fairly intensive plough scarring and compaction, little disturbance was visible below topsoil level across the area. Ephemeral furrow remains were sporadically present within some trenches on a north/south orientation, which were of a mid brown silt clay and survived to around 1.8 m in width and 0.15 m in depth. These are faintly visible as a regular system on recent aerial images of the site and more clearly on Ordnance Survey aerial imaging from 1944-50, particularly in the lower area where trenches 26 – 29 were located, although seem to be largely plough truncated.

*Plate 3: Furrow within Trench 14, from the south.*
