Chaorach, Killin Archaeological Watching Brief Data Structure Report Project 4182

Chaorach, Killin
Archaeological Watching Brief
Data Structure Report

On behalf of: WSP Parsons Brinckerhoff

Project Number: 4182

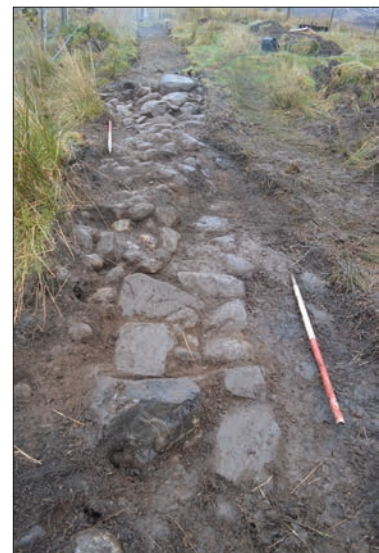
Plate 1: Detail of rubble structure from the North.

- 7.3 The rubble foundation was central to the trench, extending up to 8 m in length from the south-east to the north-west. The trench itself was 1.4 m in width and much of this was filled with rubble collapse. A section or alignment of stone was noted at the north-west end of the trench possibly displaying a return. At this point the rubble wall appeared to be 0.6 m in width.

- 7.4 The matrix of the foundation course appeared to be drystone and un-bonded. The angular and rounded granite stones ranged in size between 0.2 m and 0.45 m. During the cleaning of the feature, no material culture was recovered to indicate any age. Photographic recording was undertaken alongside planning and written description before the feature was covered by terram and backfilled. No excavation was undertaken with the decision taken in consultation with WoSAS and the client to preserve the feature in situ and re-route the cable through the neighbouring field.

- 9.2 Given that no further works will impact on the remains uncovered near to Suie Cottage, all encountered features have been recorded, covered and preserved in situ and that all ground works associated with the proposed power line upgrade have been monitored. Following consultation with the Archaeological Advisor to the planning authority, it is recommended that no further monitoring work should be required.

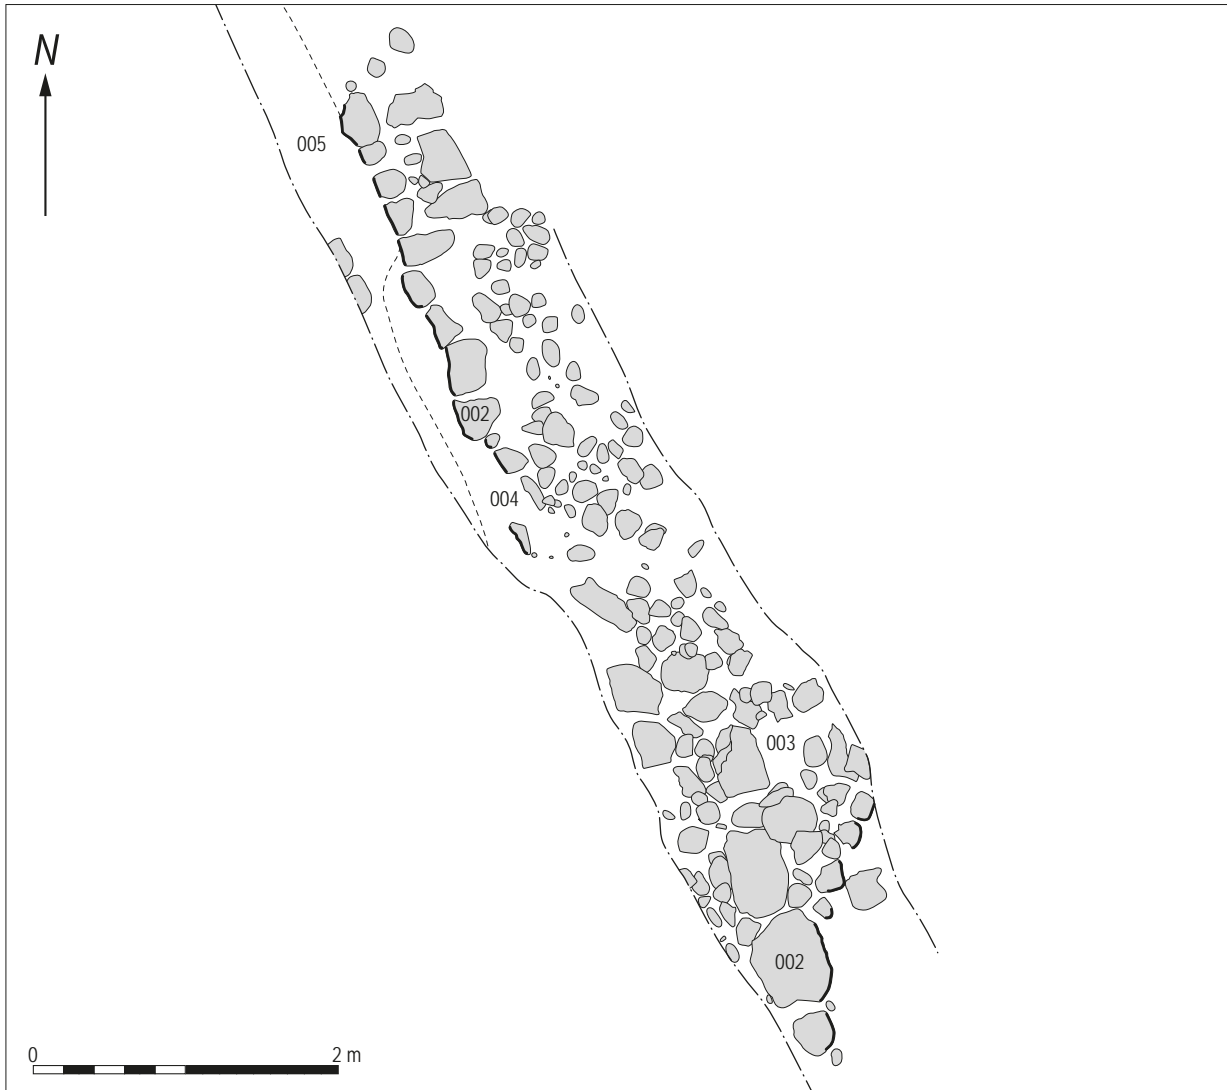
Figure 6: Plan of rubble feature at Suie cottage.

- 8.3 The rubble feature, although not excavated, likely relates to a gable end of a possible eighteenth century structure. Areas adjacent to the excavated trench appear to display extensions to the structure with visible crop-marks indicating the likely footing of a structure.
