Bruach Caorainn Hydropower Scheme Topographical Survey and Archaeological Controlled Topsoil Strip Data Structure Report Project 4283

Bruach Caorainn Hydropower Scheme Topographical Survey and Archaeological Controlled Topsoil Strip Data Structure Report

Project Number: 4283

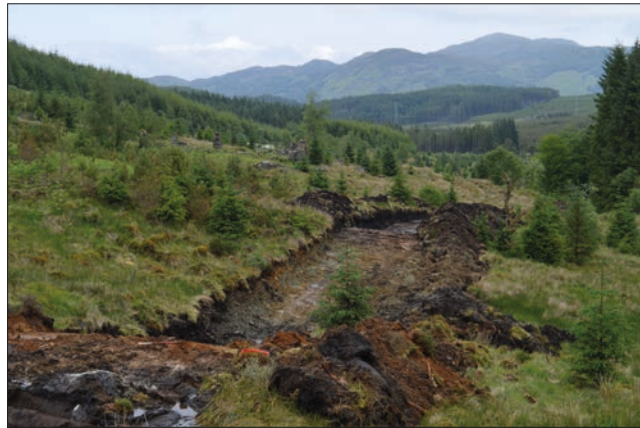
Plate 1: General view of the pipeline easement, looking towards the homestead, at the south-western end of the monitored area. Areas of deep peat can be seen in the south-east facing (uphill) section of the trench.

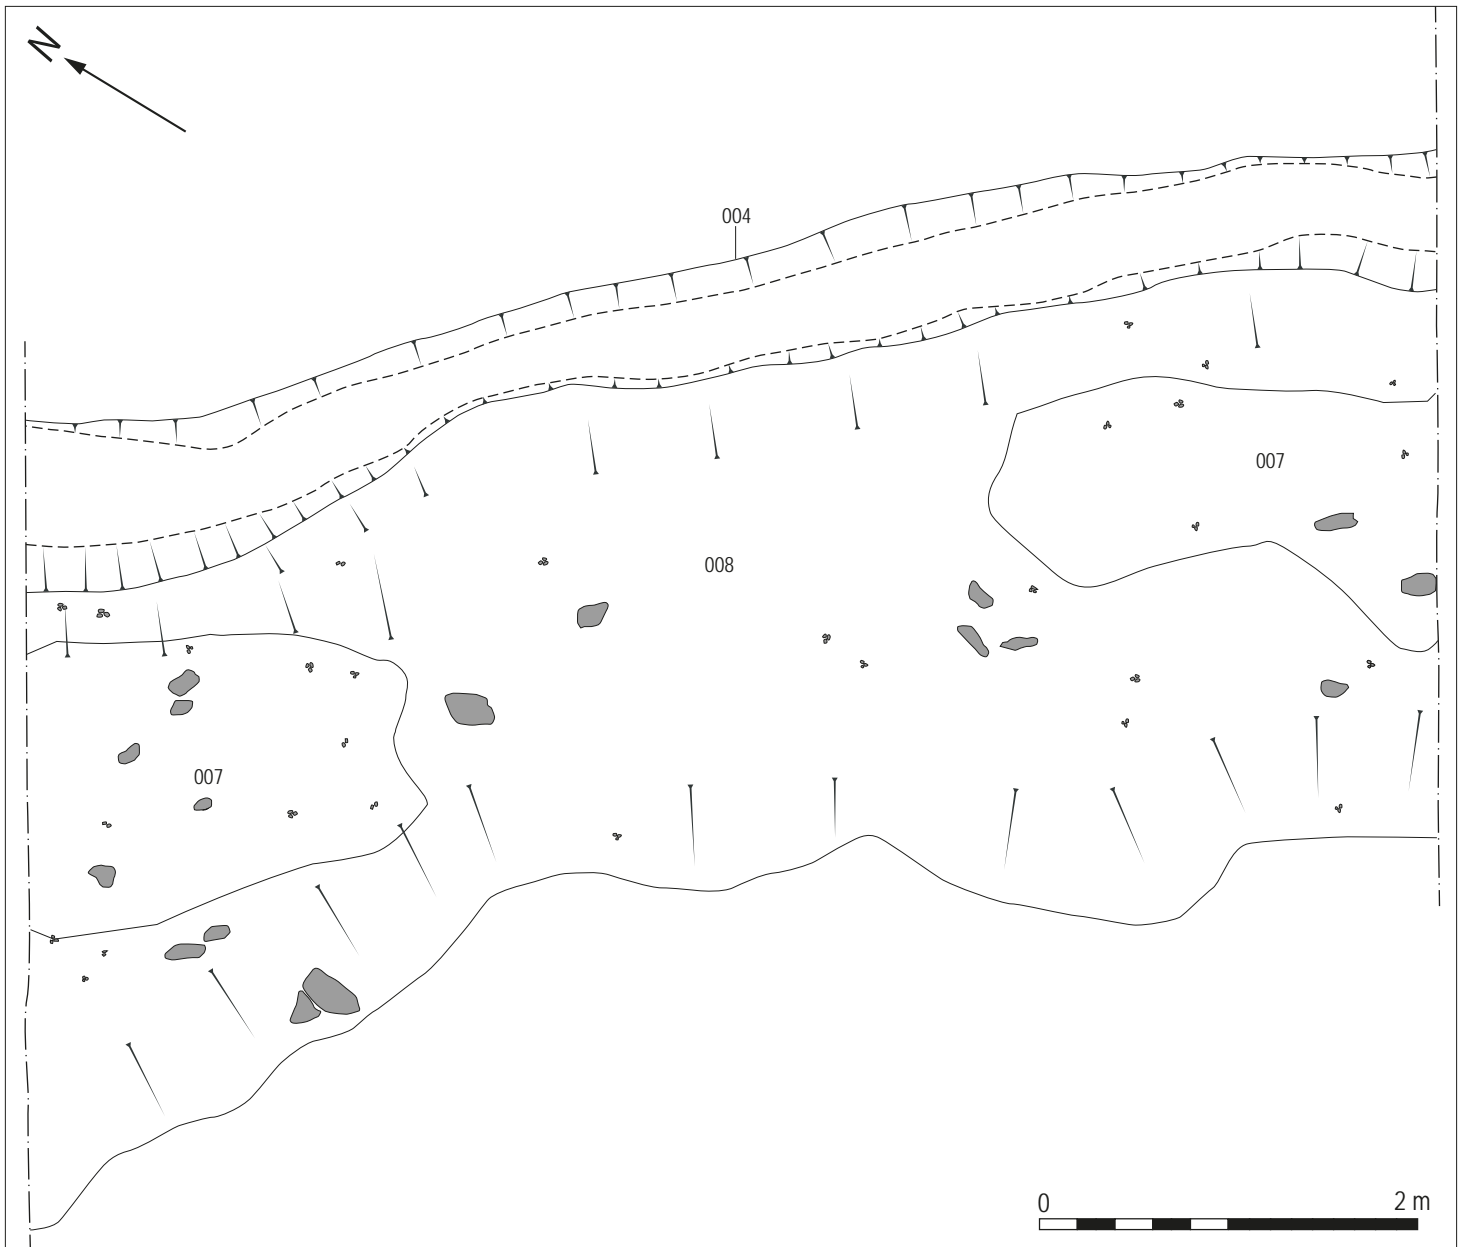
Figure 5: Plan of excavated part of track 006.

7.2.4 A track 006 (Figure 5) was uncovered during the controlled topsoil strip, this was curvilinear in plan and slightly cambered in profile. The track was made up of redeposited natural till 007, 008 and 011 (Figure 6) probably quarried from a steep sided narrow trench 004 which lay parallel to the track along its north side as the track approached the corn drying kiln, located to the south of the settlement. The narrow trench 004 switched to the west and south sides of the track as it circumvented the east and north sides of the homestead respectively. The track 006 was excavated over a distance of 7 m within the stripped area, it measured 2.2 m wide and was built up to a height of 0.29 m. The construction trench 004 measured 0.6 m wide by 0.4 m deep and was filled with a turf and negligible topsoil horizon with frequent moss and sparse grass 005 growing in the base and along the sides of the trench cut. The construction trench 004 also appeared to serve as a drain although there was no silt at the base of the trench, this function may explain the change of position of the construction trench from one side of the track to the other. A possible stone implement in the form of an ard point SF 1 was found at the base of the construction trench and the find looks comparable in size and form to at least one held in a collection of stone ard points at the Hunterian Museum in Glasgow (Hunterian Museum Archaeology collections, catalogue number GLAHM B.1914.623).

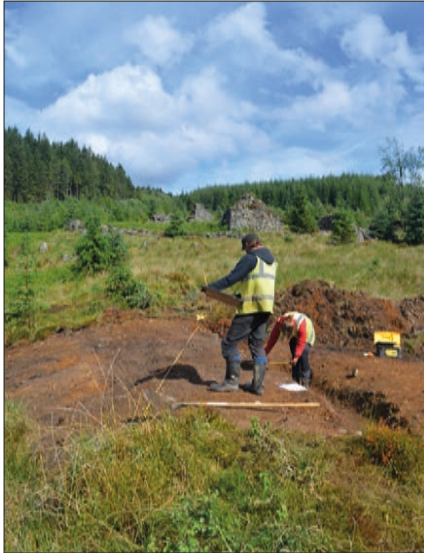
Plate 2: General view of track 006 after cleaning, during planning and recording, from the south-west.

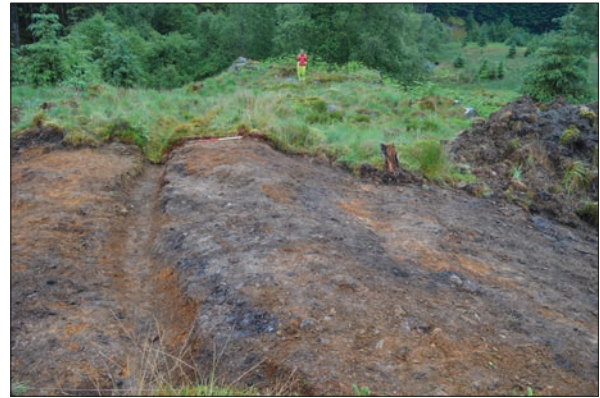
Plate 3: General view of track 006 and construction trench 004, from the north-west. Person to rear centre of frame is standing at the corn drying kiln.

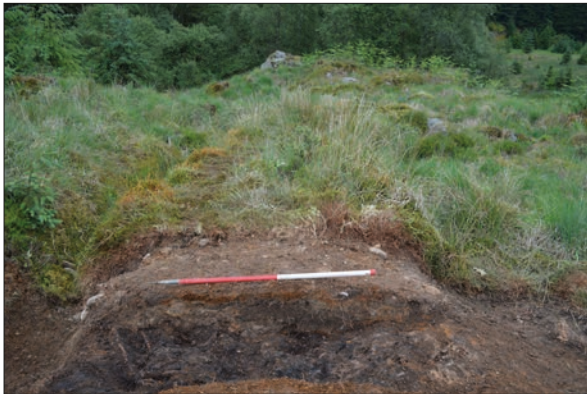
Plate 4: North-west facing section through redeposited natural deposits 007 and 008 forming the fabric of the track 006 which overlies buried topsoil horizon 009, from the north-west.

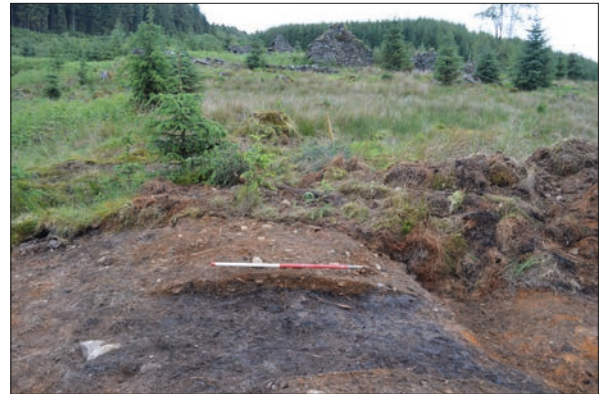
Plate 5: South-east facing section through redeposited natural deposits 007 and 008 forming the fabric of the track 006 which overlies buried topsoil horizon 009, from the south-east.

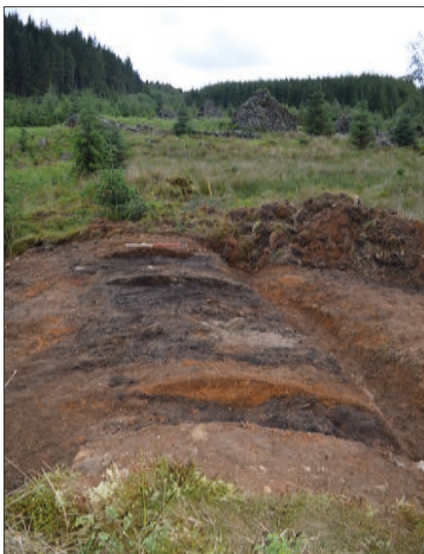
Plate 6: General view of track 006 and construction trench 004 with the majority of the redeposited natural 007 and 008 forming the fabric of the track removed, from the south-east.

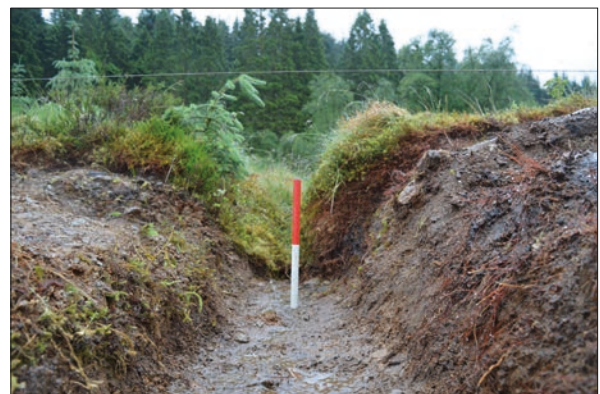
Plate 7: Detail of construction trench 004, overgrown with vegetation layer 005, from the north-west.

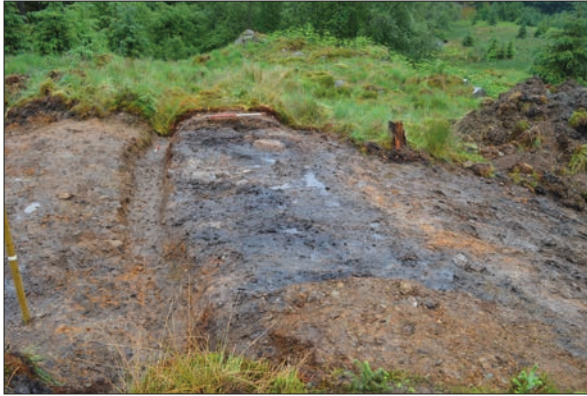
Plate 8: Post excavation view of track 006 and construction trench 004, the course of the track is clearly defined by the construction trench along the left hand side of the track and the dark buried topsoil horizon 009 below the removed material forming the fabric of the track, from the north-west.

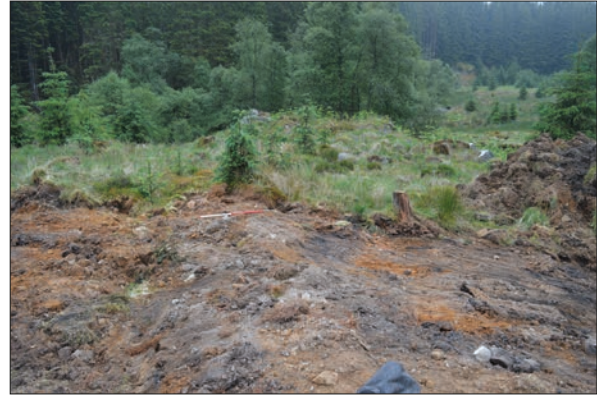
Plate 9: Pre-excavation view of track 006 and construction trench 004, from the north-west.

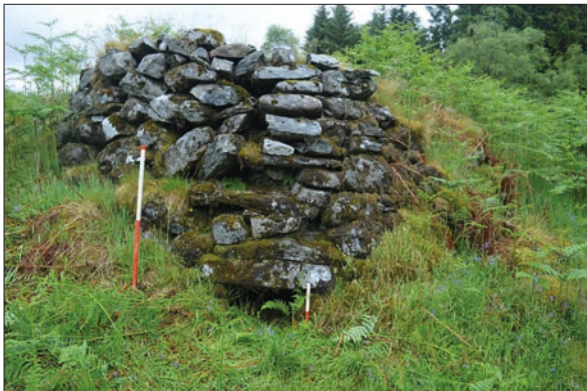
Plate 10: Corn drying kiln, stokehole visible to the immediate left of 0.4 m scale, from the south-west.

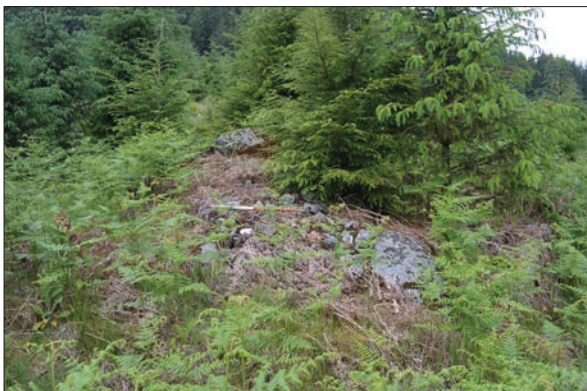
Plate 12: Possible clearance cairn at Cuil Muilinn NN 41675 00573.

7.2.5 An adjacent area of archaeology was observed at Cuil Muilinn visible on the Ordnance Survey explorer 1:25000 map sheet 364 south-west of the Bruach Caorainn settlement. In this location three possible clearance cairns visible as heaps of stones thrown up against and around large erratic boulders were visible. A track aligned from the south-west beyond Cuil Muilinn leading to the north-east to Big Bruach Caorainn before turning to the north-west and climbing the hill to the forestry track was also observed (Figure 3). These features were rapidly recorded photographically and by handheld GPS survey.

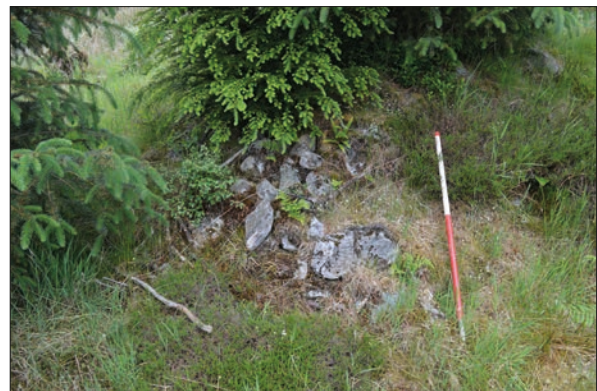
Plate 13: Possible clearance cairn at Cuil Muilinn NN 41672 00584.

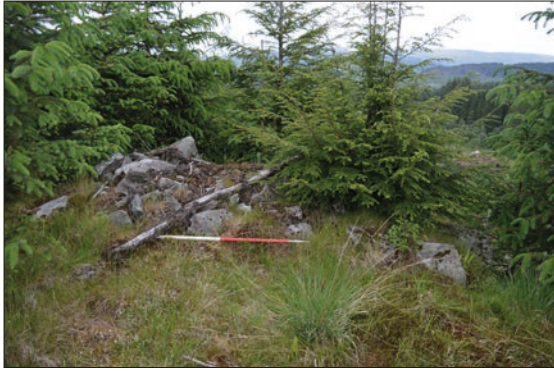
Plate 14: Possible clearance cairn at Cuil Muilinn NN 41666 00594.

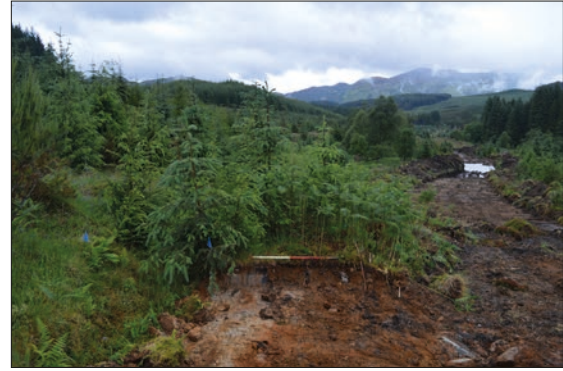
Plate 15: South-west facing section across track at Cuil Muilinn which leads to Big Bruach Caoruinn homestead, blue flags to left of track indicate position of construction trench.

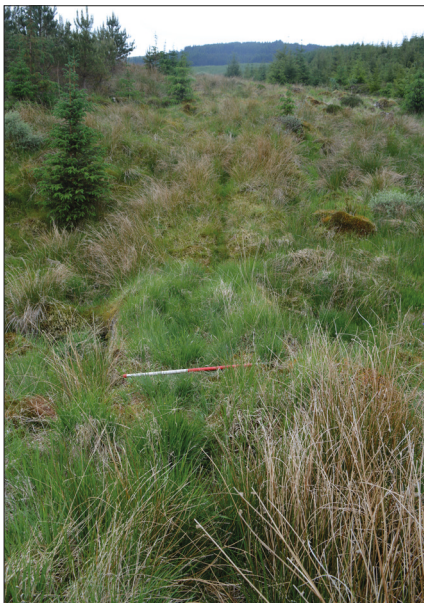
Plate 16: The track crossing the unnamed burn at Big Bruach Caoruinn homestead looking towards Cuil Muilinn.

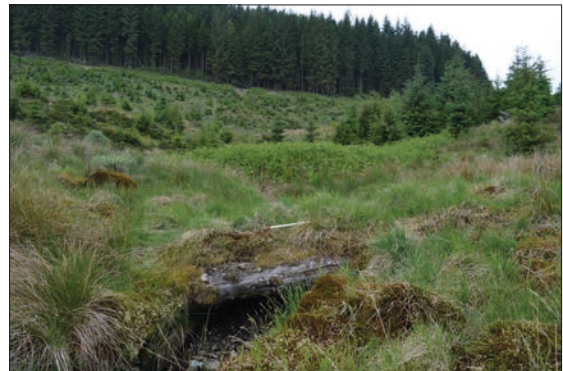
Plate 17: Tree trunks forming a bridge to carry the track over the unnamed burn at Big Bruach Caoruinn homestead.

- 8.2 Both the homestead and the tracks have young trees either growing on them or close to them, some of the trees may have reseeded naturally but ultimately these will have an adverse affect on the remains of the homestead and the tracks. It is understood that presently the Forestry Commission leave a 20 m buffer zone around cultural heritage sites when replanting or creating new woodlands. This practice will ensure that future forestry operations will have no further impact upon the surviving remains of Big Bruach Caoruinn.

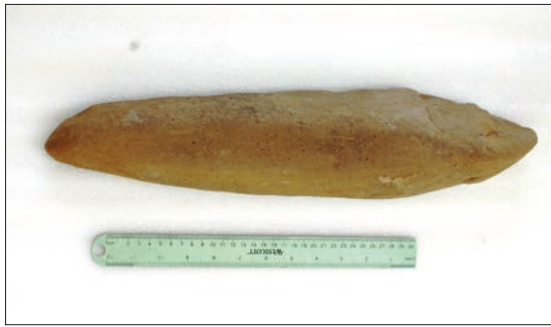
Plate 19: Rounded side of possible ard point.

Find No.	Area	Context No.	No. of Pieces	Material	Description
1	-	005	1	Coarst Stone	Coarse stone possible ard point wear mark on one side.

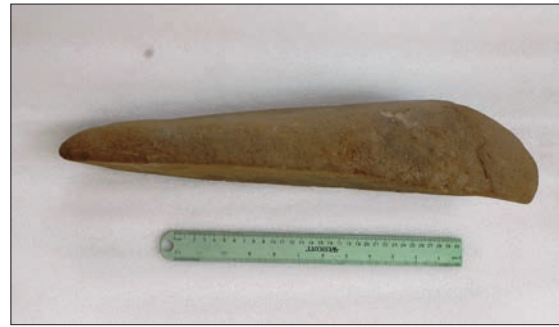
Plate 20: Possible ard point showing edge.
