Calder Park Road, Mid Calder Data Structure Report Project 4415

Calder Park Road, Mid Calder Data Structure Report

On behalf of: Robertson Homes

Project Number: 4415

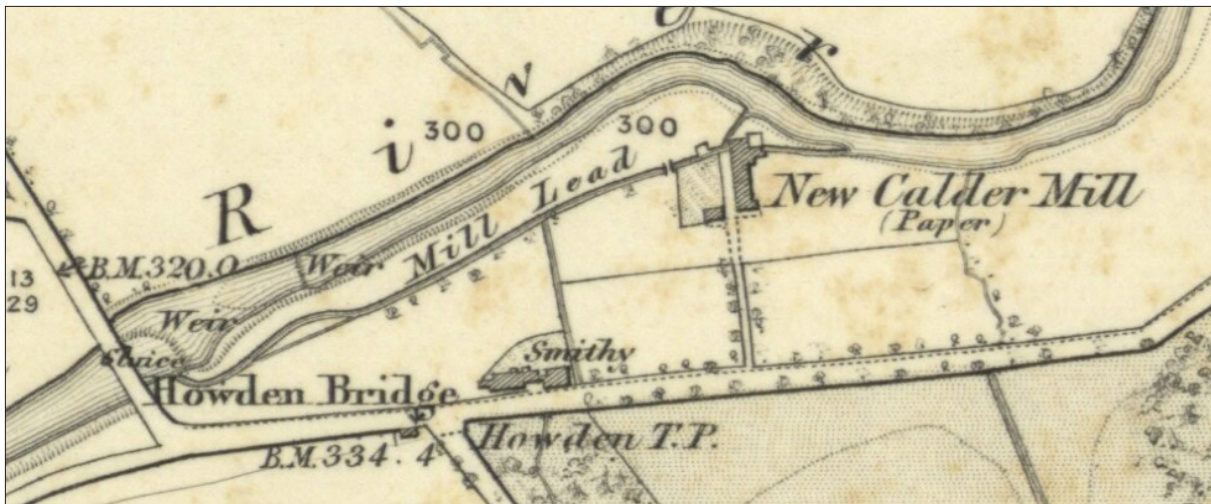
Plate 1a : Six Inch, 1st Edition Ordnance Survey, Published 1853 (Edinburghshire, Sheet 4) depicting the New Calder Mill.

- 4.1 There was one known cultural heritage asset which lay within the boundary of the development area. New Calder Mill was visible on the 1st Edition Ordnance Survey Map highlighted as a series of buildings within the north-central portion of the site. The New Calder Paper Mill' as depicted on the 1st Edition Ordnance Survey map published in 1853 was extensively redeveloped during the 1950s to form the present layout of the paper mill. The sandstone mill house was still extant and although it had been much modified still represented a good example of a building of its type from this period. The original mill buildings for the most part lay below the location of the current mill buildings on site so it was unclear if any remains relating to these earlier buildings survived. The lack of development across the remainder of the site increased the potential for the survival of hitherto undiscovered subsurface archaeological remains or deposits possibly relating to the presence of the mill or activity surrounding it.

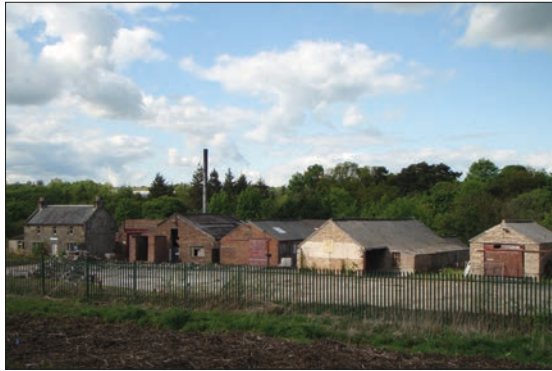
Plate 1: General view of the mill complex, from the south-east.

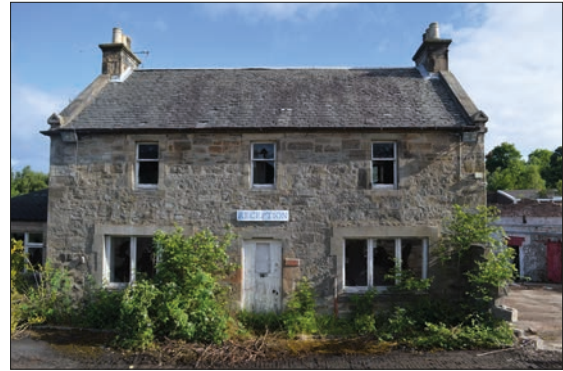
Plate 2: South facing, front elevation of the mill house, enlarged window openings on ground floor.

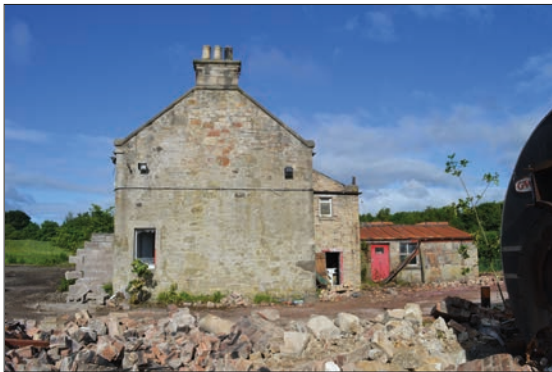
Plate 3: East facing elevation of mill house with later brick extensions abutting the north, rear elevation of the property.

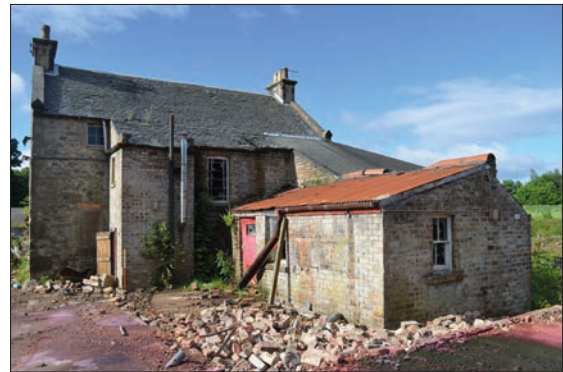
Plate 4: North facing, rear elevation of the mill house with later brick extensions.

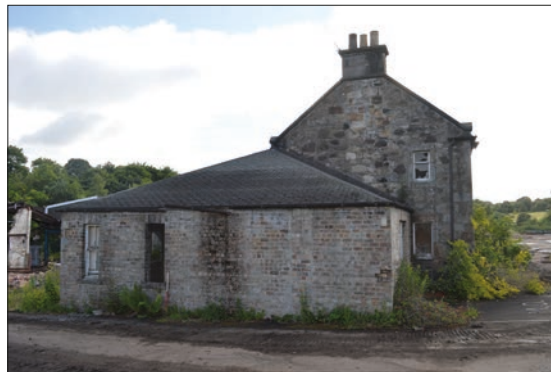
Plate 5: West facing elevation of the mill house with later brick extension.

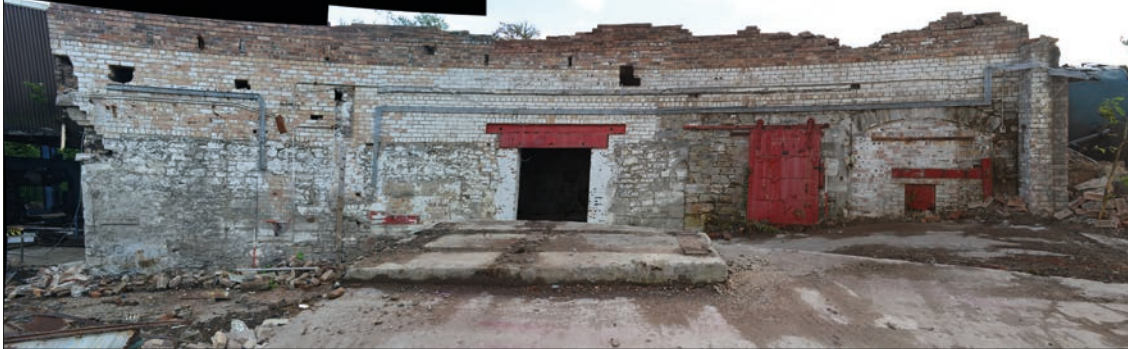
Plate 6: Composite photograph of west facing external elevation of earlier sandstone mill building below 20th century brick, the later sandstone built extension abuts the south end of the mill building wall beyond the right hand side of the open doorway. (Image slightly distorted by image manipulating software)

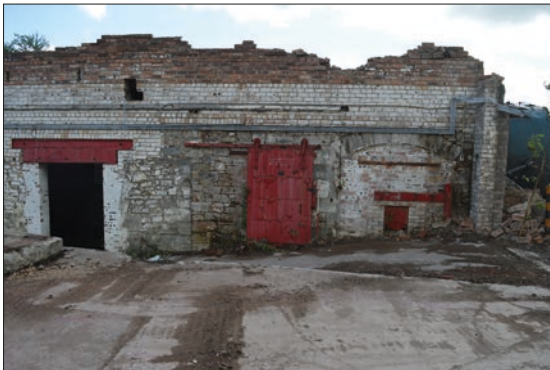
Plate 7: West facing external elevation of south end of earlier sandstone mill building and later sandstone extension showing brick blocking under sandstone arch.

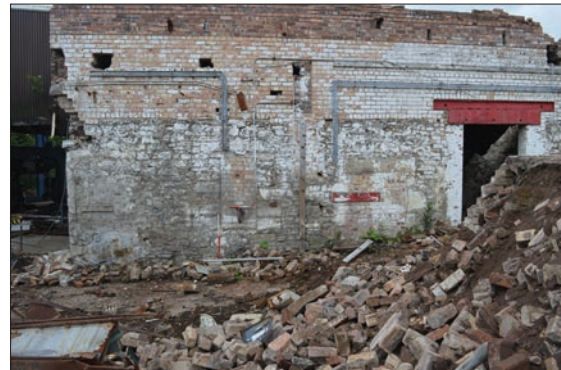
Plate 8: West facing elevation north end of earlier mill building with bricked up openings.

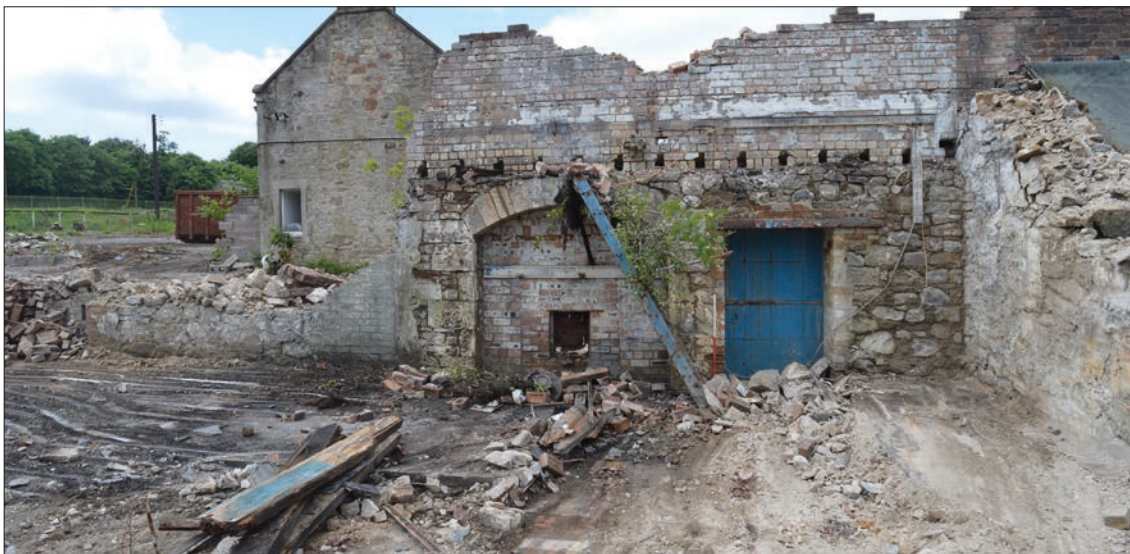
Plate 9: East facing internal elevation of later sandstone extension abutting gable end of earlier mill building right of frame.

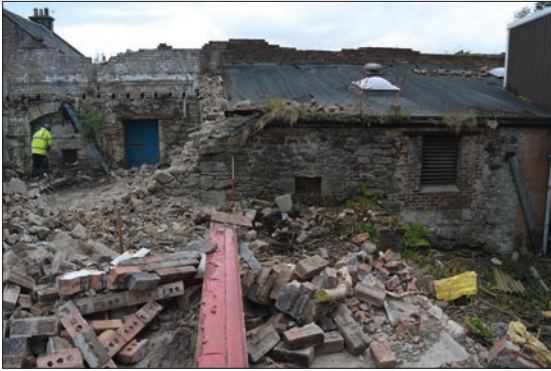
Plate 10: East facing elevation of the earlier mill building with blocked opening and later brick work and a fragment of the later sandstone built extension abutting the south side of the gable wall.

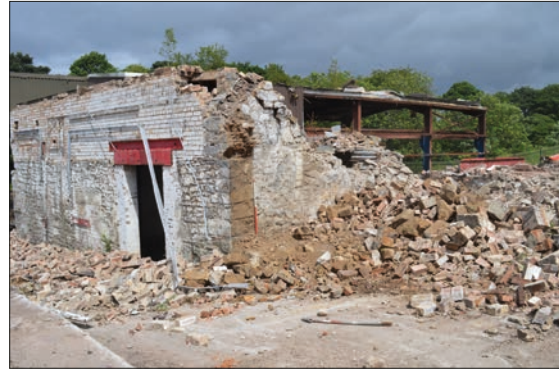
Plate 11: General view of original mid 18th Century Mill building after removal of 19th Century extension from the south-west.

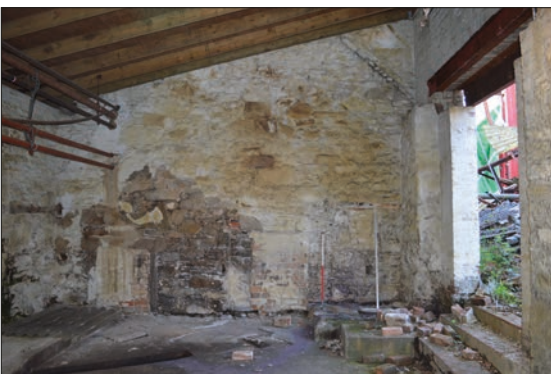
Plate 12: North facing internal elevation of gable wall in the earlier mill building with two blocked fireplaces and a small wall press, three roof scars corresponding to the height of the mill building, later sandstone built extension and the subsequent brick enlargement of the building are visible on top of and above the gable wall top right of frame.

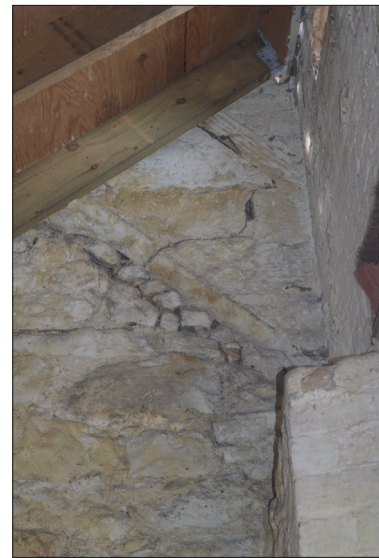
Plate 13: Detail of the roof scars associated with different phases of construction.

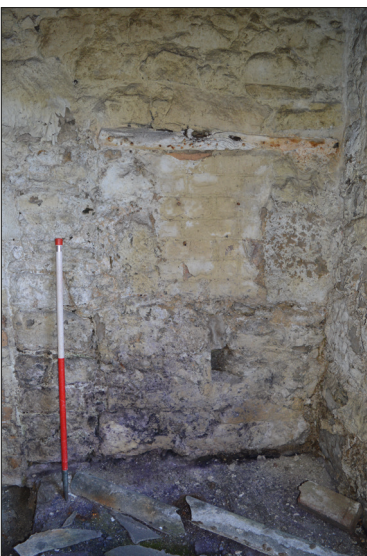
Plate 14: Blocked wall press in north facing elevation gable wall, wooden lintel visible above whitewashed brick blocking.

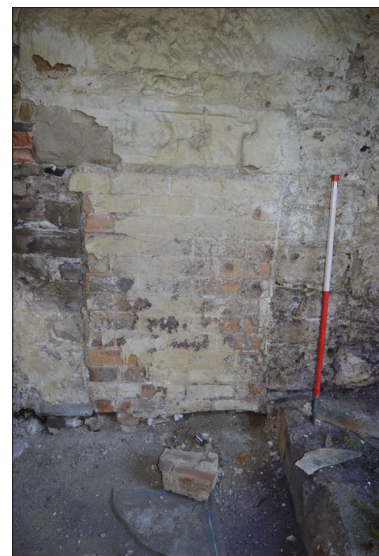
Plate 15: Blocked fireplace in north facing elevation gable wall.

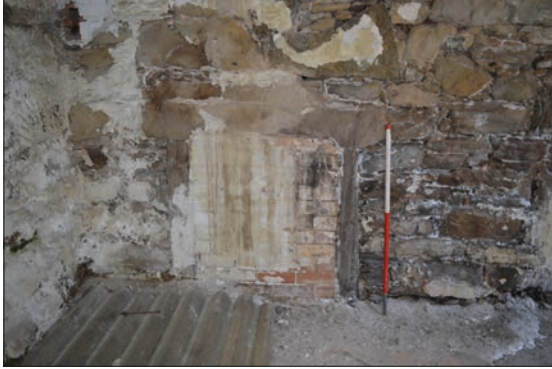
Plate 16: Blocked fireplace in north facing elevation gable wall.

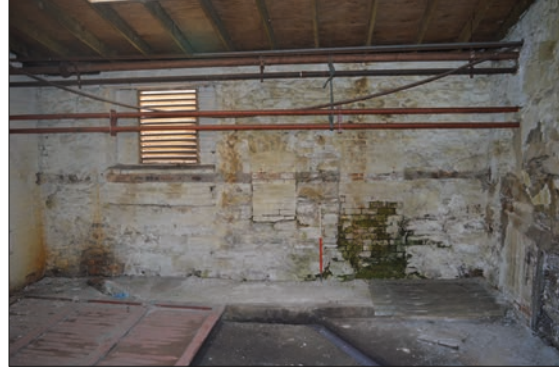
Plate 17: West facing internal elevation earlier building with blocked openings and possible later slapped through opening or remodelled original opening, deep concrete floor with channels visible base of frame.

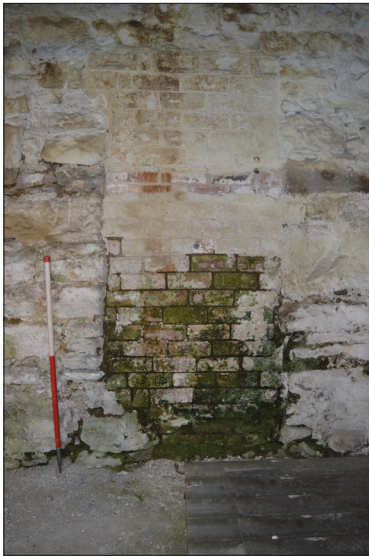
Plate 18: Detail of blocked opening in west facing internal elevation earlier mill building.

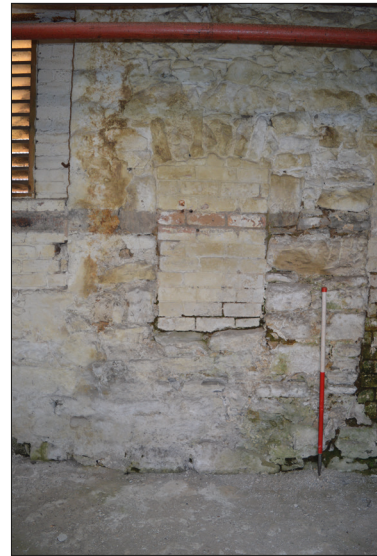
Plate 19: Detail of blocked opening and possible later slapped through opening or remodelled original opening left of frame in west facing internal elevation earlier mill building.

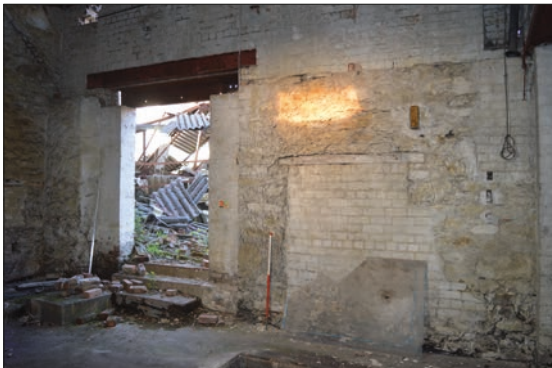
Plate 20: East facing internal elevation earlier mill building with blocked opening and later slapped through large doorway. Steel lintel over doorway rests on top of earlier sandstone building wall heads.

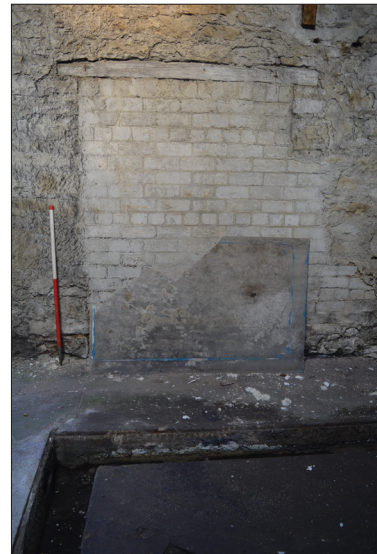
Plate 21: Detail of blocked opening in east facing internal elevation earlier mill building.

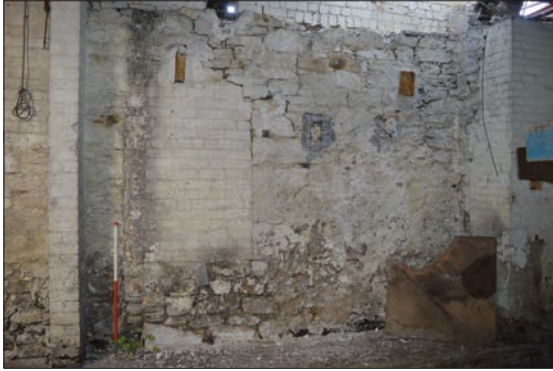
Plate 22: East facing internal elevation earlier mill building (north of previous shots) blocked opening.

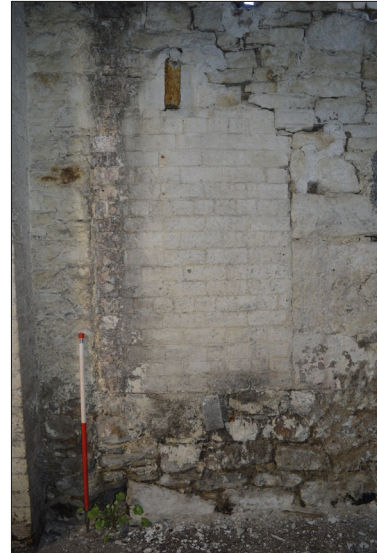
Plate 23: Detail of blocked opening in east facing internal elevation earlier mill building.

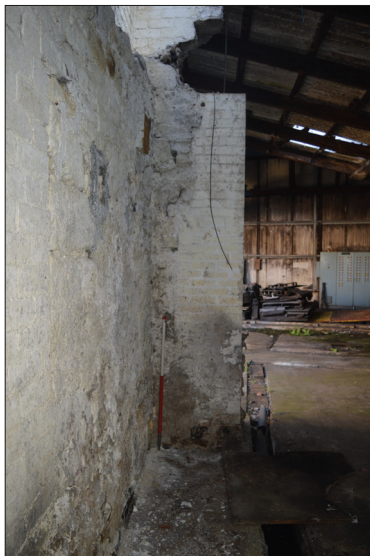
Plate 24: South facing internal elevation of stub end of northern partition?/gable? wall with brick consolidation earlier mill building.

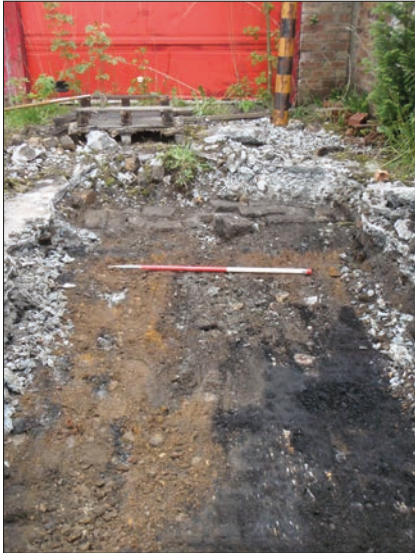
- 7.3.1** Trench 1 was excavated through concrete forming the present yard surface to the south of the existing mill complex. Beneath the concrete a cobble surface 100 was recorded. This comprised sub-square and sub-rectangular whinstone cobbles forming a surface along the west side of one of the later brick buildings that had subsumed the earlier sandstone mill building. Abutting the south side of the cobbles a natural gravel surface 101 was recorded, this was overlain by a dark grey/black accumulation of trampled material 102.

Plate 25: Accumulation of trampled material deposit 102 overlying natural gravel yard surface 101 with cobbles 100 at the north end of the trench, from the south.

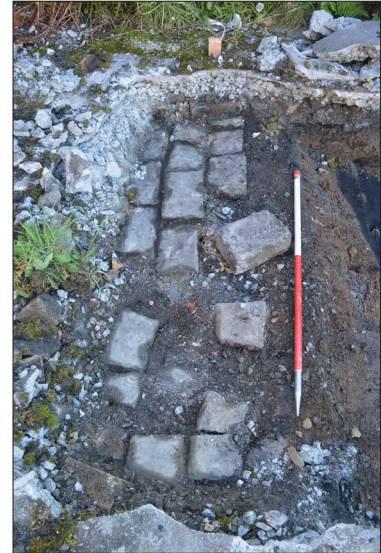
Plate 26: Detail of cobbled surface 100 in trench 1, from the west.

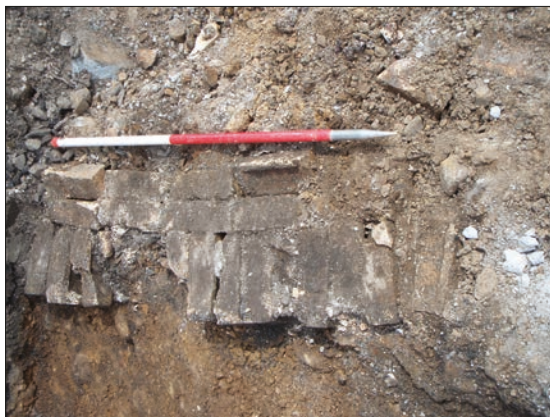
- 7.3.2** Two service trenches were also visible in Trench 1, the first contained an iron pipe, the second a fireclay pipe. To the south of the services a small brick setting 103 was recorded, this was built with unbonded bricks, laid on edge, a single course in height and three bricks wide. Some of the bricks were stamped ETNA. The ETNA brick company at Armadale operated from 1897 until finally closing its gates for business in December 2011. The structure measured 1.36 m long by 0.4 m wide and stood a single course in height at 0.08 m.

Plate 27: Brick setting 103 in trench 1, from the south-west.

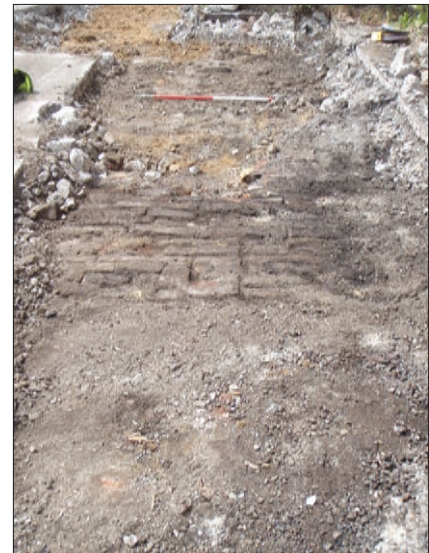
Plate 28: Partially cleaned brick and cobbled surface 201 centre of frame with possible track remnant or hard standing 200 below ranging rod, in trench 2, from the east.

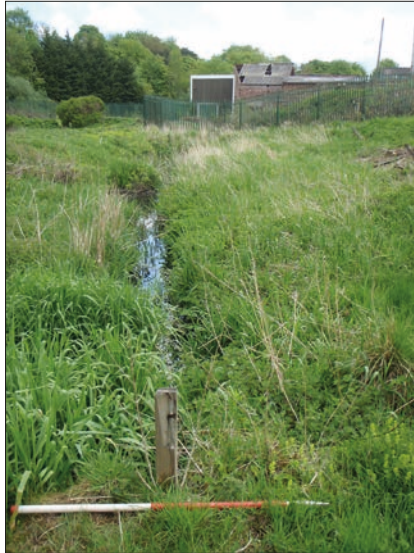
Plate 29: The mill lade to the west of the mill, from the west.

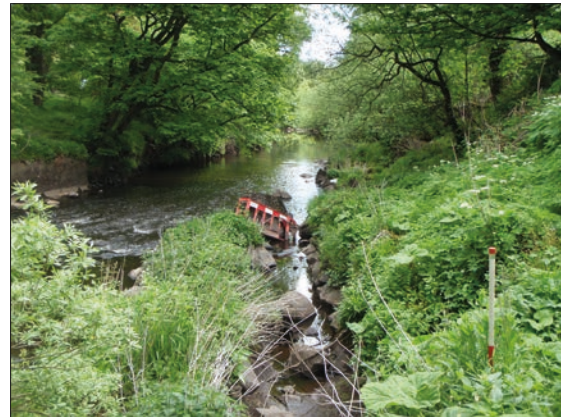
Plate 30: The outfall of the mill lade to the east of the mill, from the west.

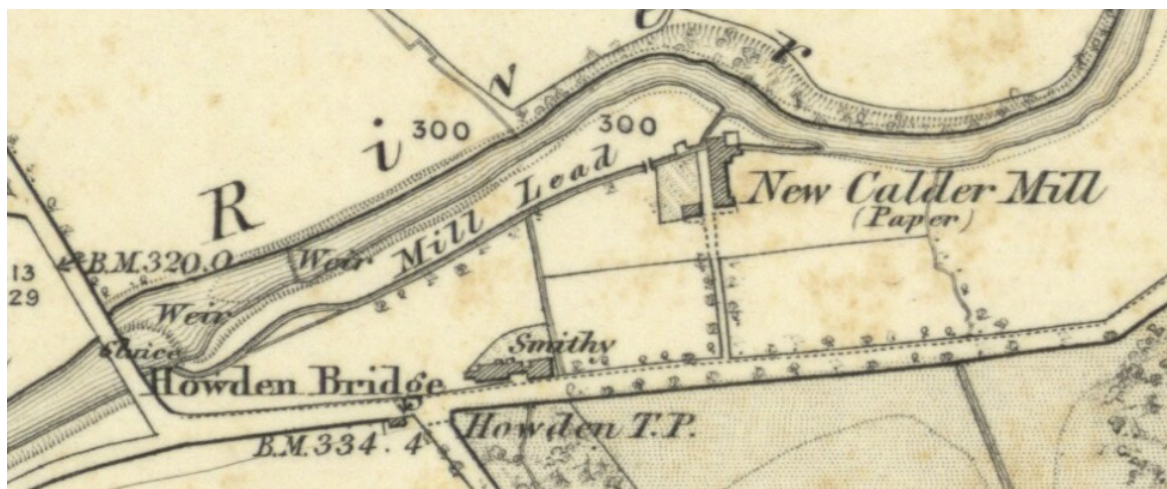
Plate 1: Six Inch, 1st Edition Ordnance Survey, Published 1853 (Edinburghshire, Sheet 4).

- 4.1 There is one known cultural heritage asset which lies within the boundary of the development area. New Calder Mill is visible on the 1st Edition Ordnance Survey Map highlighted as a series of buildings within the north-eastern portion of the site. These buildings for the most part lie below the location of the current mill buildings on site so it is unclear if any remains relating to these earlier buildings survive today. The lack of development across the remainder of the site increases the potential for the survival of hitherto undiscovered subsurface archaeological remains or deposits possibly relating to the presence of the mill or activity surrounding it.
