**Dalmacoultter Works:  
SI and Topsoil Strip Watching Brief  
Data Structure Report  
Project 4234**

**On behalf of:** Scottish Water

**Project Number:** 4234

**Dalmacoulter Duplication:  
Archaeological Assessment  
Project 4234**

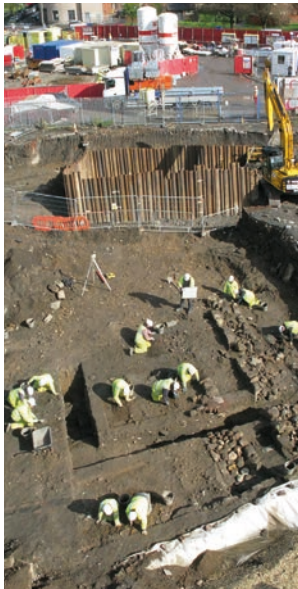
Plate 3: Kiln.

- 7.4 The lime kiln and well were located to the east of Cameron Burn on ground that sloped downwards towards the water course and to the immediate north of Cameron Road. The remains of the lime kiln, which were not fully exposed, appeared to be roughly square in shape and of drystone construction 003/007. It was very degraded and survived to a maximum width of 3.4 m, length of 4.2 m and a height of 0.8 m comprising at most two stone courses. In-between and below the stone courses was found an in-fill of smaller sub-angular cobble sized stones. Several smaller spreads of stones (005 and 009) were found to the immediate east and west of the main structural remains leading to the possibility that these smaller spreads might be part of a larger structure (plates 3 and 4; figures 2 and 3).

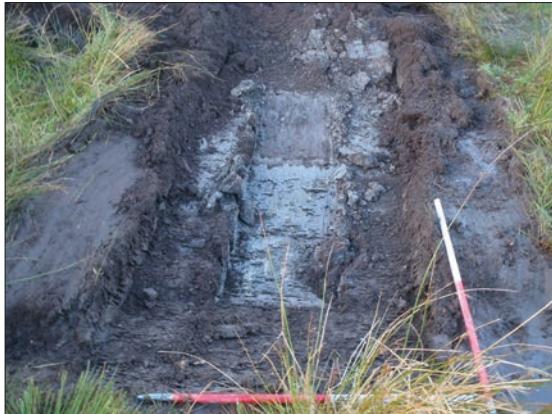
Plate 1: TP 35 post-excitation.

- 7.1 A total of 17 test pits measuring between 3 m - 5 m in length by 0.5 m – 1 m in width were scattered along the proposed water pipeline route. Following excavation, they revealed a wide variety of subsoils, from dark brown loamy peat to light brown clayish silt (plate 1). Over the majority of the area topsoil deposits measured between 0.2 m - 0.6 m in depth. A system of field drainage was noted during the work, but no features of archaeological significance were encountered.

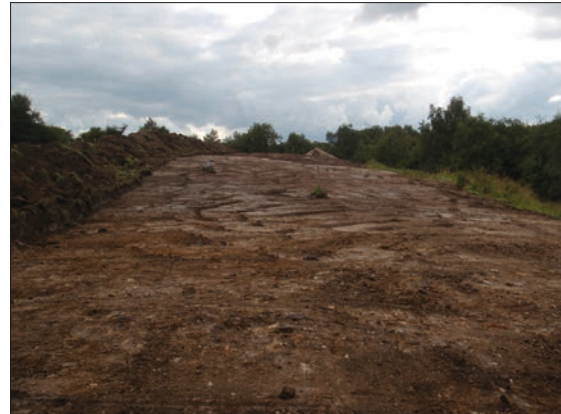
Plate 2: Post-excitation of wayleave section.

- 7.2 Most of the pipeline was covered by a topsoil 001 comprising mid-reddish brown clay silt which measured between 0.19 m – 0.4 m in depth. The subsoil 002 mainly comprised medium brownish orange silty sand with field drainage truncating its surface throughout much of the route (plate 2).

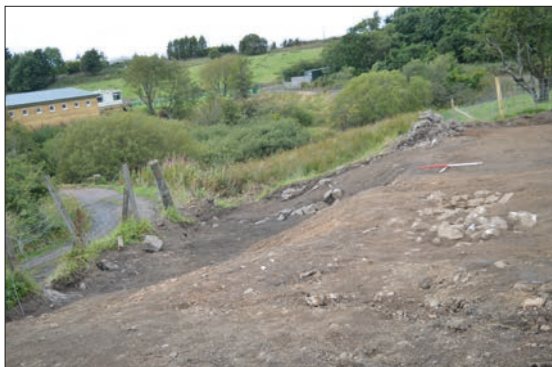
- 7.3 Of particular note was the uncovering of the remains of an historic lime kiln and associated well close to the south of Cauldhame farm and to the west of the pipeline route. These features were not directly affected by the pipeline but following instruction from the Client it was decided to superficially hand clean and then record the features by means of documentation, elevation drawings, surveyed plan, written description and photographic record.

8.1 The watching brief uncovered no features or finds of archaeological interest along the pipeline route except the fragmentary remains of a lime kiln and stone well, both just out with the bounds of the development site. Lime kilns are a relatively common feature in rural areas and

were used by farmers to produce lime which was then spread onto the fields to improve the quality of the soil. The lime, which was often mixed with water, raised the pH value of the soil making it less acidic resulting in greater crop yields. The kilns generally began to appear during the eighteenth century, a period of agricultural improvement which included not only the production of lime for addition to soil but also field drains to aid the drainage of marginal land producing more land available for cultivation. Many farmers had their own lime kiln which was a draw-type kiln but it was also commercially produced for farmers to buy. Lumps of limestone were added to the kiln in-between successive layers of wood fuel and then set alight at the base. Following burning the lime was left to cool and then raked out and collected. Water would be added to the lime to produce slake lime which was then spread onto the soil.

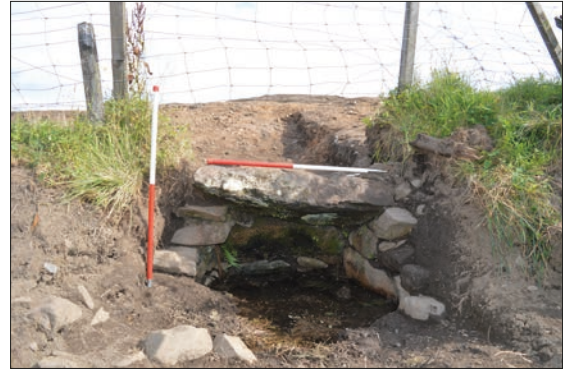
Plate 5: Well.

7.5 The well 008 was located to the south of the lime kiln and immediately adjacent to Cameron Road. It appeared to be preserved quite well although very overgrown with vegetation. It measured approximately 0.85 m in height, 1.5m in length and 0.9 m in width and was sub-circular in shape. It had a roughly flat rectangular stone at its northern side and several smaller stones to the east and appeared open to the elements and filled with water, presumably from a natural spring (plate 5; figure 2).

- 8.2 Water wells are also common features in both rural and urban areas, particularly pre-mains water supply. The present well is an open well with the water close to the surface with no upstanding perimeter wall evident, although some upright stones are present on the north side. Its location next to the roadway would have made the water easier to collect and its closeness to the lime kiln suggests that it might have been used during lime production.

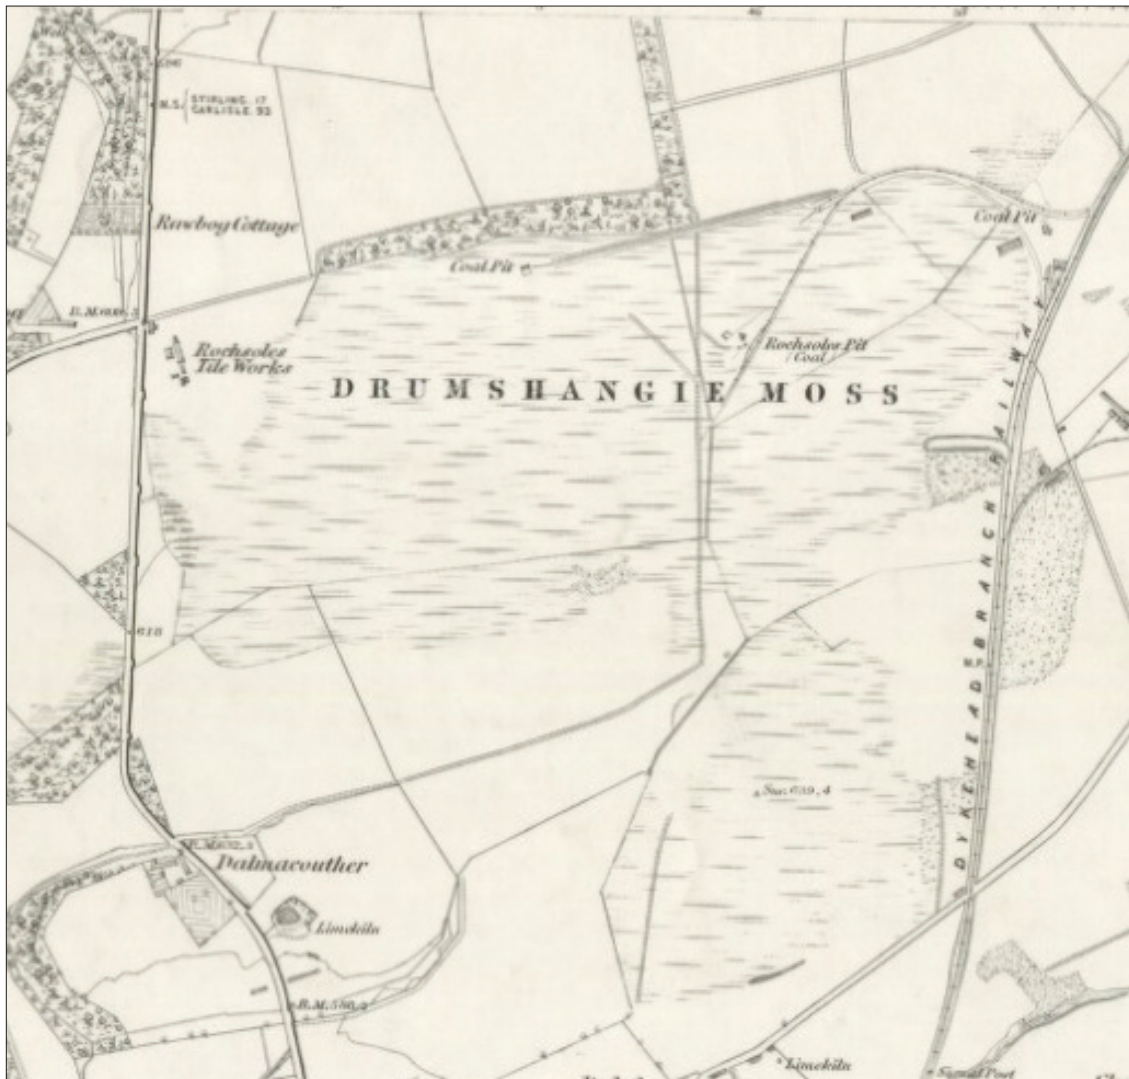
Figure 3: Excerpt from Ordnance Survey Lanarkshire Sheet VIII 6'' map of 1864. Reproduced by permission of the Trustees of The National Library of Scotland.

- 6.3 The First Edition Ordnance Survey map of 1864 (Figures 3 and 4) depicts Rochsoles tile works (CHS 1) on the west side of Drumshangie Moss, and a structure named as High Rigend (CHS 2) lies on the east side of Old Biggar Road. A former lime kiln (CHS 3) lies to the south of Cauldhame farm, and a curling pond (CHS 4) is located on the east side of Old Biggar Road, adjacent to Cameron Burn. The land between Cauldhame and Glenhove Reservoir consists of enclosed agricultural fields.
