**Oak Place, Mayfield  
Data Structure Report  
Project 4348**

## Oak Place, Mayfield Data Structure Report

**Project Number:** 4348

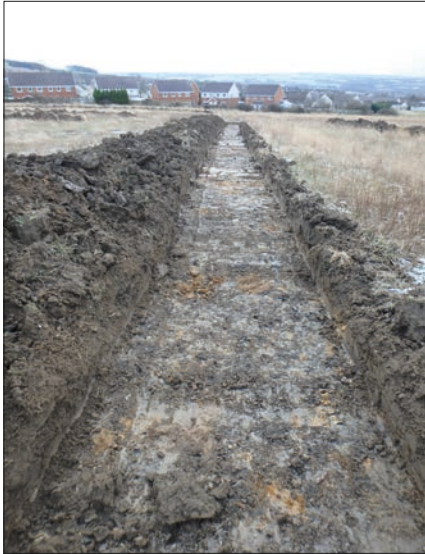
*Plate 1: Trench 45, from the north east.*

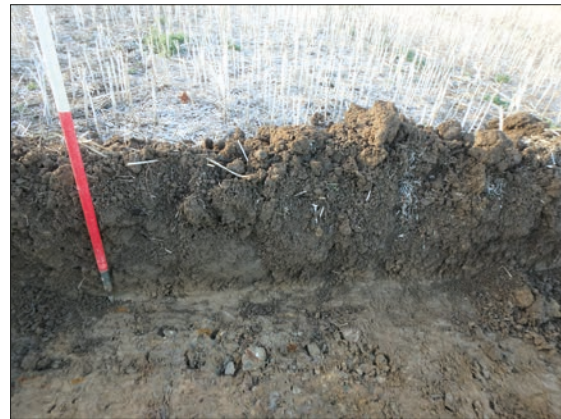
- 7.1 Topsoil across the area was a dark brown grey loam which varied between 0.25 m to 0.35 m in depth. Below the topsoil there was frequently observed a mid brown silty intermediate deposit, which was mainly between 0.2 m and 0.3 m in depth, but was up to 0.6 m in depth in some of the downslope trenches or covering natural undulations within the bedrock. Natural subsoil across the area was also variable. Most commonly this was a light to mid brown beige grey sandy or silty clay with frequent sandstone inclusions, however in some areas a denser lighter clay with gravelly silts, again with frequent stone inclusions was uncovered. In several trenches areas of bedrock were located directly below subsoil, and the sporadic presence of this along with the undulating topography presumably accounts for the varied nature of the natural subsoil deposits.

*Plate 2: North-east facing section of trench 24.*

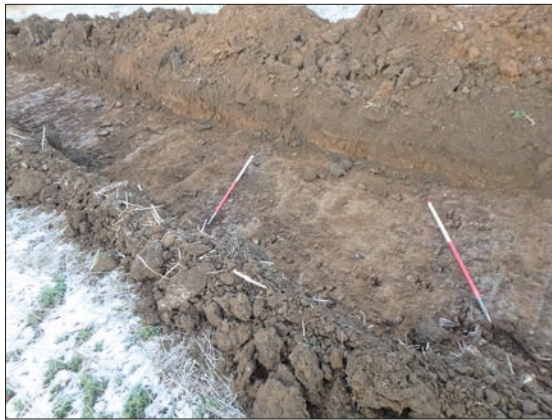
7.7.1 A series of possible agricultural furrow were identified across these trenches, which sat on the highest ground within the western field. These were bands of a homogenous light brown sandy silt material which was relatively sterile and looked partially leached as if water affected or washed and were orientated east/west across trenches 37, 38 and 39, with a more ephemeral example present within trench 40 on the same orientation with a similar fill. Eight were identified in total, and all were between 1.2 m and 1.6 m in width. The distance between the furrows varied, with 12 m – 15 m between examples in trenches 37 and 38, but only 2 m between furrows in trenches 37 and 39.

7.7.2 Two of the furrows were investigated in trenches 37 (37003) and 39 (39003). Excavation revealed that the possible furrows had shallow sides with flat bases and were of similar depth of 0.3 m and 0.35 m. There was no evidence of material culture present either within the test slots or on the surface of the features. It seems likely that the features represent the truncated remains of a series of agricultural furrows running downslope from the north.

Plate 3: East-west orientated furrows in trench 37.

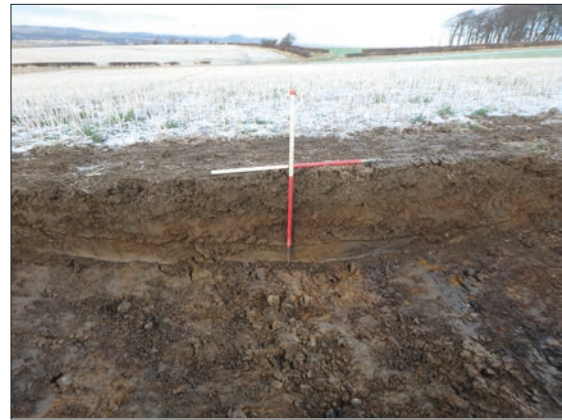
Plate 4: South-east facing section of furrow in trench 39.

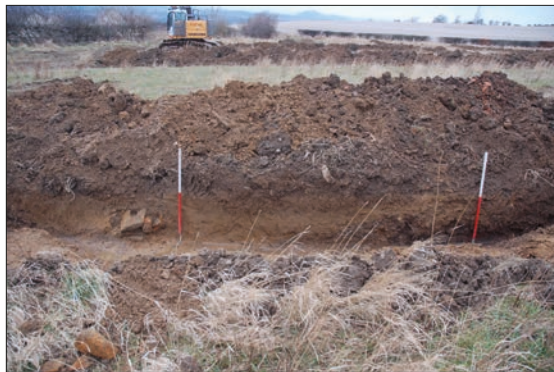
on the edge of a possible furrow or undulation of east-west orientation (53006, 53007) with a similar sterile sandy silt fill to those seen upslope to the north. However the furrows seem to be unrelated given the difference in orientation and appear to predate the stone feature. This stone feature was also noted in trench 54 but not within trenches 55 or 56.

Plate 5: South-east facing section of furrow 53007, with stone feature 53004 present at south-west.

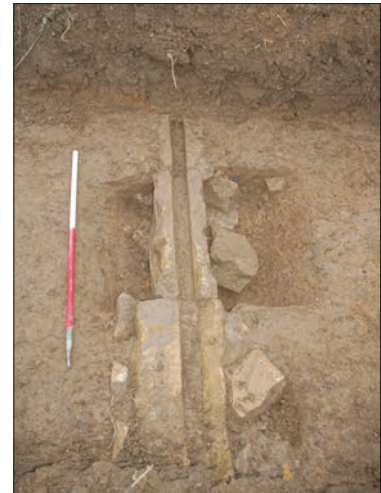
7.8.1 A linear stone built feature was identified stretching across the south-west ends of trenches 55 (55004-55007) and 56 (56004, 56005). On investigation, this was revealed as a line of flat sandstone blocks set within a rubble packed cut orientated north-west/south-east.

7.8.2 The blocks had a shallow narrow channel 10 mm wide and 10mm deep cut into the upper face. There was no evidence of cap stones, so it seems unlikely that this was intended to serve a drainage function in the manner of a small stone lined culvert given the lack of any barrier against external silting. Further cleaning within adjacent trench 53 revealed a further partial continuation of the feature within the trench edge (53004, 53006, 53008). In this section the sandstone blocks had been disturbed possibly either robbed of stone or this may have been the original terminal of the feature. Several sherds of ceramic were recovered within the associated rubble packing (SF 2), possibly of Post-Medieval or slightly later date (Bob Will, pers comm). Four of the sherds appear to be from a section of field drain made from white coarse clay while three sherds are from a jug or similar vessel. The feature containing the sandstone blocks was located

Plate 6: Stone feature 55004 in trench 55, from the south-east.

- 9.1 The evaluation work encountered no features of archaeological significance across the vast majority of the development area, with the only feature of note being the sandstone block feature present within the south-west area. This may have served some kind of drainage or other agricultural related function given the lack of any associated structural evidence, and is likely of later historic date.

- 9.2 It is possible that the Archaeological Advisors to Midlothian Council may require further investigative and recording work to be carried out in relation to this feature prior to the development of the site and the likely destruction of the material.

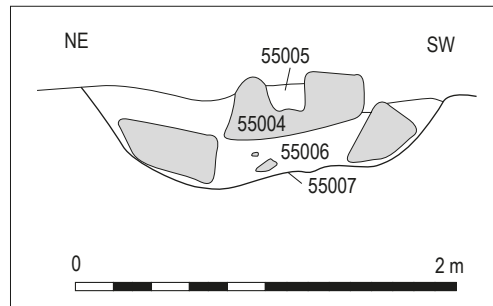
Figure 3: North-west facing section of sandstone feature, trench 55.

7.8.3 A slot was hand excavated through the sandstone block feature and outer rubble filled cut within trench 55. The cut (55007) had sloping sides and a flat base, 1.1 m in width and 0.3 m in depth. The sandstone blocks were set in a linear arrangement within this (55004). The blocks themselves were faced and measured c 0.7 m in length, 0.18 m in width and 0.25 m in depth, although size varied slightly. The cut channel was 90 mm in width and 80 mm in depth, and contained a light brown silt fill (55005) which appeared to comprise mostly of silted overburden material. The outer rubble fill of the cut (55006) was a light brown-orange silt with frequent sub-angular sandstone cobbles and small boulders. Within trench 55 several fragments of coarse white clay possibly from a ceramic drain (Bob Will, pers comm) were recovered within this, which suggests the possibility that the channel may originally have incorporated or supported ceramic drainage of some kind. Although the feature is elaborate for a field drain, this south-west corner of the field is the lowest downslope area where all the modern drainage converges, and its possible that this was intended as a more substantial drainage system to encourage run off and groundwater out of this lower area to aid in the prevention of waterlogging.

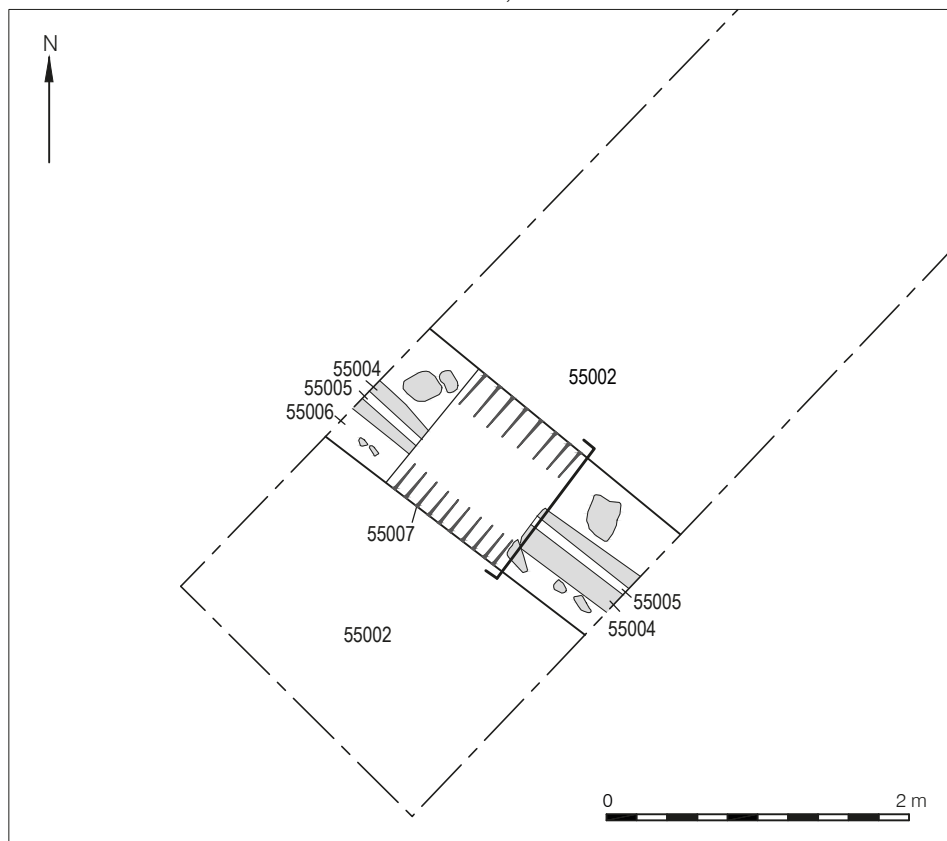
Figure 4: Plan of sandstone feature, trench 55.
