**Craigmillar Town Centre
Watching Brief, Monitored Strip and
Archaeological Excavation
Data Structure Report
Project 4092**

On behalf of: Luddon Construction Ltd.

Project Number: 4092

Report by: Alan Hunter Blair

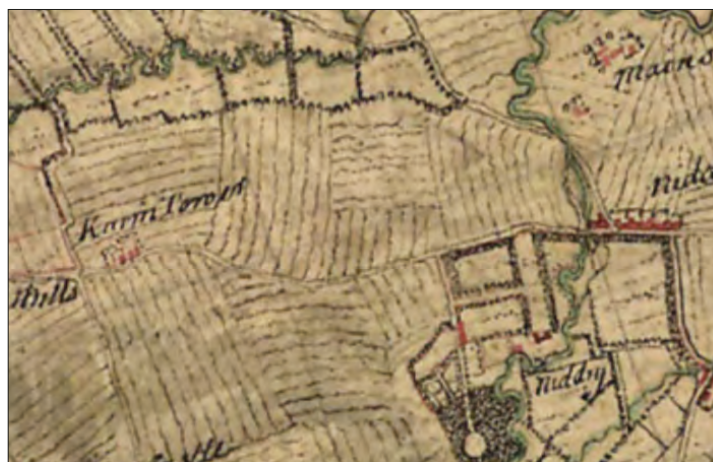
Roy's Military Survey of Scotland 1747-55.

- 4.2 Map regression research examined a total of 14 historic maps dating from Roy's Military Survey of Scotland 1747-55 to the Ordnance Survey map of 1959 (see Appendix 1). On the earliest maps the land within the study area was shown as enclosed agricultural fields and the estate of Niddry was shown on Roy's map along with the farm of Karm Toroe (Cairntows on later maps) which is located to the west of the development area. The development area remained as fields until 1852 when the Ordnance Survey map showed a group of four small buildings on Niddrie Mains Road along with field boundaries. It is this group of buildings that were investigated during this phase of work.

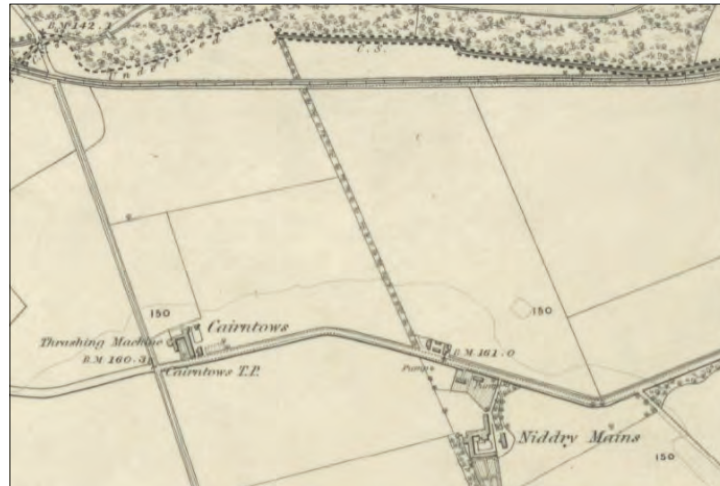
Ordnance Survey map of 1852.

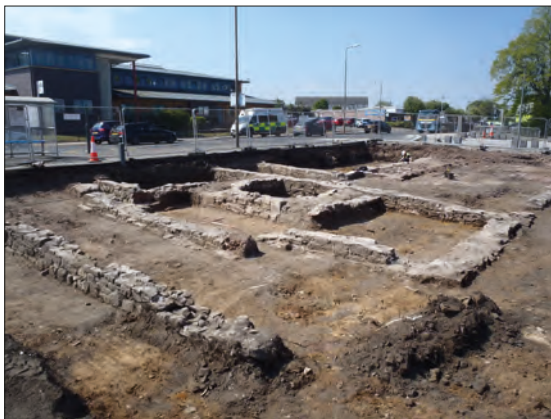
Plate 1: General view of Building A from the north-east.

- 7.4 **Building A** (Figure 3, Plates 1 and 2)
- 7.4.1 Building A was aligned NE-SW and comprised five lime mortar bonded walls (006), (009), (010), (014) and (020) aligned NE-SW and four walls (011), (012), (013) and (022) aligned NW-SE. Walls (010) and (014) forming the external walls at the north end of Building A tied into the property boundary wall (021). The more substantial load bearing walls which measured 0.6 m wide were built off the sandy clay subsoil (005) with the less substantial internal walls which measured 0.4 m wide built of the agricultural soil (002). A small concrete pad (007) was located towards the south-east end of the building. Construction cuts were visible for some of the load bearing walls which were generally built off a sandstone footing that projected 0.15 m beyond the width of the base of walls which survived to a height of approximately 0.5 m. A small area of mortar floor (008) was recorded to the north of wall (006) The complete footprint of the building was not recorded due to the walls forming the south end of the building continuing beyond the limit of excavation to the south. The overall dimensions of the excavated building was 12.5 m long x 7.8 m wide.

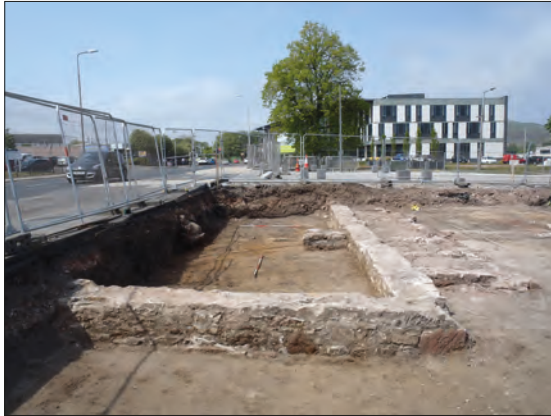
Plate 3: General view of Building B from the south-east.

- 7.5.1 Building B comprised six lime mortar bonded walls (015), (024), (025), (027), (028) and (031) aligned NE-SW and two walls (023) and (026) aligned NW-SE. As with Building A the wider load bearing walls were built off a projecting wall footing over the natural subsoil (005) with the narrower internal walls built off the relict agricultural soil (002). The building appeared to be sub-divided in two by a very truncated wall (024) aligned NE-SW in the middle of the building. A wall (030) on the same alignment to wall (024) to the north of Building B effectively divided

the courtyard area into respective east and west halves. The southern and eastern extents of Building B continued beyond the limit of the excavation area. The overall dimensions of the building as excavated was 12.5 m long x 6.2 m wide.

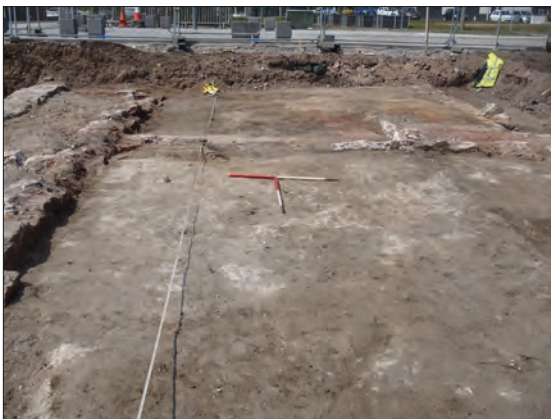
Plate 5: General view of mortar floor (029) on the north-west side of Building B from the south-east.

- 7.5.2 A degraded mortar floor (029) was recorded in the courtyard area to the north and west of Building B this covered an area measuring 4.9 m long N-S x 5.6 m E-W and was 0.06 m thick. Two patchy remnants of mortar flooring (034) and (035) were visible to the north and east of Building B, these measured 6 m long E-W x 4.2 m long N-S x 0.04 m thick and 1.8 m long x 0.6 m wide x 0.03 m thick respectively. The very truncated remains of a wall (036) formed part of a putative Building C. The wall abutted the east side of wall (030) and only the south face of the wall survived and extended for a distance of 2 m.

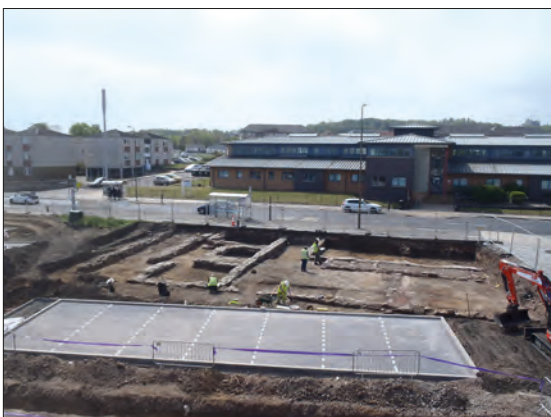
Plate 7: General view of Buildings A, B and C from the north-east.

- 7.3 In total 19 lime mortar sandstone rubble walls and one concrete base were uncovered. The walls formed part of the remains of three buildings, Building A, Building B and Building C. The easternmost and northernmost walls (003) and (021) formed part of the property boundary wall with the north-east to south-west aligned buildings A and B tied into the northern property boundary wall (021) Three areas of degraded possible mortar floors were revealed across the western part of the site.

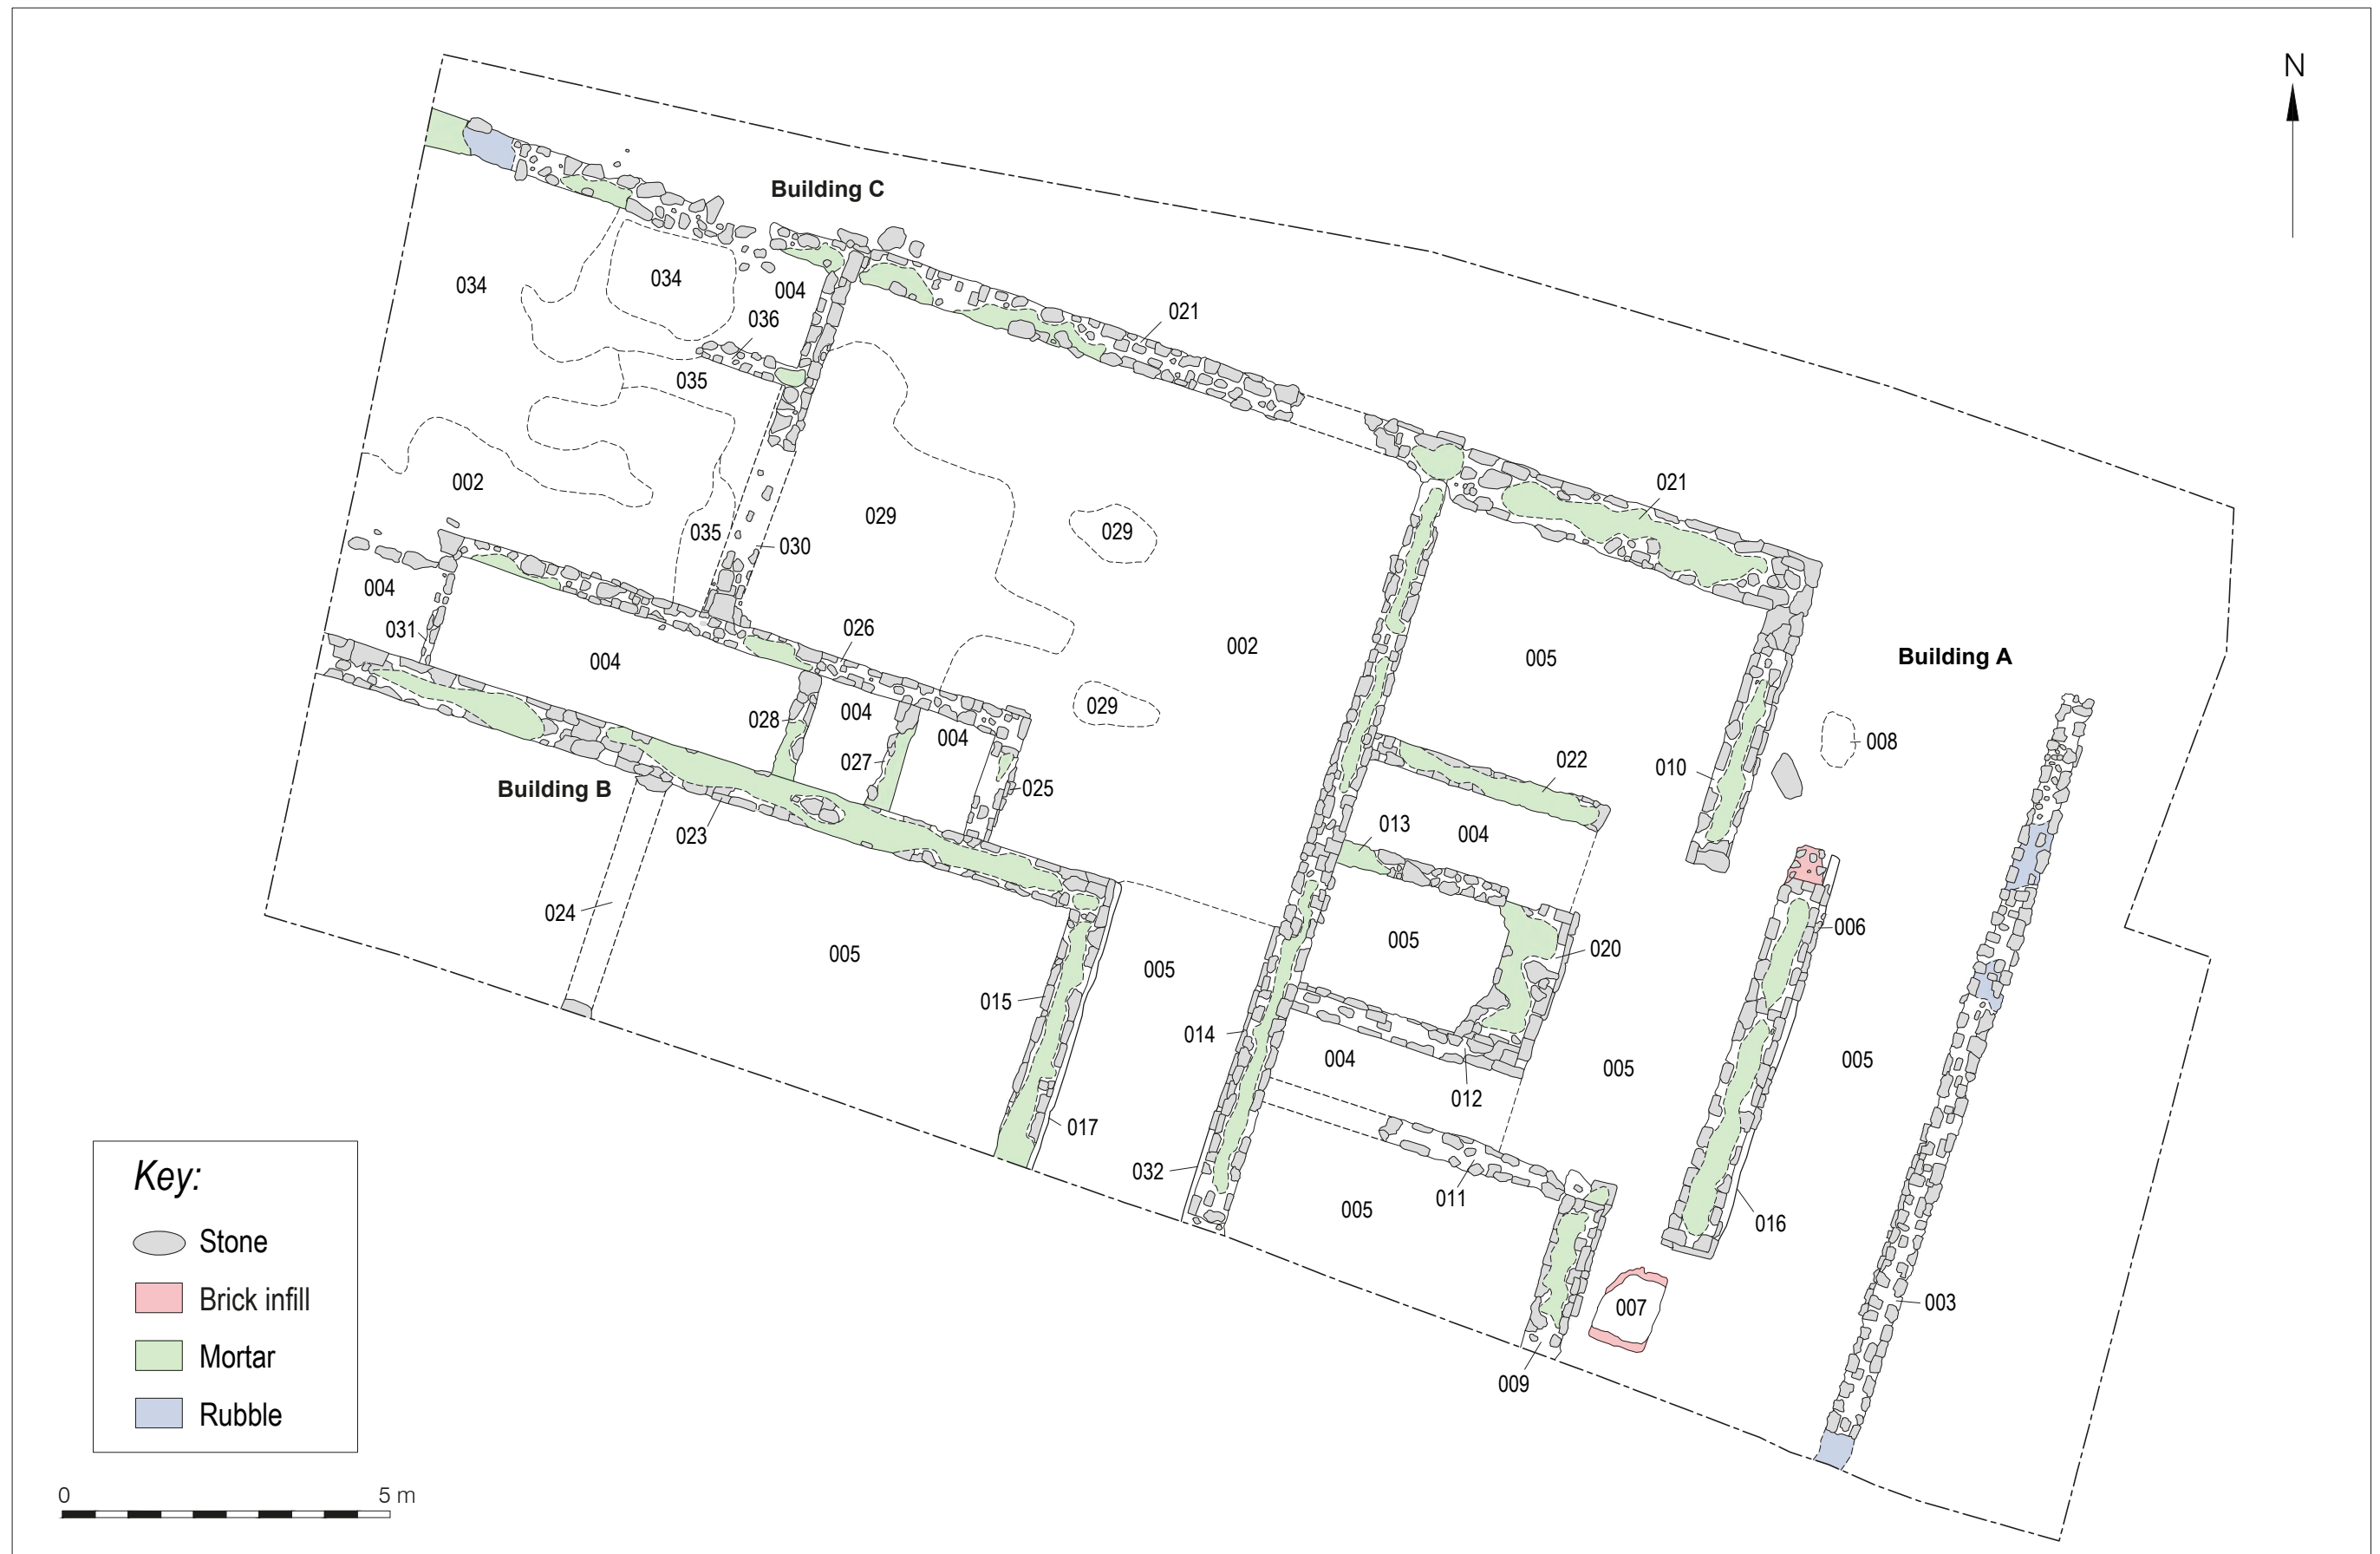
Figure 3: Plan of parts of buildings A,B and C.

7.5 Building B and C (Figure 3, Plates 3-7)

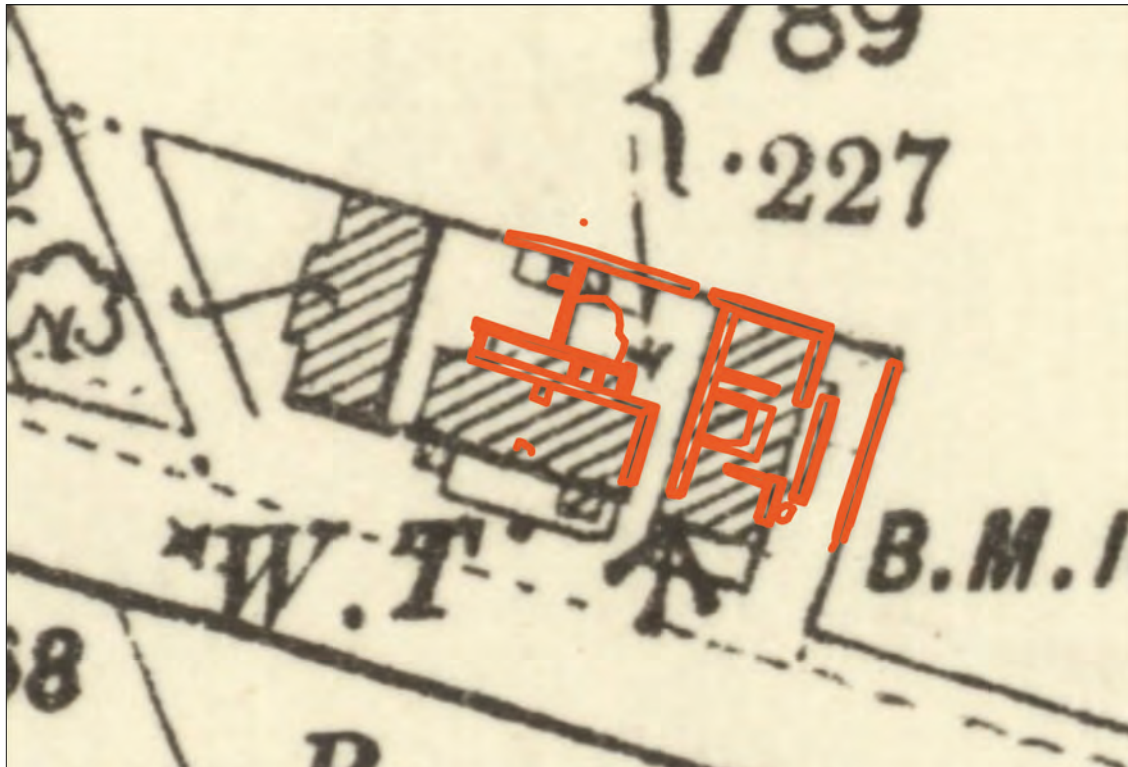
Plate 8: Ordnance Survey map published 1895 with site plan overlaid onto it.

- 8.1 Buildings are first recorded in this area on the Ordnance Survey map published in 1852 as a series of four detached buildings, while the Ordnance Survey map published in 1934 depicts a series of six semi-detached buildings suggesting that the site has been remodelled in this period. The building remains recorded during the archaeological work most closely match the series of buildings depicted on the Ordnance Survey map published in 1895 and probably originated as buildings, perhaps tied cottages, attached to Niddrie Mains Farm, part of the Niddrie Estate owned by the Wauchope's who eventually gave their land to the city. As a family, the Wauchopes were long established at Niddrie, which borders the estate of Edmonstone to the north. Around 1400, Robert III (1390-1406) gave charter of the lands of Nudry to a Gilbert Wauchop (Thomson (ed) 1912, 644).

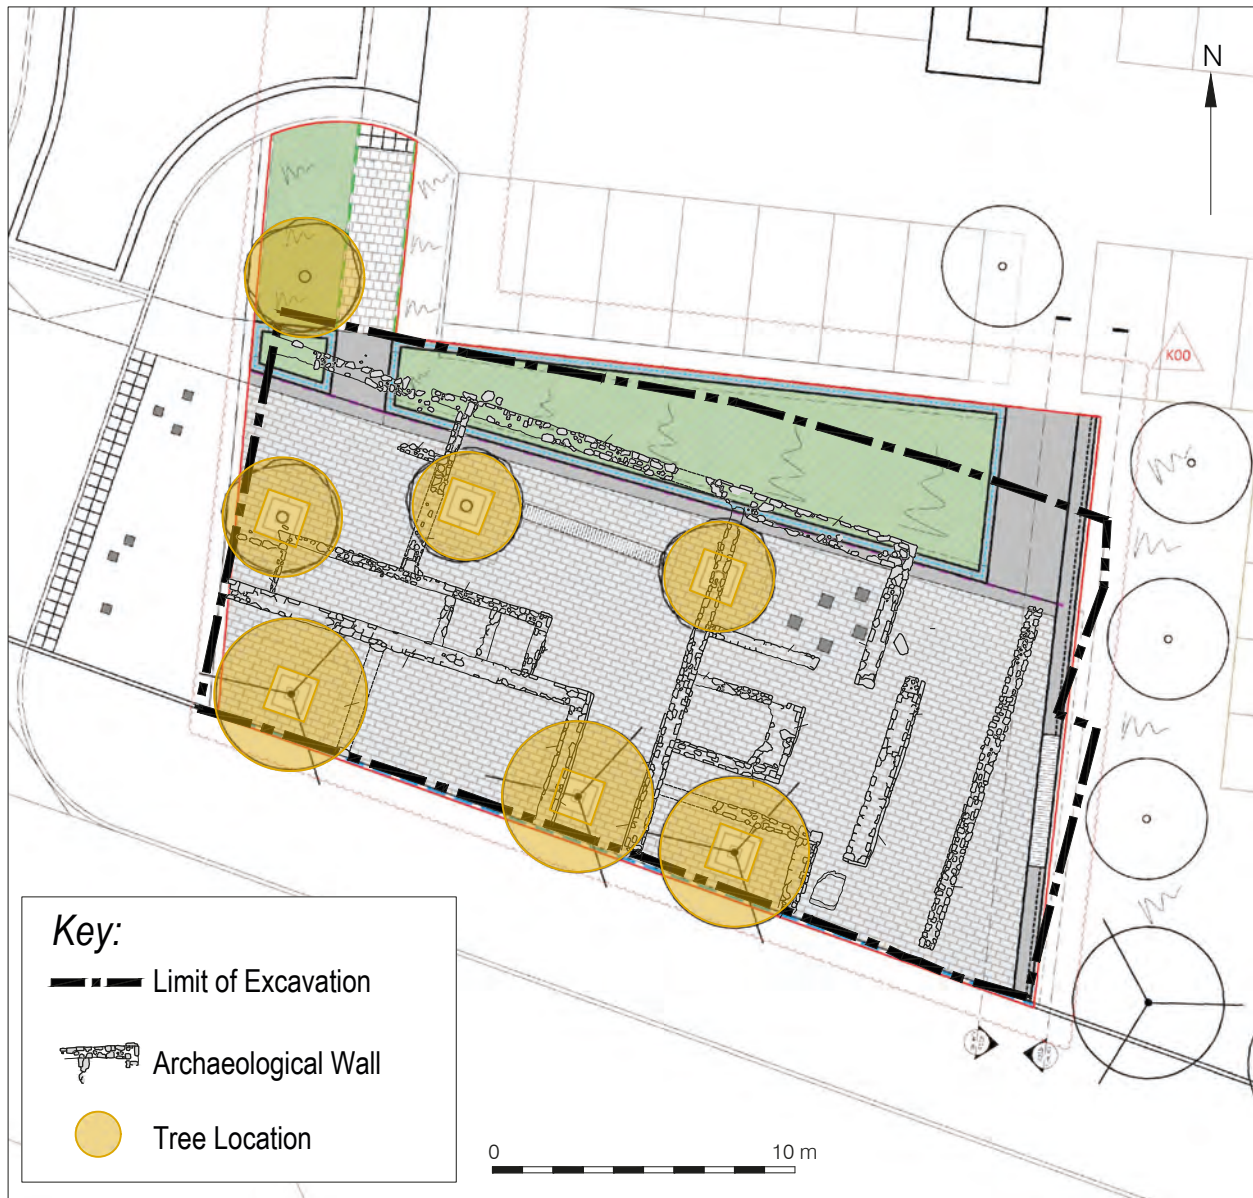
Figure 4: Archaeology overlaid onto the Tree Location Plan.

- 8.2 Following completion of the fieldwork the walls forming the buildings were protected and left in situ. During later landscaping two trees were planted adjacent to the walls which required slight reduction of the walls. Where possible the walls were avoided during planting (Figure 4).

- 9.2 The proposed development is unlikely to impinge greatly on the building remains as the areas around the walls are to be infilled with ballast up to formation level. Some down taking of the walls may be required if they rise above the base of the formation level and tree planting will have a limited impact on several walls.

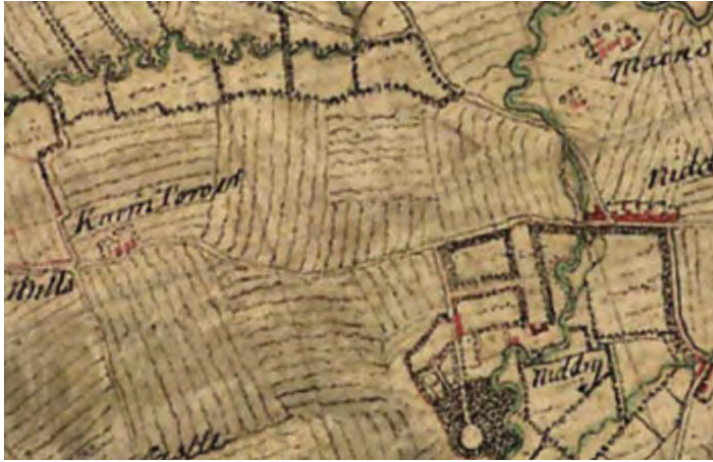
Roy's Military Survey of Scotland 1747-55.

- 4.2 During the course of the map regression research a total of 14 historic maps were examined dating from Roy's Military Survey of Scotland 1747-55 to the Ordnance Survey map of 1959 (see Appendix 1). On the earliest maps the land within the study area was shown as enclosed agricultural fields and the estate of Niddry was shown on Roy's map along with the farm of Karm Toroeer (Cairntows on later maps) which is located to the west of the development area. The development area remained as fields until 1852 when the Ordnance Survey map showed a group of four small buildings on Niddrie Mains Road (Site 1) along with field boundaries. Raeburn's Brewery (Site 2) first appears on a map of 1906 which would fit with its establishment on the development area in 1901. During the map regression research no detailed plans for the brewery were uncovered but there are general locations of the buildings without details of the functions and activities that took place in them. There is a description that states that the brewery had 'a single malt kiln and a circular section brick

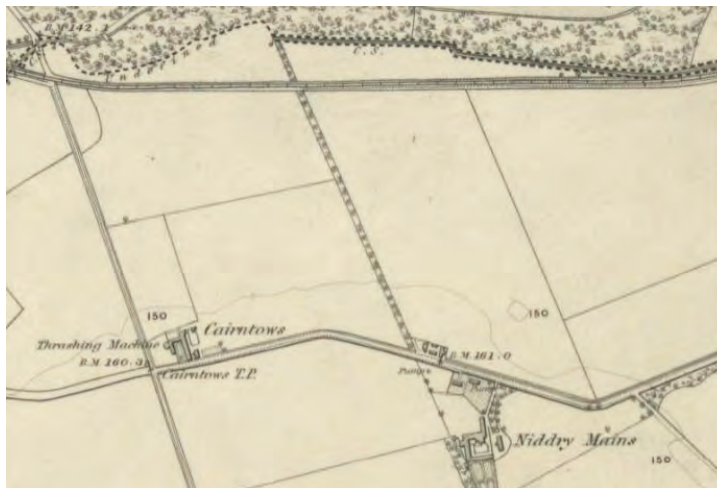
Ordnance Survey map of 1852.

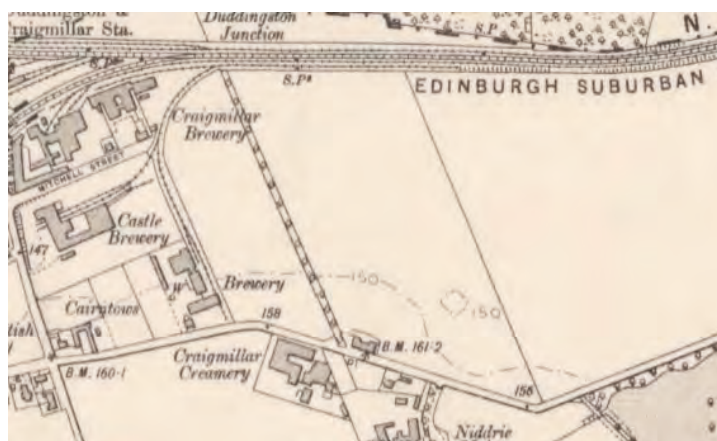
Ordnance Survey map of 1906 showing Raeburn's Brewery.

chimney' (Hume 1976). The Ordnance Survey map of 1906 does show the main buildings on the east side of the site along with a railway siding and a well on the west. Photographs held by RCAHMS show several of these buildings along with chimneys and yards.
