Haudagain Roundabout, Aberdeen
Watching Brief
Data Structure Report
Project 4677

On behalf of: ERS

Project Number: 4677

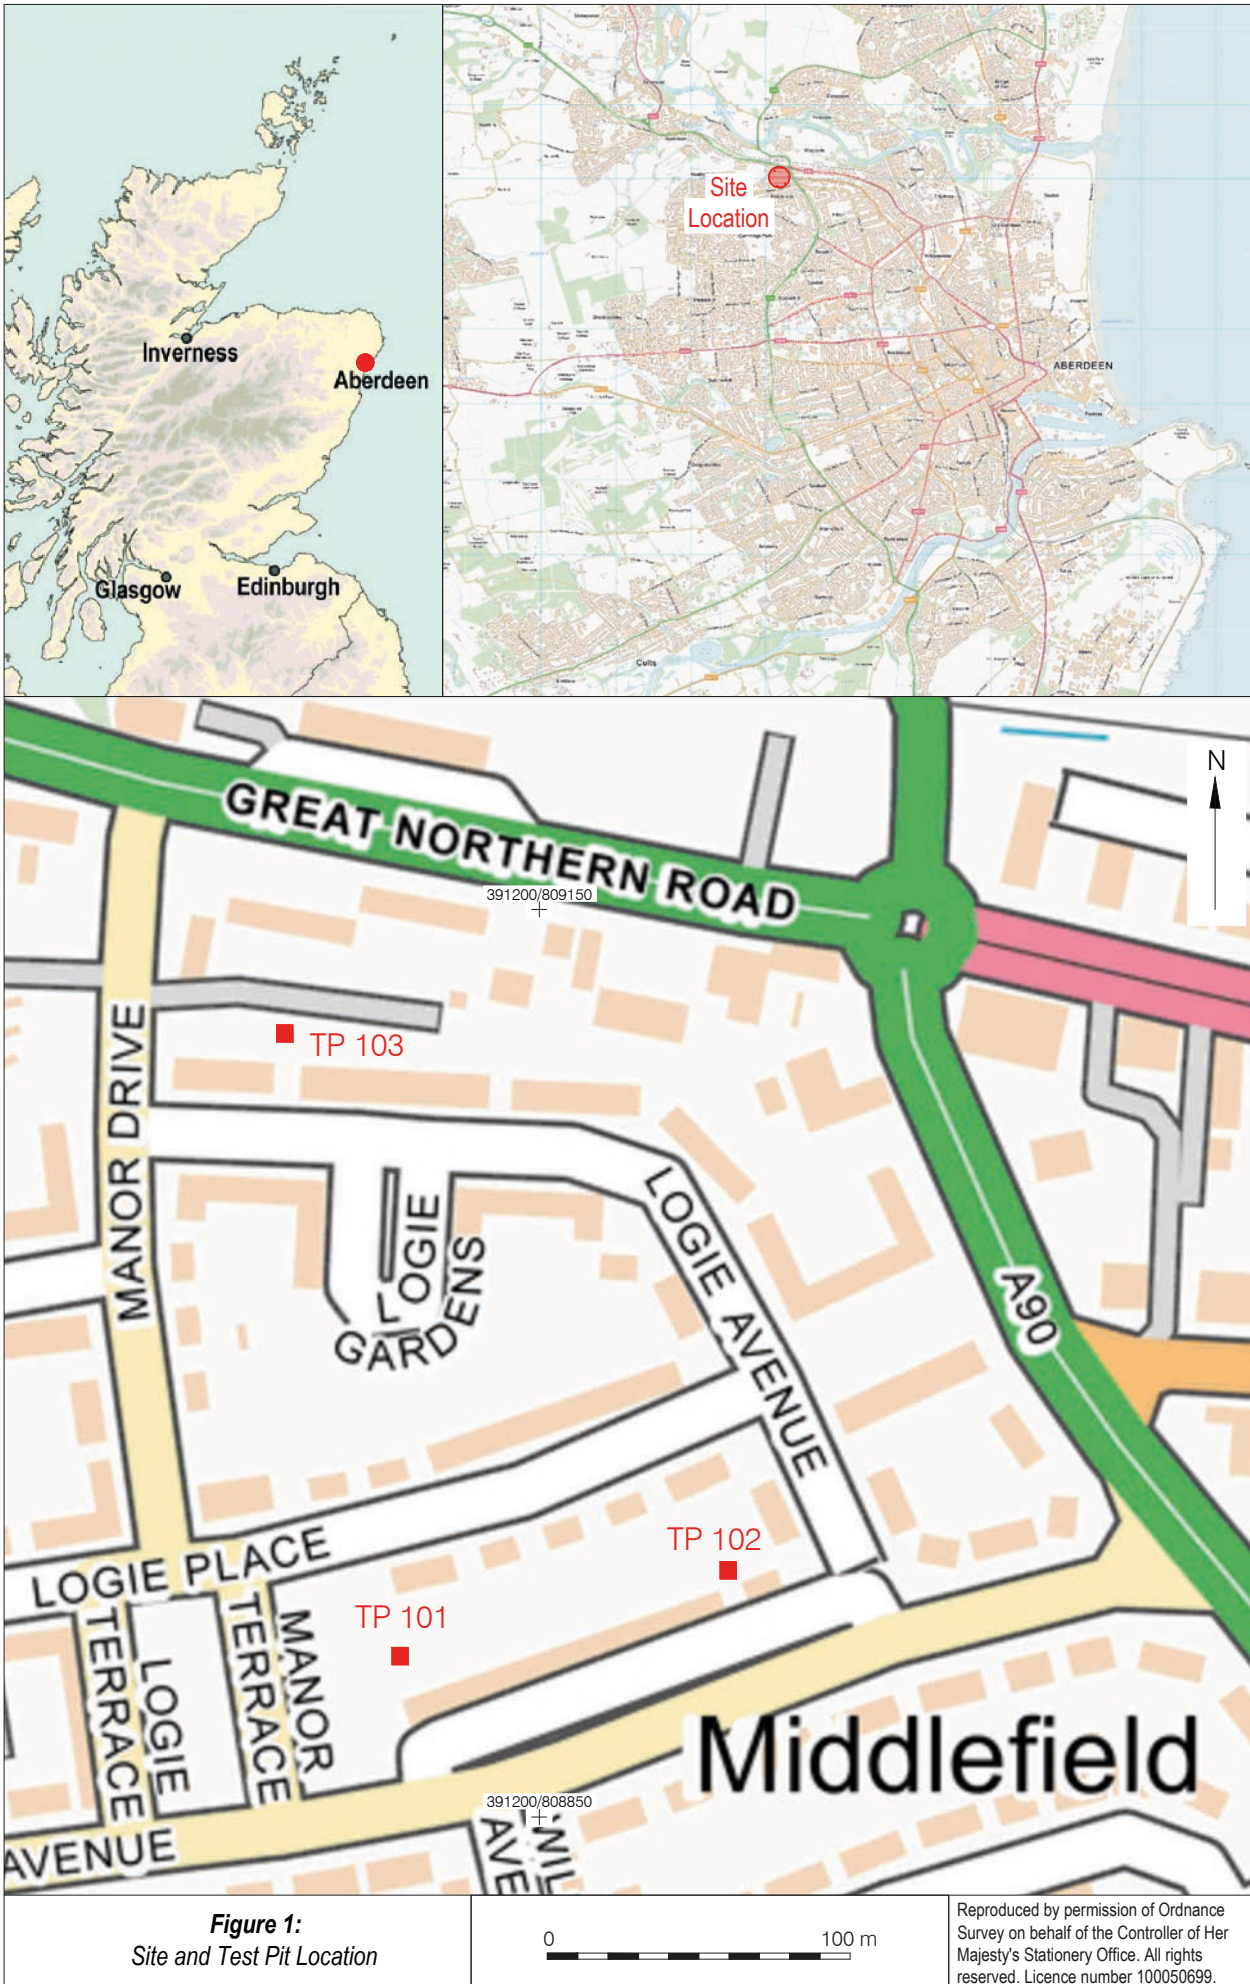
Figure 1:
Site and Test Pit Location

- 3.1 The development area is located to the north west of Aberdeen at the Haudagain roundabout on the junction between North Anderson Drive and Great Northern Road (NGR NJ 913091 centred, Figure 1). The locations of the test pits were within a current housing development.

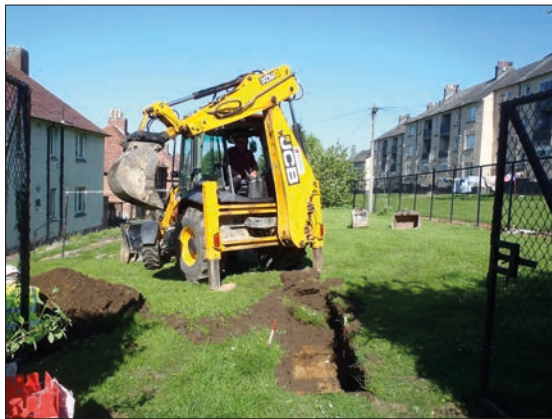
Plate 1: General view of test pit 101, from the west.

7.2.1 Test pit 101 was located on a lawn between the rear of two properties, on ground very gently sloping down from south to north. The test pit was aligned east to west and measured 2.6 m long by 0.6 m wide, topsoil was removed to a depth of 0.5 m, this overlay a pale yellow/brown clay with orange mottling. No archaeological features or artefacts were identified.

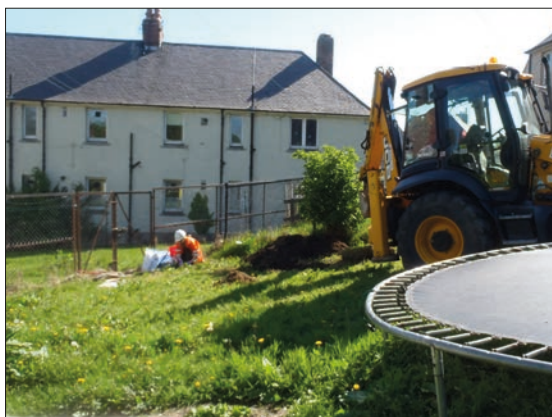
Plate 3: General view of test pit 102, from the west.

7.3.1 Test pit 102 was located on a lawn between the rear of two properties, on ground sloping down from south to north. The test pit was aligned north to south and measured 2.4 m long by 0.6 m wide, topsoil was removed to a depth of 0.6 m, this overlay a pale yellow/brown clay with orange mottling. No archaeological features or artefacts were identified.

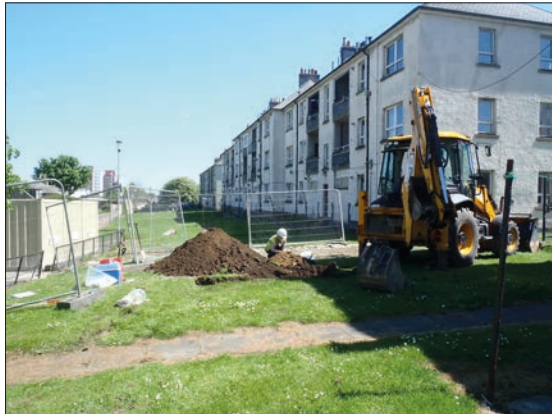
Plate 5: General view of test pit 103, from the west.

7.4.1 Test pit 103 was located on a lawn between the rear of two properties, on flat ground. The test pit was aligned north to south and measured 2.6 m long by 0.6 m wide, topsoil was removed to a depth of 1.2 m, this overlay a pale yellow/brown clay with orange mottling. No archaeological features were identified although a modern rim sherd of glazed stoneware pottery SF.001 possibly from a ink bottle or similar was recovered from the topsoil during excavation.

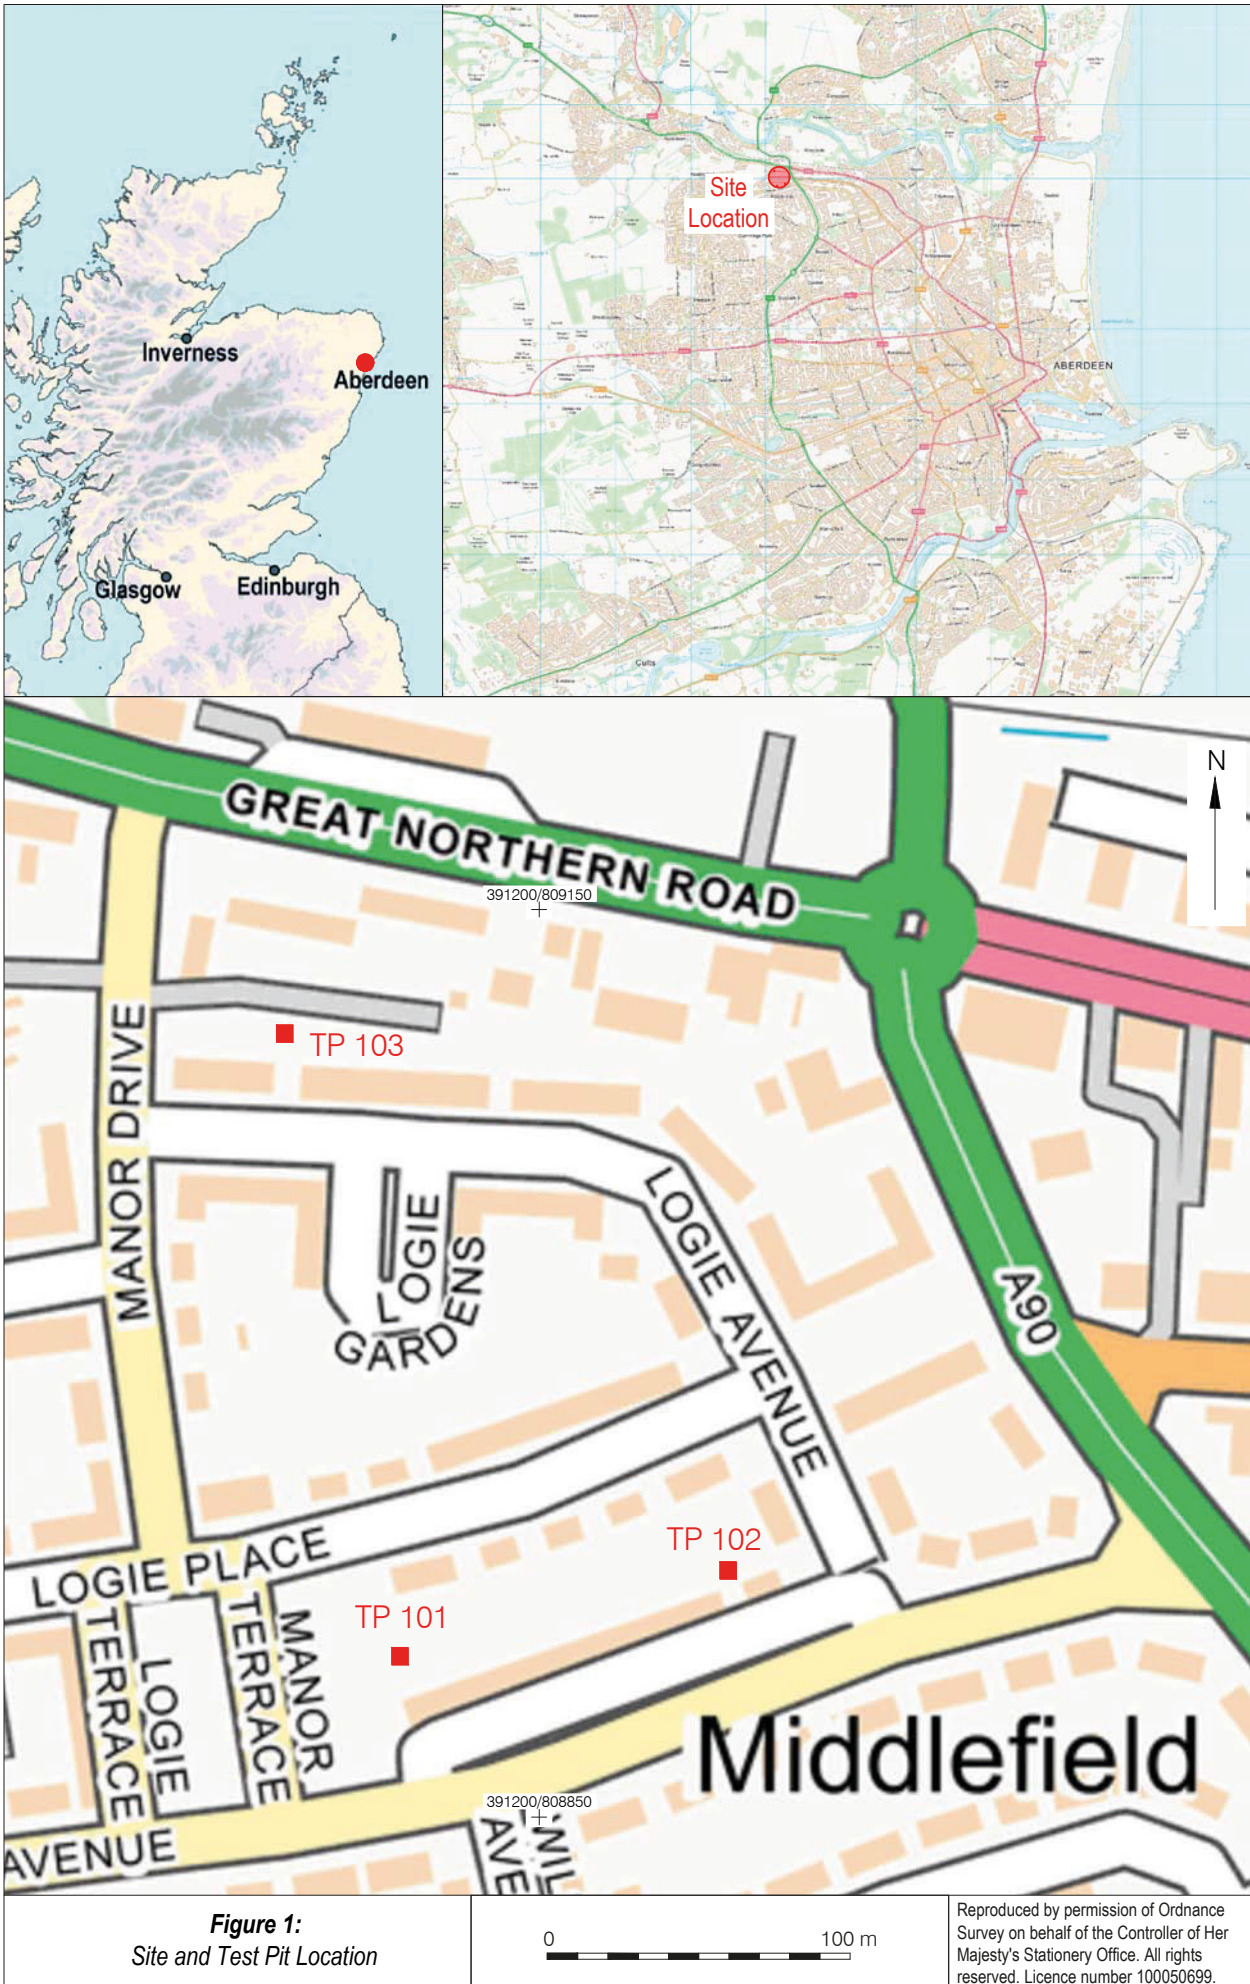
Figure 1:
Site and Test Pit Location

- 3.1 The development area is located to the north west of Aberdeen at the Haudagain roundabout on the junction between North Anderson Drive and Great Northern Road (NGR NJS 913091 centred, Figure 1). The locations of the test pits are within a current housing development.
