**Prestongrange Church, Prestonpans, East Lothian  
Data Structure Report  
Project 4660**

**On behalf of:** East Lothian Council

**Project Number:** 4660

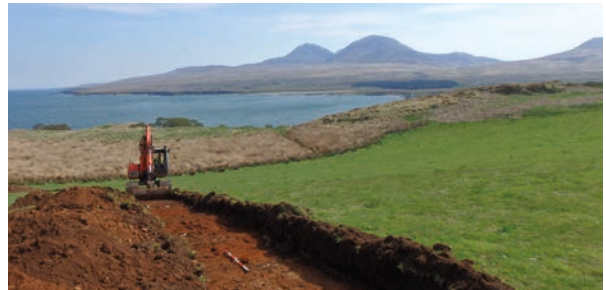
Figure 2: South facing section of foundation trench showing position of features

**7.1.2** The remains of three possible structures were found against the north side of the graveyard wall. The first (003) comprised modern brick and sandstone fragments, haphazardly laid and bound in a cement mortar. Some of the bricks were stamped 'Prestongrange'. The feature measured 1.6 m long by 0.35 m wide by 0.4 m in height. The second structure (008) comprised sandstone rubble consisting of sub-angular stones and measured 3.8 m long by 0.35 m wide by 0.72 m in height. The third structure (009) also consisted of sandstone rubble and measured 1.2 m long by 0.35 m wide by 0.58 m in height. These deposits may relate to an earlier boundary wall or possibly foundations for memorial stones that were located next to or actually attached to the wall.

## 7.2 Excavating foundation trench for new wall (Figure 2 and 3 and Plates 7-11)

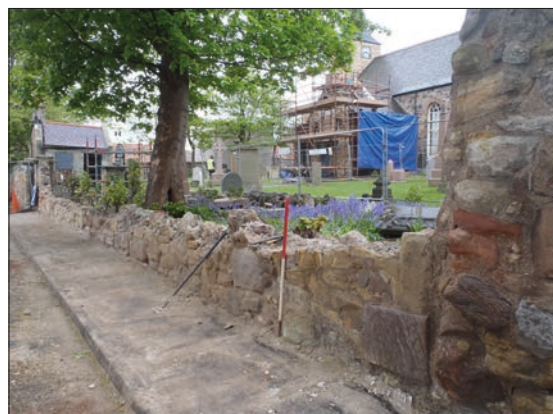
Plate 1: View of the wall after removal of upper courses, prior to archaeological monitoring commencing, taken from the east

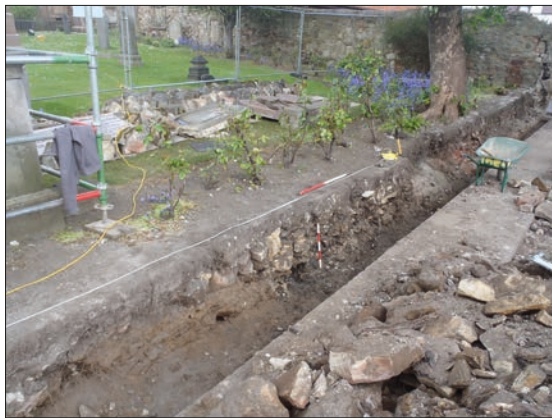
Plate 2: View of foundation trench with rubble features from the south west

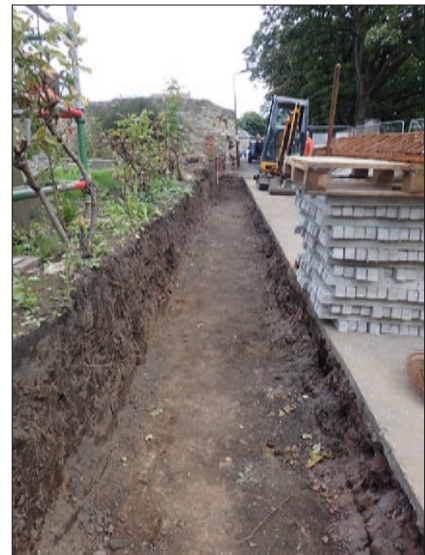
Plate 3: View of fully excavated foundation trench from the west

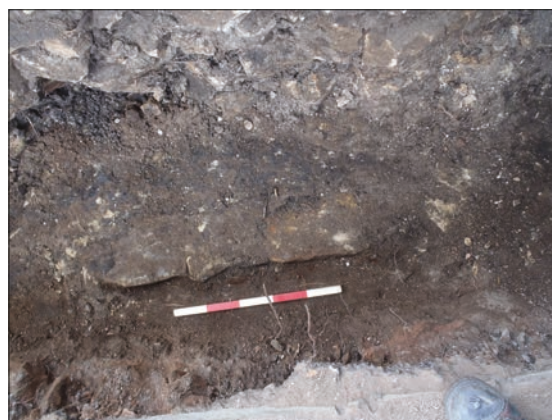
Plate 4: Part of the clay bonded wall 011 below the graveyard wall 001

011		Clay bonded sandstone rubble wall found below formation level for new wall. Only partially exposed in exploratory sondage below wall 001	The remains of an earlier wall on the same alignment as wall 001. Possibly the remnant of the original graveyard wall.

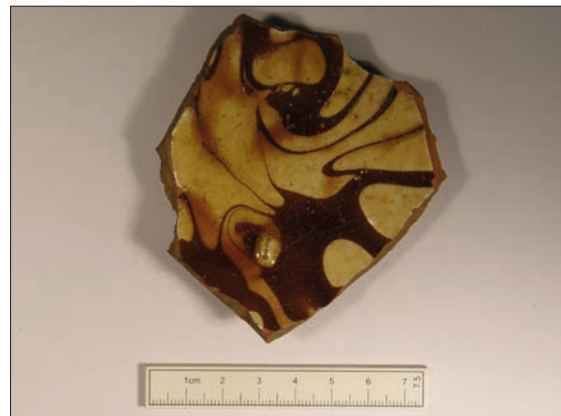
Plate 6: red earthenware with brown glaze and yellow slip decoration

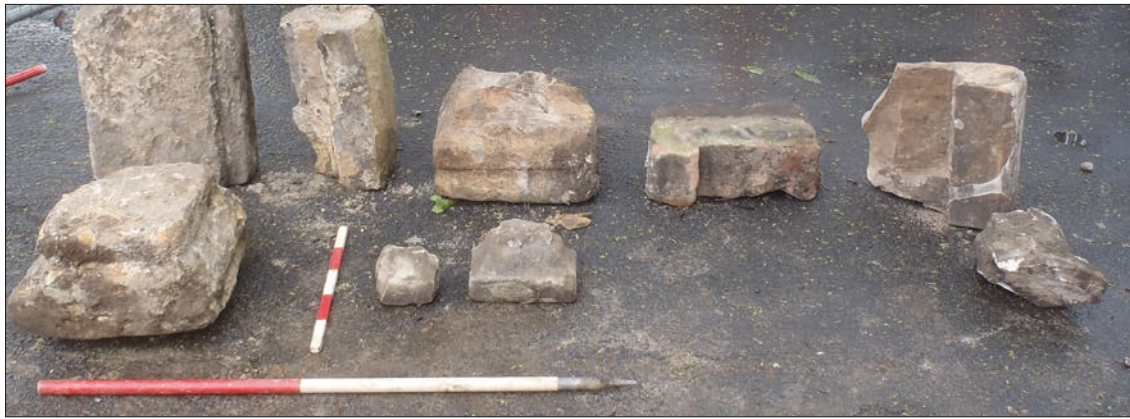
Plate 7: Dressed masonry stones recovered from the fabric of the wall.

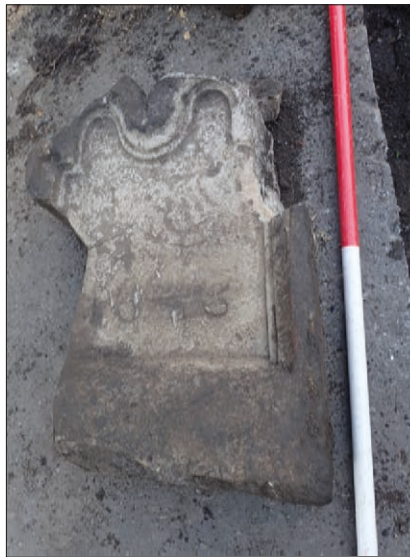
Plate 8: 1646 dated gravestone recovered from the foundations of the wall.

- 9.2 The 1646 gravestone was moved into the watch-house by the entrance to the churchyard for safe keeping and could at a future date be displayed mounted onto the graveyard wall. The dressed masonry blocks were removed from site and are currently stored temporarily in the GUARD Archaeology Ltd offices until a decision is made on their final destination.
