**Lang Loan, Edinburgh: Metal Detecting Survey and Evaluation**  
**Data Structure Report**  
**Project 4770**

**On behalf of:** Persimmon Homes/Miller Homes

**NGR:** NT 2850 6757 (centred)

**Project Number:** 4770

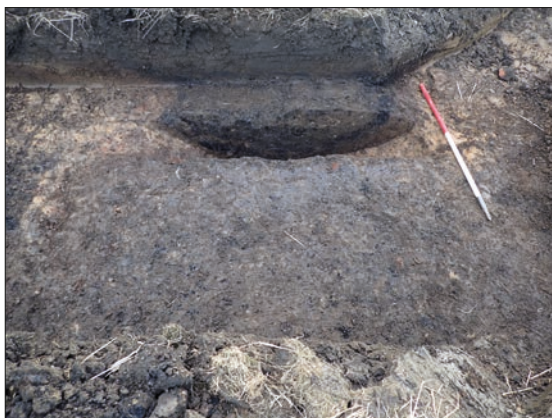
Plate 1: Trench 42. Plan of natural channel. Taken from NNE

- 7.7 In trench 42, due to the presence of a possible archaeological ditch, an investigative slot was excavated. In addition, three trenches (A, B and C) were excavated by machine, to check the orientation/curvature of the possible archaeological feature, and to check if it was archaeological. Trenches A and B were located east of trench 42, and trench C was in the north-east corner of trench 42. The additional trenches established that it was a natural accumulation of silt in a slight hollow and not an archaeological ditch.

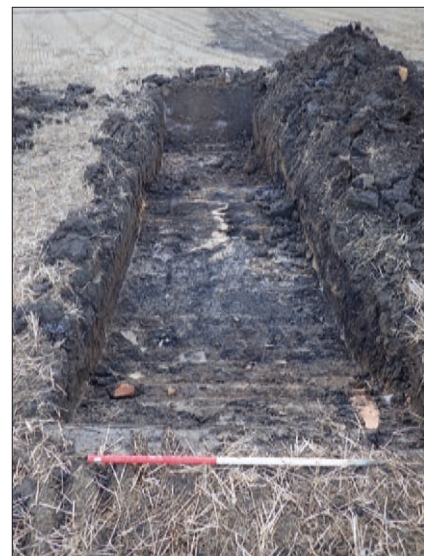
Plate 2: Trench B. Post excavation plan. Taken from NE

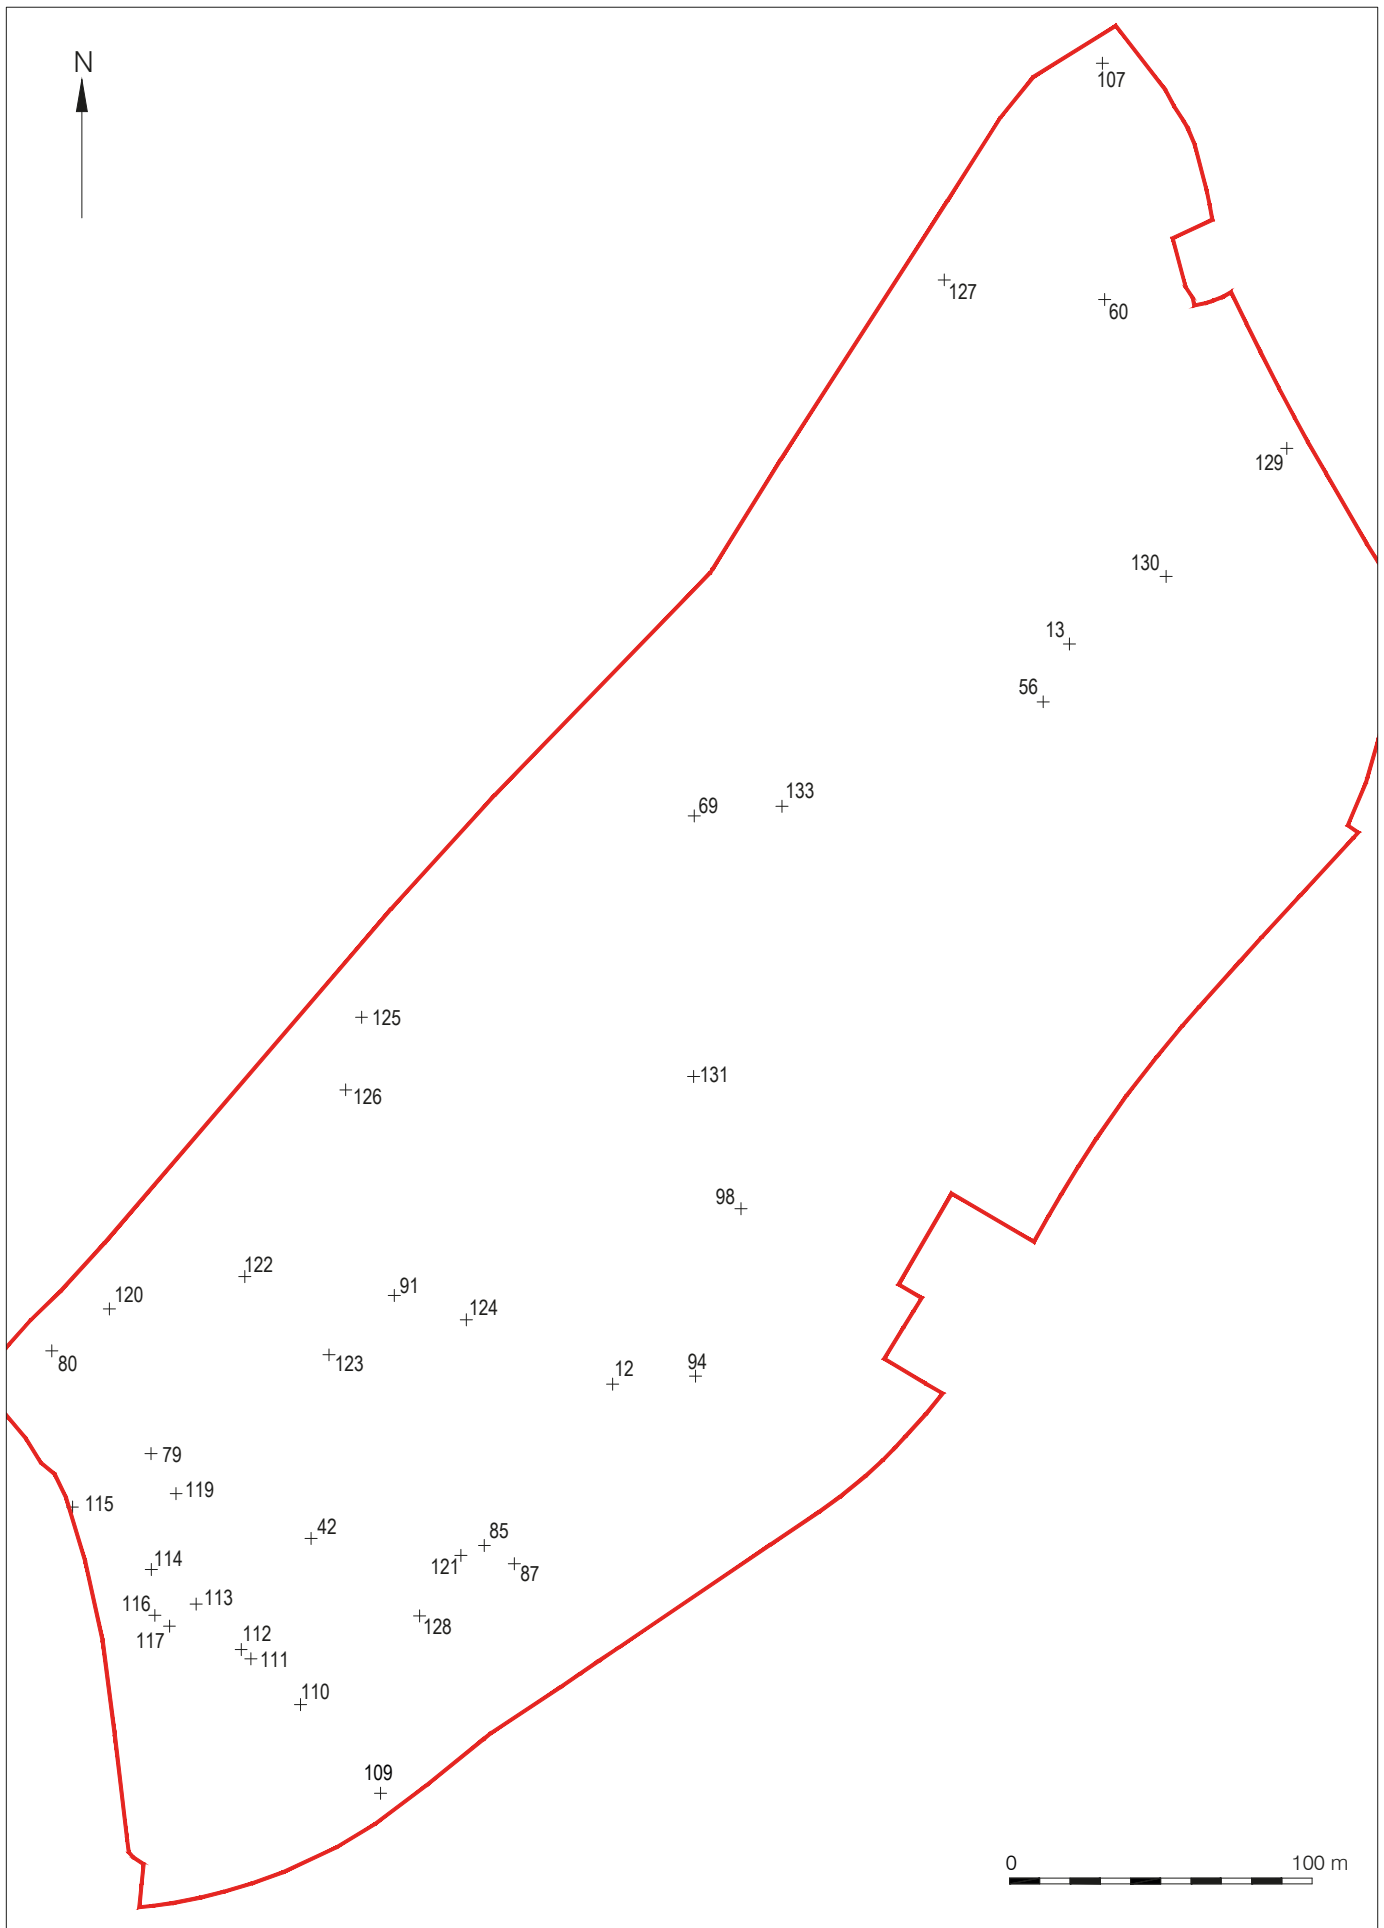
Figure 2: Metal detecting transects and location of find spots.

- 6.2 The archaeological metal detecting survey was undertaken within the entire proposed development site (Figure 2).
- 6.3 The archaeological metal detecting survey was undertaken in linear transects tied into the National Grid using a sub-cm GPS (accurate to +/- 0.1m relative to established control). Transects were aligned both north-west by south-east and north-east by south-west at ten metre intervals.

- 7.1 All significant finds will be referred to in the text using the abbreviation SF (Small Find). During the course of the survey a total of 38 retained metal objects were recovered from topsoil deposits across the site using metal detectors (Figure 2). See Appendix D for full details of retained finds.

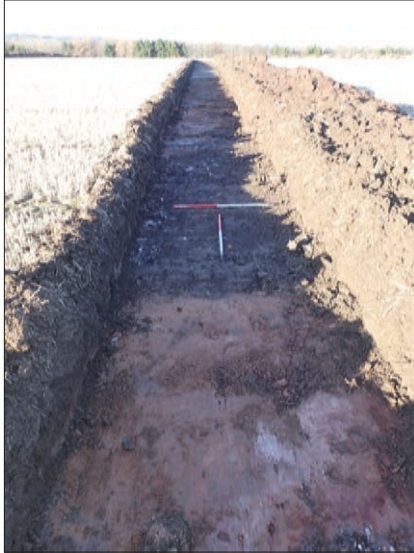
Plate 3: trench 69. plan of trench, detail borrow pit from quarry. Taken from NE

- 7.8 In eight of the trenches (trenches 12, 13, 15, 22, 58, 61, 62 and 69) was located evidence of activity associated with the former quarry from the nineteenth century. These remains consisted of borrow pits infilled by layers of make up material 004 consisting of heavily compact dark brown/grey/black mixed deposits of clay, gravel, sand and silt, with coal fragments, ceramic drain fragments, plastic, metal, modern pottery and stones. Two other similarly mixed infill layers (007 and 008) were also noted in the borrow pits.

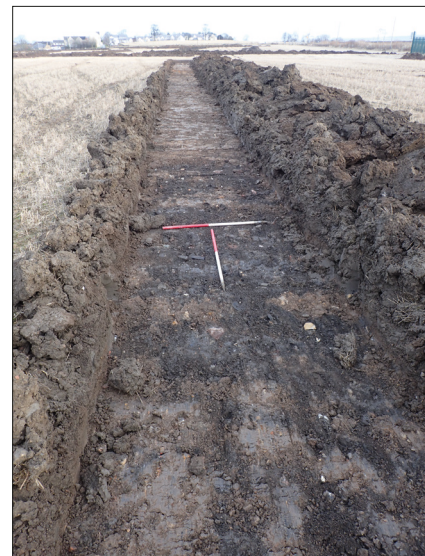
Plate 5: Trench 27. Post excavation plan where the cropmark enclosure identified from aerial photography. Taken from SE

- 7.9 In the area of the potential prehistoric settlement within the development area, represented by the cropmark enclosure identified from aerial photography, three trenches were excavated (trenches 27, 28 and 29) but there was no evidence of any archaeological features here. The crop mark may therefore be a result of differential drainage in this area as a result of variations in the underlying geology, creating the illusion of a curving feature.
