**Archaeological Building Recording at  
Consall Flint Mill  
Ipstones  
Staffordshire  
NGR SK 00460 48398**

Site Code: CFM11

Report No. 1

February 2012

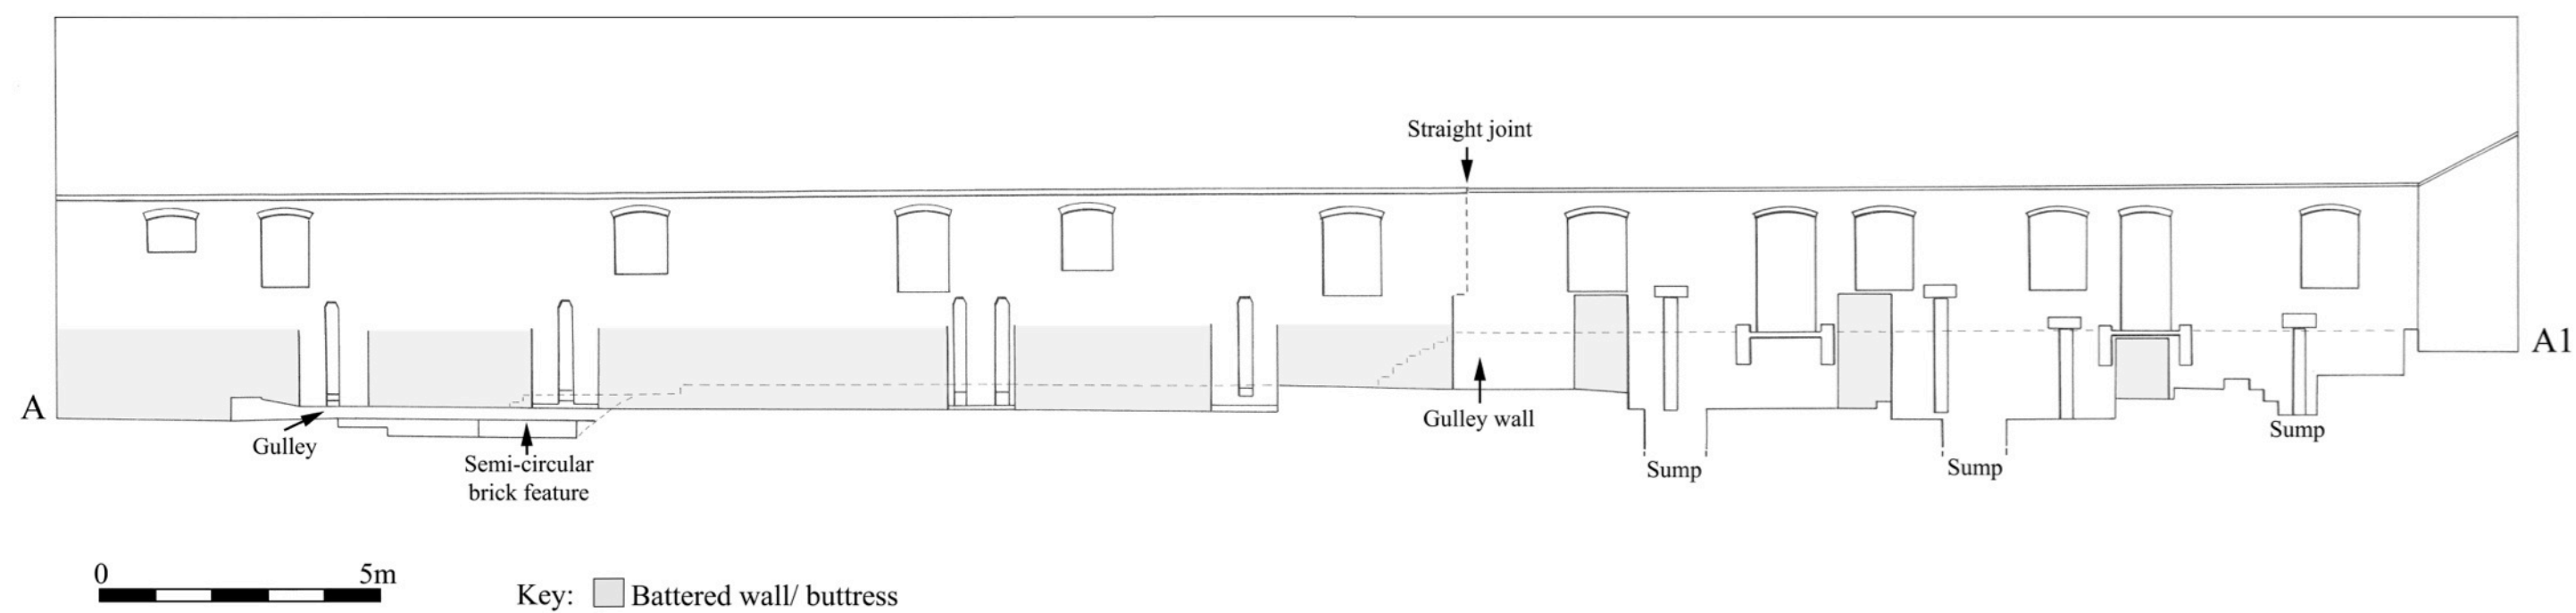
**FIG. 8**

South elevation of Building 1

**5.2.1** Building 1 was a long, single storey building constructed with red bricks in an English garden-wall bond and with a pitched roof covered with blue/grey clay plain-tiles. The building curved slightly to follow the line of the canal and the south-east corner was chamfered (Plate 2). The foot of the south wall was at a lower depth than that of the north wall, there being a low level channel or gulley which extended along much of the south side of the building (Figs. 8 & 9). The ground level dropped away to the same level as the gulley towards the west end of the building. The higher ground level at the east end of the building was retained by the gulley wall, and access over the gulley to the building was achieved by means of concrete bridges opposite each doorway. A straight joint was evident on the north and south elevations, approximately half way along, suggesting that Building 1 was constructed in two separate phases. The difference in construction between the two phases of the building was most evident in the lower half of the south wall. In the west half of the building this was battered, with recesses at intervals which contained tall narrow slots with shouldered heads (Plates 3). Each slot contained a metal plate with circular holes in it (visible on the interior only), identified as plug-planks, the means by which water was drained from the settling arks. The east half of the building (Plate 4) was constructed with three sloped buttresses against the lower part of the south wall. Narrow slots containing plug planks were also evident on this half of the building, in this case with pink sandstone lintels.

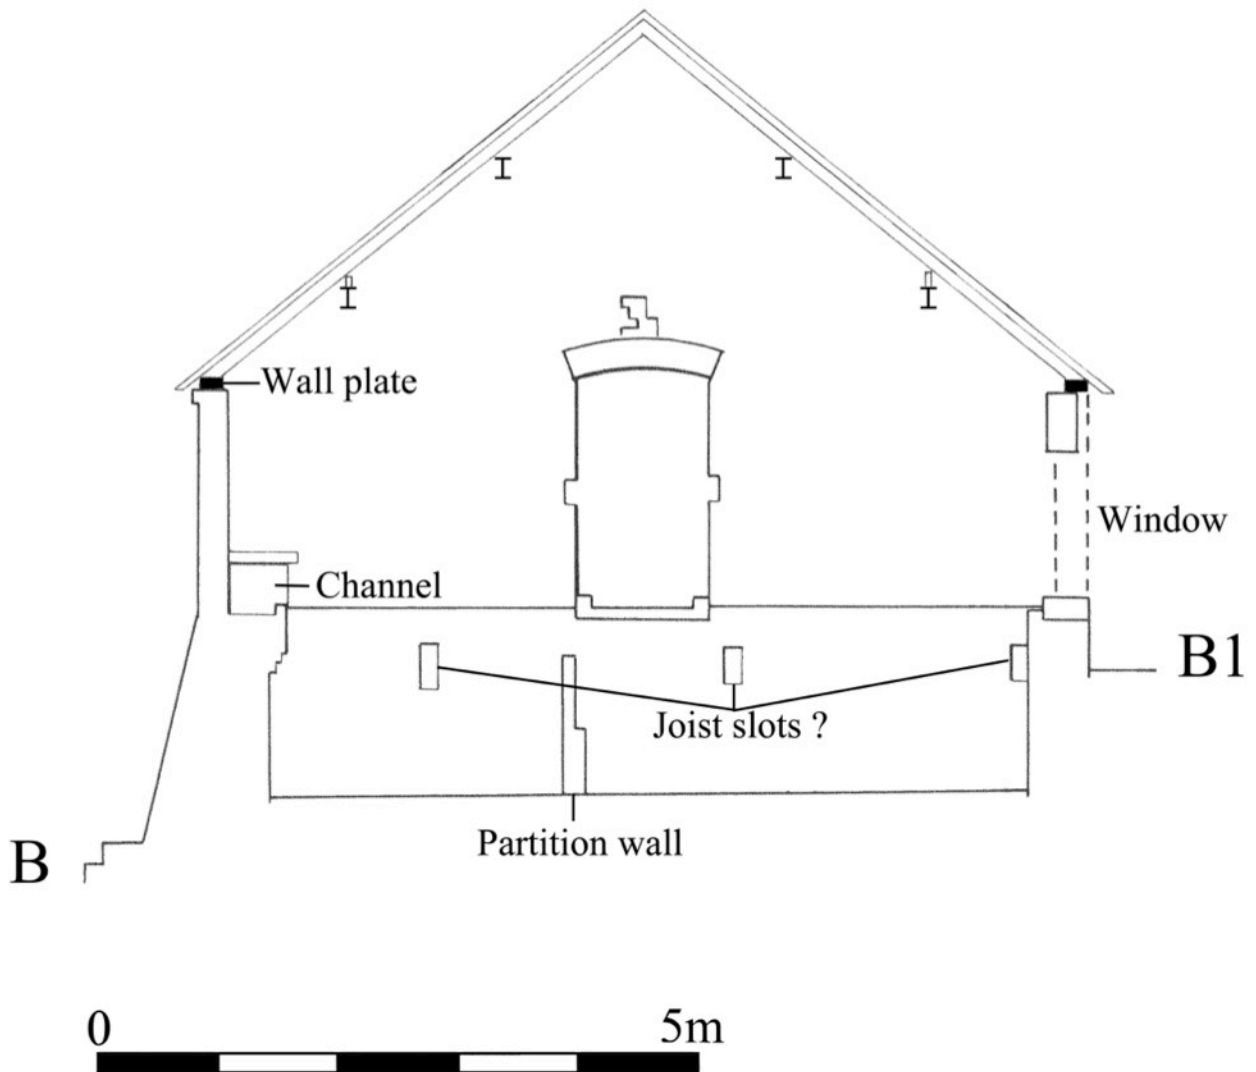
**FIG. 10**

East-facing section through Room 002 in Building 1

**5.2.5** Room 002 differed somewhat from the other rooms/arcs in that its south-west corner was partitioned off with 0.23m wide brick walls (Figs. 9 & 10, Plate 13). A small rectangular area of the floor next to the north wall of the partition was sunk to a depth of approximately 0.20m. A row of three slots in the north wall of the partition and a

corresponding row in the supporting brickwork of the channel, hinted at the former presence of machinery or some other super-structure that had spanned the partition. Room 002 also showed evidence of having at some point had a floor inserted at roughly the same level as the threshold. Three opposing slots were seen in the east and west walls which may have taken floor joists (Fig. 10) and three brick piers aligned north-south down the middle of the room may also have been designed to carry a floor.

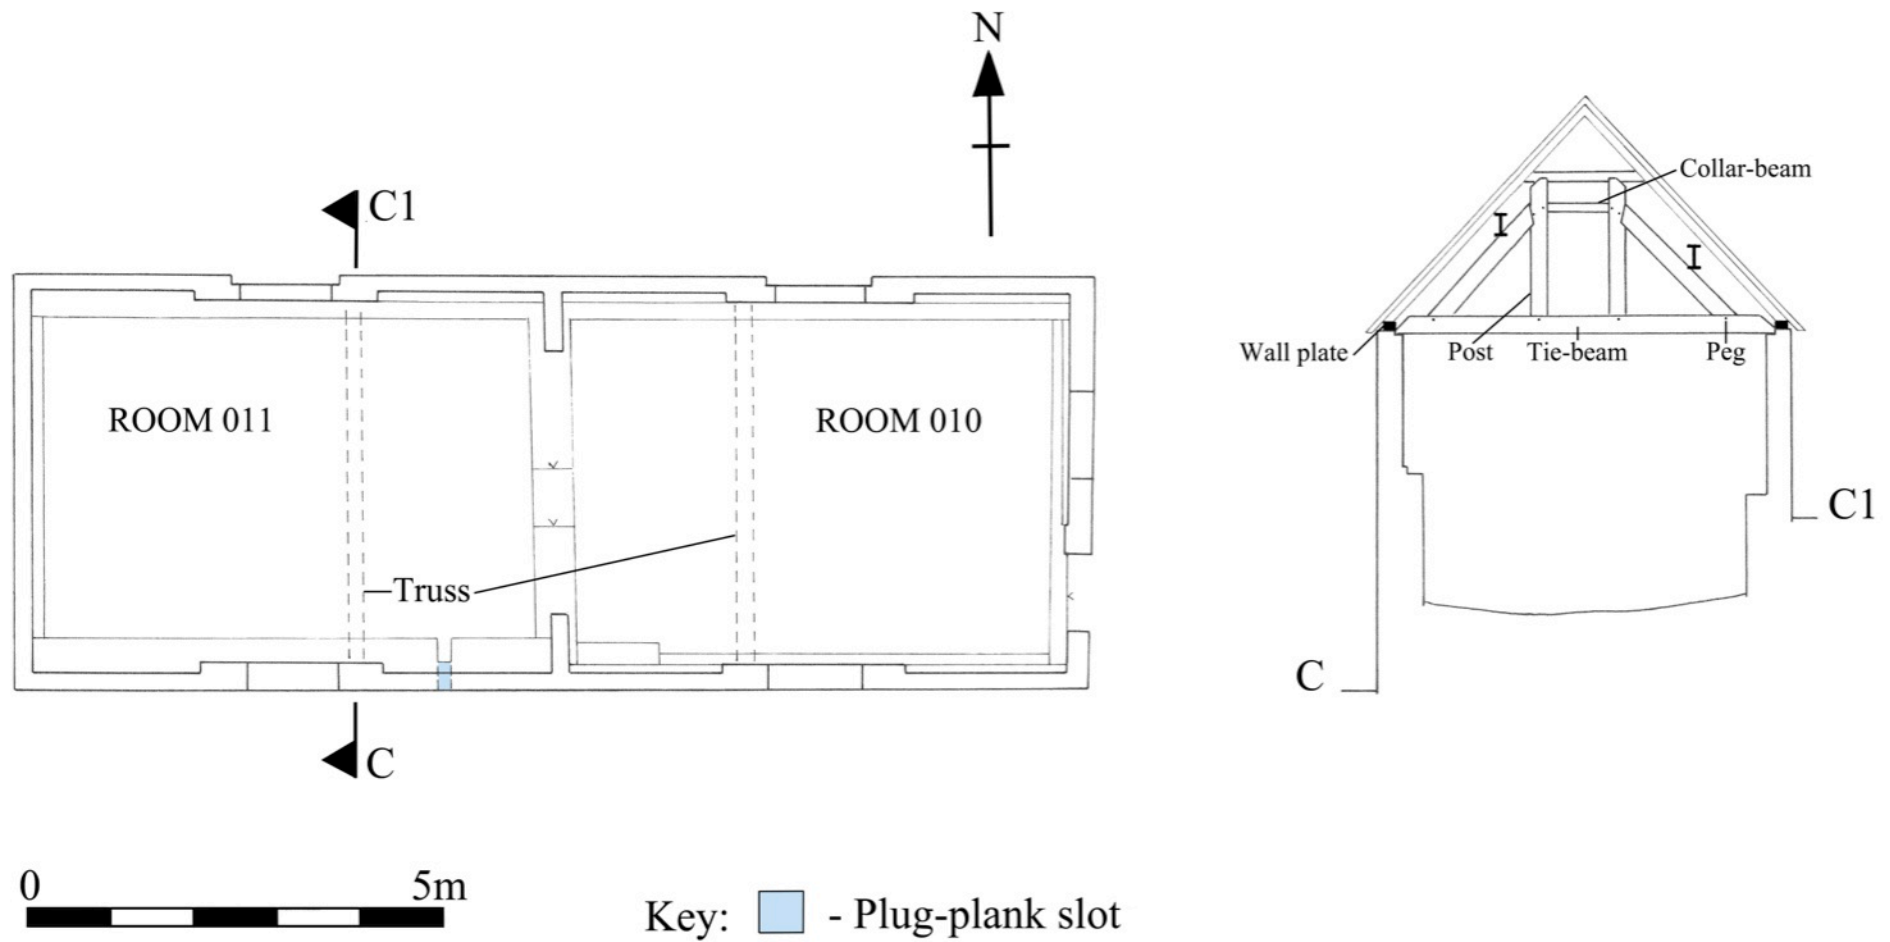
**FIG. 11**

Plan of Building 2 and east-facing section through Room 011

**5.3.2** The interior of Building 2 comprised two rooms/arks (010 and 011) with the characteristic sunken floors and stepped out walls (Fig. 11). Access to the building was possible *via* the door in the east elevation, which entered into Room 010. A wide opening with a steel lintel, possibly an enlargement of an original doorway, had been made between the two rooms (Plate 18). The building did not feature a walkway and the threshold levels had not been altered meaning access between the two spaces was somewhat awkward. The inner skin of brickwork in both rooms had been substantially re-built with areas of light-grey, dark-grey and red bricks, but whether the different colours signified different phases of construction, or the use of readily available materials was unclear. Both rooms featured blue brick floors that sloped down from north and south towards the middle of the building. A metal plug-plank remained within the slot in the south wall of Room 011.

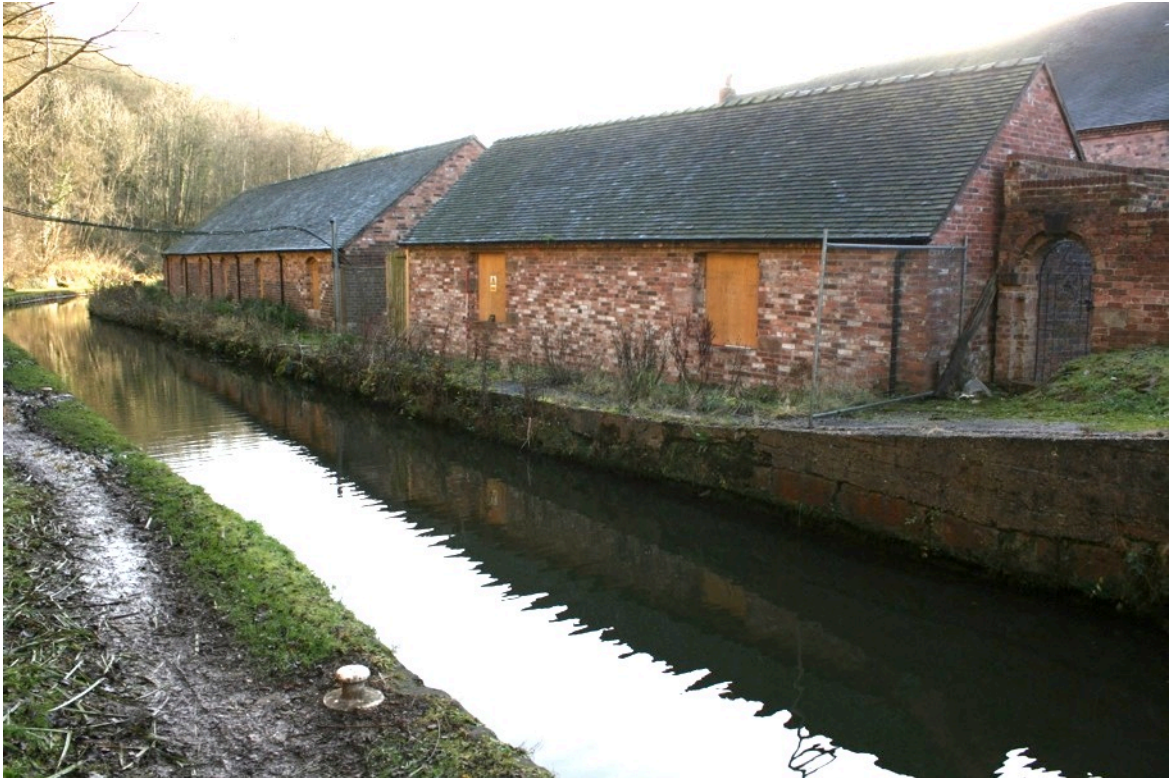
**PLATE 1**

Buildings 1 and 2, looking south-east

alongside the canal on a roughly east-west alignment (Plate 1). These buildings were used as settling arks, where water was drained off the ground flint slurry until the desired consistency was achieved (Copeland 1972, 26 & Dean 2011, 1). The main mill building, subject of two previous building recording programmes (Nicholls 2010 & Sutherland 2007), is located just to the south of these. A row of six kilns on a north-south alignment is located to the east end of the main mill building.

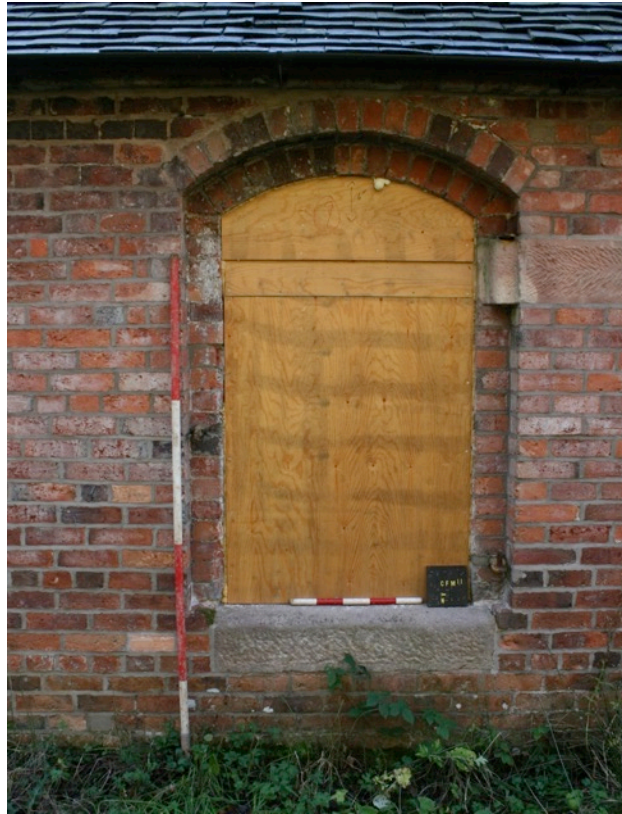
**PLATE 5**

One of the recessed windows in the north elevation of Building 1

Those windows in the north elevation and that in the east elevation had pink sandstone sills and were recessed within slightly larger openings of the same form. The windows in the north elevation had sandstone hinge-blocks built into the west side of the outer openings, towards the top of each, indicating that they had been closed with shutters on

the exterior (Plate 5). The former presence of shutters, and the wear to the stone sills, suggested that the canal side windows were used primarily in moving materials between the building and canal boats. Any original doors or window frames had been removed; the former were fitted with temporary ply-wood substitutes and the latter were boarded over. An area of repaired brickwork on the east elevation of the building (Plate 6), evident as lighter coloured bricks, was suggestive of an opening that had been blocked. This was confirmed with reference to a c. 1960-65 photograph of the building (Staffordshire Past Track), which shows a double doorway in this location. The door and window seen in the east elevation at the time of survey must, therefore, be later insertions. It is also worth noting that at the time the c. 1960-65 photograph of the mill was taken, the easternmost window on the north elevation was blocked and the window next to it had been converted to a door.

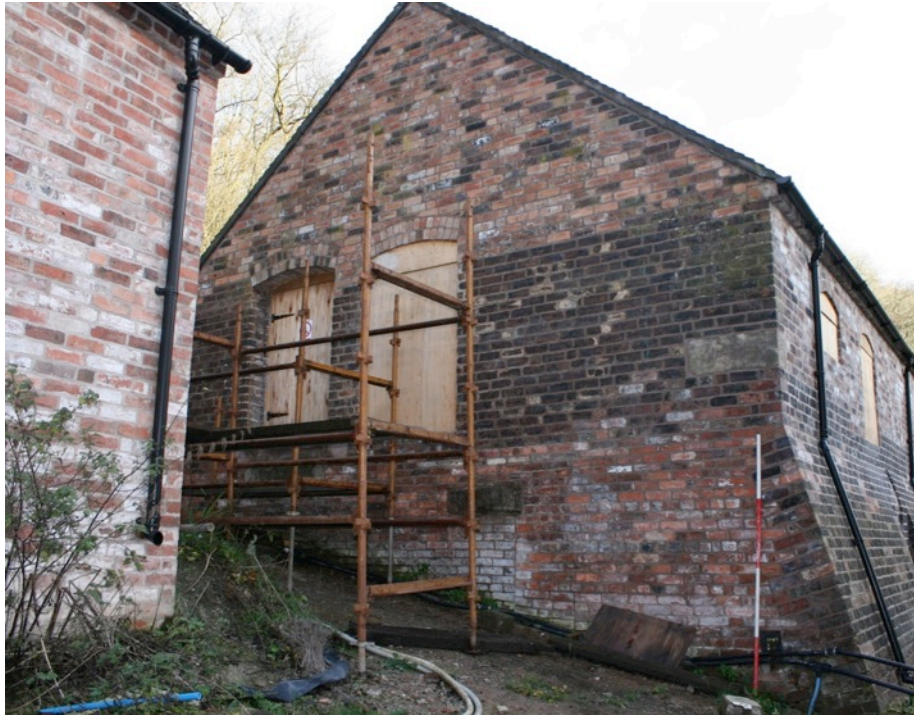
**PLATE 9**

The west elevation of Building 1

largest of these contained four rooms (001 - 004) and was entered *via* a door in the west end of the building (Plate 9). An aperture of the same form and dimensions was located immediately to the south side of this door, and it too may have been used as a doorway. The rooms were open to the rafters, which were supported on east-west aligned steel I-beams. The floors of Rooms 001-004 were all approximately 1.60m below the level of the threshold (Fig. 10), effectively creating tanks or arks in which the ground flint slurry could be settled. The walls of each ark were stepped out, presumably in consequence of the semi-subterranean nature of the structure as well as the weight of the flint slurry that it contained. A brick built channel, carried on corbelled brickwork built out from the south wall, extended the length of all four rooms, passing through 0.50m wide apertures with timber lintels in the dividing walls between the rooms. Pieces of a u-shaped ceramic lining to the channel, which contained the residue of a whitish material (possibly flint slurry) were evident in Rooms 002 and 004. This channel may have been the means by which the flint slurry was carried to the arks, with two possible external in-lets: the first a blocked aperture in the west wall of Room 001 and the second in the south wall of Room 003. A wooden hatch, which may have let the flint slurry out of the channel and into the arks, was located in the north side of the channel in Room 003 (Plate 10). The timber, however, looked a recent addition, possibly replacing an original feature of the same design. Elsewhere the north side of the channel did not remain to sufficient height to determine whether or not such hatches were originally present in the other rooms. Each room/ark had a plug-plank slot located below the channel (Plate 11) with the blue-brick floor sloped down towards it. Access between the rooms was possible *via* a central concrete walkway, which extended east-west between doorways with segmental-arched heads (Figs 9 & 10, Plate 12). A metal handrail to the walkway survived in Room 003 only; its removal in the other rooms had resulted in slots to each side of the doorways. The walkway crossed Room 001 and Rooms 003 and 004. A blocked door central to the east wall of Room 004 indicated that access to Room 005 (within the second unit of Building 1) was originally possible. The walkway did not, however, extend across Room 002. Instead, it stopped at the threshold of the doorways at either end of the room.

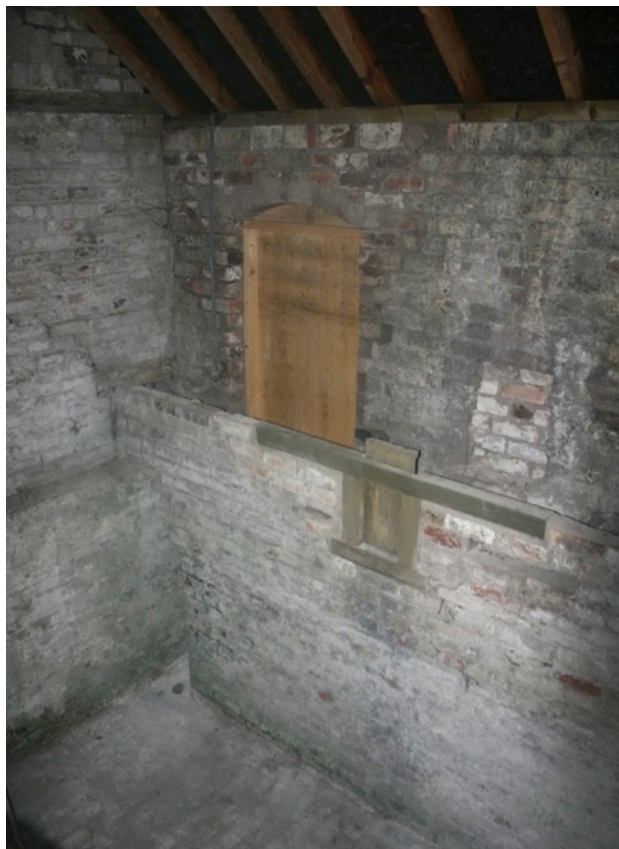
**PLATE 10**

The channel and hatch in Room 003

**6.5** The means by which the ground flint slurry was carried from the main mill building to the arks is not clear. The channel which extended along the south wall of Building 1 probably let the flint slurry into the arks through such hatches as were seen in Room 003. Two

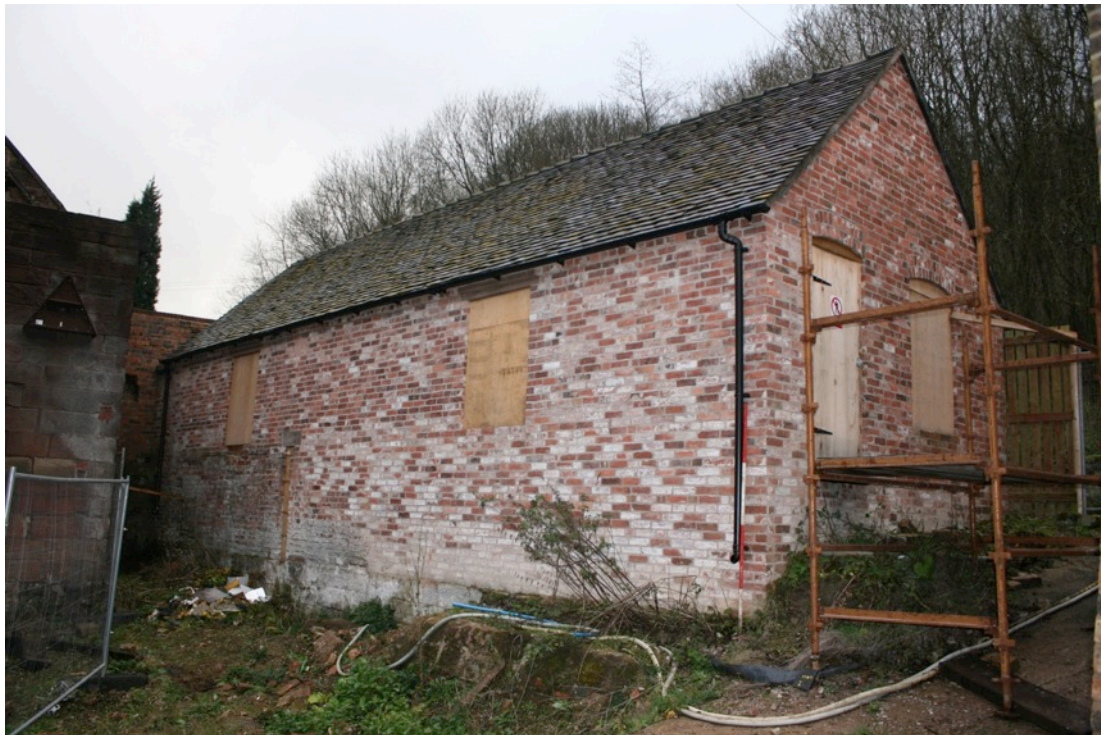
**PLATE 16**

Building 2, looking north-west

**5.3.1** Building 2 was a small single-storey structure located to the west end of Building 1 (Figs. 2 & 3, Plate 16). The west end of Building 2 was built against the wheel-pit at the rear of the main mill building, towards its west end. Building 2 was constructed with red bricks on a stone base. The bricks were arranged in a Flemish stretcher bond. The roof was pitched and clad with blue-grey clay plain tiles. Like Building 1 the south wall extended to a greater depth than the north wall. A plug-plank slot with a stone lintel was located in the lower half of the south wall, towards the west end of the building (Fig. 11). There was, however, no evidence for a gulley to take excess water from the plug-plank. The window and door at the east end of Building 2, had segmental-arched heads, in-keeping with those seen in Building 1. The windows in the north and south elevations, however, had straight stone lintels. Those in the north elevation were recessed slightly and each had a pair of hinge blocks on the west side, indicative of the former presence of shutters (Plate 17).

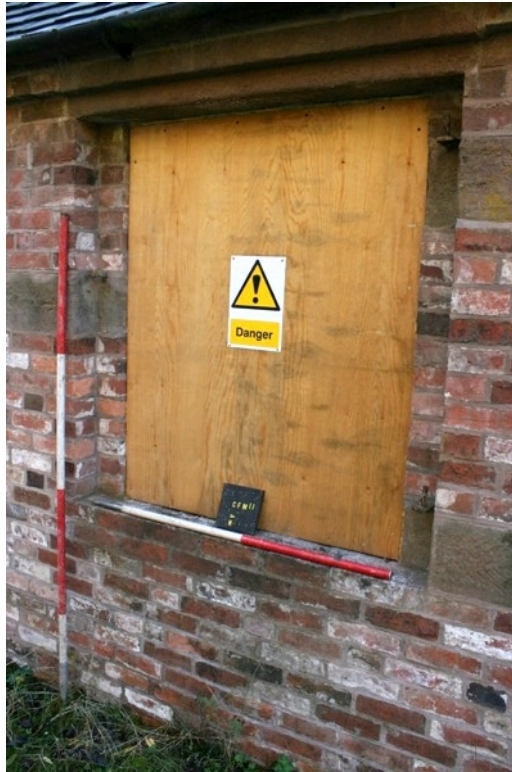
**PLATE 17**

Recessed window in the north elevation of Building 2

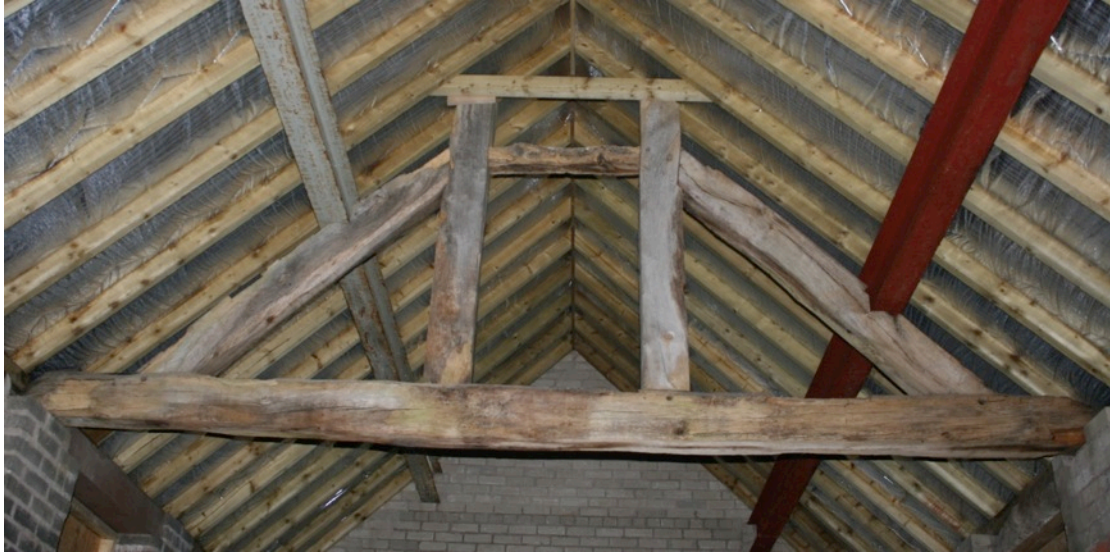
**PLATE 19**

The truss in Room 011

**5.3.3** The rooms in Building 2 were both open to the rafters, revealing that the roof structure had been replaced with new timbers supported on steel I-beams. The exception to this was a pair of Queen-post timber trusses, which had been adapted to carry the I-beams. The trusses were located to the dividing wall side of the windows in each room and spanned the building north-south. Each truss (Fig. 11, Plate 19) comprised a tie-beam, the end of which rested on the side walls of the building. A pair of vertical posts with a collar-beam between them, were positioned towards the middle of the tie-beam. A pair of inclined timbers extended between the tie-beam and the posts on each side of the truss. These would essentially have functioned as principal rafters and pairs of slots that would have carried the purlins were evident on each. The tops of the posts were slanted in order to accommodate the common rafters that would have rested on the purlins. The whole structure was jointed together and fixed with wooden pegs.

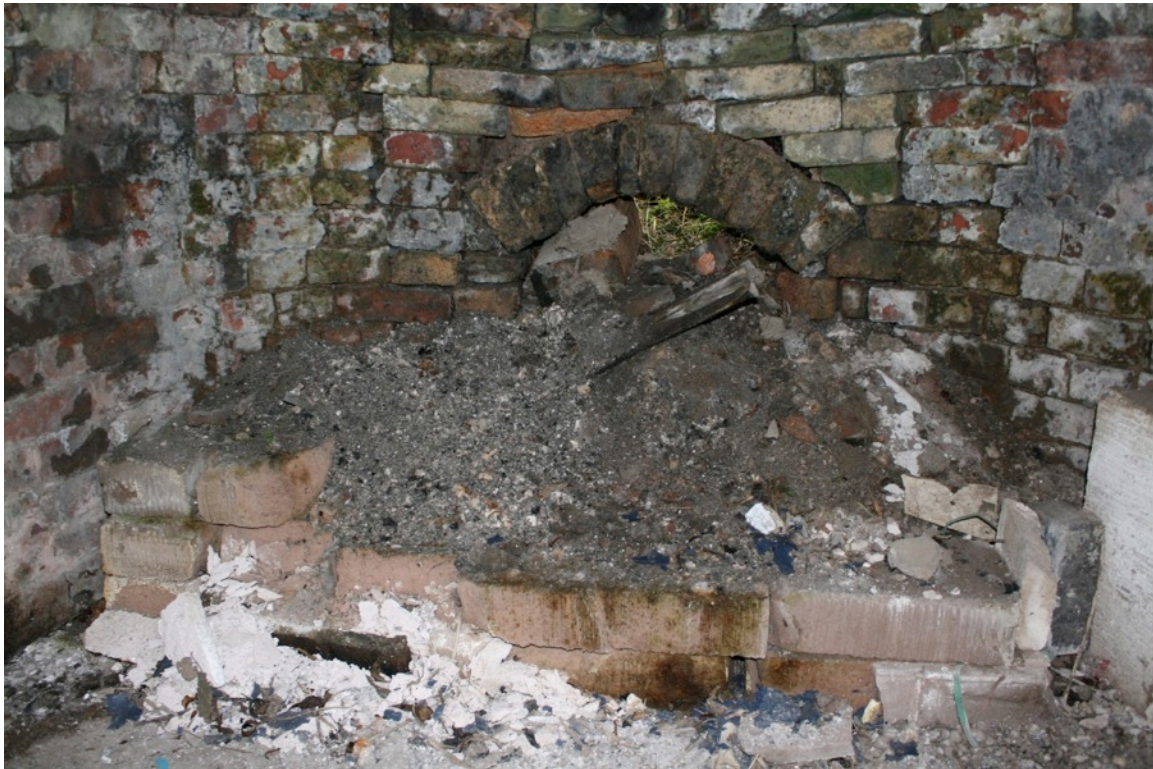
**PLATE 24**

Detail of Kiln 5 draw-mouth

bricked up and was indistinguishable from the brick paving that surrounded the other kilns. No evidence of any superstructure, forming a hovel or otherwise surrounding the kilns, was visible. The draw-mouths were located at the base of the kilns on their west side with a consequent drop in ground level on that side. A flight of stone steps at the south end of the row allowed access between the two levels (Plate 22). The face of the draw-mouths rose to form a wall at the higher level, preventing falls. The draw mouths had semi-circular arched openings, which had been bricked up except in Kilns 1 and 5 (Plate 23). The arches in Kilns 1 and 5 formed the entrance to a recess with concave walls, which had a small aperture at the back opening into the base of the kiln well. That in Kiln 1 had a metal lintel and was bricked up. That in Kiln 5, with a segmental-arched head, remained open (Plate 24).
