**Archaeological Watching Brief at
Statfold Farm
Clifton Lane
Tamworth
Staffordshire
NGR SK 23733 07581**

Report No. 004

December 2012

Produced for: C L Gilman & Son

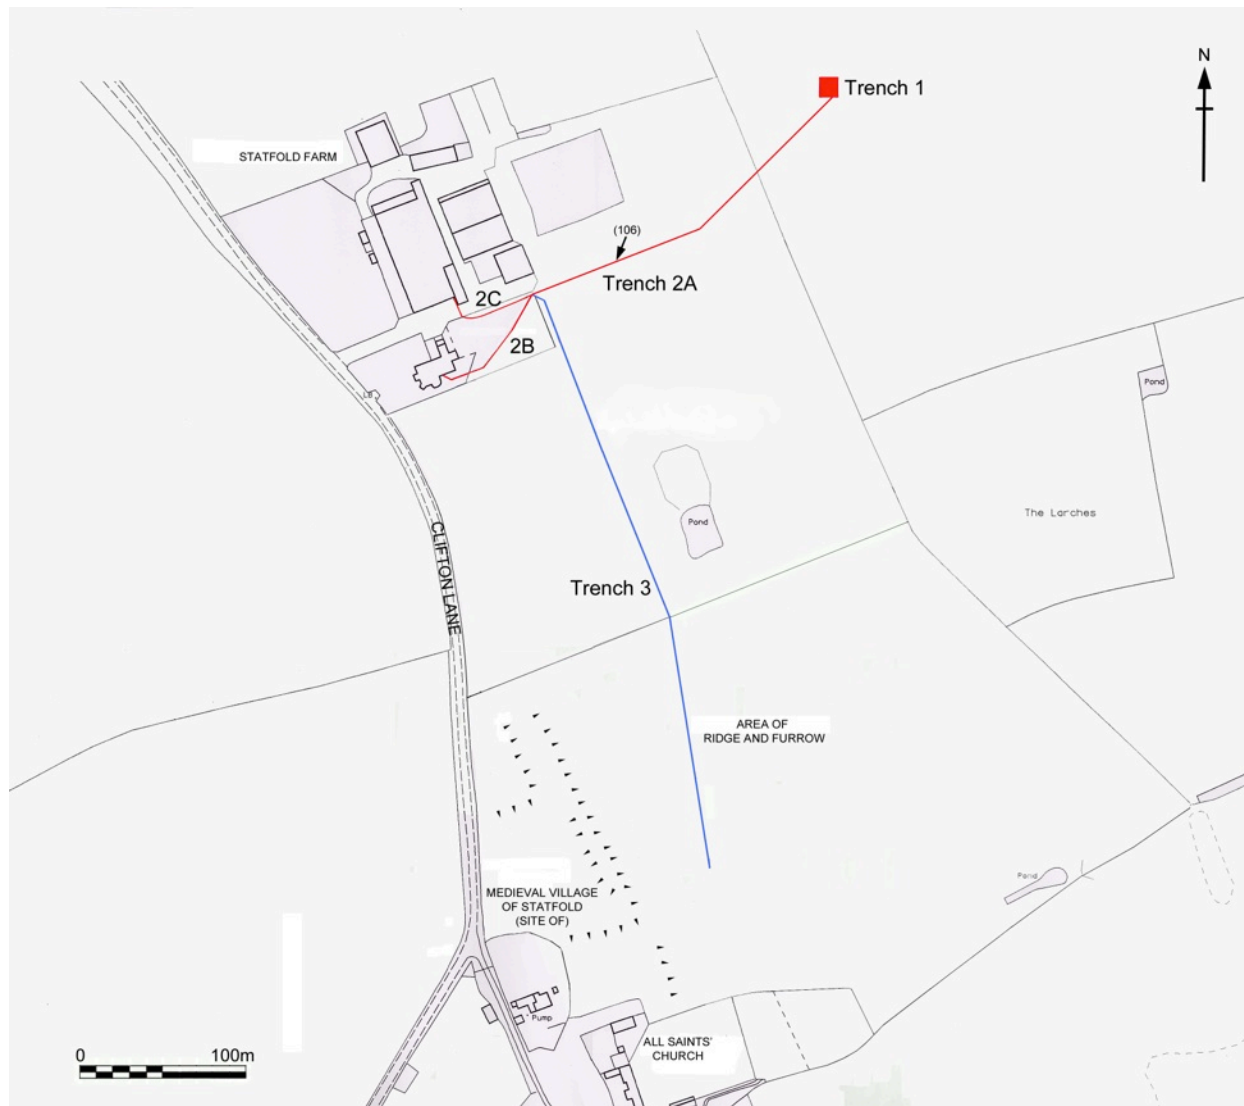
FIG. 2: Trench location plan with the turbine trenches indicated in red and the Western Power upgrade trench in blue.

5.1 The watching brief was undertaken in three main phases during excavation of: 1) the turbine foundations, 2) the turbine cable trenches, and 3) the Western Power upgrade trenches (Fig. 2). All excavation was carried out with 360° tracked excavators using toothless ditching buckets. For the sake of clarity and consistency the same context numbers have been used throughout all three phases of the watching brief.

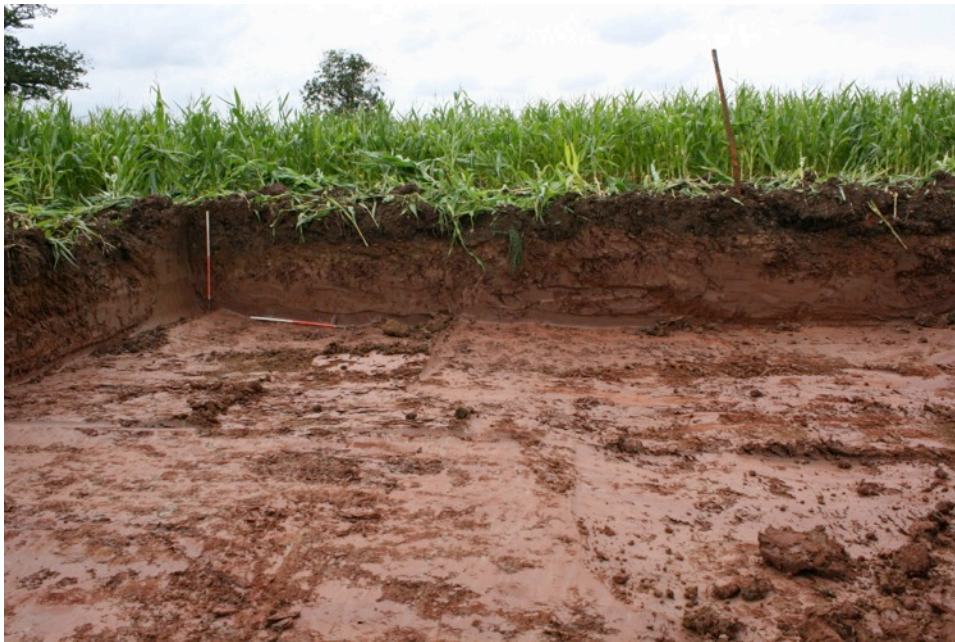
PLATE 1

Trench 1, the turbine foundation, looking north-west (scales: 1m).

5.2.1 The turbine foundation (trench 1) encompassed an area of 9m x 9m, within a corn field approximately 200m to the east of the farm buildings (Fig. 2, Plate 1). It was excavated to a depth of 1.90m, during which the following layers were encountered:

- (100) Dark-brown clay-silt with frequent inclusions of small, rounded pebbles, identified as topsoil. 0.30-0.35m thick.
- (101) Brownish-red clay with frequent inclusions of small, rounded pebbles, identified as natural subsoil. 0.18-0.20m thick.
- (102) Red clay with occasional blue-grey mottling and containing occasional small rounded pebbles. Identified as natural subsoil.

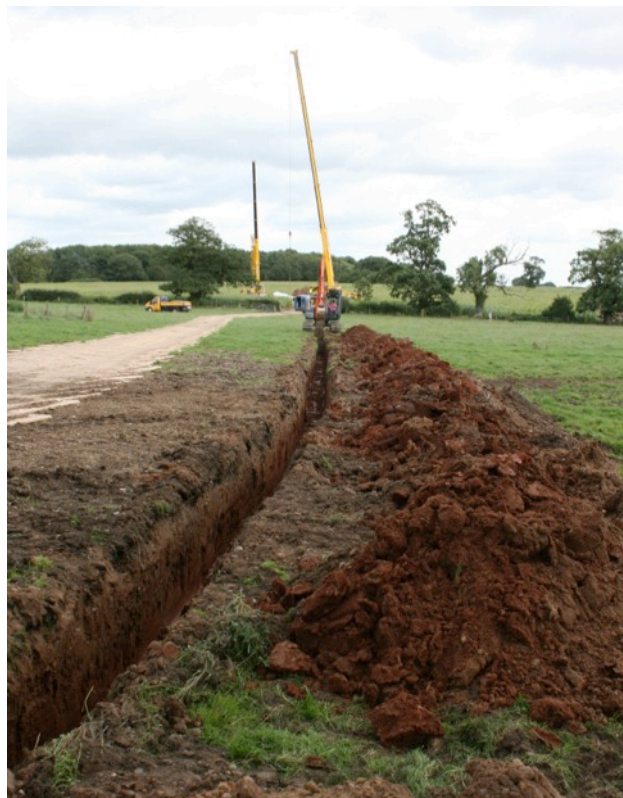
PLATE 2

Trench 2A, looking east towards trench 1.

5.3.1 The turbine cable trench extended 210m across grazing land between the turbine and the connection point in the north-east corner of the orchard. This first section (trench 2A) was 0.70m wide and 1.10m deep (Fig. 2, Plates 2 & 3). The trench then forked into two, one section extending south-west across the orchard to the farm house (trench 2B) (Plate 5) and the other extending eastwards and then northwards to one of the farm outbuildings (trench 2C). These trenches were 0.60m wide and 0.60m deep, excepting the portion next to the farm house which was only 0.35m wide. The soil profile (Plate 3), which varied slightly from that seen during the turbine foundation excavations, was as follows:

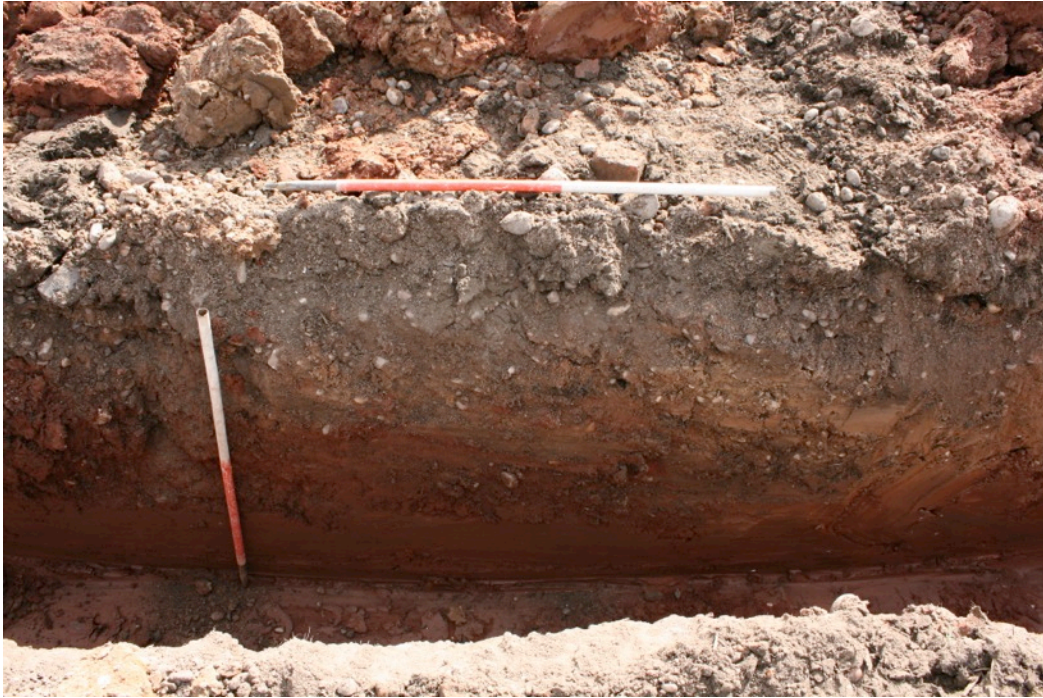
PLATE 3

Representative view of stratigraphy within trench 2A; showing topsoil (103), silty-sand (104) and natural clay (101) (scales: 1m).

- (103) Dark-brown, loose, silty-loam, identified as topsoil. 0.10m-0.25m thick.
- (104) Mid-brown, loose, slightly silty-sand with moderate inclusions of small rounded pebbles. 0.35-0.40m thick
- (101) Brownish-red clay.

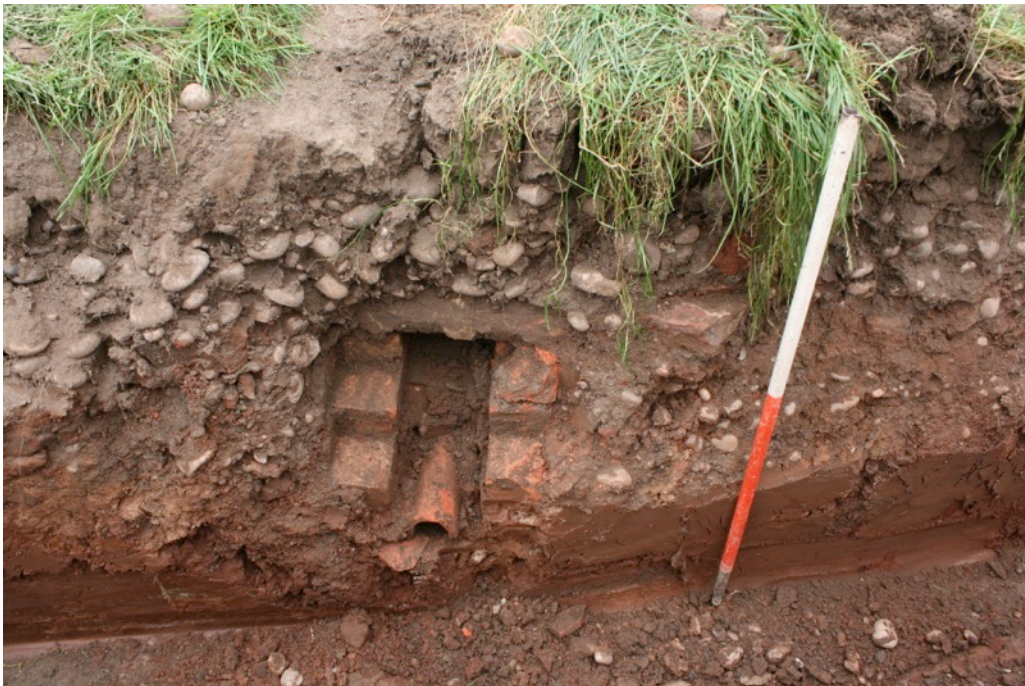
PLATE 4

Brick culvert (106) in trench 2A, looking south (scale: 1m).

5.3.2 A small culvert (**106**) constructed with brick sides and a stone cap was seen crossing trench 2A on a roughly north-south alignment (Plate 4). The culvert was 0.27m wide and 0.27m high internally, and contained a red ceramic horseshoe drain (0.10m wide and 0.09m high). The base of both culvert and drain were formed by the natural clay (**101**). A cut for the culvert [**108**], made into silty-sand (**104**), was only partially visible. A layer of pebbles (**105**) topped the whole.

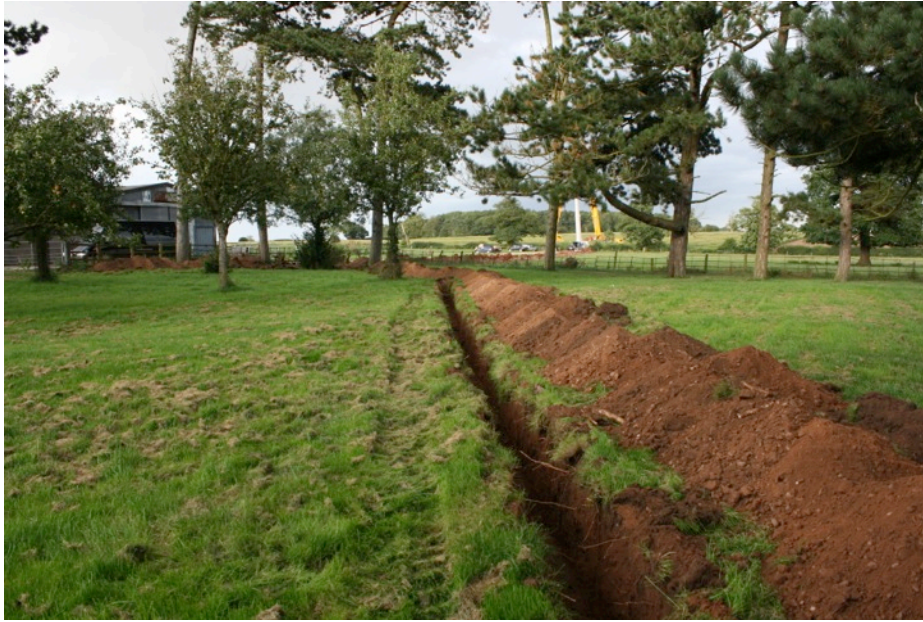
PLATE 5

Trench 2B looking north-east across the orchard.

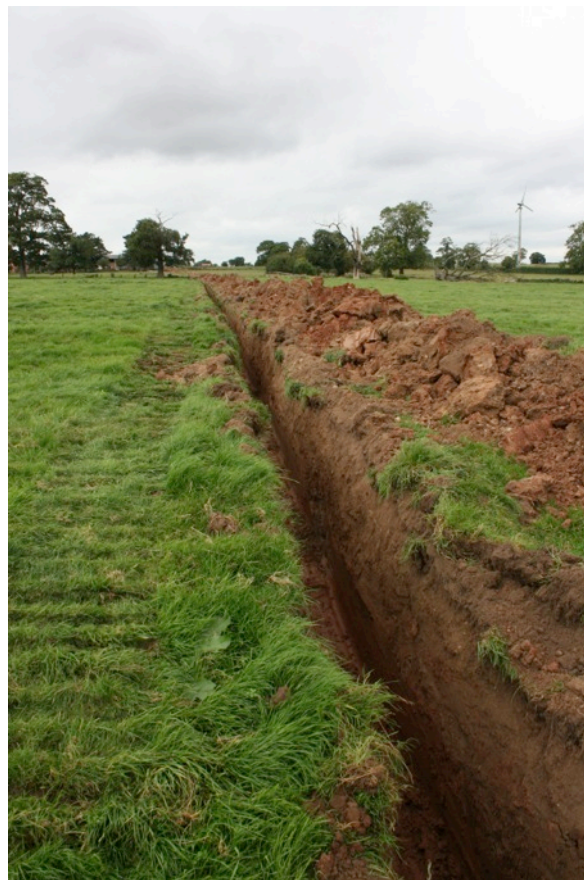
PLATE 6

Trench 3 looking north towards the farm buildings and new turbine

5.4.1 The Western Power upgrade trench (trench 3) was 0.70m wide and approximately 1.20m deep. It extended roughly 350m southwards from the connection point in the north-east corner of the orchard and across two cattle grazing fields (Fig. 2, Plate 6). The soil profile seen within the trench was much the same as seen in the previous trenches despite its route through an area of obvious ridge and furrow (PRN 20259) (Plates 7 & 8). The depth at which clay (**101**) was encountered did, however, gradually increase to 1.00m below ground level as the trench moved south, with the silty-sand (**104**) above, increasing to a maximum thickness of 0.75m.

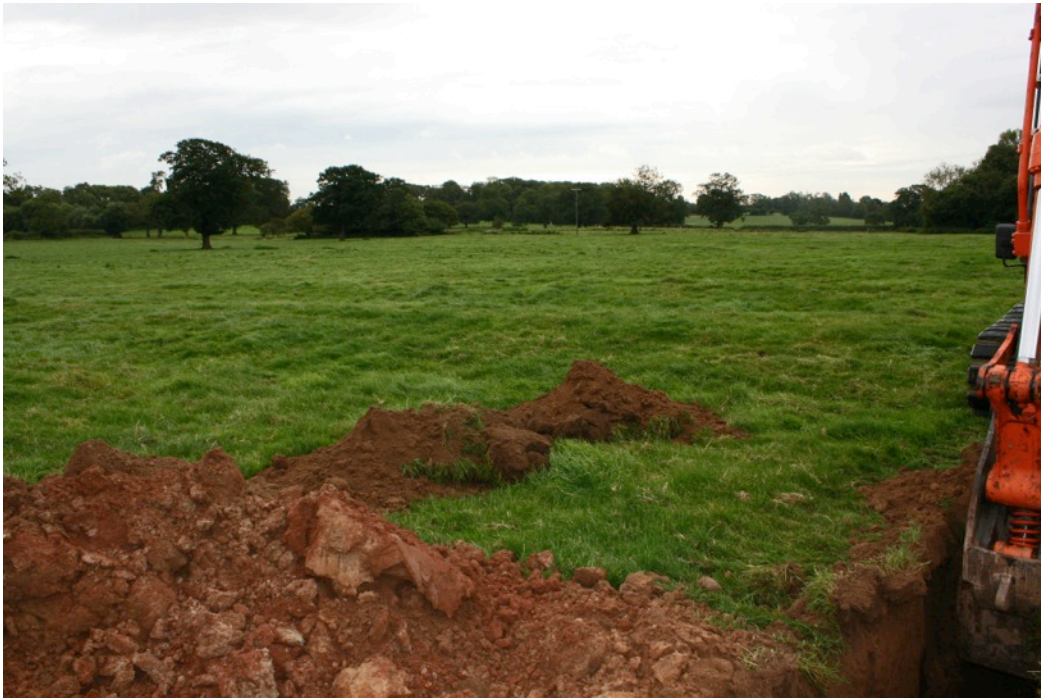
PLATE 7

Excavation of Trench 3 through ridge and furrow, looking south-east.

- 6.2** The absence of archaeological finds or features suggests that the excavations fell outside the area of concentrated settlement, in surrounding agricultural land bearing fewer traces of activity. The southern half of trench 3 was routed through an area of known ridge and furrow (PRN 20259), but this feature was not evident in the soil profile and no further evidence was revealed. Given the current, if not historic, use of the area as grazing land, it is also likely that the surviving features have suffered some damage and erosion.

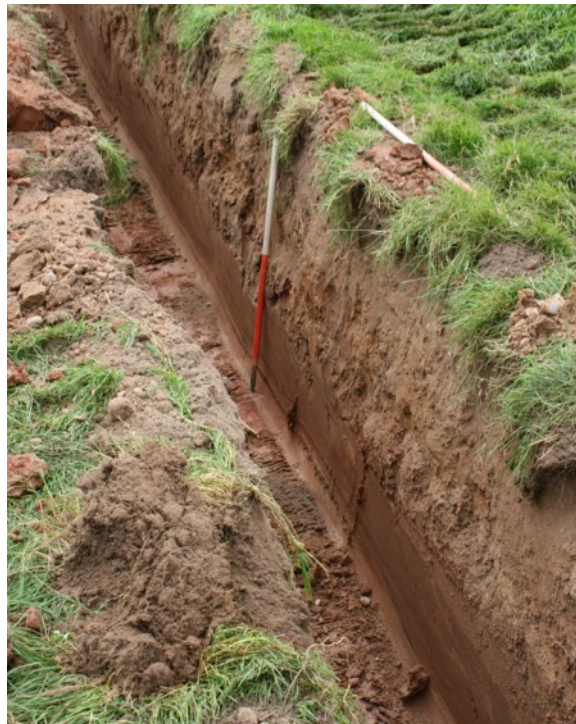
PLATE 8

Representative view of stratigraphy within trench 3, again showing topsoil (103), silty-sand (104) and natural clay (101) (scales: 1m).
