**Archaeological Watching Brief at
St Barnabas' Church
Erdington
Birmingham
NGR SP 1101 9171**

Planning Application No: 2009/05470/PA

Report No. 006

Cramp Sutherland Archaeological Services

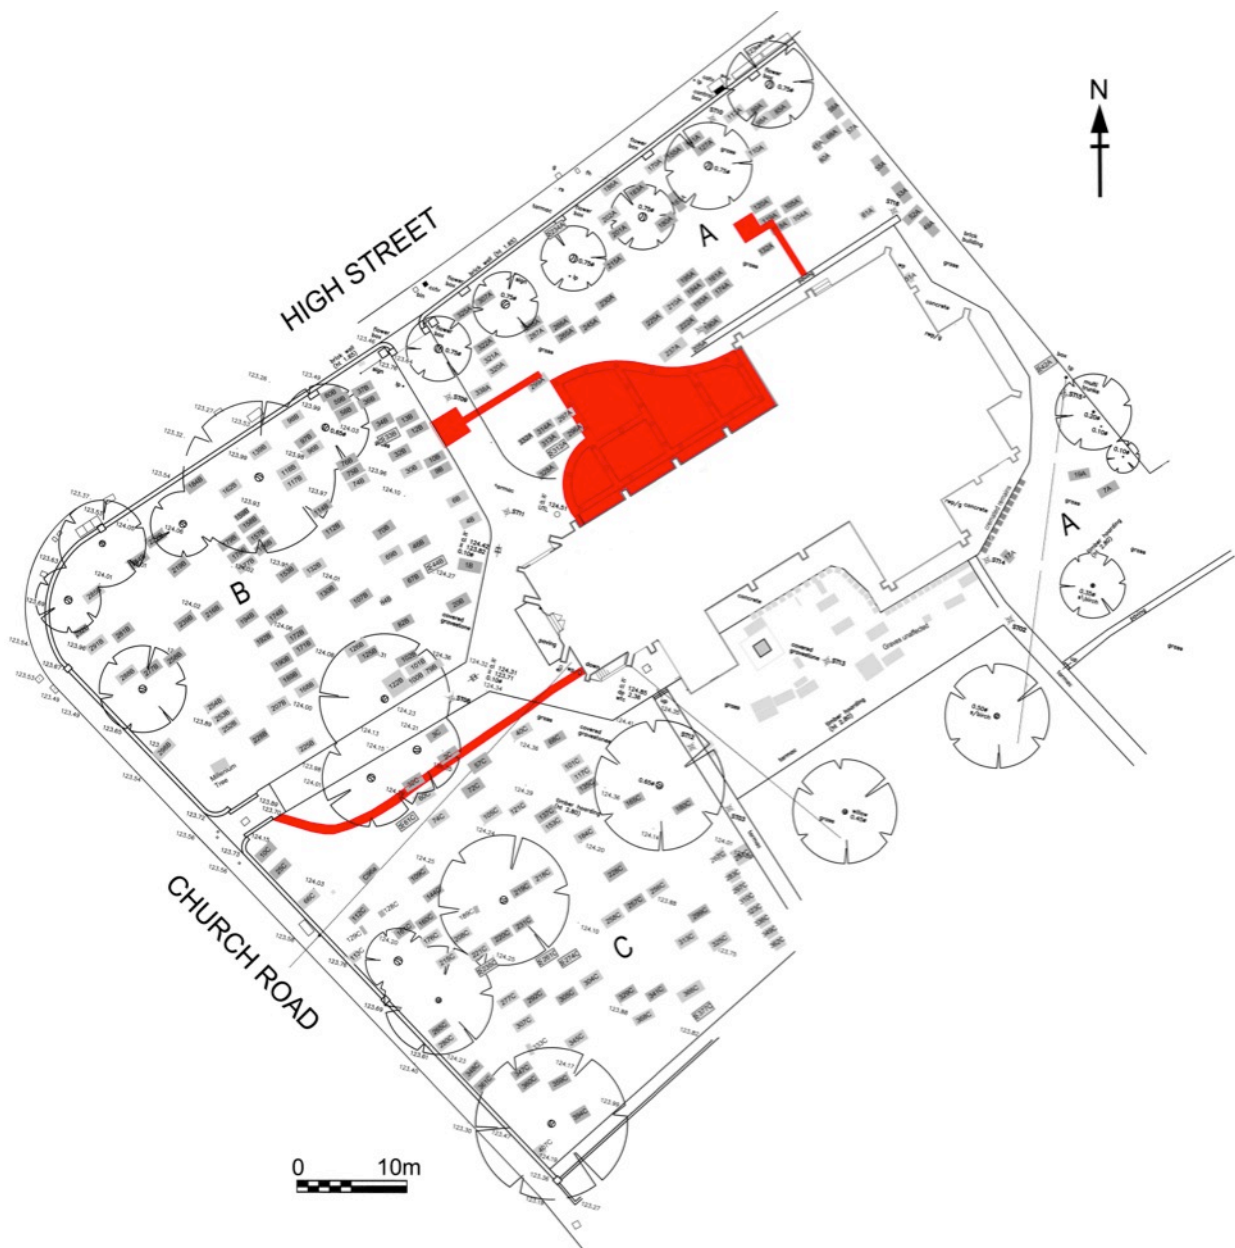
FIG. 2

Plan of the church, with the new extension area and associated service trenches marked in red.

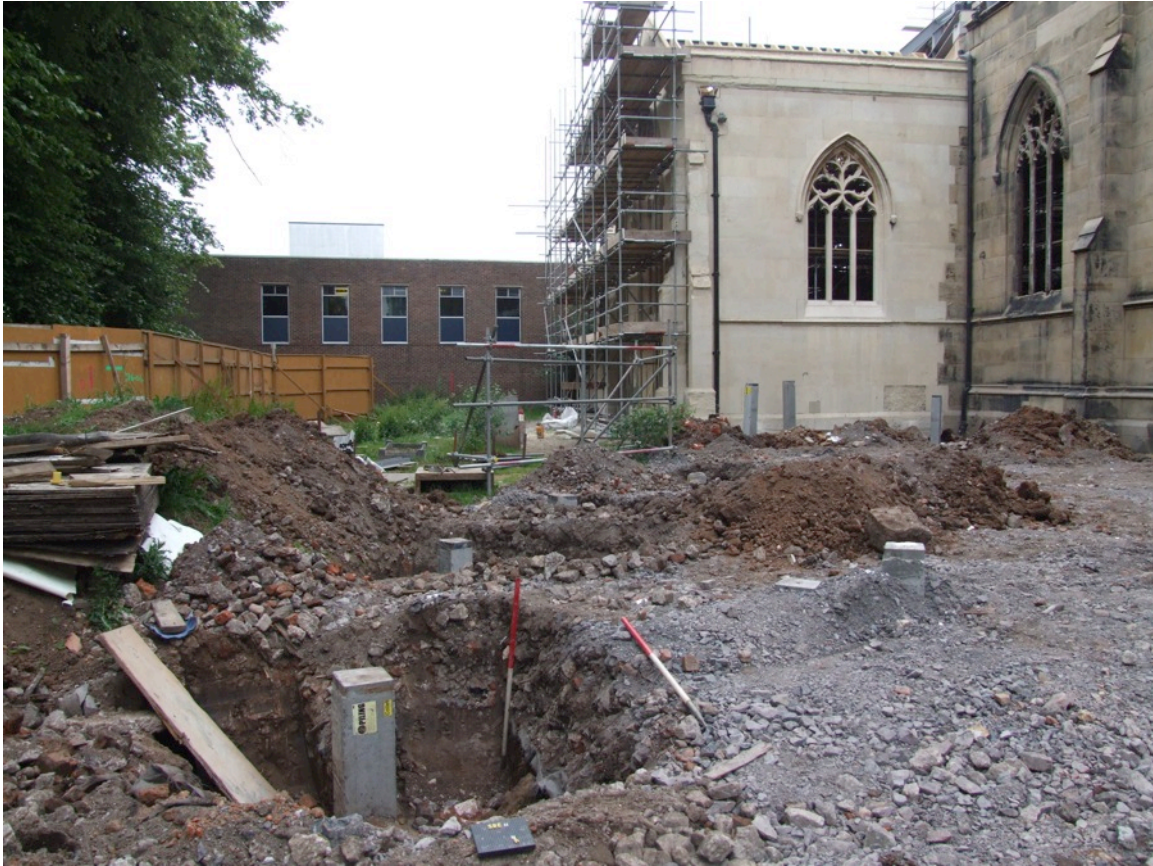
PLATE 1

Excavation around the pilings, looking north-east (scales: 1m)

- 5.0 Results of the watching brief**
- 5.1** The ground-works were carried out in three main stages:
- 1)** Excavation around 25 previously sunk concrete pilings for the new extension (Plate 1). The area excavated around each of the piles was between 1.50m and 2.00m square and approximately 1.00m deep.

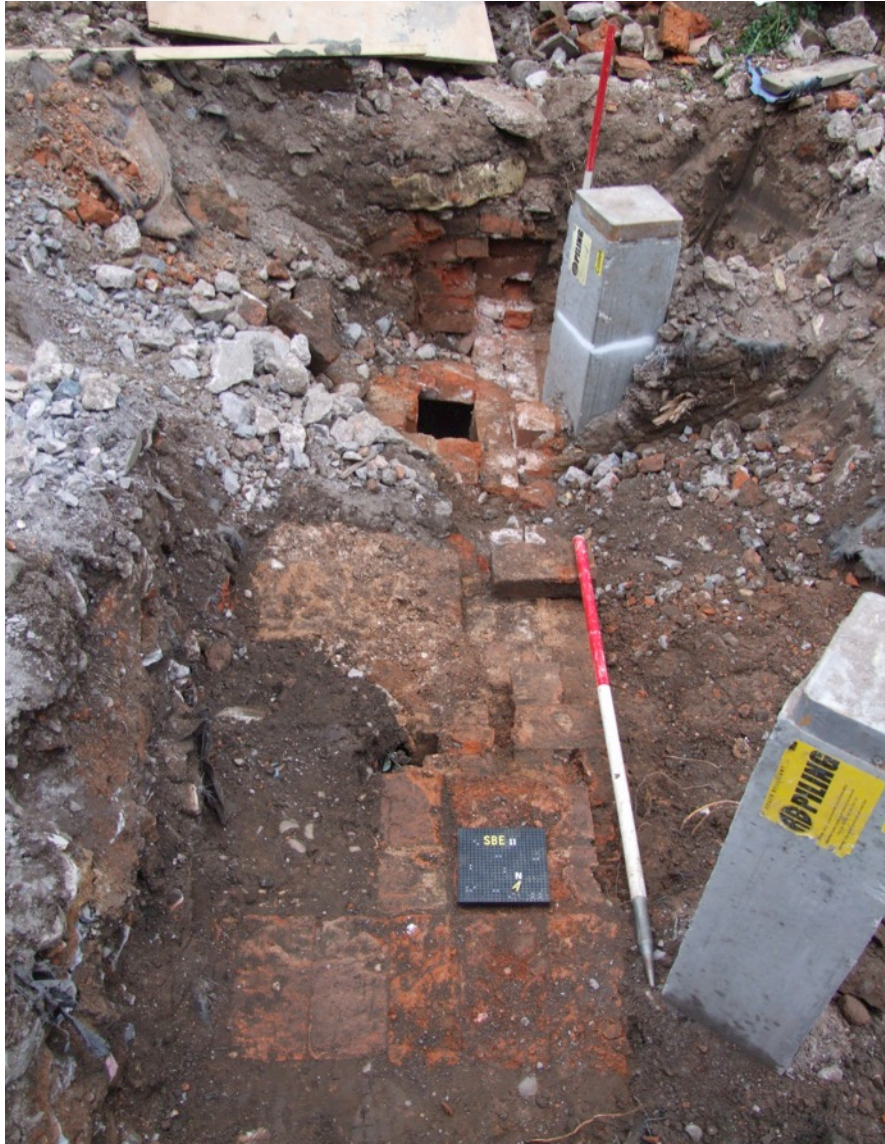
PLATE 2

5.2.4 This was a vault (100), constructed with red un-frogged bricks and
located immediately to the south-east side of Pile No. 22 (Plate 2). This
location corresponds with the chest-tomb to James Cartwright (d. 1843),
grave A299, identified during the graveyard survey. The north-east end of
the vault only was exposed, below 0.45m of (001). This revealed, however,
that the structure was at least 1.55m wide (NW-SE) and consisted of 0.23m
thick walls with a vaulted top. The side walls, seen in section, continued
0.34m above the level of the vaulted roof to support a 0.15m thick stone
slab, probably part of the chest-tomb super-structure. The vault was
presumably cut into the surrounding sandy-clay (002)

5.2.7 This was a c.1.50m wide brick vault (**200**) adjoining the south-east side of vault (**100**) (Plate 2). The two structures were not bonded together, but the small gap between them had been mortared. Vault (**200**) was of a similar construction to its neighbour, however, a reddish mortar layer (**201**) sat above the vaulted top. Much of the top had been damaged resulting in a void filled with a dark brown clay-silt (**202**) containing the

remnants of a plastic flower arrangement, perhaps an indication of relatively recent disturbance.

Vaults **(100)** (back) and **(200)** (front) looking north-west. (scales: 1m)

- 5.2.8** Prior to further construction works, and with the approval of the Planning Archaeologist, the revealed sections of vaults **(100)** and **(200)** were covered with a layer of earth and then capped with shuttered concrete.

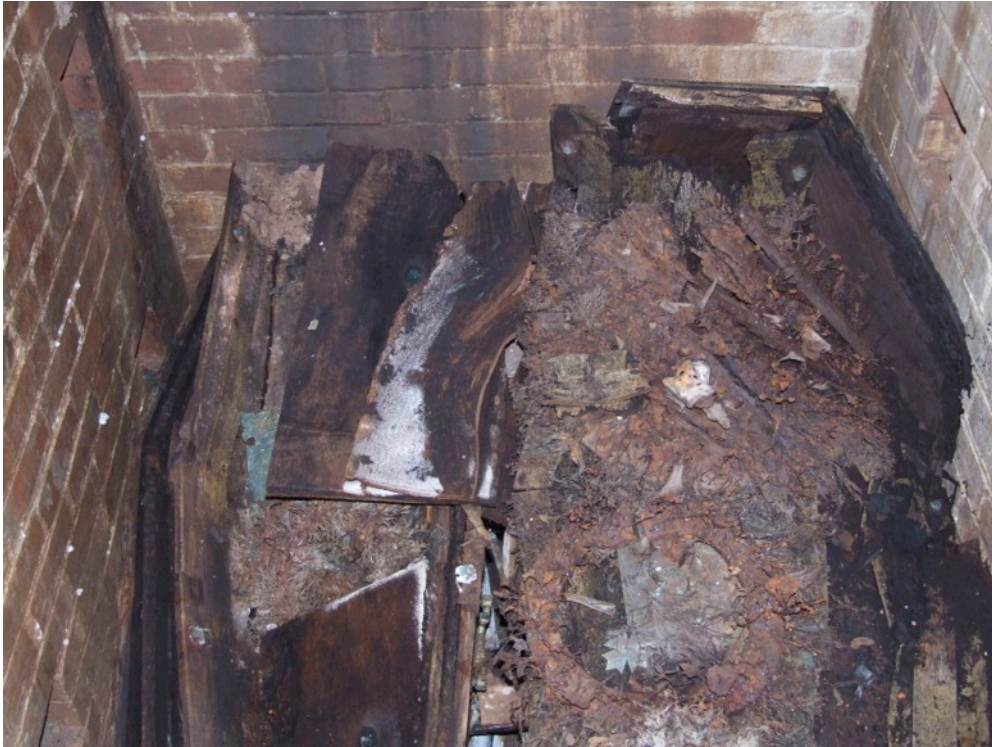
PLATE 3

5.2.5 Damage to the vaulted top allowed a visual inspection of the structure's
interior, which was approximately 2.25m deep. Vault (100) contained five

coffined burials (C1-C5); arranged with two coffins on the south-east side (C1 below and C3 above) and three on the north-west side (from bottom to top: C2, C4 and C5). The middle pair of coffins (C3 and C4) were resting on three metal bars which spanned the vault and were supported at each end in slots in the side walls (Plate 4). Similar, unutilised, pairs of slots were seen in the side walls five brick courses higher up. The uppermost coffin (C5), however, rested on metal bars supported in additional slots seen on the north-west side of the vault only. These were located between the two levels of paired slots and appeared to be later insertions (Plate 5). The south-east end of the bars carrying C5 were supported on stacks of bricks placed on the lower bars.

5.2.6 Some information on the coffin types could be gathered, albeit limited by their deterioration and collapse as well as the lack of accessibility. As far as could be ascertained all were wooden coffins, and those belonging to the upper burials (C3 and C5) were of the single-break type (Plate 3). The C3 coffin at least was double-skinned but collapse of the C5 coffin meant that its construction was hard to discern. Both the C3 and C5 coffins had trapezoidal copper-alloy *depositum* plates placed on the lids with *fleur-de-llys* embellishment at the corners of the former and with *patée* type crosses at the corners of the latter. Small lid embellishments, possibly lid-screws or escutcheons, were also visible on both the upper coffins as were the remains of wreaths, surviving as metal rings and evergreen foliage. Gilt coffin handles of a geometric type design were evident on the C3 coffin.

The interior of vault (100) with coffin 3 to the left and coffin 5 to the right.

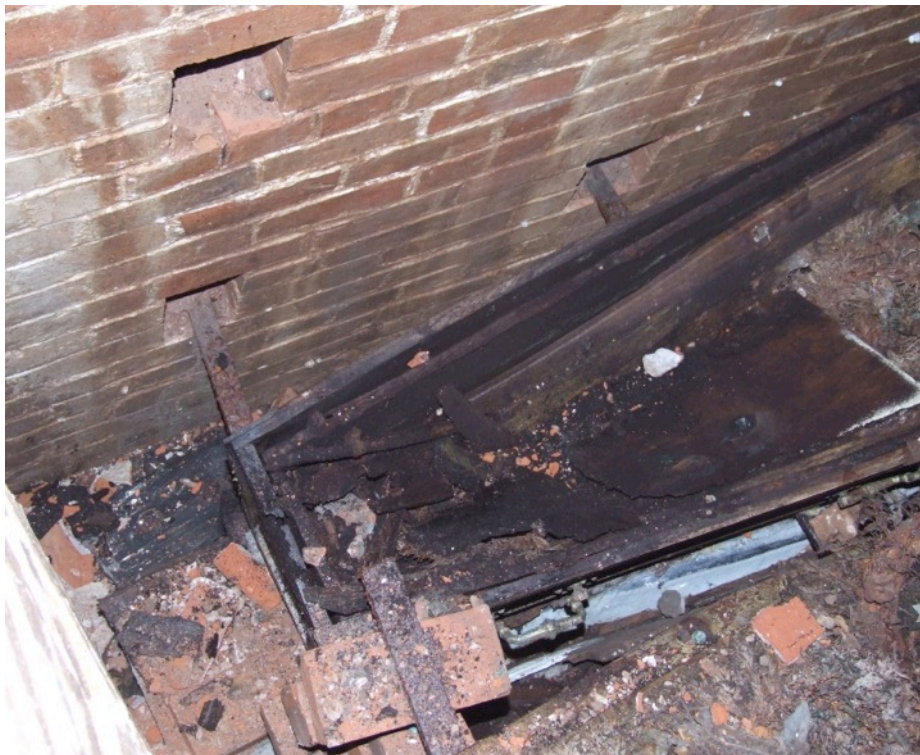
PLATE 4

The wall slots and metal bars supporting coffin 3

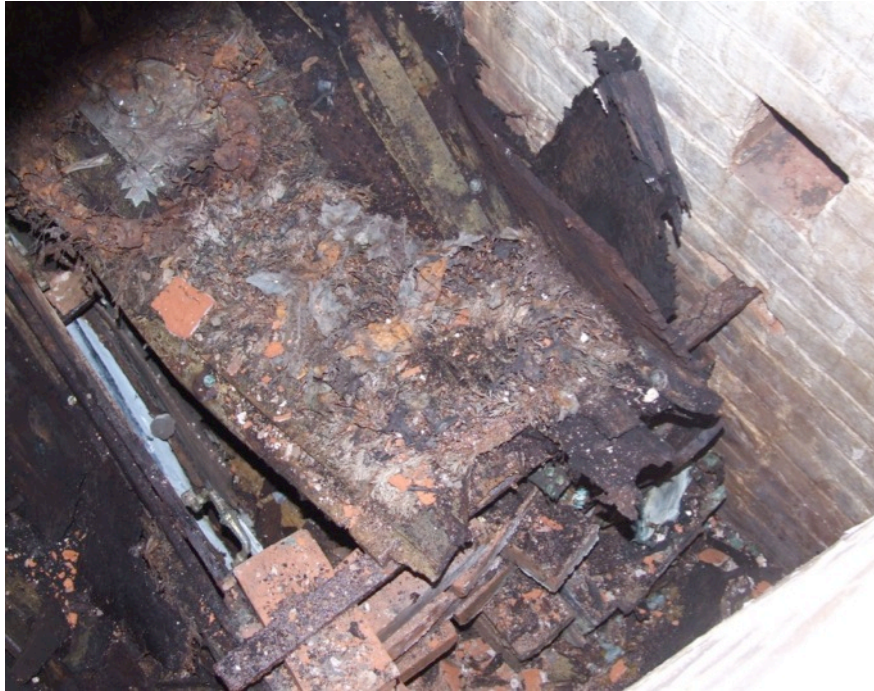
PLATE 5

The inserted slots on the north-west side of vault (100)

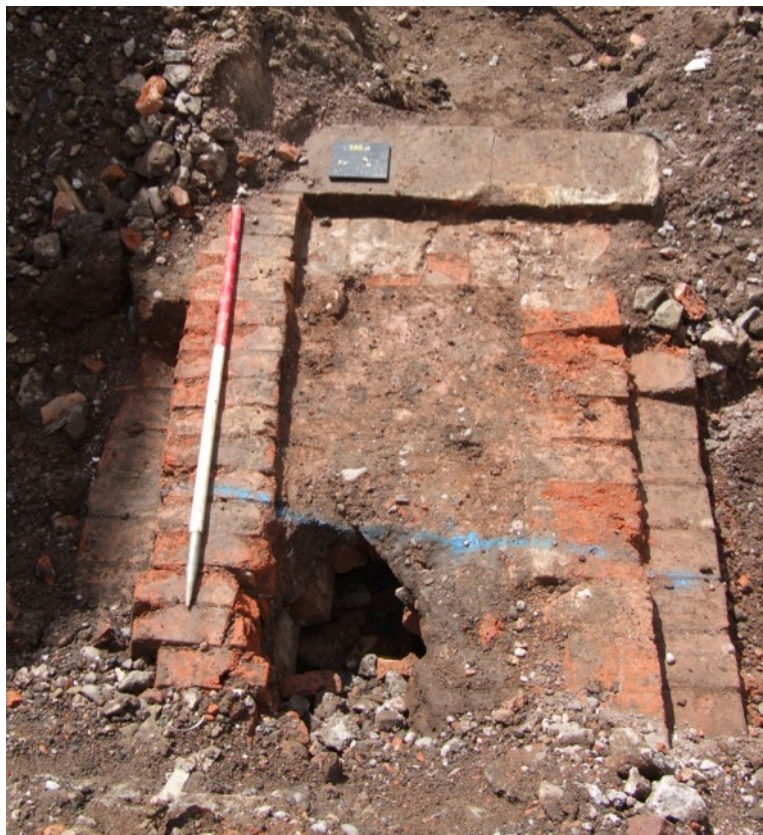
PLATE 6

- 5.2.9** Brick vault **(300)** was encountered between Piles No. 11 and 12, below 0.62m of brick rubble **(001)** (Plate 6). Again, it was most likely cut into the surrounding sandy clay **(002)**, although no cut for its construction was evident. Further excavation during the excavation of Trench 7 revealed the south-west end of the structure. The vault, as revealed, was 1.06m long (NE- SW), 1.30m wide and 0.40m high. It consisted of parallel brick walls, each 0.23m wide but then stepped out by 0.18m below the uppermost two courses. An arched brick top to the vault was evident below 0.10m of red-brown silty clay **(301)**. The inner part of the side walls appeared to be built over the arched vault top, extending at least 0.11m above it. The south-west wall of the vault had an inner and outer skin, each 0.23m wide, with a 0.16m thick stone slab resting on top of the outer skin. It is possible that the stone slab was associated with an entrance to the vault.

Vault (300) looking south-west (scale: 1m)

5.2.11 Vault (300) was encountered at a sufficiently low level that the steel foundations beams for the new structure would span over the top of it without causing any damage.

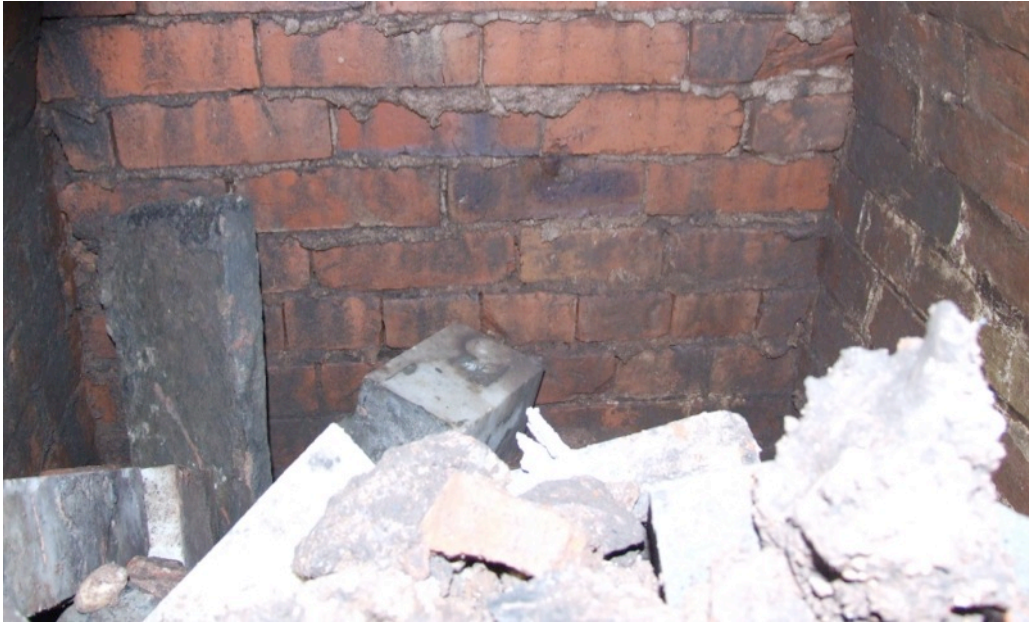
PLATE 7

- 5.2.10** Damage to the vault top towards the north-east end of the revealed portion, again, allowed a visual inspection of its interior. No coffins, however, were visible within the vault. Instead, a number of broken grave markers **(301)** were evident (Plate 7), presumably the result of the deliberate clearance of this part of the graveyard and the probable cause of the damage to the vault top. A number of broken pieces of grave marker in the vicinity of vault **(300)** may also have resulted from this clearance episode. One fragment found next to Pile No. 11 bore the inscription ‘..OVING MEMORY OF / WILLIAM PAXTON / ..USBAND OF ELIZABET... / THIS LIFE JULY... / ED 54 YE..’.

Broken grave stones within vault (300)

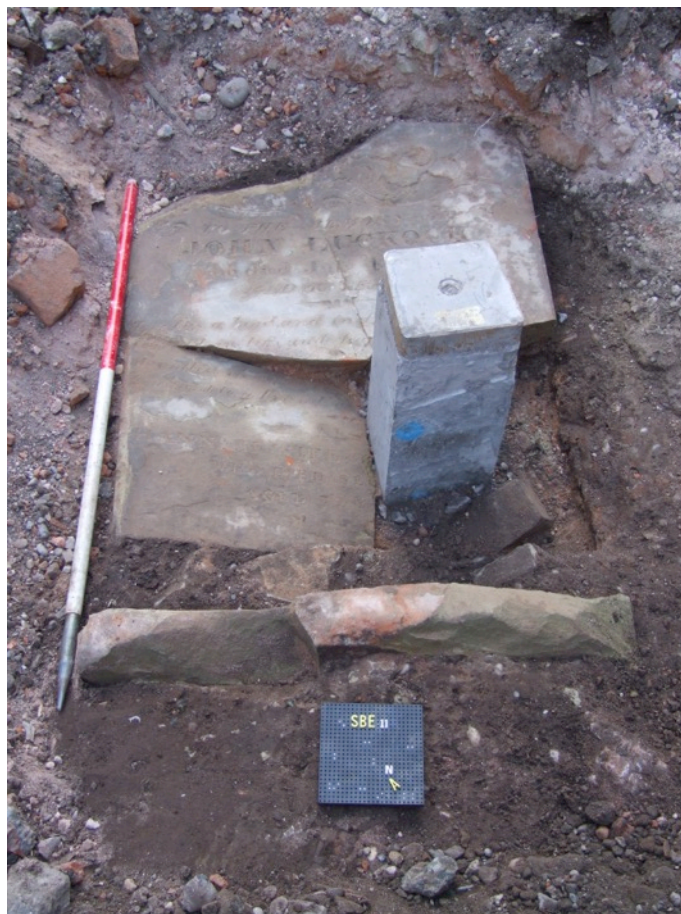
PLATE 8

5.2.12 This was the *in-situ*, 0.10m high, stump of a grave marker (400), located immediately to the south-west side of Pile No. 23, below 0.25m of rubble (001) and set within sandy-clay (002). The main part of the stone (which measured approximately 0.84m x 0.95m) was lying flat to the north-east side of the stump, having fallen or been pushed over (Plate 8). The upper face of the fallen grave stone had an incised foliate decoration at the top and was inscribed with:

Grave stone (400) looking north-east (scale: 1m)

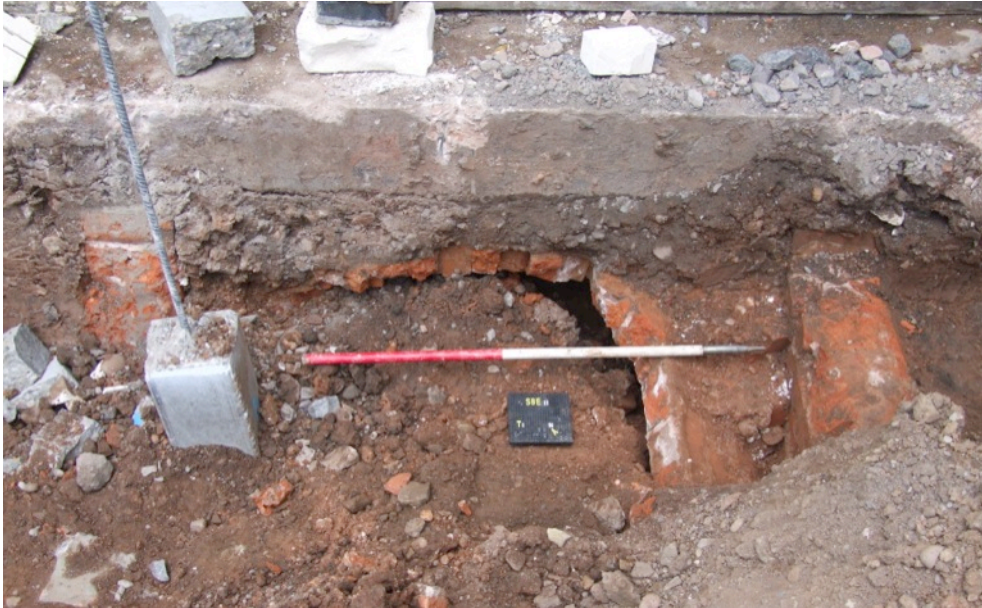
PLATE 9

5.2.14 Vault (600), constructed with red un-frogged bricks, was located in Trench 1, between Piles No. 1 and 2 (Plate 9). It was revealed to a height of 0.35m, below 0.22m of (001) and extended across the trench and beneath the church wall. It was of similar construction to the other vaults encountered, with side walls which extended above the level of the arched top by some 0.10m. At 2.00m (NW-SE), it was, however, wider than the other vaults revealed. The vault top, which was covered with a 0.18m thick layer of mortar clay (601), had been badly damaged and the vault interior was filled with a mid-brown clay-silt (602).

Vault (600) looking north-east (scale: 1m)

5.2.15 Like (100) and (200), vault (600) was covered with a layer of earth and capped with concrete before the foundations of the new extension were laid.

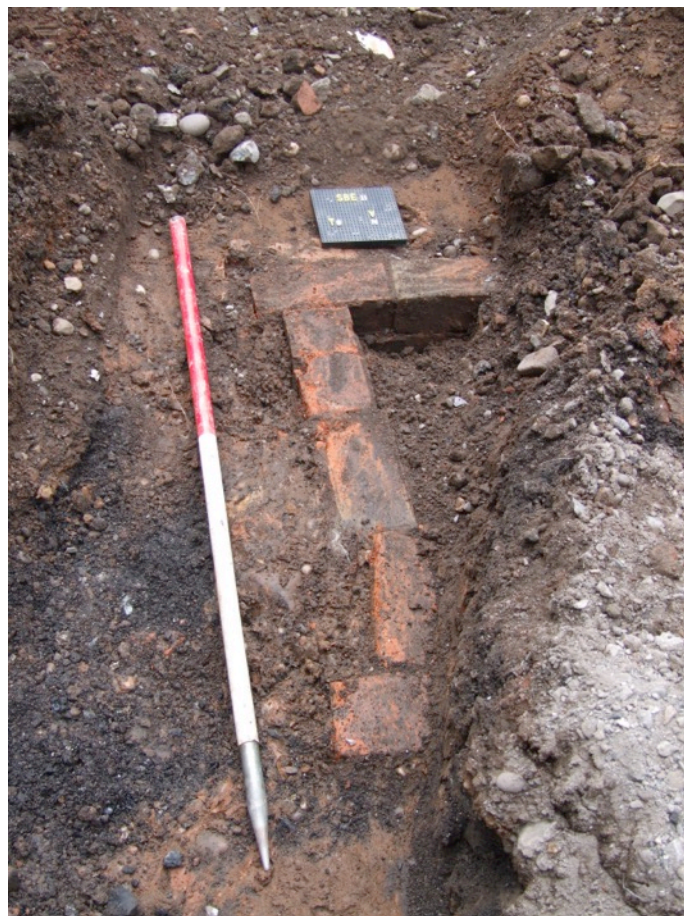
PLATE 10

5.2.16 The south-east end of a rectangular brick structure (700) was seen towards the north-east end of Trench 8, extending into the south-east facing trench section (Plate 10). This 0.91m wide structure was revealed below 0.39m of rubble (001) and was probably cut into the surrounding sandy-clay (002), although no cut was visible. The walls were constructed with red un-frogged bricks and were one brick (0.11m) in width. The mid-brown sandy clay (701) within the walls was loosely compacted, indicative of a void. The structure may have been a vault or brick-lined grave, although the relative thinness of the walls would tend to indicate the latter.

Probable brick-lined grave (700) looking south-west (scale: 1m)

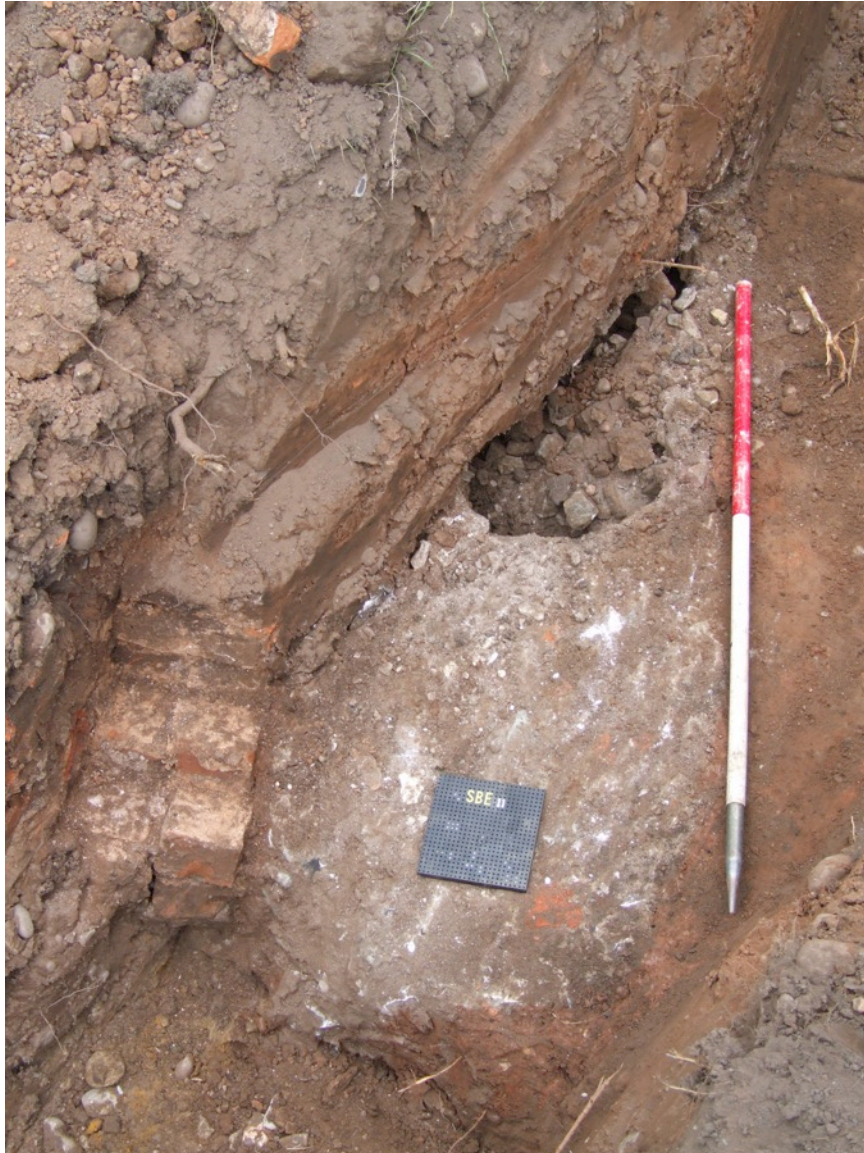
PLATE 11

CONTEXT NO.	DESCRIPTION	MEASUREMENTS
Grave Plot 9 (Plate 11)		
900	L-shaped brick structure, probably a vault. 0.23m wide walls constructed with red unfrogged bricks. Located at SW end of trench below (008). Construction of this structure cut through (009) and (1000).	1.47m NE-SW x 0.30m NW-SE x 0.40m high (minimum).
Grave Plot 10 (Plate 11)		
1000	Sub-rectangular area of greyish-white mortary stone chippings, very compact. Located to SE side of (900), 0.88m below ground level (bgl). Upper fill of cut [1001], possibly related to construction of (900).	1.44m NE-SW x 1.60m NW-SE (min) x 0.25m thick.
1001	Roughly rectangular grave cut, evident as a void below (1000). Fragments of wood and arm bone (humerus?) visible within this void. Cuts (009).	1.44m NE-SW x 1.60m NW-SE x 0.40m deep (min).
Grave Plot 11 (Plate 12)		
1100	Remains of coffin, evident as a line of dark-brown rotten wood defining the NW side and NE and SW ends. Also a Yellowish-brown stain at NE end. Located approximately 8.00m NE of lych gate, 0.80m bgl. Within cut [1101].	1.70m NE-SW x 0.20m NW-SE (min).

Probable vault (900) alongside grave cut [1001] with upper fill of compact mortar (1000), looking north-east (scale: 1m)

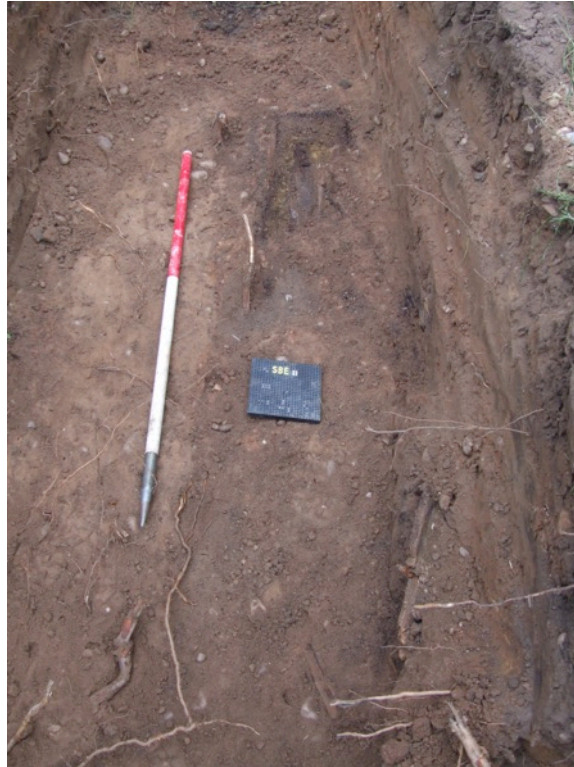
PLATE 12

Grave plot 11 looking north-east (scale: 1m)

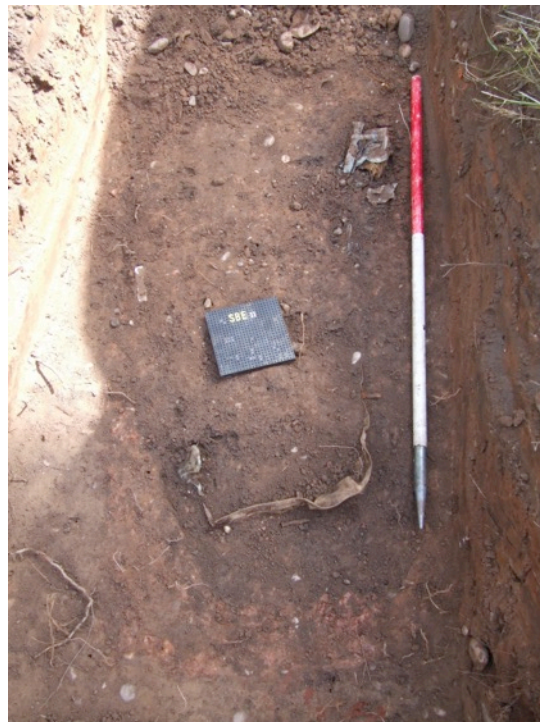
PLATE 13

Grave plot 12 looking north-east (scale: 1m)

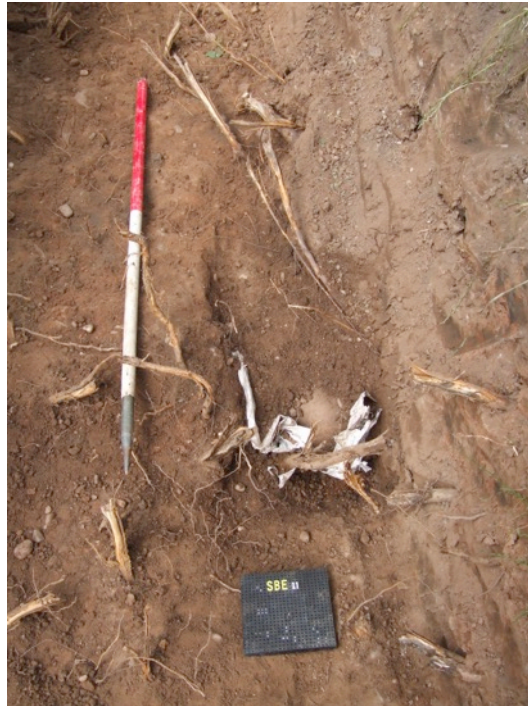
PLATE 14

Grave plot 13 looking north-east (scale: 1m)

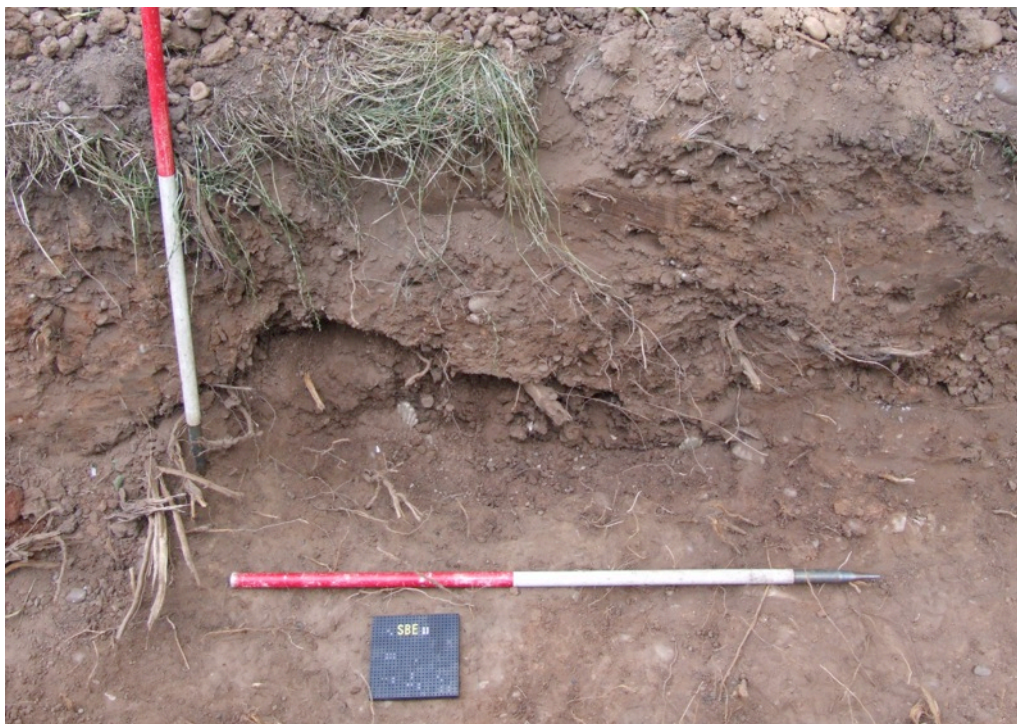
PLATE 15

Grave plot 14, visible in the south-east facing section of Trench 9 as an area of collapse (scale: 1m)

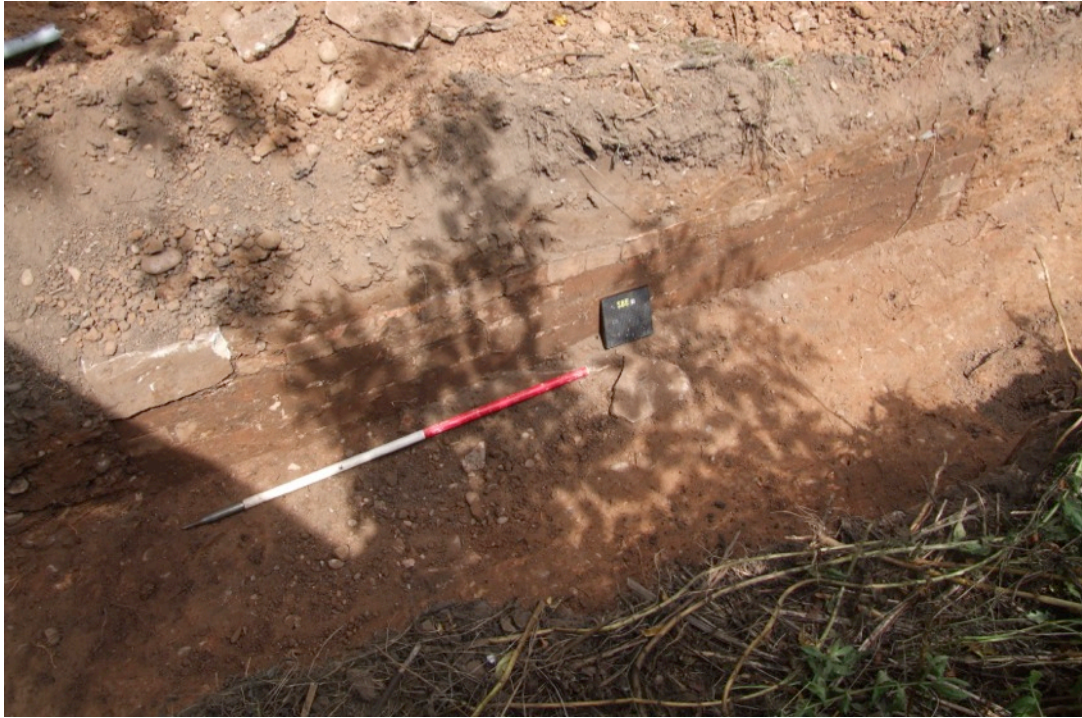
PLATE 16

1401	Cut for grave, defined by looser, collapsed fill material (1400) seen in section and also seen in plan as darker sub-rectangular area. Cuts (009).	
Grave Plot 15 (Plate 16)		
1500	Red brick structure seen in SE-facing section. Probably a burial vault. It incorporates a 0.18m thick, 0.30m wide stone slab at its SW end. Located at approximately 12.50m from the SW end of the church, 0.22m bgl. Construction of the vault has cut (009). In vicinity of grave stone 2C (Mary Baker, died 1943).	2.71m NE-SW x 0.40m high.

Vault (1500) looking north (scale: 1m)

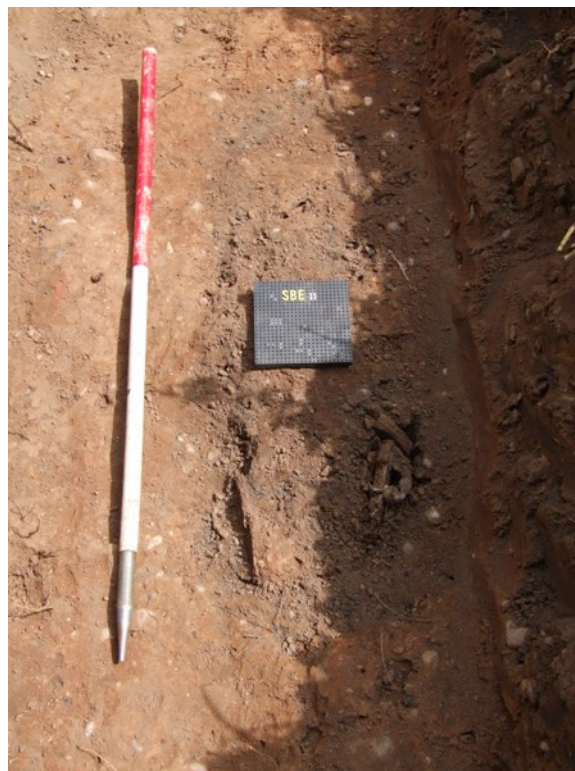
PLATE 17

Grave plot 17 looking north-east (scale: 1m)
