Cumbria County Council's Historic Environment Service (CCCHES) was consulted by Copeland Council regarding a pre-planning application for the renovation of the former oil and dye mill and demolition of buildings at Weddicar Hall, Keekle, Whitehaven (NY 014 573), Planning Application Number 4/10/2066.

The scheme has the potential to affect the extant remains of standing walls and shells of nine farm buildings (HER 41688) and one mill (HER 12343) and as a result an assessment programme of archaeological building recording was required to inform upon a management plan.

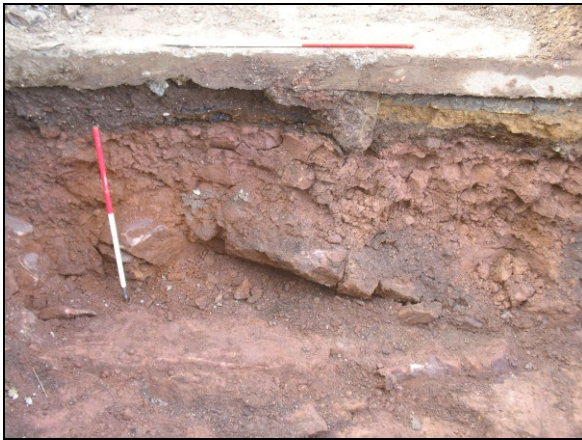
Figure 6. Trench 1 showing modern deposits

The principal area covered by Trench 1 comprised of a raft of concrete 0.20m in depth, resting above a bed of brown-grey gritty ash 0.20m in depth, overlying a mid-brown gritty ash 0.10m in thickness.

The concrete raft also appeared to replace a yellow brick horizon 0.10m in thickness, resting above a grouting bed of yellow sand 0.10m in thickness, lying above a spread of mid-brown gritty ash also 0.10m in thickness (figure 6).

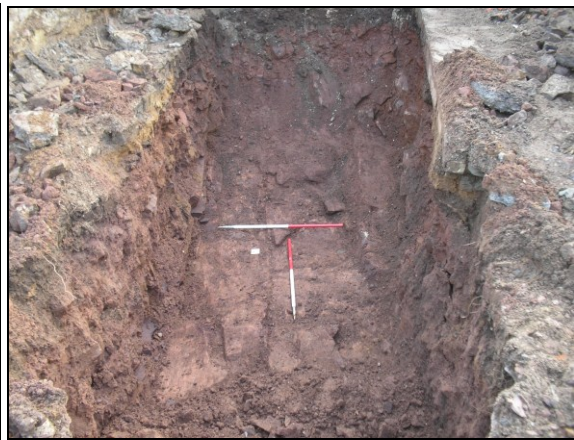
Figure 7. Trench 1 showing natural bedrock

The insertion of a brick and concrete surface had totally truncated any putative earlier features, the modern floor and its attendant core, resting above natural red sandstone bedrock (figure 7) reduced to a depth of 1.10m.

Trench 1 was archaeologically sterile suggesting that earlier stratified deposits either did not exist or had been removed by later truncation.

The complex of buildings forming the Hall had been built directly onto sandstone bedrock, the bedrock obviating the need for foundations.

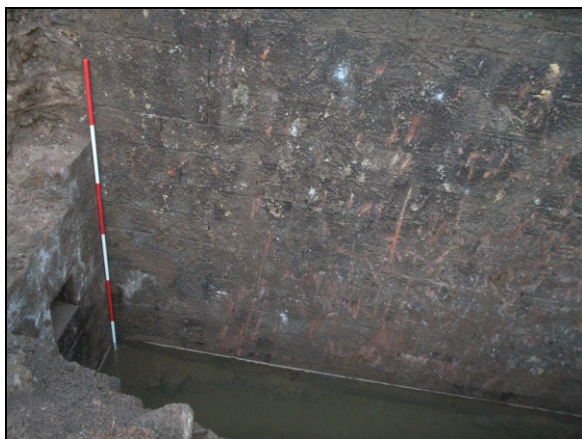
Figure 9. Eastern wall of wheel-pit

The eastern wall 3 (figures 9 and 11) measured 5.60m in length and was 4.00m in height. It possessed no architectural embellishments, although the superstructure above yielded two blocked apertures that formerly maintained the water wheels.

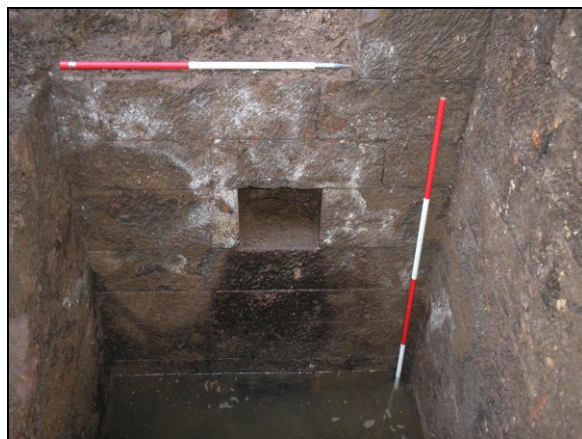
Figure 10. North wall of wheel-pit

The northern wall 4 (figure 10) measured 1.70m in length and survived to a height of 2.60m. It possessed a rectangular plan aperture measuring 0.40m x 0.40m, 1.35m above the base of the wheel-pit.

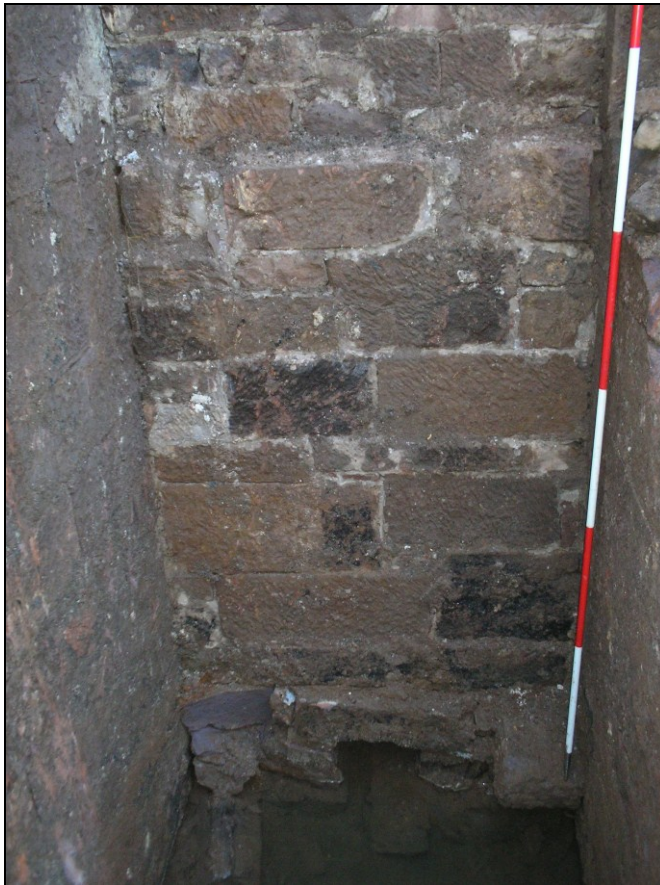
Figure 13. South elevation 2 of wheel-pit

Unlike stone walls 3, 4 and 5 (the east, west and northern elevations), the southern stone elevation 2 (figure 13) was not keyed into the other walls.

The adaptation of the wheel-pit by blocking the southern elevation probably occurred when the Mill was in use possibly when a number of doors and windows were filled elsewhere on site.

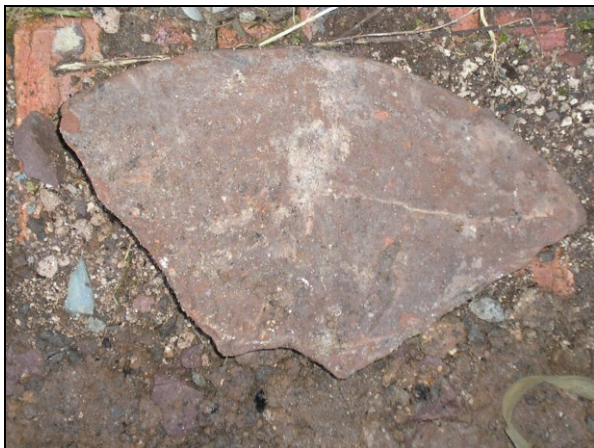
Figure 15. Millstone found in wheel-pit

The pit was filled with some broken brick and cream mortar but primarily broken dressed red sandstone blocks and discarded stone of which two pieces appeared to be stone rollers or millstones (figure 15). Possibly, some of the internal building fabric and fittings ended in the wheel-pit when the Mill changed use.

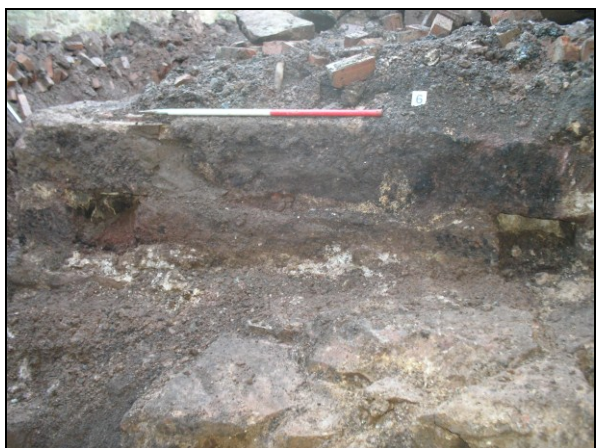
Figure 16. Podium 6 in Trench 3

Beside the northern elevation was a stone podium 6 (figure 16). It consisted of red sandstone masonry formed from dressed blocks bearing a flagstone surface grouted into a hard lime mortar.

Two square apertures were present that may suggest a subterranean room or facility. The feature was directly in line with a blocked northern doorway, the association probably being significant albeit unknown based on current fieldwork.

Trench 3 suggested that store-rooms and cellars may have existed beyond the wheel-pit but little definitive evidence could be ascertained for spatial organisation due to onsite impediments.

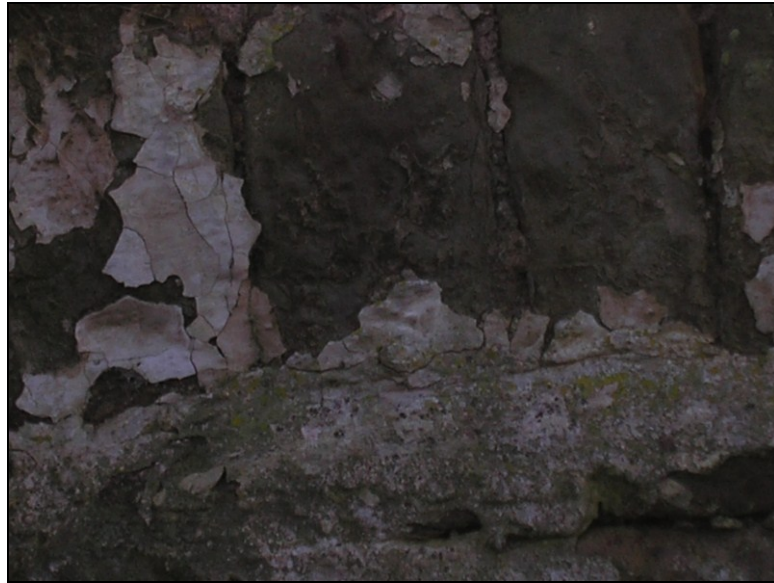
Figure 17. Stone voussoir in Building 4

In Building 4, the voussoir stones within a truncated stone arch (figure 17) were revealed following demolition. This architectural embellishment may reflect an earlier architectural style subsequently lost when a modern window was inserted.
