## 1 INTRODUCTION

### 1.1 Project origins

Cumbria County Council's Historic Environment Service (CCCHES) was consulted by Eden District Council regarding a planning application for the conversion of former stables, part of Strickland Hall (also known as Low Hall), Little Strickland for domestic use (NY 56370 19695), Planning Application No. 3/10/0968.

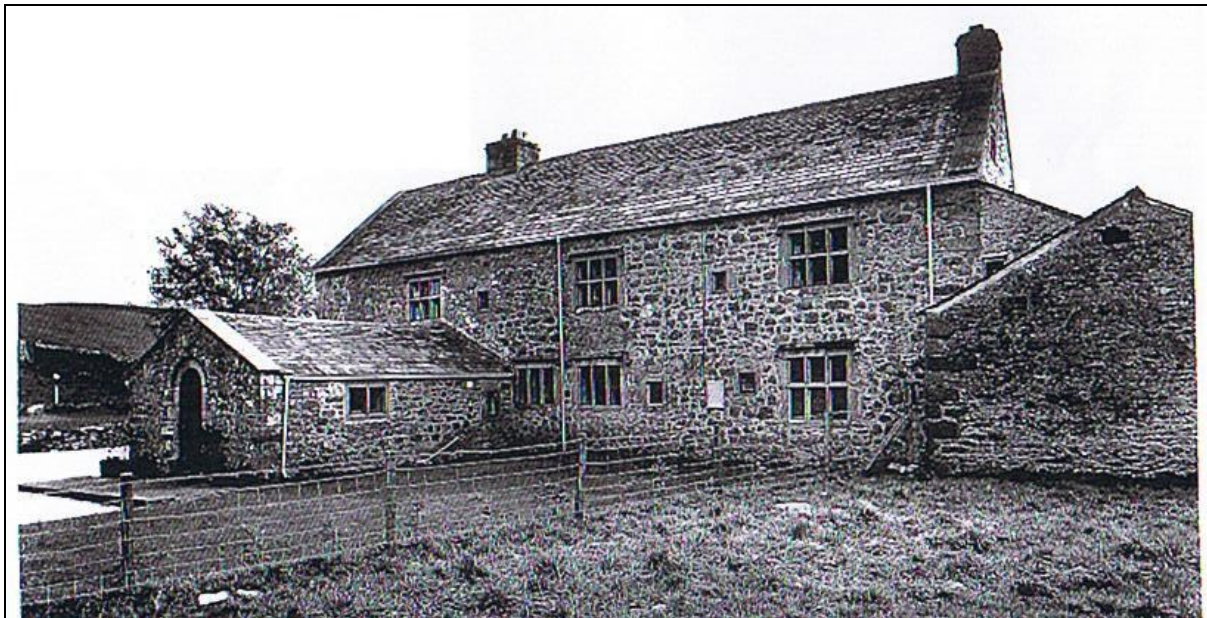
Figure 4. Northern elevation of Strickland Hall, 1988 RCHM 28/2157

West of the 17<sup>th</sup> Century entrance, on this side are two three-light windows with chamfered and grouped beneath a common *moulded* (shaped ornamental strip of continuous section) label (figure 3). Just west of these is a one *light* (a window with fixed glazing) *window* (an opening to allow light and air into a building that has developed into a significant element of architectural detail), now blocked, and at the west end is a three light *transom* (a horizontal glazing bar in a window) window with a moulded label, blocked in 1935 but now apparently open.

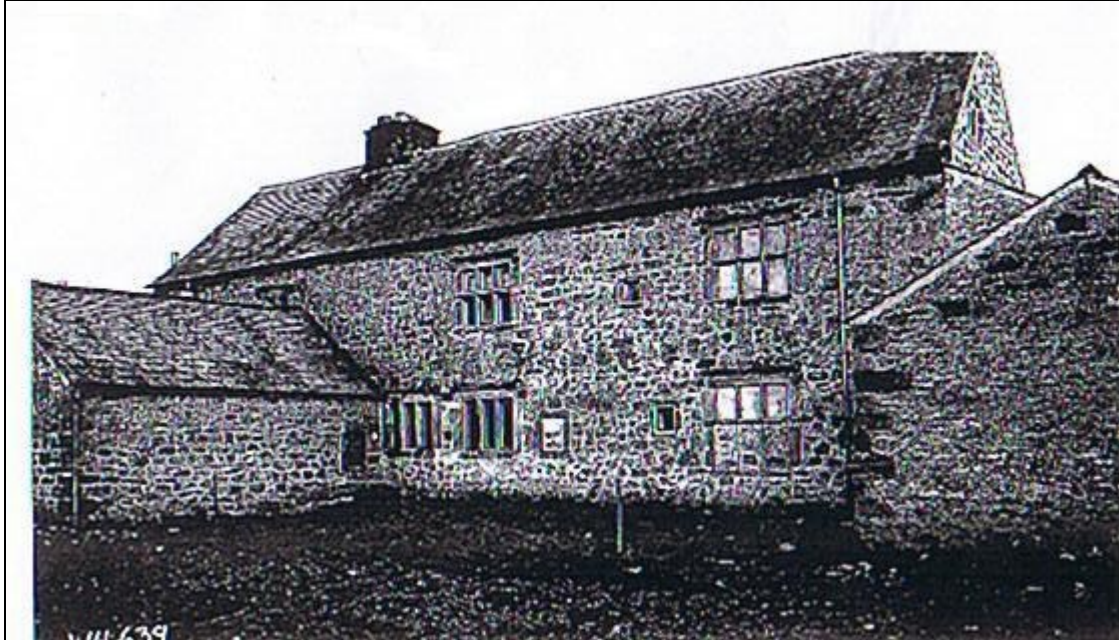
Figure 5. Looking south showing the original hall and 17<sup>th</sup> Century entrance, 1935 (WH 639)

The south wall east of the south wing has a doorway with a square chamfered head and further west a small one light window, subsequently blocked (figure 5). By 1988, this doorway and window were replaced with a mullioned window containing four lights (figure 6)

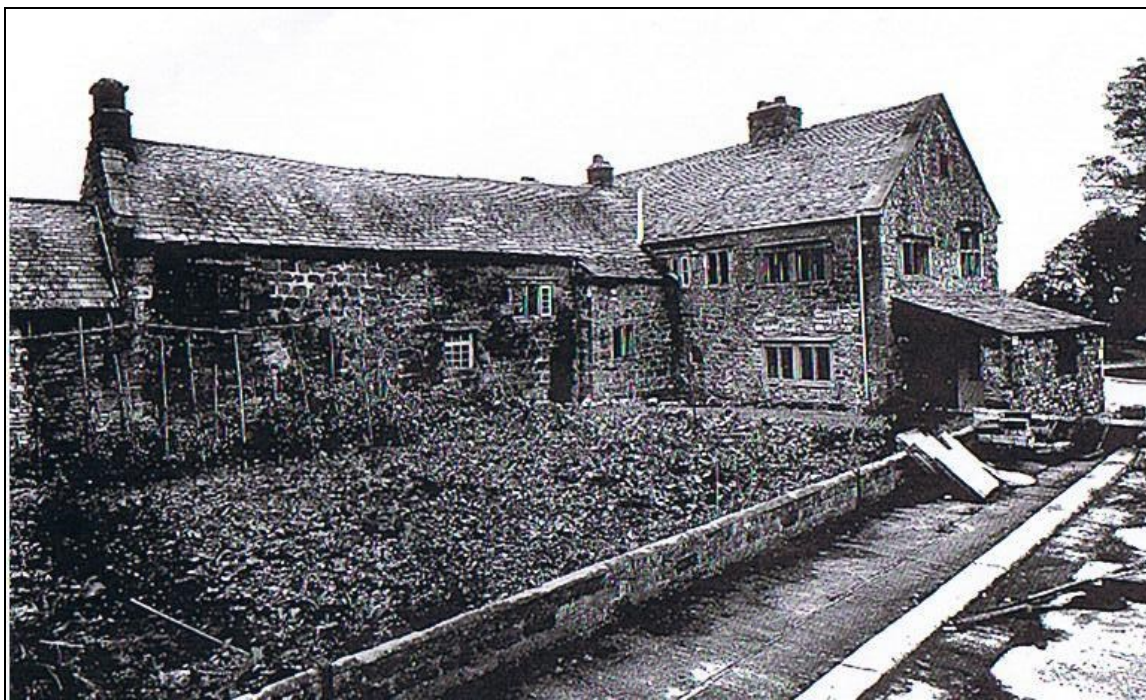
Figure 8. Later southern wing and the eastern range of the hall, 1988 RCHM 28/2157

West of the south wing, the south wall has a two-light first floor window and a four-light transom window to each of the ground and first floors. One of the ground floor windows has been blocked (figure 8).

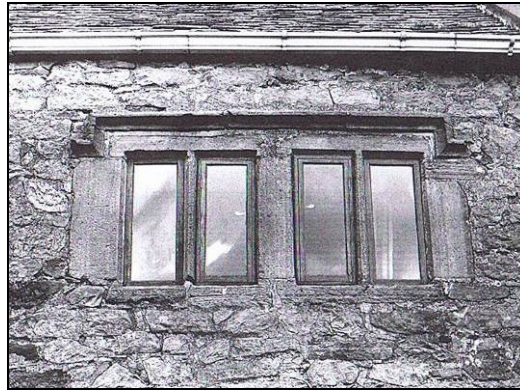
Figure 9. Pair of two-light windows sharing a common head, south side, north range RCHM 28/2157

Between ground and first floors windows is a rectangular panel which is said to have enclosed the arms of Crackenthorpe. The panel and the windows have moulded labels, the latter with shaped stops (figure 9).

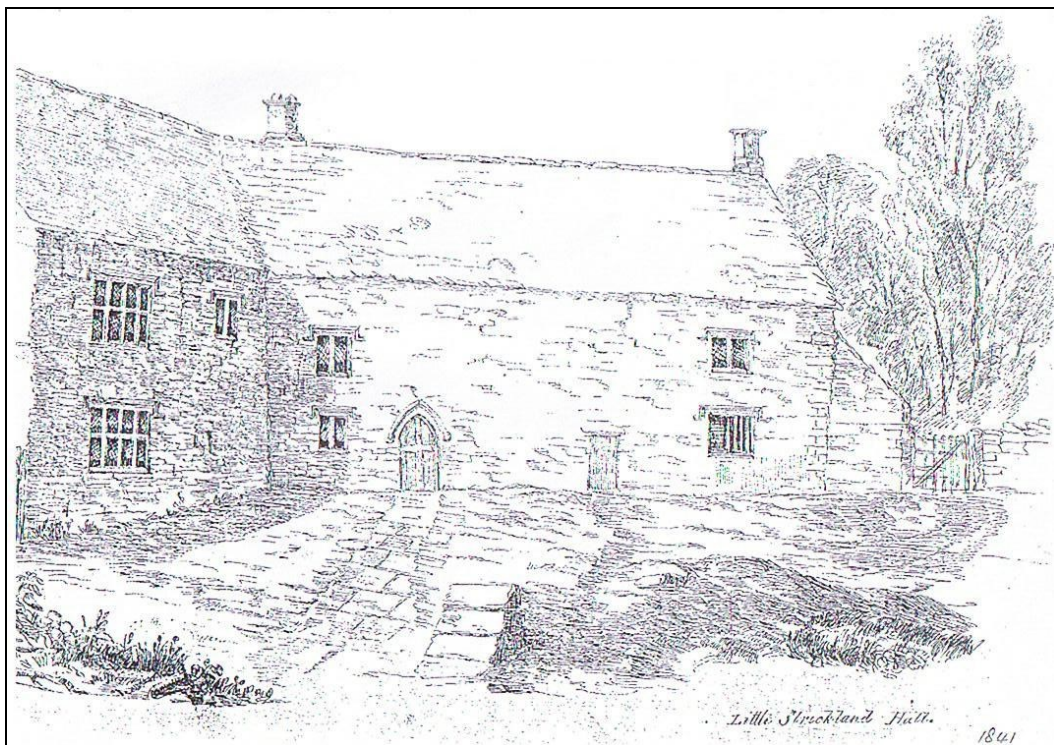
Figure 16. Drawing from circa 1841 showing the south range of Low Hall

Possibly, rough cast, a lime render traditionally applied to give protection to walls built of poor quality rubble stone or to walls in exposed locations facing driving winds, was applied, a possibility intimated by the clean finish illustrated in the 1841 drawing (figure 16). During the late 19<sup>th</sup> Century in Cumbria, the roughcast application was often removed.

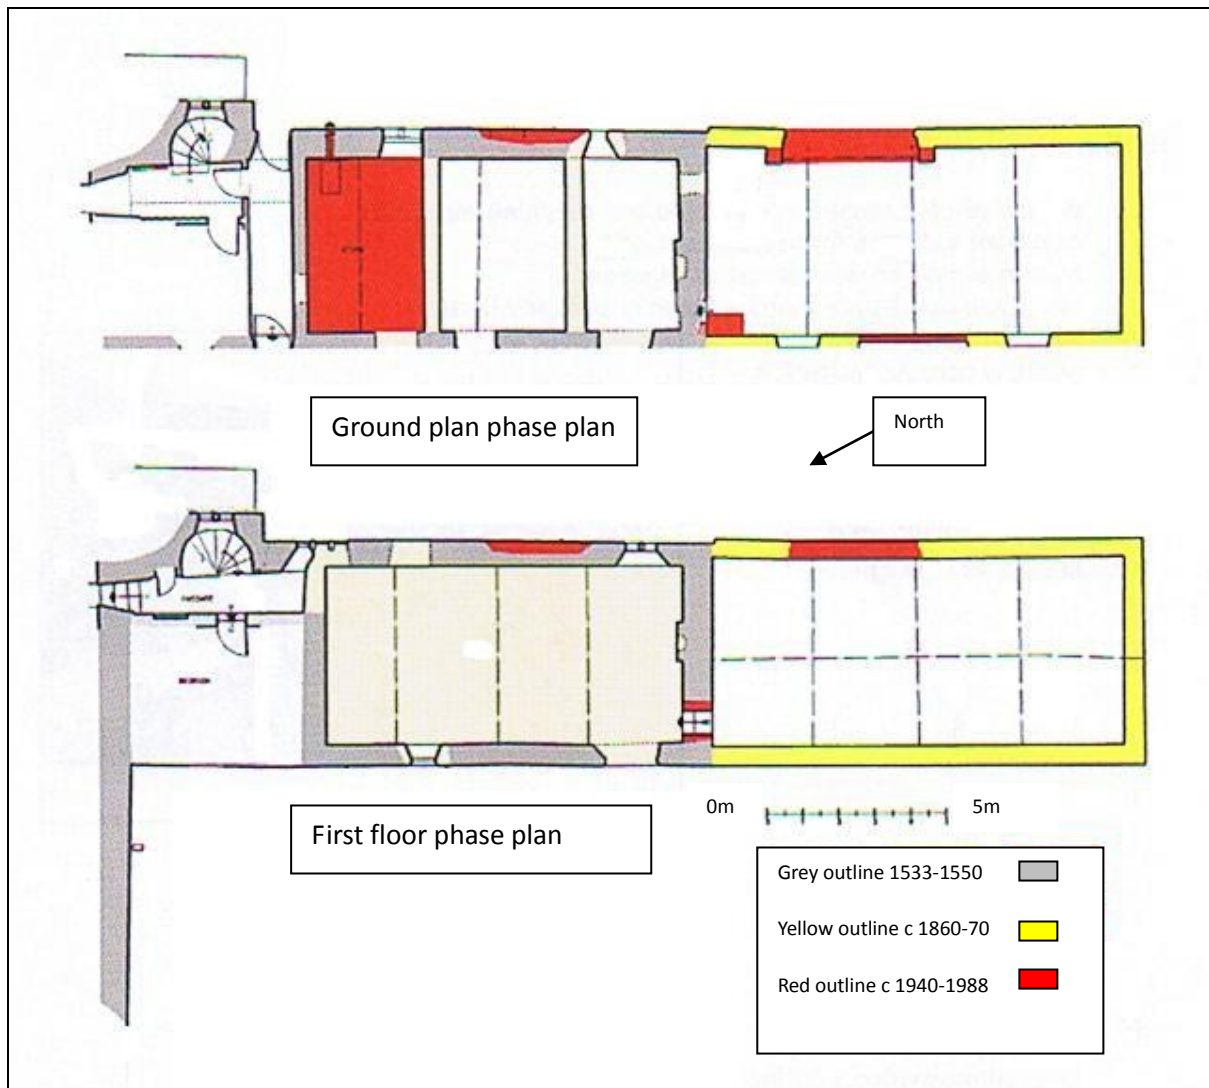
Figure 29. Phase plan relating to the south range.

In the northern range, the dairy roof was lowered and established as the main entrance whilst the internal staircase was altered.

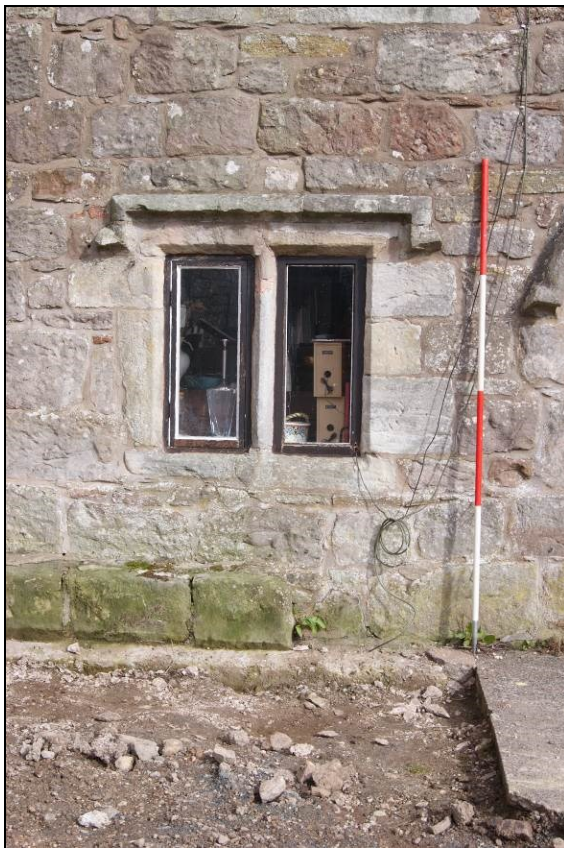
Figure 32. Elongated window with repair (1)

1. Cement repair to the central mullion on the lower window, not subject to the development (figure 32).
2. Brick repair to the wall fabric, not subject to the development (figure 33).

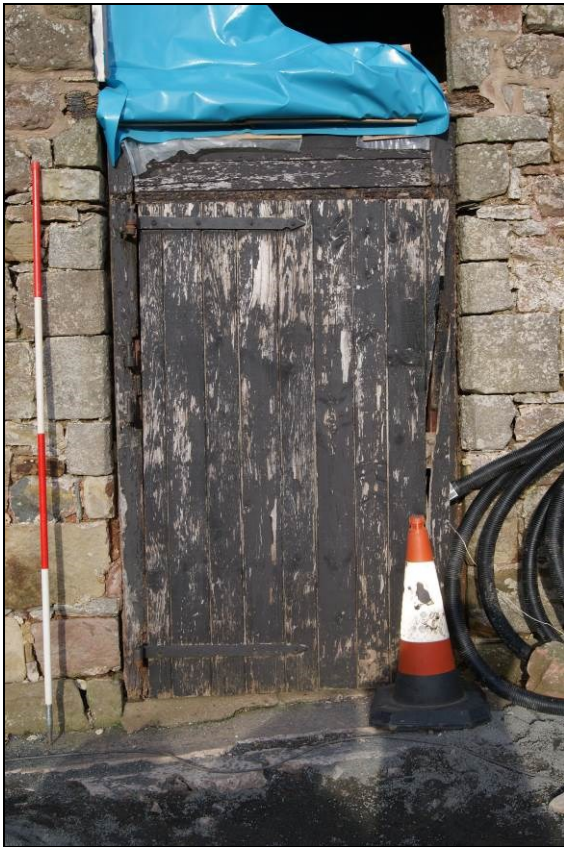
Figure 36. Doorway to south stable 2 (7)

6. An upper set of five concordant, horizontal stone *throughs*, approximately 1.60m in length and projecting 0.10m (figure 35).
7. A door inserted after 1841 that comprised eight courses of dressed sandstone (varying sizes

0.20-0.37m x 0.20-0.31m) to form the southern jamb to stable 2. The northern jamb only possessed four courses, both jambs possessing a slight chamfer. A timber lintel surmounted a black painted, machine-cut, modern door (figure 36). On both jambs there was a slight chamfer from the middle to the top of the jamb.

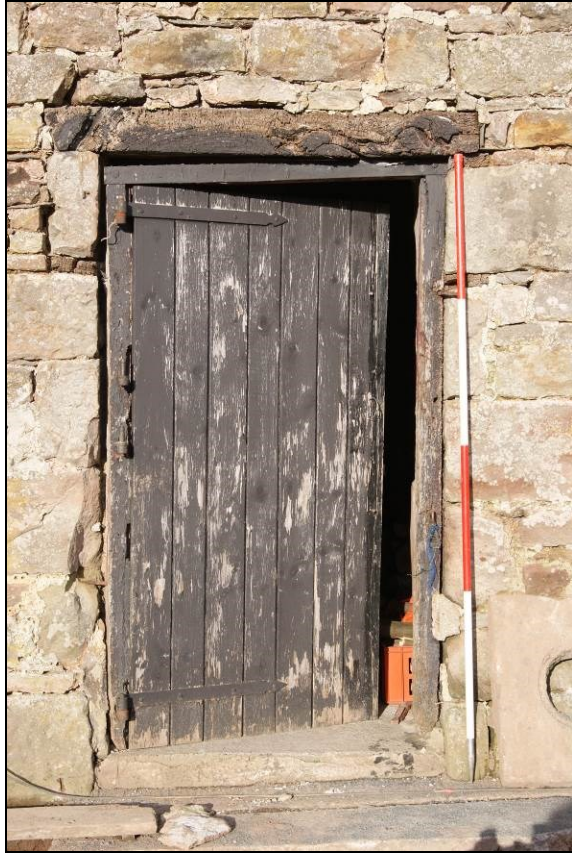
Figure 39. Stable 1 doorway (16)

16. A doorway to Stable 1 (figure 39) comprising of set of five rough hewn sandstone quoins, the largest stones measuring 0.48m x 0.36m, the smallest 0.20m x 0.30m. There is a door bolt on the right hand-side, whilst the timber door and frame is modern. This doorway was probably extant in 1841 (figure 16).

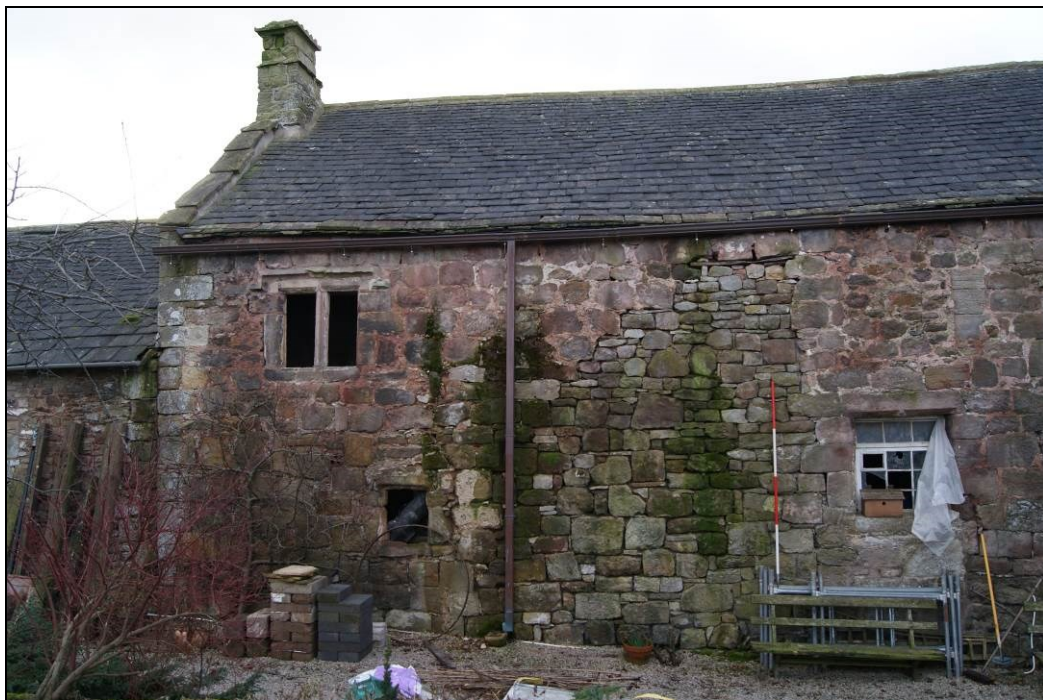
Figure 41. Detail of architectural elements (1-5), (8) and (10)

1. Fifteen courses of neat sandstone blocks (approximately 0.30-0.50m x 0.30m) that form the original south-eastern corner of the hall (figure 41).
2. Randomly coursed dressed yellow sandstone blocks bonded by a pink sandy mortar (figure 41). There is a pink sandy mortar repair around the upper window. Three ceramic drains have been inserted as air vents.
3. A repair around the lower window to Stable 2 comprising cream lime mortar and small stones (figure 43). The window (0.45m x 0.65m) probably a later amendment has a crude, rough hewn surround with a slight hood.
4. A crude stone repair of square rough hewn blocks and an occasional irregular block (circa 0.42m x 0.30m), unmortared, that occurred when the facade collapsed during the 1980s

(figure 41).

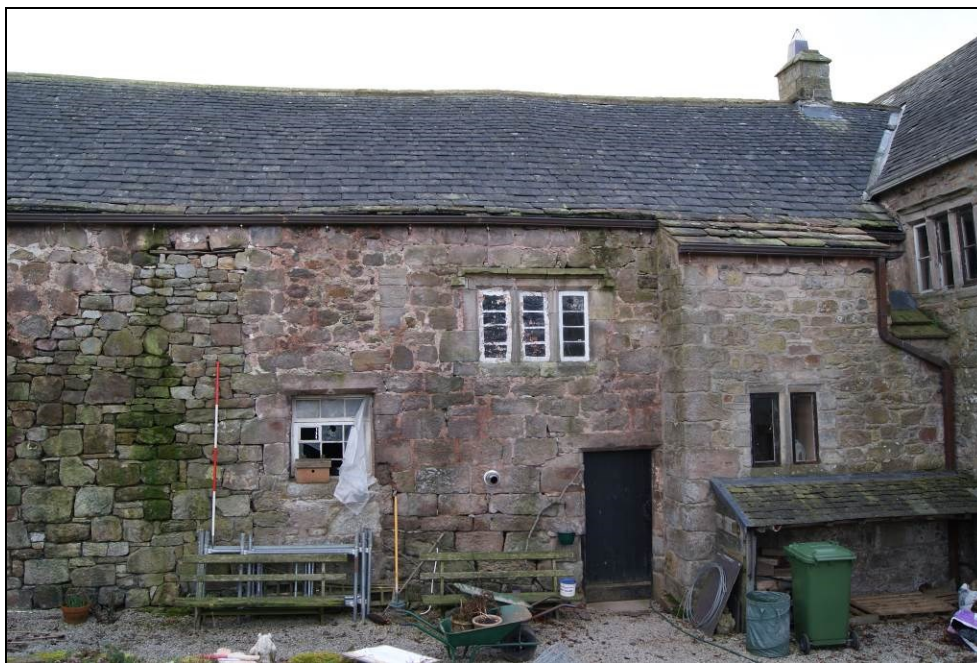
Figure 42. Northern part of south wing of hall

5. A window that enters the tack room (figure 44). The jamb consists of three courses of sandstone blocks (0.36m x 0.30m). Originally this was a two-light window but the mullion has been removed. The sill lies beneath a cement render. Beneath the lintel, each light has a square recess for a glazing bar, since replaced by a modern timber casement.
6. A slight sandstone offset measuring 3.00m in length (figure 42).

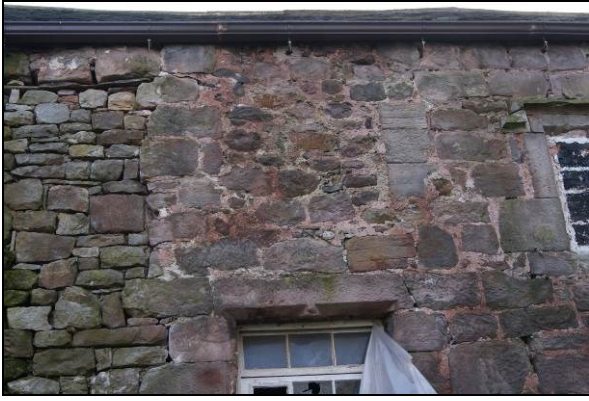
Figure 45. Blocked window (8)

As the wall had collapsed during the 1980s, it was difficult to ascertain whether this had been rebuilt or was a feature of some antiquity. The recesses appeared to correspond with the blocked window seen on the eastern elevation (figure 45).

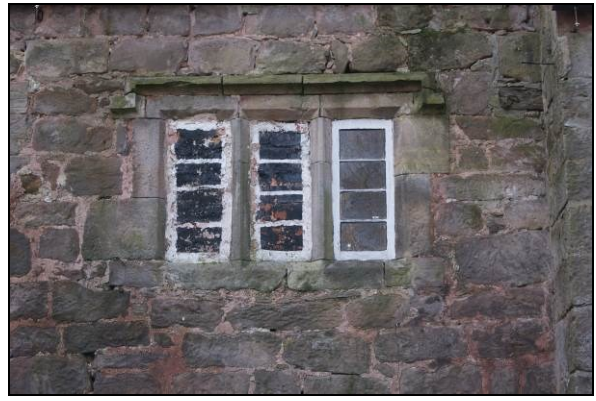
Figure 46. Dummy window (9)

9. A former triple light elongated window (figure 46). The southern and central lights have been blocked by an internal partition wall, the outside lights being painted in as dummy windows. The remaining light possesses a timber frame of probable 19<sup>th</sup> or 20<sup>th</sup> century date.

During the 19<sup>th</sup> century, the doorway was sealed (red outline figure 49) with a rubble wall blocking two lights of a three light window (figure 46).

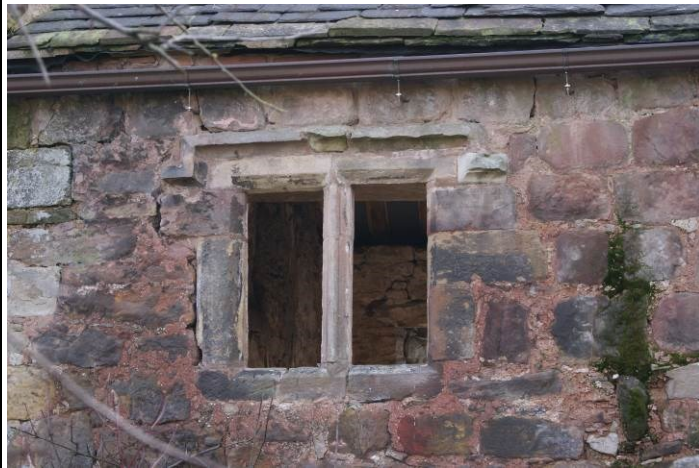
Figure 48. Double light mullion window (10)

10. An elongated double light window possessing chamfered jambs and moulded labels with returned props (figure 48).

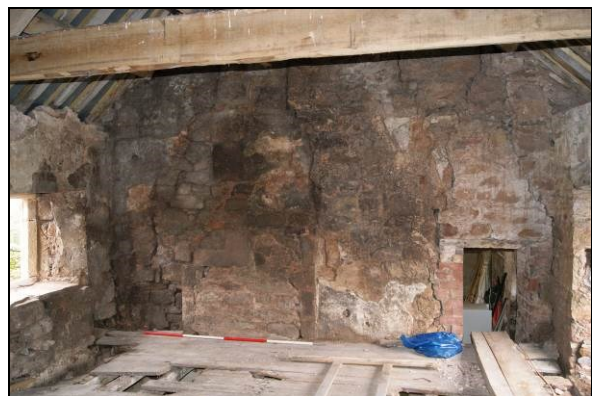
Figure 51. Exposed southern gable end in the attic

A breach (1.10m x 1.25m in height) had been made into the western side of the southern gable allowing access from the Victorian barn to the attic. The finished doorway (0.66m x 1.20m) was formalised by a brick surround (orange outline figure 49) surmounted by a timber lintel (figure 51).

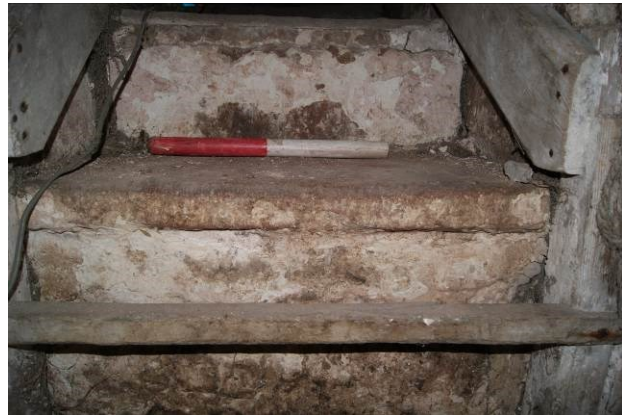
Figure 53. Probable former window, south end of attic

The breach replaced an earlier window (turquoise outline figure 49) that probably was contemporary with the suite of late Medieval elongated windows also within the southern range of the hall. A stone sill survived that had been incorporated into the breach as a step whilst the eastern prop of the former window became the eastern jamb for the entrance (figure 53).

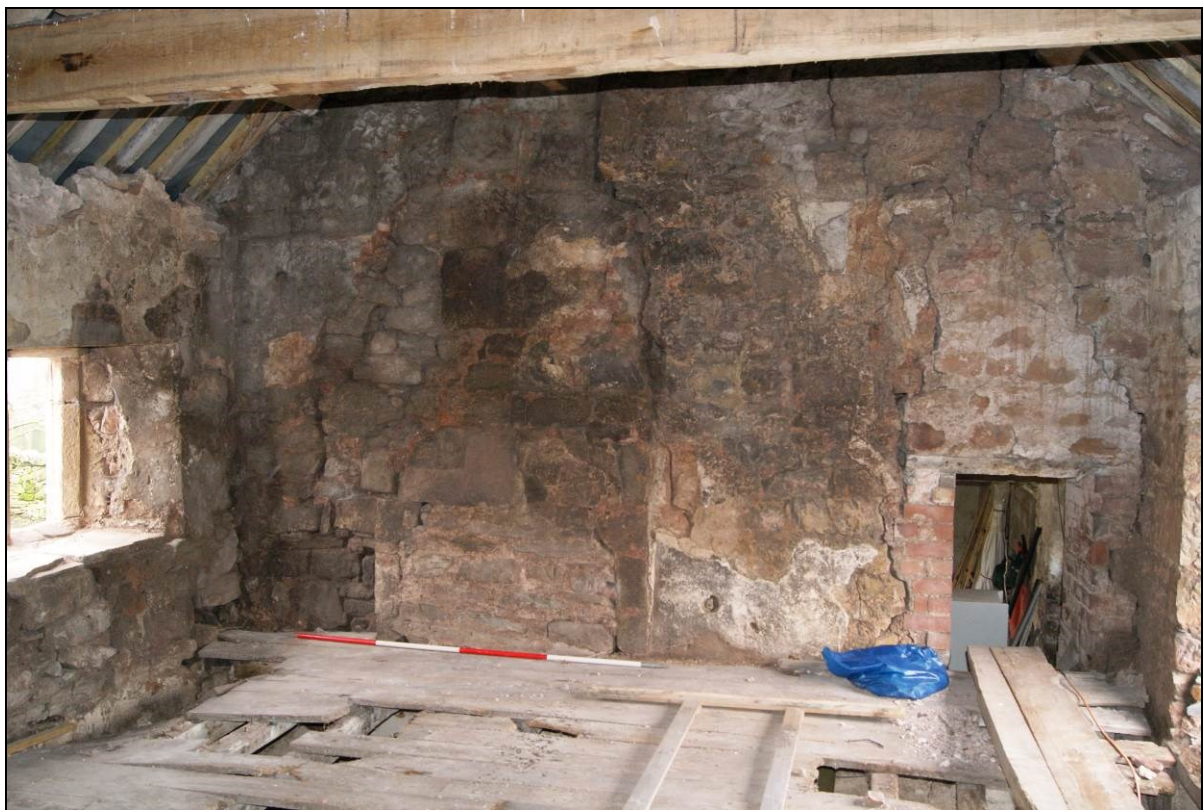
Figure 54. Southern gable end with fireplace within the attic

Parker 1996, 152). Interestingly, the chimney breast formed from dressed stone blocks appears to be butted by the southern gable suggesting that the current gable end may have been a replacement.

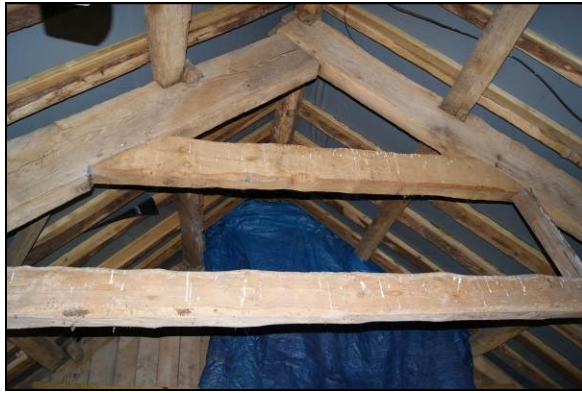
Figure 59. Roof truss (A)

- Truss A (figure 59), a replacement but the tie-beam has some antiquity although there are no recesses for joists
- Truss B (figure 60), the tie beam is possibly original and has mortices that tally with the

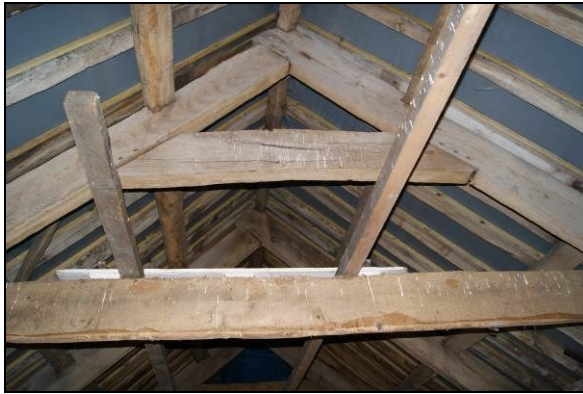
Figure 61. Roof truss (C)

- Truss C (figure 61), all replaced and machine-cut
- Truss D (figure 62), hand-cut with bracing tie-beam and light-collar

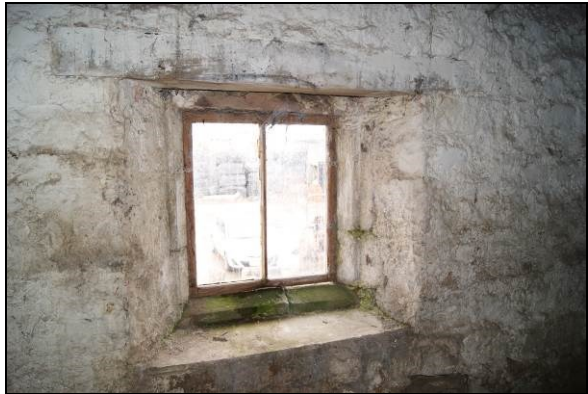
Figure 64. Window on north side of west elevation

0.80m) with a flat stone sill, chamfered recess containing a double hinged window. A machine-cut timber lintel replaced the original support (figure 64).

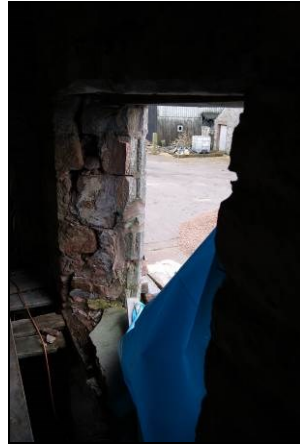
Figure 65. Opening at south end of western elevation

- On the southern end of the western elevation was a former elongated window (approximately 1.50m x 1.00m). This was very badly damaged, inaccessible and was now an opening without glazing or frame (figure 65).

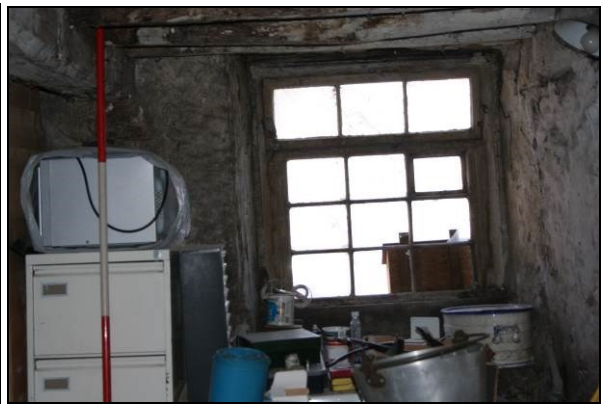
Figure 68. Eastern window with bench seat

The western and eastern walls possessed respectively, a modern doorway (figure 83) measuring 1.14m x 2.08m and a window measuring 1.20m x 1.15m complete with stone bench seat 0.25m in depth (figure 68).

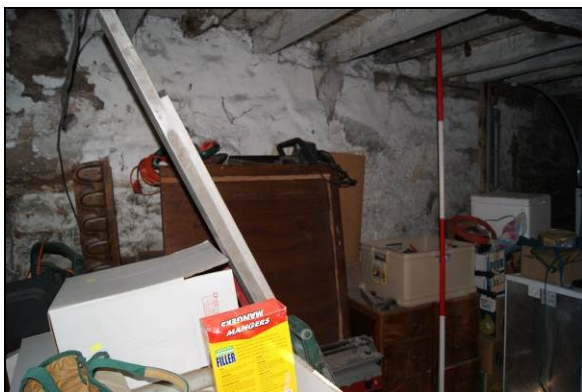
Figure 70. North wall with blocked door

This wall contained a block doorway (red outline figure 66) towards the east measuring 1.25m in width and outlined in quoins on its western side (figure 70). This feature is not visible from the passage side.

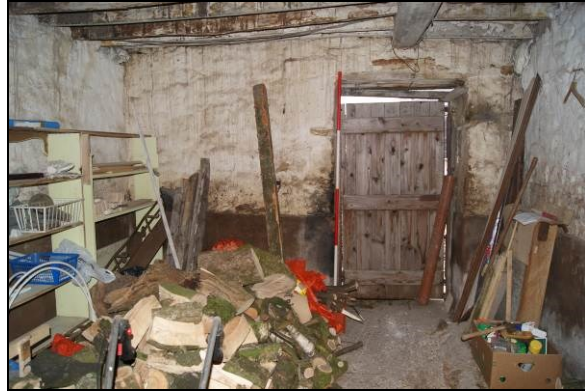
Figure 72. Door at western end of stable 1

A concrete plinth for a tank or water trough existed towards the western side, the entry point via whilst a modern door measuring 1.16m x 2.12m was situated in an earlier door jamb bearing sandstone quoins (figure 72).

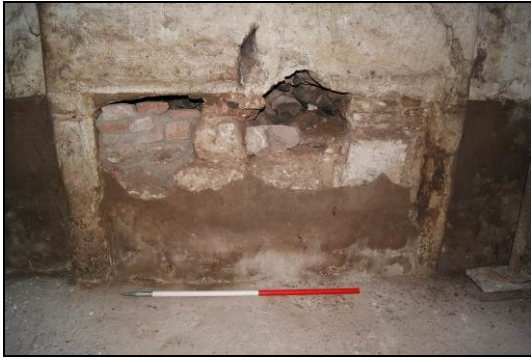
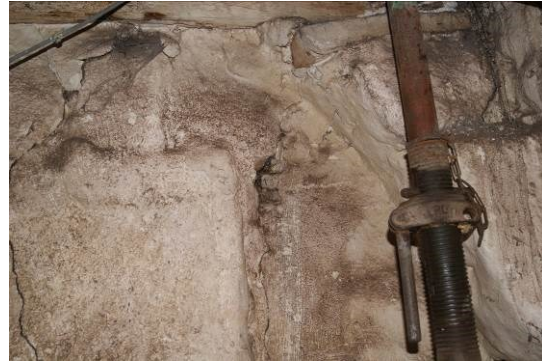
Figure 74. Fireplace within southern elevation Figure 75. Detail of truncated window jamb

- Two timber lintels or beams (figure 78) measuring 0.70m in length and 0.18m in thickness that bore peg holes. This arrangement may have overlain a filled doorway, unseen in the barn due to the presence of an oil tank.
- A timber beam of uncertain function.
- A remnant elongated window (figure 75); the left prop was 0.16m in width whilst the sill extended 0.12m westwards. The window prop corresponds with two dressed stone blocks observed on the northern face of the barn.
- A smoothed moulded, dressed, stone corbel painted white (figure 79) measuring 0.40m in length, 0.22m in thickness and 0.70m in height protruding from the western wall.
- A sandstone fireplace measuring 1.90m in width and 1.10m in height possessing stone props measuring 0.18m in width. The hearth has been filled with stone, brick and partially cement rendered recently (figure 74).

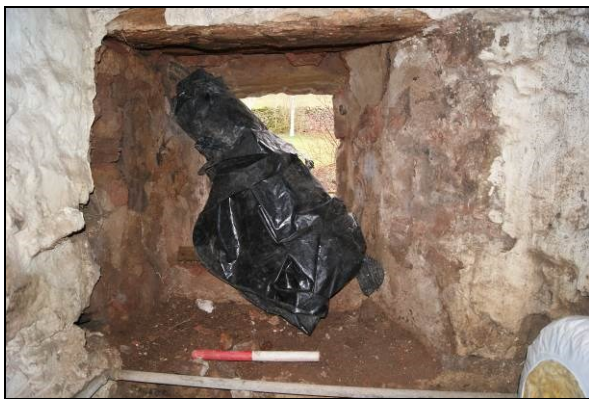
Figure 76. Eastern window, stable 2

The eastern elevation displayed a single window measuring 1.10m x 0.87m in height surmounted by a decayed timber lintel measuring 1.20m in length and 0.18m in thickness.

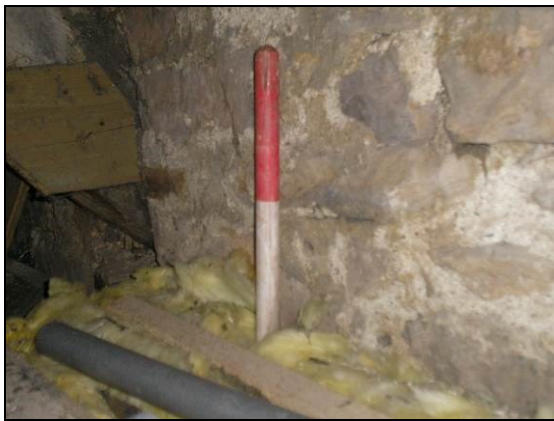
Figure 80. Roof truss in the attic, north range

The roof beams were embedded onto a rubble stone wall (figure 80), but as the northern range was physically higher than the southern range no stratigraphic relationship between the two buildings could be ascertained.

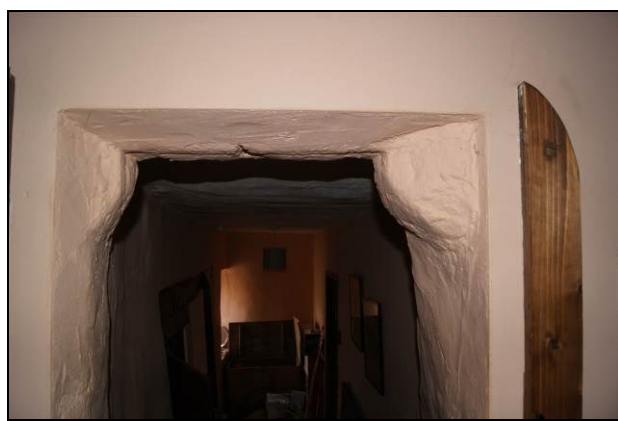
Figure 81. Door linking the north and south ranges

- The threshold was a former elongated window (figure 81) measuring 0.58m in width, providing a light 0.41m in width.
- A groove 4mm in depth that the light sat within was on the south side of the jamb whilst the fastening bolt was also on the south side (figure 82) that would have secured a casement window. It was customary for leaded casement windows to open inwards, whilst shutters either hinged or sliding in grooves were the rule rather than the exception during the Tudor period (Breckon & Parker 1996, 116).

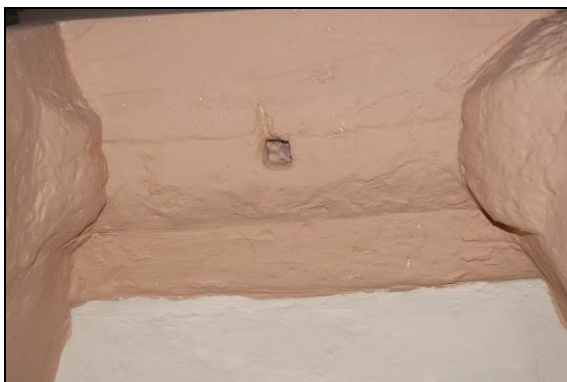
Figure 82. Detail of bolt hole and window jamb

- Functional exterior shutters protected the window often unglazed and opened outwards possibly indicated by an arcing groove in the stonework (figure 82). Until the 16<sup>th</sup> century windows were kept to a minimum as glass was expensive, the practice of shutters continuing beyond this period (Brown 1994, 93-95).

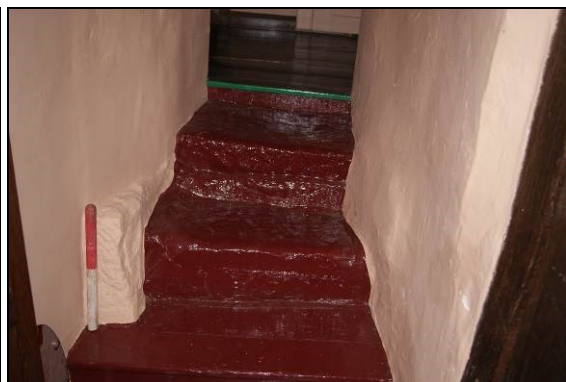
Figure 83. Stonework protruding within south range

- A protruding stone block above the later steps (figure 83) indicated the original internal face of the northern extent of the southern range. This provided a wall thickness of approximately 0.96m, wider than the southern gable end (0.80m) but appreciably closer in dimension than 0.66m for the remaining part of the southern side of the northern range.

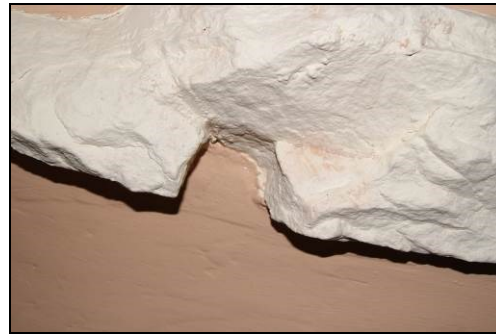
Figure 85. Detail of bolt-hole

- Set back 0.37m from the southern face was a single piece of rough hewn stone measuring 1.00m in length, 0.07m in depth and over 0.21m in width indicative of a former lintel or jamb for a probable door, heavily damaged when knocked through and then expanded (figure 84).
- The eastern jamb for the new door was a neat and dressed stone prop (0.15m in thickness), probably a remnant of the original door
- A bolt-hole 0.04m in depth was located on the southern side of the party wall (figure 85).

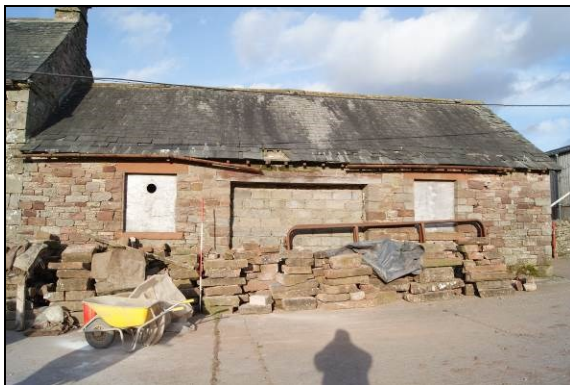
Figure 86. West elevation of Victorian barn

The building measured 12.10m in length, 3.00m in height, rising to 5.80m at the apex of the modern slate roof. The building butted the pre-existing hall, hence the lack of stone quoins at the northern end. The building fabric consisted of rough hewn sandstone blocks lain in courses with walls measuring 0.50m in thickness.

ingress was blocked by modern breeze blocks (figure 86).

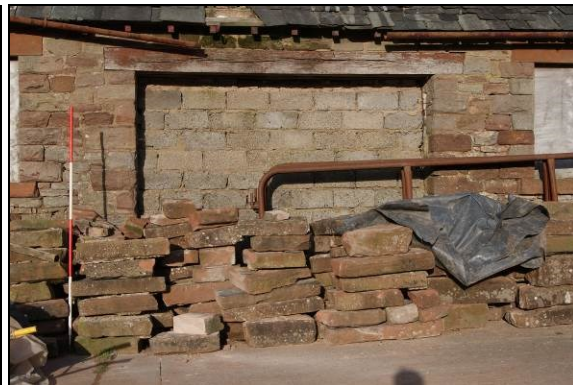
Figure 87, Filled doorway

2. The corner at the southern gable end (figure 87) comprised twelve courses of sandstone quoins with alternate sized blocks measuring 0.44m x 0.18m and 0.32m x 0.30m respectively. There was a slight rebate on the corner that terminated 1.00m above the ground.
3. A modern window (currently boarded over) measuring 1.00m x 1.20m with sandstone sill and lintel (figure 89). The window was outlined by six sandstone quoins to the south and seven sandstone quoins to the north (0.16-0.20m x 0.20m-0.35m) with a slight rebate to the jamb.
4. A modern window (currently boarded) measuring 1.00m x 1.20m with sandstone sill and lintel (figure 90). The window was outlined by six sandstone quoins to the north and seven sandstone quoins to the south (0.18-0.20m x 0.20m-0.35m) with a slight rebate to the jamb.

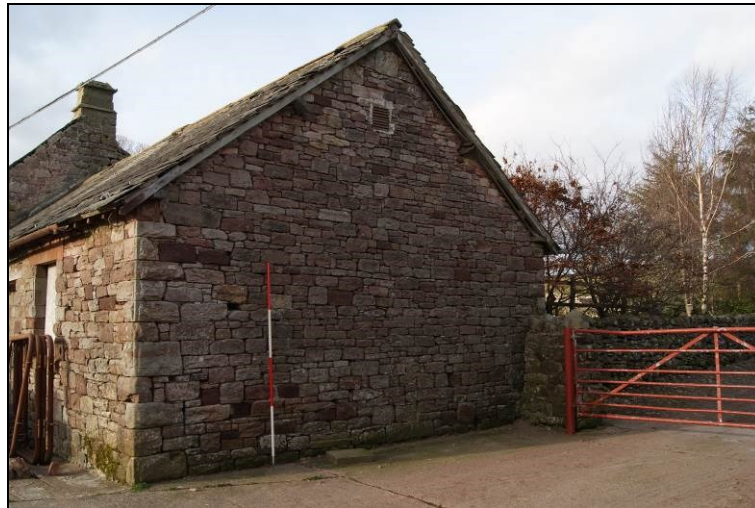
Figure 91. South elevation of barn

The south elevation consisted of plain, rough hewn, randomly coursed sandstone blocks (figure 91). There existed a central *louvred* vent 1.00m below the roof ridge.

Modern machine-cut timbers formed the eaves supporting a slate roof. Each corner comprised neat quoins formed from rough hewn sandstone blocks with a moulded rebate (discussed above).

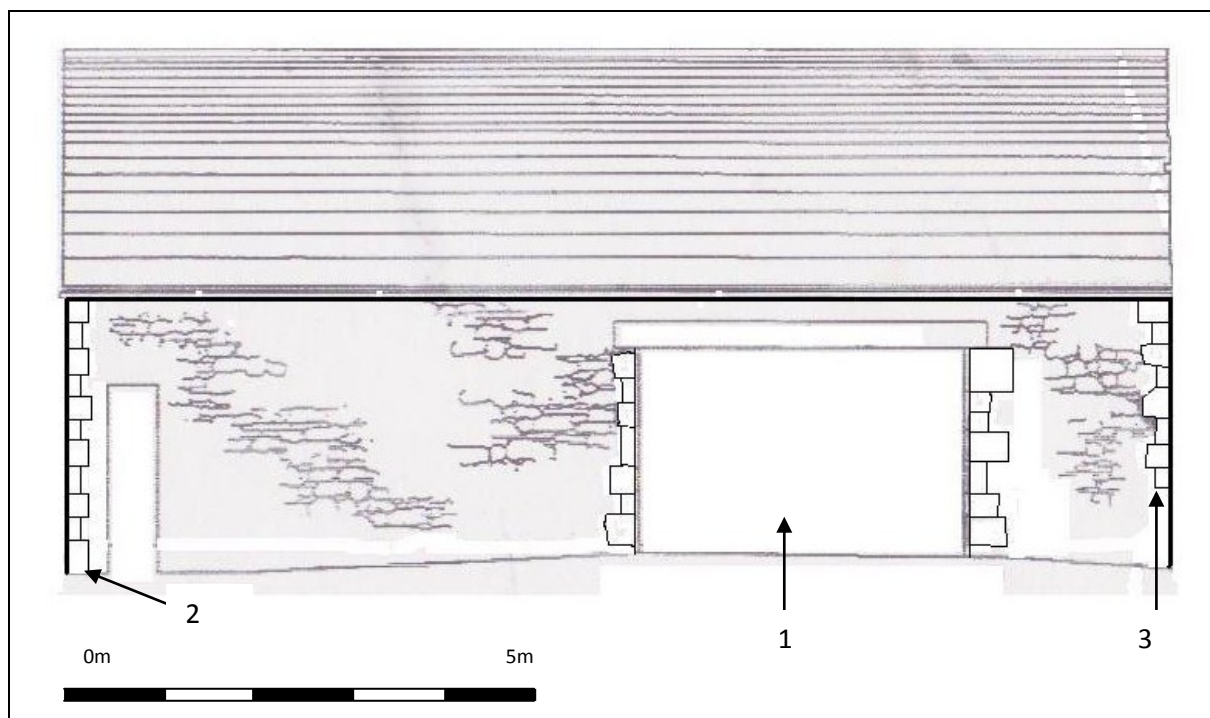
Figure 92. East elevation of Victorian barn

The eastern elevation (figure 92) was 0.13m eastwards of the hall and butted the barn to the north.

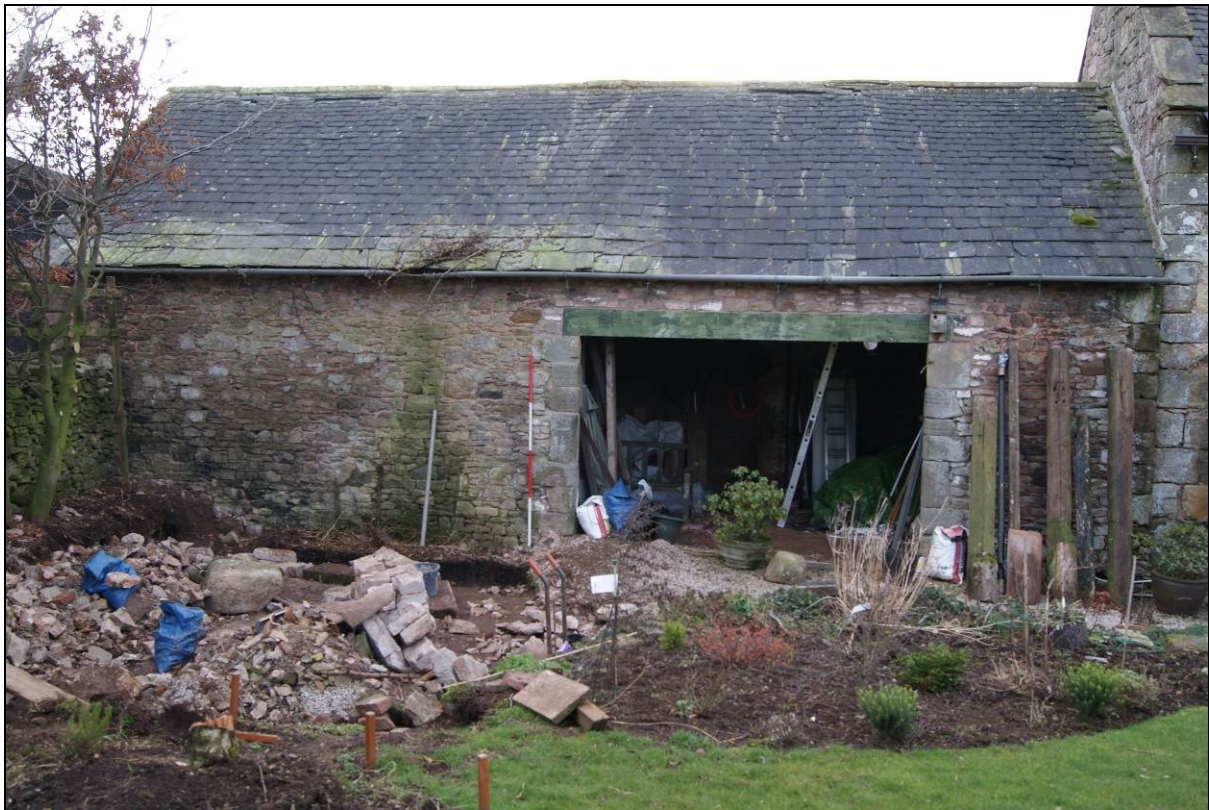
Figure 93. Eastern elevation of the Victorian barn

1. An open doorway measuring 3.50m in width and 2.30m in height. A modern timber lintel surmounted a seven course high, double set of dressed red sandstone quoins approximately 0.35m x 0.25m in size and 0.22m in thickness (figure 93).
2. The south-eastern corner at the southern gable end (figure 91) comprised twelve courses of sandstone quoins with alternate sized blocks measuring 0.44m x 0.18m and 0.32m x 0.30m respectively. There was a slight rebate on the corner extending from the ground to the roof.
3. A series of eight rough hewn red sandstone blocks (0.30m x 0.40m approximately) beginning 0.67m from the ground

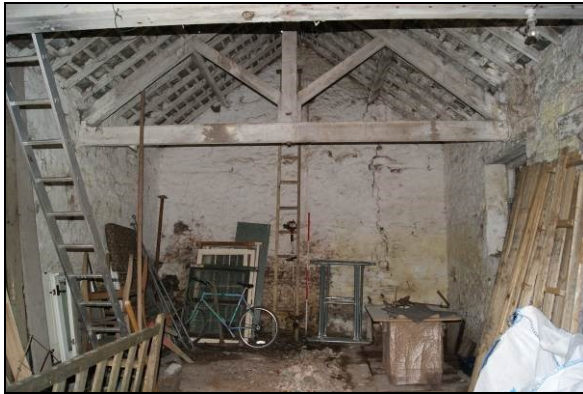
Figure 94. Roof trusses within the barn

The roof comprised three machine-cut modern roof trusses with machine-cut purlins, eaves and battens supporting a slate roof (figure 94).

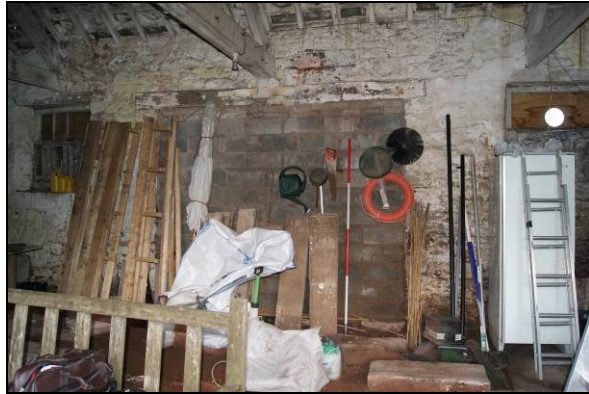
Figure 95. Blocked doorway within the barn

The western door was blocked by breeze blocks and yielded a timber lintel (figure 95).

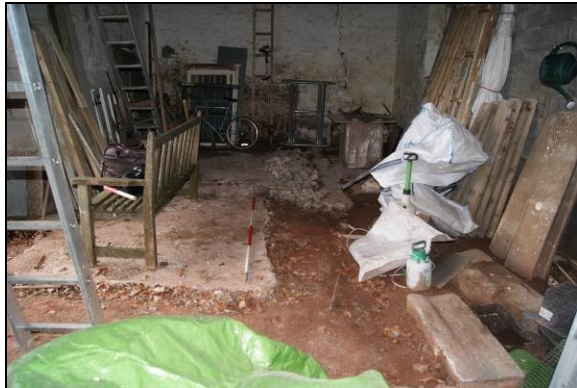
Figure 96. Floor to the barn

Most of the floor had been removed although some large stone flags (1.00m x 0.56m x 0.09m in thickness) had been bedded directly onto reddish brown silty sand. Elsewhere, there was a remnant cobbled floor almost totally lost to the north of the barn. Towards the centre and the south of the barn there existed a thin concrete surface (figure 96).

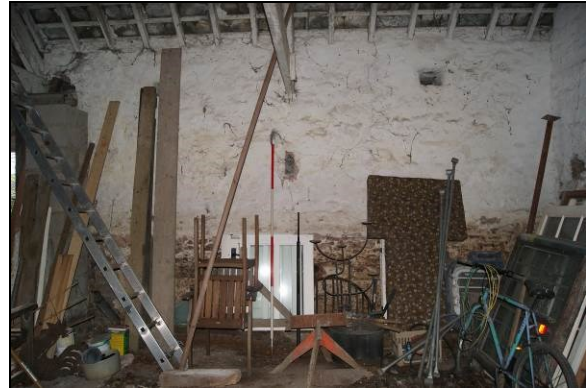
Figure 97. Air vents within the barn

On the eastern elevation two air vents (figure 97) measuring 0.30m x 0.10m and 0.25m x 0.18m were present, but were not visible on the outside.

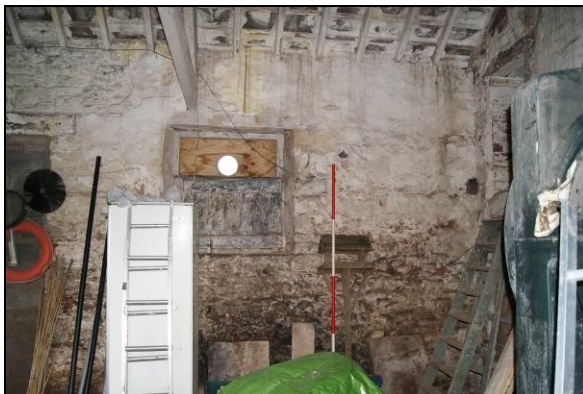
Figure 98. Northern window within the barn

On the western elevation, both the southern window (figure 99) and north window (figure 98) measured 1.30m in width and 1.23m in height and comprised machine-cut timber lintel but had no sill. The original timber shutter and frames were present.
