The building survey at Croft End, Blackford confirmed the presence of a clay dabbins cottage that comprised of a single eastern gable, the remaining parts of the building have been demolished or collapsed leaving little recoverable evidence for further study.

Cumbria County Council's Historic Environment Service (CCCHES) was consulted by Carlisle City Council regarding a planning application for the conversion of a bank barn for domestic use at Croft End, Blackford, Carlisle, (NY 41270 62405), Planning Application No. 1/09/0994.

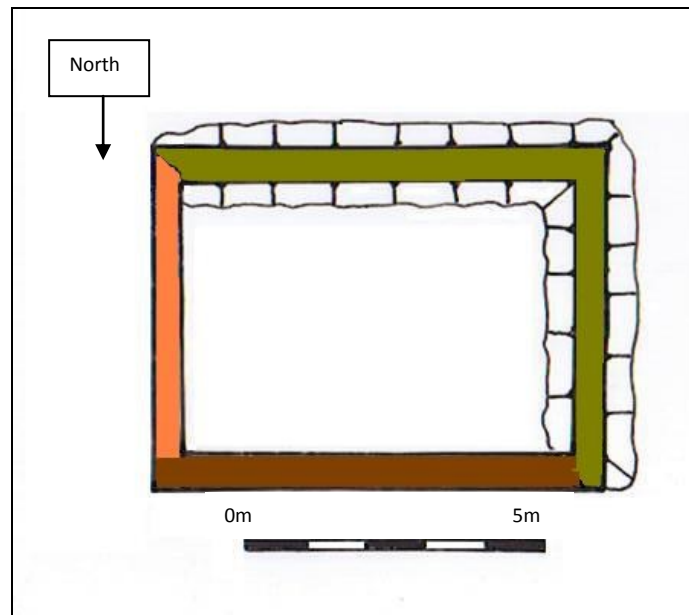
Figure 5. Ground plan of cottage.

The floor plan for the cottage measured 6.59m x 4.49m and was covered by linoleum above a modern concrete floor.

The eastern gable was still extant (orange shade in figure 5) and measured 4.49m in width, 6.33m in height and 0.50m in thickness. It comprised of pitted, red clay bricks with minimal straw inclusion and very occasional rounded small pebbles, approximately 0.08m-0.10m in thickness, lain in horizontal courses that formed the clay dabbin super-structure (figure 6).

The southern clay dabbin wall had collapsed or was demolished and reverted ostensibly to its clay constituent (figure 5 olive shade). A mound stood approximately 0.50m in height where the wall once stood (figure 9). Examination of the eastern gable end demonstrated that the southern clay dabbin wall was 0.50m in thickness and currently stood to a maximum height of 1.20m.

The western clay dabbin wall (figure 5 olive shade) was buried under collapsed brick debris (figure 10) probably from the former cottages first floor. A door appeared to exist in the south-west corner of the building but the area was overgrown and impenetrable. The wall still stood to a height of approximately 1.00m.

The northern wall (figure 5 brown shade) had been replaced in brick following deliberate removal of the clay dabbin wall in the past. This brick wall pre-dated the brick barn that conjoined the cottage to the east.

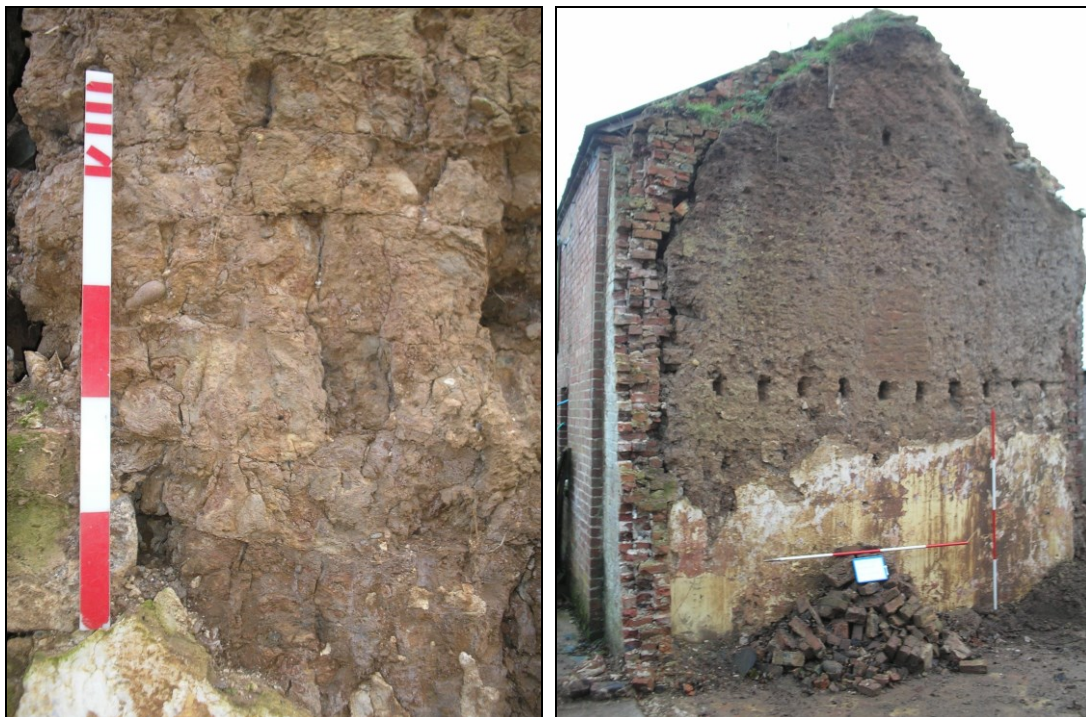
Figure 6 and 7. Detail of clay dabbins and eastern elevation showing clay dabbin wall

On the ground floor, the gable had been painted cream onto plaster 0.03m in thickness applied directly to the clay wall (figure 7).

At a height of 2.12m were ten rectangular recesses measuring 0.23m in height x 0.10m in width accommodating former roof joists. These recesses were spaced approximately 0.25-0.30m apart.

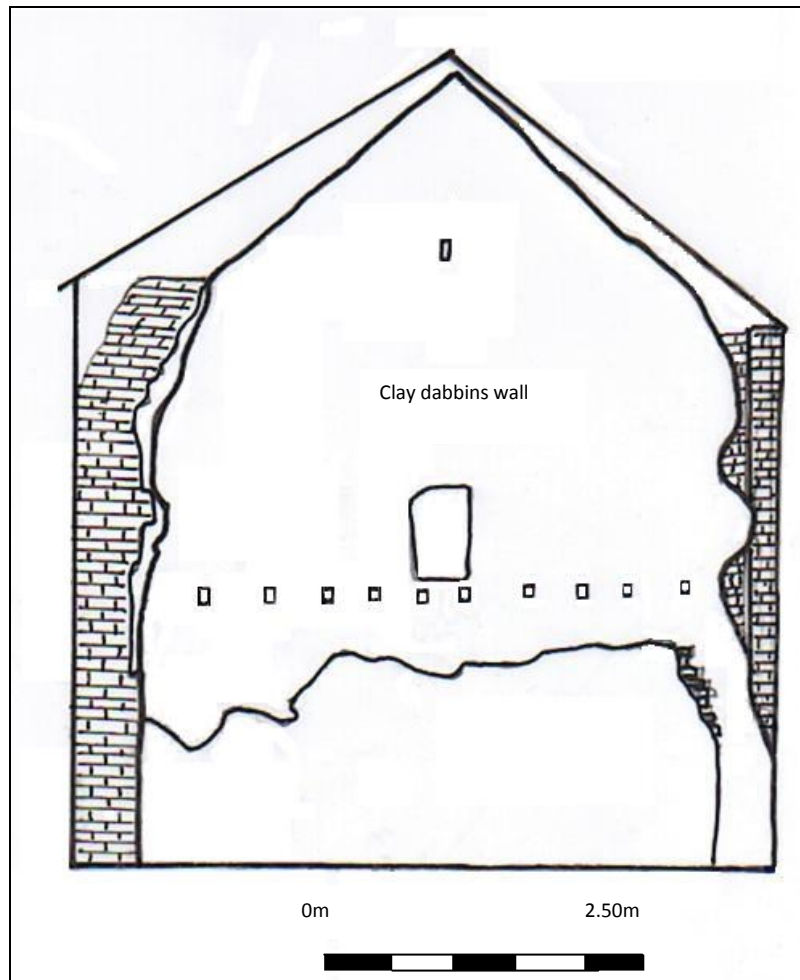
Figure 8. Western gable end illustrating the clay dabbins

On the first floor, the clay dabbin had been left exposed apart from a red brick "fire back" 0.95m in height x 0.75m in width, probably representing the sleeping quarters for the cottage. A single recess for a roof joist marked the central point in the roof trusses (figure 8).

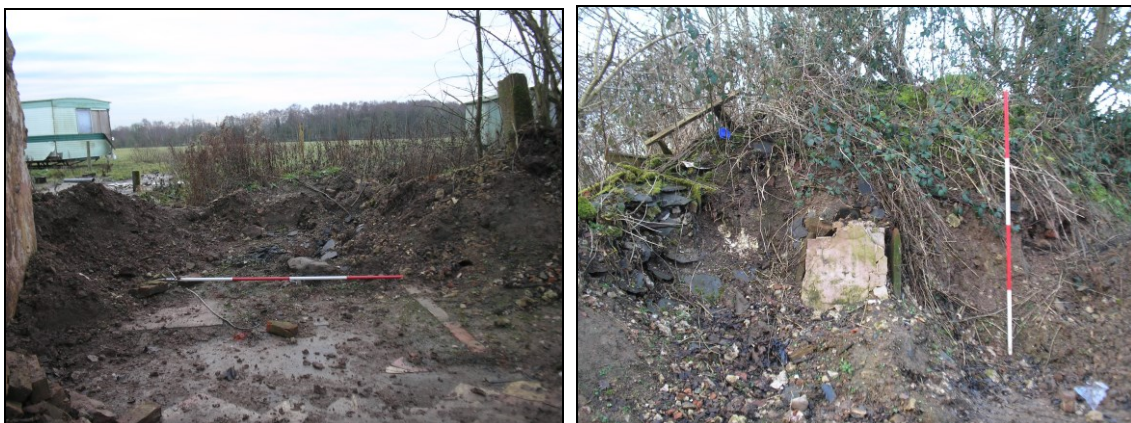
Figure 9 and 10. Reduced southern clay dabbin wall and western clay dabbin wall

A walk-over of the site found the clay dabbin building to be in a poor state of repair; the southern wall having collapsed, the western wall overgrown, the northern wall totally removed and only the eastern gable extant.

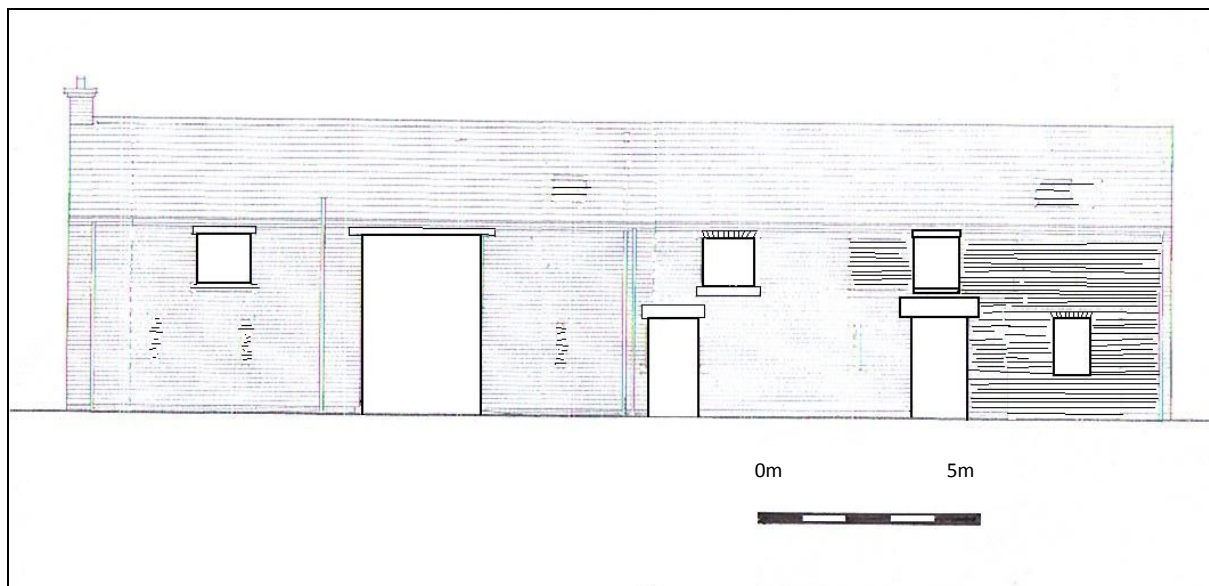
Figure 12. Northern elevation of barn.

The northern elevation also possessed a window measuring 1.64m x 1.18m outlined by a red sandstone sill and lintel.

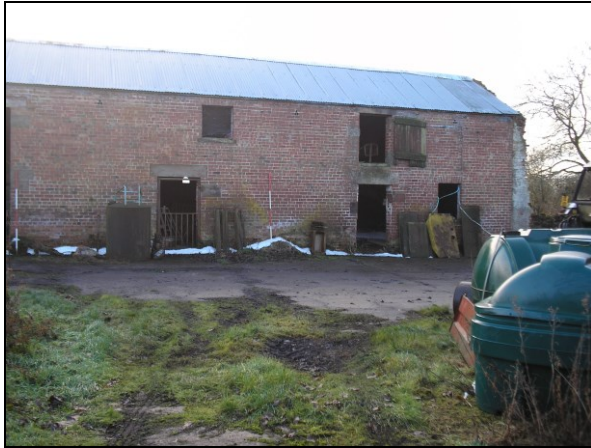
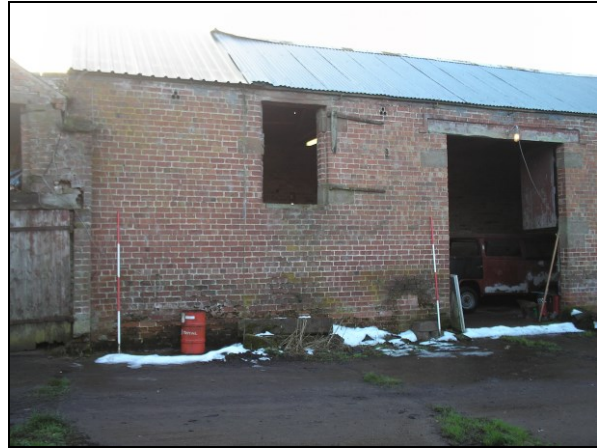
Figures 13 and 14. The brick barn showing the cattle shed and the barn now used as a workshop

Only the northern facade (figure 13) of the cattle shed demonstrated any architectural features namely:

- A window measuring 0.86m x 1.17m in height with a stone sill, brick fan lintel and timber surround, 1.16m above the ground
- A doorway measuring 1.18m x 2.14m in height bearing a red sandstone lintel measuring 1.62m x 0.38m

- A window 0.62m directly above the door described above measuring 1.18m in width and 1.00m in height outlined by a red sandstone lintel
- A doorway measuring 1.14m x 2.14m in height bearing a red sandstone lintel measuring 1.60m x 0.30m
- A window 1.06m above the west end of the doorway described above, measuring 0.92m x 0.96m in height bearing a stone sill and brick fan lintel

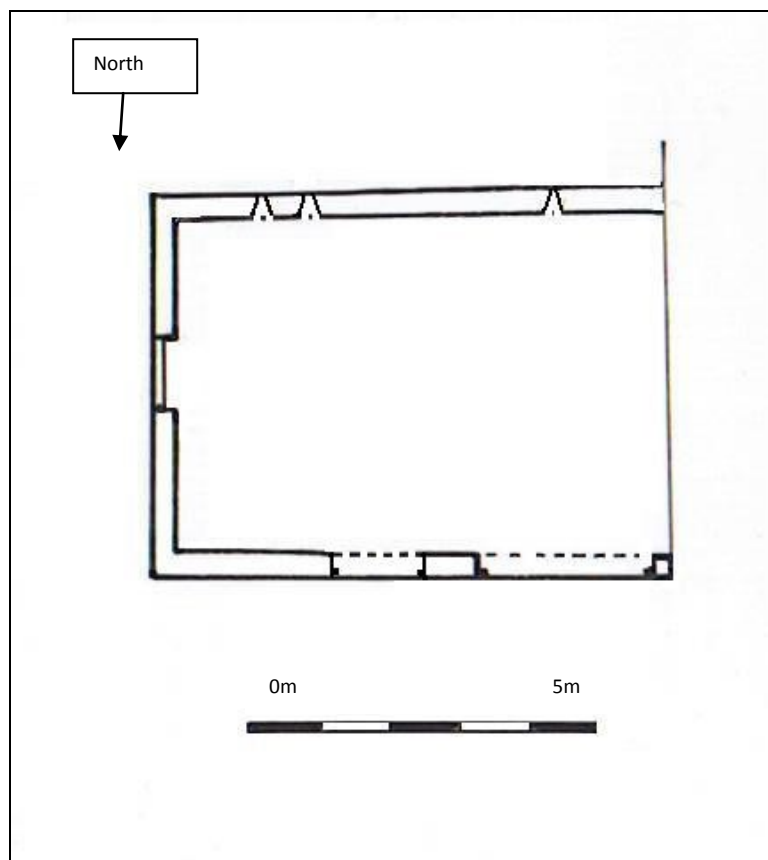
Figure 17. Ground plan of offshoot.

The brick offshoot measured 7.34m x 5.59m in area (figure 17) and stood to a height of 4.60m (figures 18 and 20). The interior (figure 19) was cement rendered with a concrete floor that had been used as a cattle shed. The building contained the following architectural details:

- A doorway measuring 2.51m in width and 1.95m in height bearing a timber lintel 2.90m in length and 0.25m in thickness
- A window measuring 1.24m in width and 1.28m in height bearing a red sandstone lintel
- A timber door measuring 1.27m in width and 1.94m in height bearing a red sandstone lintel measuring 2.42m x 0.41m in thickness

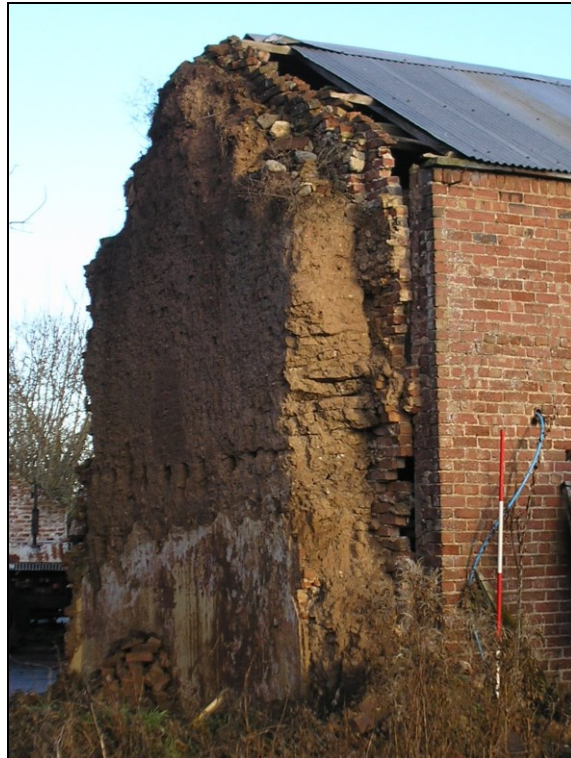
Figure 21. Eastern gable with applied brick skin

As the clay dabbins building was vulnerable to rain, a skin of a single course of bricks appears to have been applied to the exposed eastern gable (figure 21). Most probably this action was repeated on the southern and western elevations.
