The Level III building survey at Hill Farm, Crosby Garrett recorded a probable 18<sup>th</sup> to early 19<sup>th</sup> Century stone bank barn, this example being a true bank barn (Brunskill 2002, 105).

Cumbria County Council's Historic Environment Service (CCCHES) was consulted by Eden District Council regarding a planning application for the conversion of a bank barn for domestic use at Hill Farm, Crosby Garrett, Kirkby Stephen, (NY 72945 09530), Planning Application No. 3/09/0436.

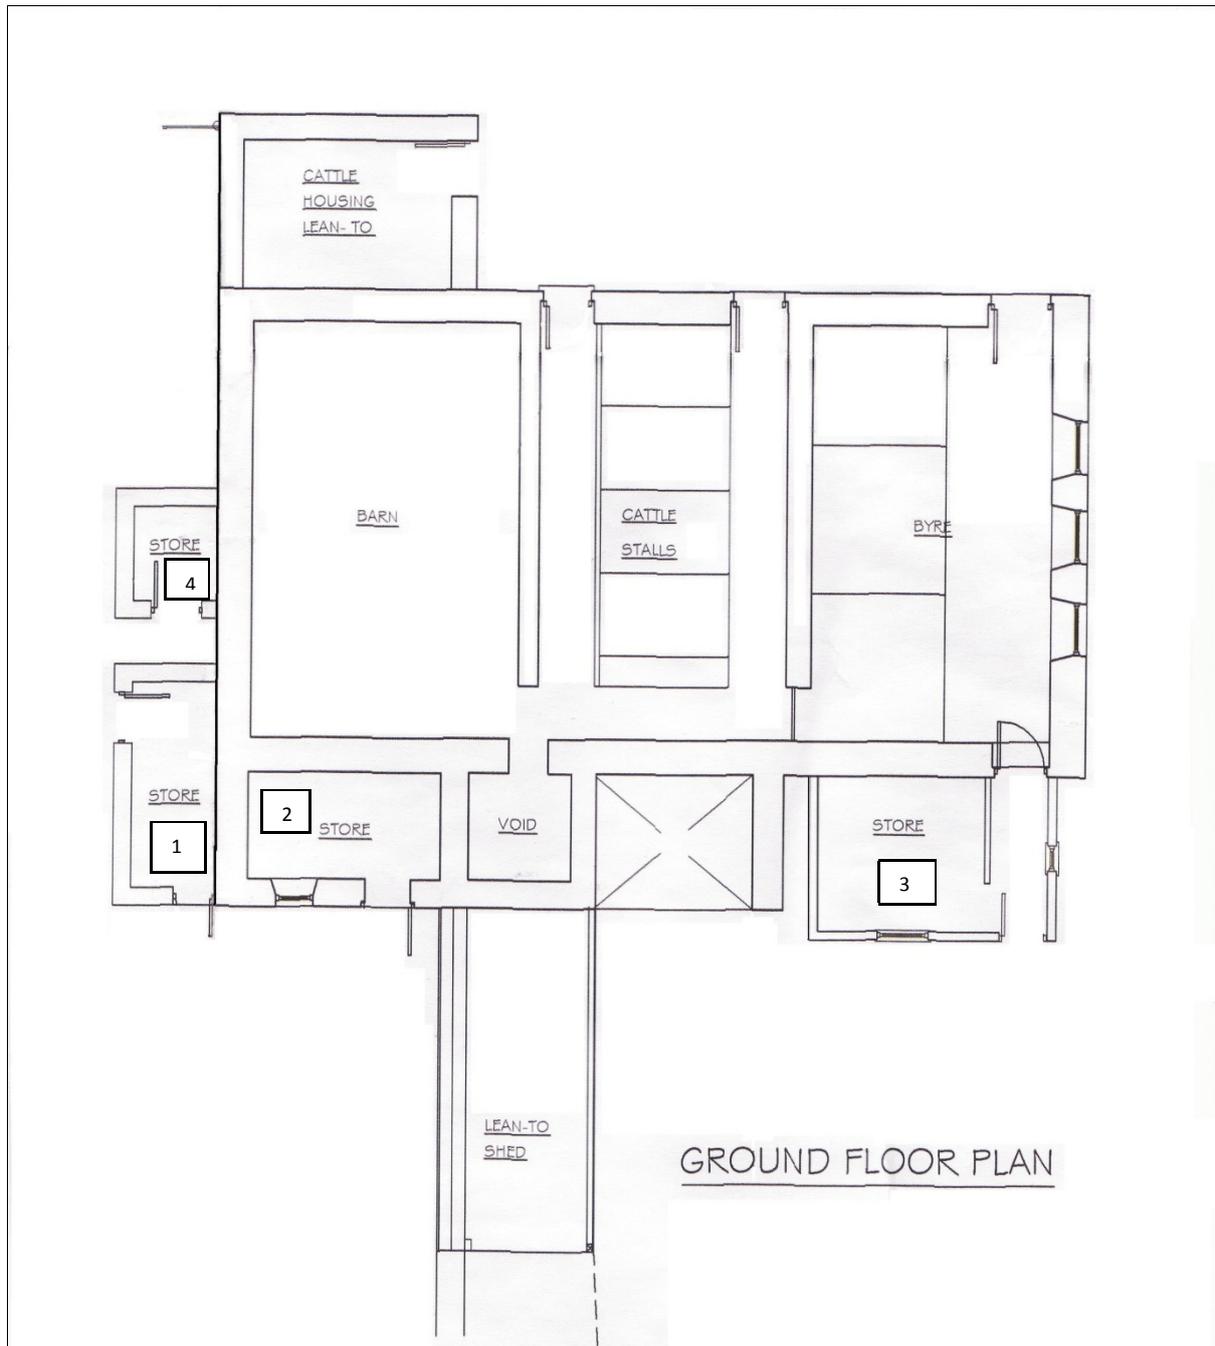
Figure 6. Ground plan of the principal rooms.

The ground floor of the bank barn (figure 6) covered an internal area measuring 14m x 7.3m and was partitioned into three areas: byre, cattle stalls and barn. A further area existed beneath the ramp but was inaccessible have been backfilled during the late twentieth century (B.Witterick *pers comm.*).

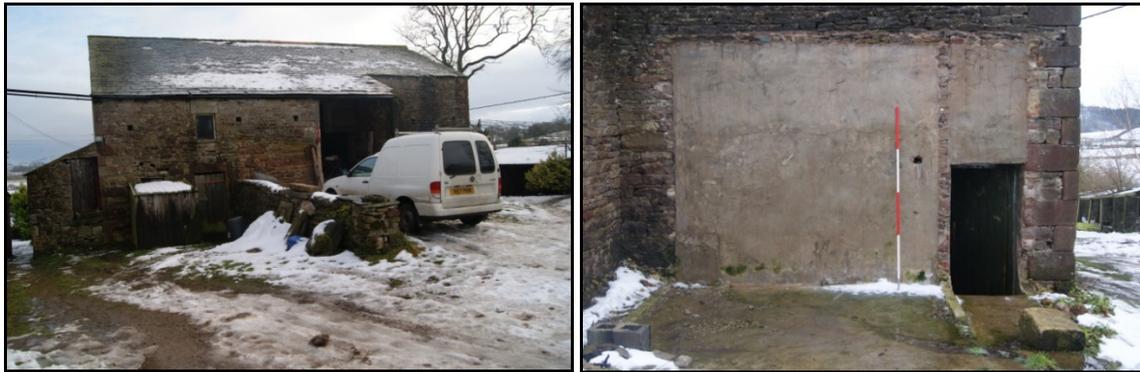
Figures 7 and 8 showing northern range outshot and southern dismantled Store 3

This elevation illustrates a range of attached buildings including stores 1-3 (Store 3 recently removed, figure 8), a lean-to shed (subsequently dismantled) and building fabric covering a void.

At the northern end of the elevation was an outshot building (figure 7) divided into Store 2 and housing a void. This structure measured 6.7m x 2.4m and stood to a height of 4.15m with walls 0.50m in thickness. It consisted of coursed, roughly hewn stone blocks, left unrendered. The northern corner that served as Store 2 consisted of fourteen dressed red sandstone blocks measuring 0.60m x 0.30m x 0.20m, lain alternately.

At the division between Store 2 and a void was a dry-stone wall (figure 7), measuring 1.60m in height and 0.40m in width that had previously served as the northern limit of a now dismantled, crude lean-to shed.

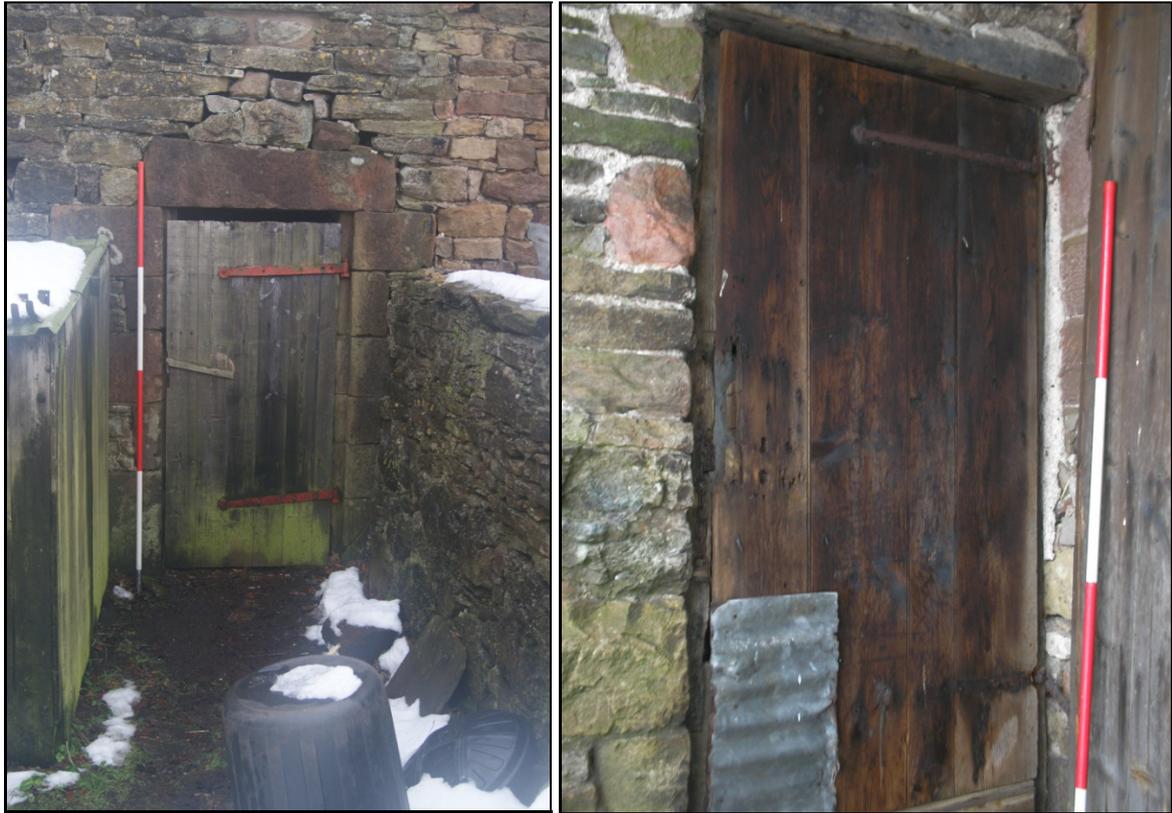
Figures 9 and 10 showing door to Store 2 and a door of some antiquity leading to the void

Store 2 also yielded a small ventilation slot or vent measuring 0.40m x 0.20m and a stone door jamb measuring 1.91m x 0.95m surmounted by a machine-cut, stone lintel measuring 1.22m x 0.28m. The door surround comprised five courses of dressed, red sandstone quoins enclosing a six plank timber door 0.85m x 1.84m in height (figure 9).

The void (floor area 1.80m x 1.90m) was accessed by a southern, four-planked door measuring 1.72m x 0.72m possessing a rough hewn stone lintel measuring 0.82m x 0.18m. The jamb comprised rough hewn limestone blocks 0.49m x 0.14m with intermediate slabs coursed randomly (figure 10).

Graffiti inscribed into the door stylistically suggests that the door was in existence during the early to mid 19<sup>th</sup> Century.

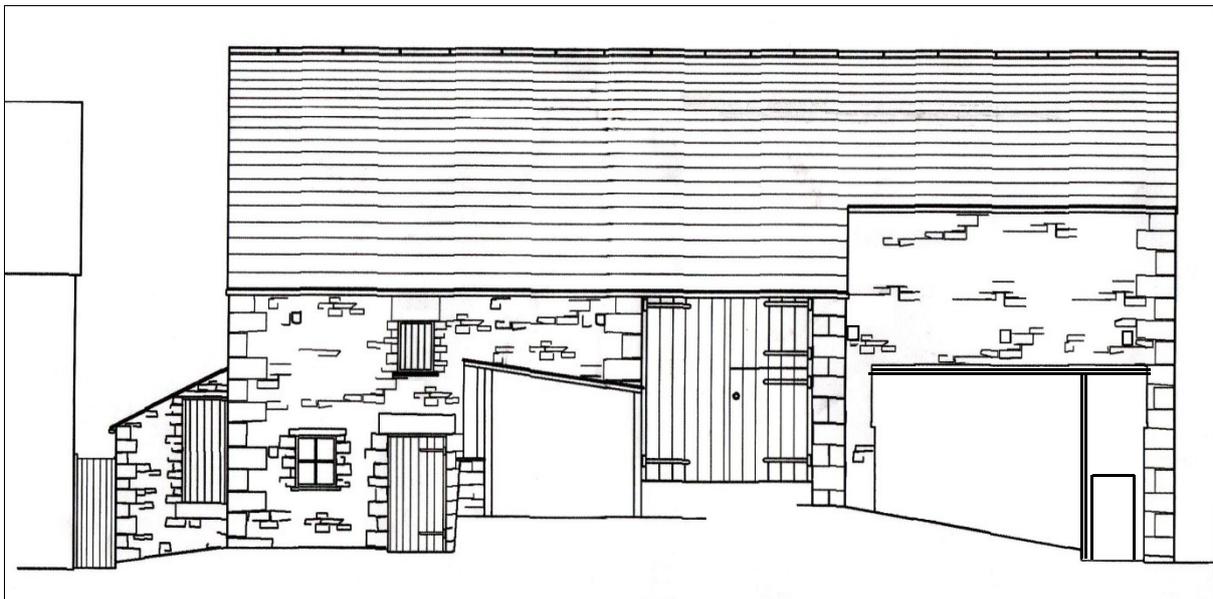
Figure 11. Western elevation of bank barn

The western elevation measured 15.2m in length x 8.3m in height and comprised of the front view of the bank barn.

At the centre of the western elevation was a porch formed from the stone walls of two outshot buildings 2.97m apart; the northern structure still extant, the southern now a rough hewn wall.

A slight gradient formed a ramp leading up to a poorly maintained, two-part “stable door” of no great antiquity, measuring 3.00m in height and 2.75m in width.

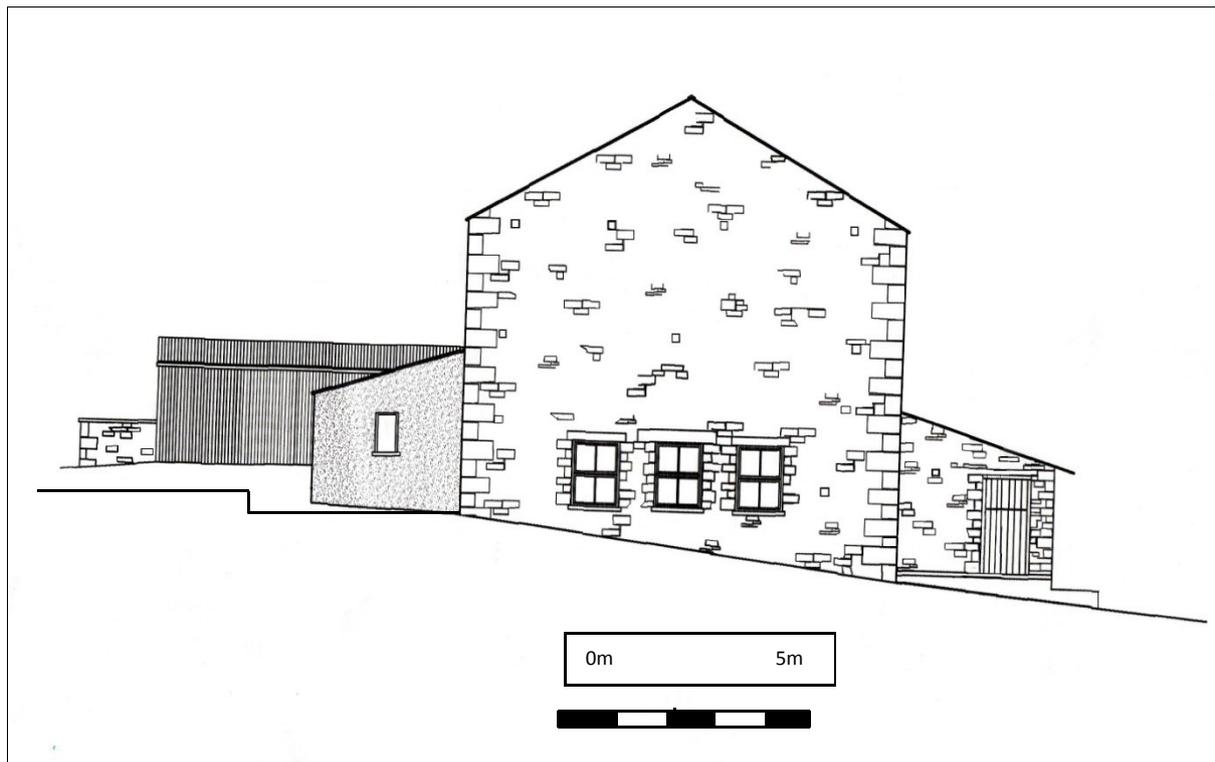
Figure 13. Southern elevation of bank barn

The southern elevation measured 8.6m in width and varied from 5.9m to 6.9m in height illustrating the fall for the barn. An additional 2.5m for the roof truss made the combined height approximately 8.9m.

The gable end had been left plain in roughly hewn randomly coursed limestone with no architectural embellishments.

The south-western corner comprised of 19 dressed red sandstone blocks measuring 0.69m x 0.33m x 0.18m forming stone quoins. The south-eastern corner comprised of 23 dressed, red sandstone blocks measuring 0.57m x 0.36m x 0.18m. This achieved a fall of approximately 1.00m.

The facade contained three evenly spaced ground floor windows containing four panes of glass. The central window possessed a rough hewn limestone lintel and sill measuring 1.24m x 0.89m whilst the flanking windows were outlined by concrete lintels and sills and measured 1.28m x 0.86m.

The elevation possessed nine air vents all measuring approximately 0.15m x 0.20m formed at three levels to ventilate the hayloft above. These were in courses of two, three and four respectively.

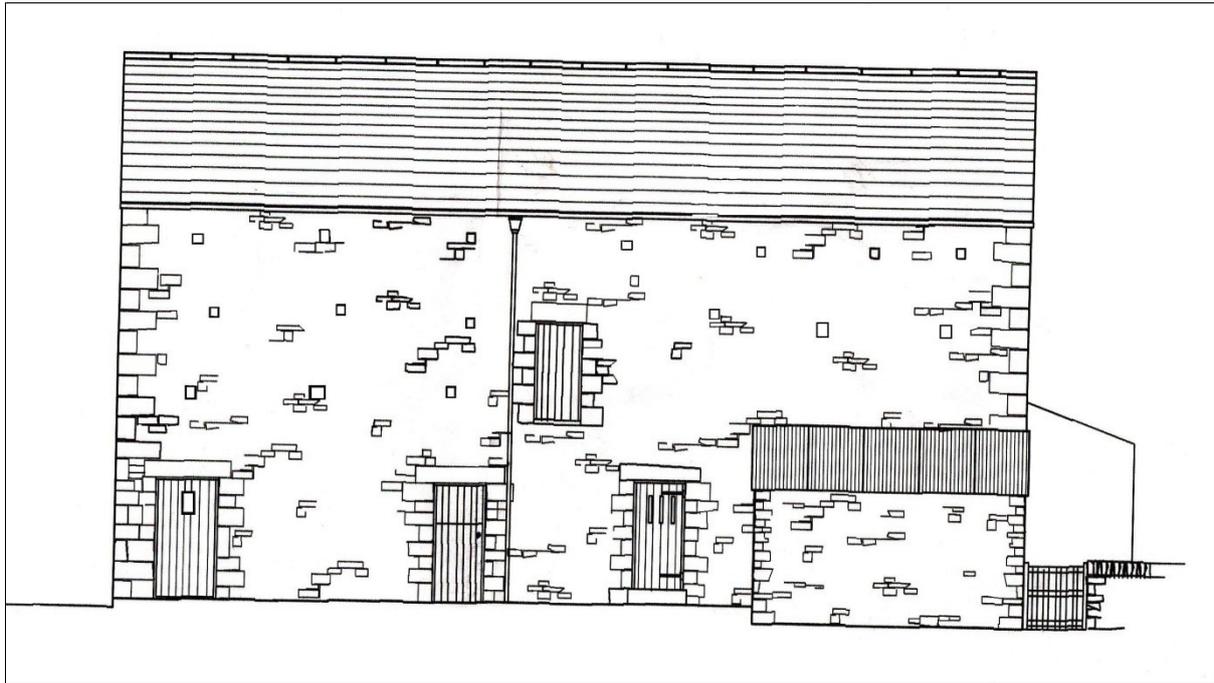
Figure 15. Eastern elevation of bank barn

The eastern elevation measured 15.2m in length and 6.7m in height, elevated a further 2.5m by the roof to a combined height of 9.2m.

It displayed the rear view of the bank barn, where it was entered at ground level. The facade had been left plain in roughly hewn randomly coursed limestone with no architectural embellishments.

The ground floor possessed three doorways that measured from south to north 2.02m x 1.06m, 2.07m x 0.90m and 1.87m x 0.82m in size, respectively. All the thresholds possessed stone lintels and were outlined in red sandstone quoins approximately 0.18m x 0.26m x 0.37m in size and maintained timber plank doors of relatively recent age.

A cattle housing lean-to measuring 4.5m x 3.1m, had been added to the northern end of the bank barn that was not keyed into the main fabric of the building. The structure had a concrete floor and contained two cattle stalls.

This adjunct possessed a non-existent door measuring 1.94m x 0.98m with a timber surround. The building was constructed from roughly hewn limestone, randomly coursed and contained no other apertures or thresholds whilst the roof was constructed from corrugated metal sheet.

The first floor of the eastern elevation displayed a solitary window measuring 1.66m x 0.80m that contained no glass or frame but possessed a stone lintel and was outlined by dressed sandstone quoins.

The elevation possessed sixteen air vents all measuring approximately 0.15m x 0.20m formed at three levels to ventilate the hayloft above. These were in courses of three, six and seven respectively.

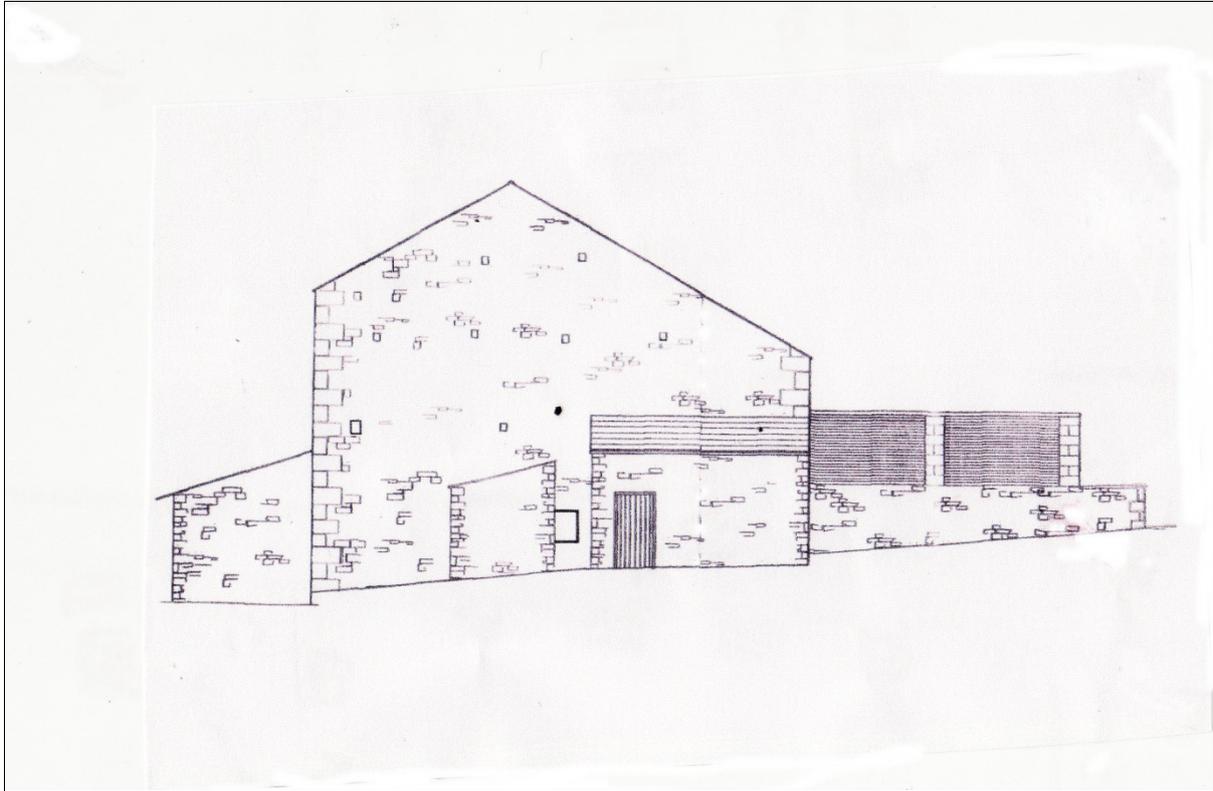
Figure 17. North elevation of bank barn

The northern elevation measured 14m in length and 8.5m in height, elevated a further 2.5m by the roof to a combined height of 11m.

This elevation displayed the side view of the bank barn, where it entered at ground level. The facade had been left plain in roughly hewn randomly coursed limestone with no architectural embellishments except that the corners were constructed from red sandstone quoins (0.60m x 0.36m x 0.18m in size) standing 22 courses high.

The elevation possessed eight air vents all measuring approximately 0.15m x 0.20m formed at three levels to ventilate the hayloft above. These were in courses of two, four and two respectively.

A crude, small, unglazed aperture measuring 0.60m x 0.46m was present behind Store 4.

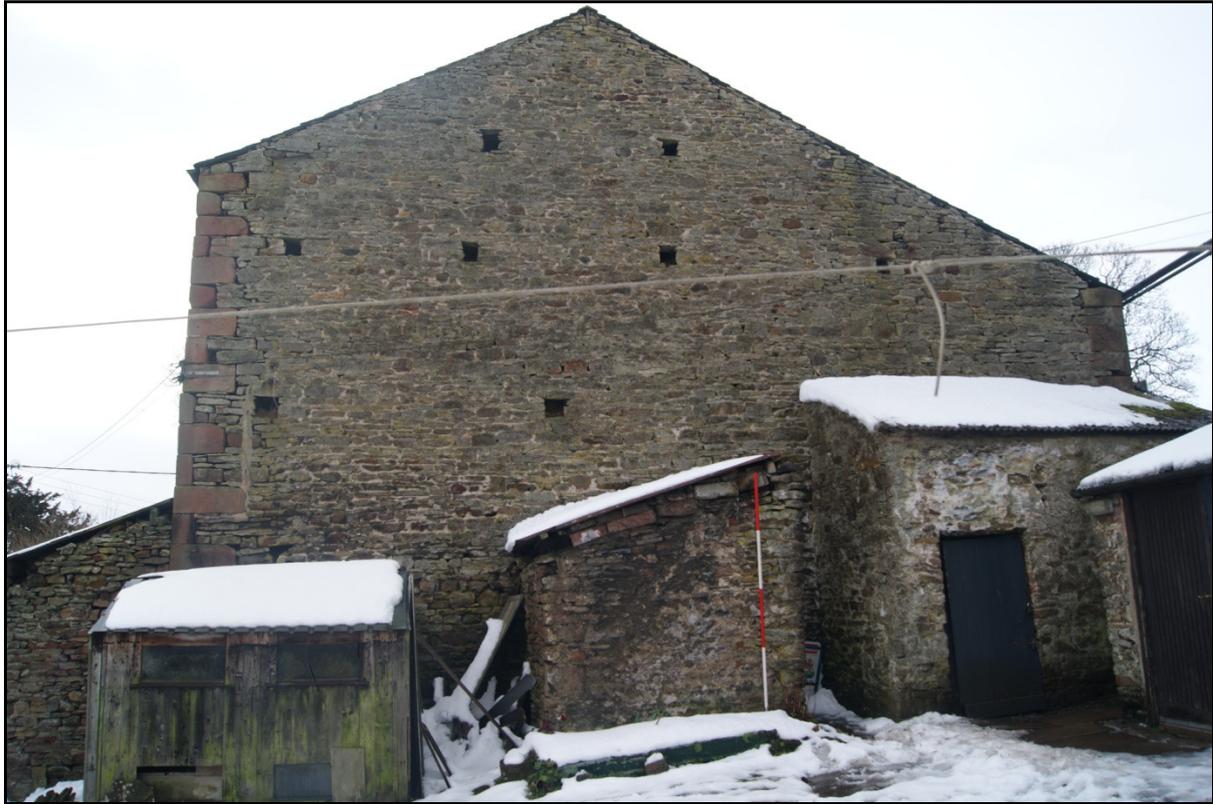
Figure 18. View of north elevation showing stores 1 and 4

Two outbuildings, stores 1 and 4 adjoining the main structure are also illustrated in the elevation.

Store 4 measured 2.3m x 1.8m in area and stood to a height of 2.30m. It was unlight, entered by a timber door from the west and formed a rough hewn, stone lean-to adjacent to the northern elevation.

Store 1 measured 4.3m x 1.8m in area and stood to a height of 4.40m. It possessed two timber doors and formed a rough hewn, stone lean-to adjacent to the northern elevation.

Both stores bore corrugated sheet metal roofs.

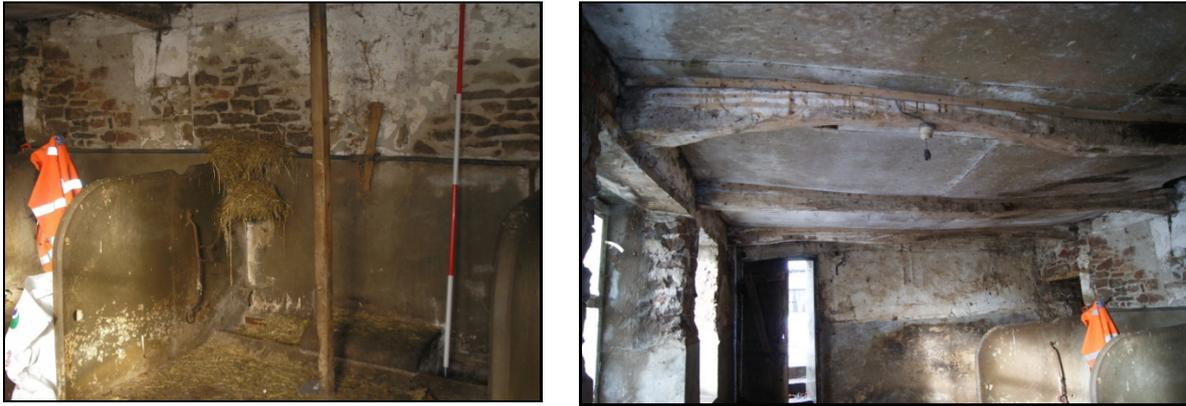
Figures 19 and 20. Stall within the byre and oak beams forming the ceiling

The byre possessed an internal area measuring 7.3m x 4.2m divided into three large stalls each containing two bays accommodating six animals at a time. Each stall was 2.06m in width and had a ceramic trough with feeders provided for eating hay.

The byres' concrete floor was raised with a shallow central gully 0.94m in width provided for "mucking out"

The interior of the byre was finished with a cement render, the eastern wall however was formed from randomly coursed sandstone abutting some existing stone quoins.

The ceiling comprised of four roughly finished oak beams, almost certainly re-used surmounted by a modern asbestos panel floor.

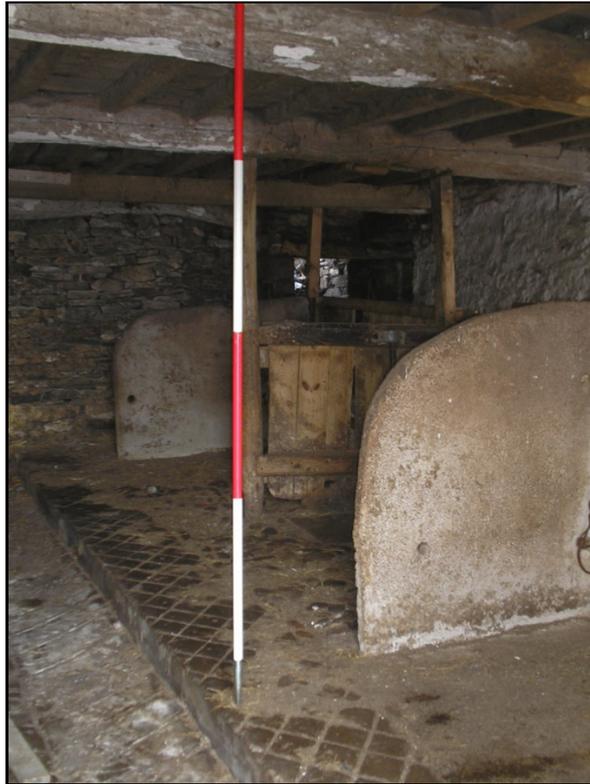
Figures 21. Detail of cattle stall

The interior area that formed the cattle stalls measured 7.3m x 4.4m. The room was accessed via two doors on the eastern side of the room that lead to a central range of four cattle stalls measuring approximately 2.1m x 1.5m divided by concrete partitions. Each stall was located on a raised cobbled floor 0.18m high, accessed by a concrete path 1.15m in width to the south. A narrower path measuring 0.78m in width to the north ran behind the stalls.

The ceiling was supported by three square cut roof beams, handworked, re-used and retaining their bark measuring 0.20m x 0.20m that supported a series of joists 0.08m x 0.09m in size.

The internal rough hewn sandstone walls were finished in lime wash.

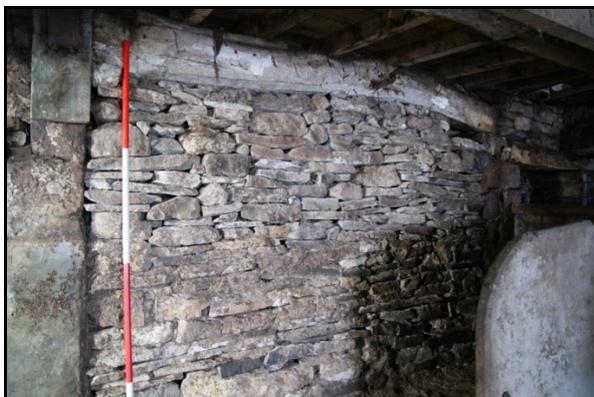
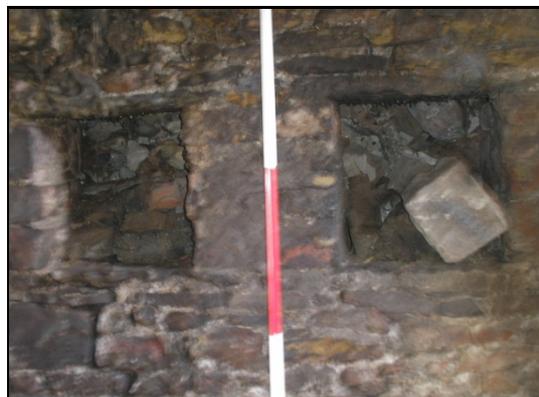
Figure 22 and 23. Filled wall within cattle stalls room and detail of portals in earlier wall.

At the western end of the room, there was evidence for an infilled wall (figure 23). This comprised randomly lain, flat limestone fragments left unmortared that butted a series of dressed red sandstone quoins to the south, smoothed red sandstone blocks just to the north and lay under a timber beam. This action was clearly later than the rest of the building construction and appeared to indicate a room that was now sealed off.

A stone-built room lay adjacent to this filled wall. This structure consisted of smooth stone blocks, randomly coursed but fixed by a white lime mortar (figure 22). The elevation contained two square portals or windows (0.56m x 0.51m) that demonstrated that the void had been backfilled with stone rubble (figure 23).

The only uncertain element within its fabric is the enigmatic blocked room that lies directly beneath the ramp.

As the stones for this room are abutted by the remaining building fabric it would appear probable that this structural element is earlier than the bank barn. The two recesses could be interpreted as windows perhaps suggesting that an earlier modest, stone building had been built into the side of the incline, to be subsumed by the later larger bank barn.

Possibly, this blocked room served as a store when the bank barn was in use, the cool ambient temperature and the constant darkness suitable for storage of root crops and seeds.

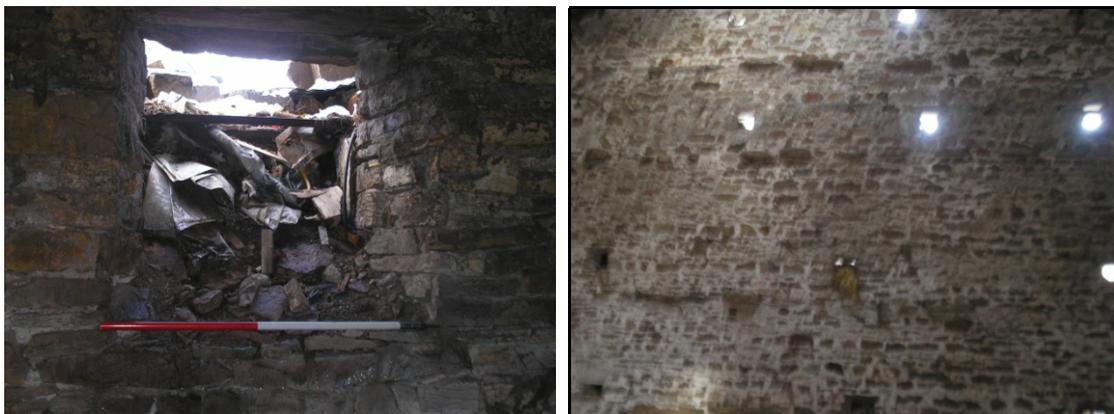
Figures 24 and 25. Chute leading into barn and detail of “throughs” in barn

Within the northern gable end were at least eight vents. The gable also displayed a number of concordant “through” stones reminiscent of the technique employed to build dry-stone walls (figure 26).

A crude chute (figure 24) measuring 1.10m x 1.14m constructed from limestone was evident in the south-west corner of the barn. This may have supplied or serviced the barn or the adjacent filled void described above.

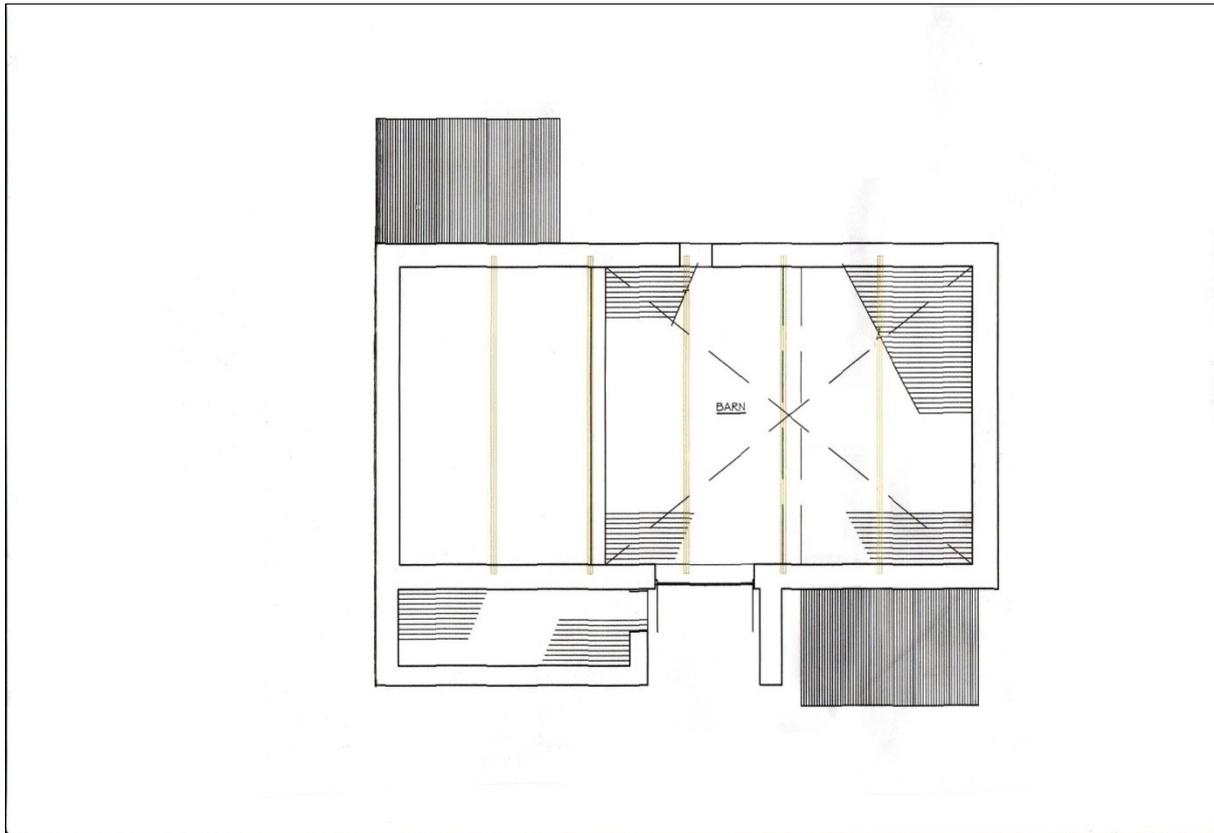
Figure 26. Plan of first floor of bank barn

The first floor comprised of a single room measuring 9m x 7.3m that was entered via a ramp and served as a hayloft. The superstructure comprised rough hewn stone walls, partly lime washed with “throughs” and air vents strategically located (figure 27).

The hayloft was timber decked but with split levels, the southern half being 0.32m higher than the decking towards the north.

A trap door 0.80m x 0.90m provided access to the barn below.

A single window on the eastern wall without frame or glazing and measuring 0.46m x 0.59m was the only source of light apart from a series of air vents on each wall.

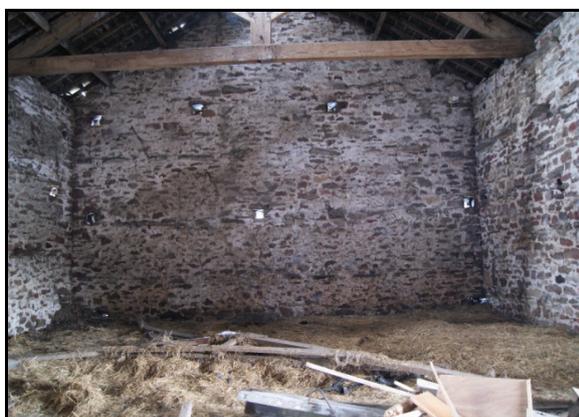
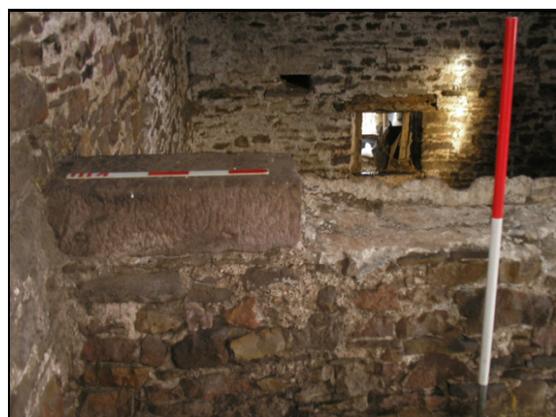
Figures 27 and 28. View of the hayloft looking south and partition wall with stone coping

The northern limit of the hayloft was marked by a low stone wall surmounted by a stone coping (figure 28) that stood to a height of 1.10m and was 0.50m thick.

Forming the roof were five modern, machine-cut roof trusses resting on the shell of the building.

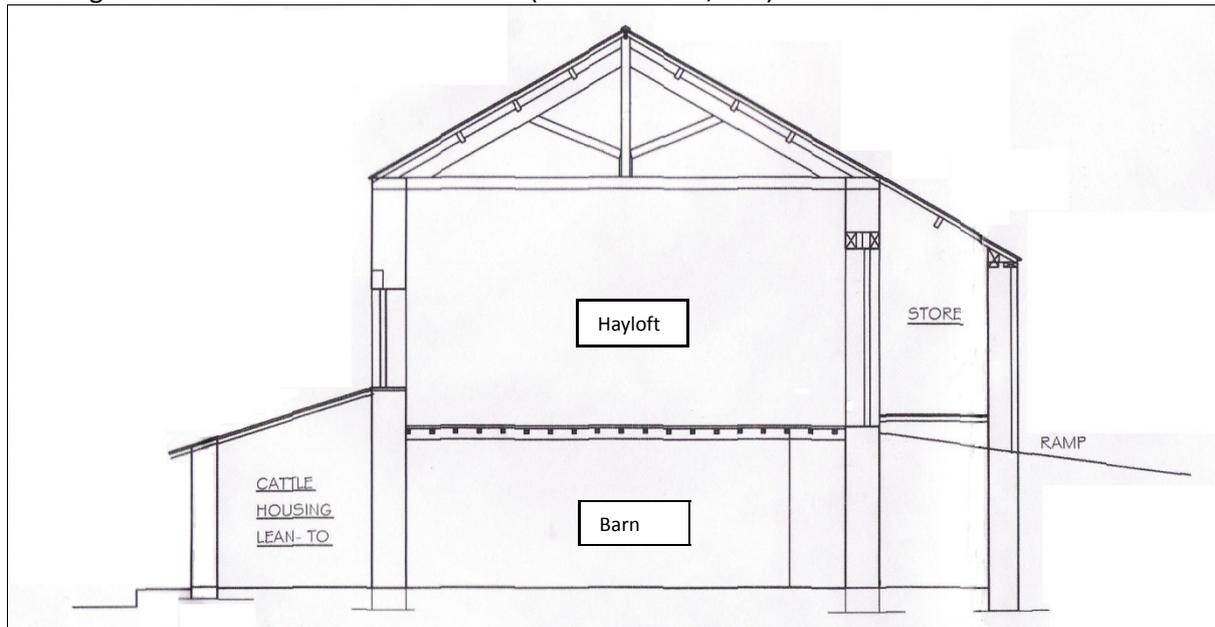
Figure 29. Cross-section through the bank barn

The bank barn at Hill Farm appears to be large for its purpose, ostensibly the collection of hay on the first floor to be fed to livestock in the stalls and winter quarters below (figure 29).
