The watching brief revealed that any putative archaeological deposits had been removed during the footprint insertion when the village hall was built.

English Heritage was consulted by Eden District Council regarding a planning application for remedial works regarding the foundations for the village hall, Maulds Meaburn. English Heritage confirmed that SMC (Scheduled Monument Consent) will be required for work within this site.

Gerry Martin Associates Ltd has been commissioned by Mr Jon Underwood, acting on behalf of the client, to undertake a Programme of Archaeological Watching Brief relating to the ground works for this development.

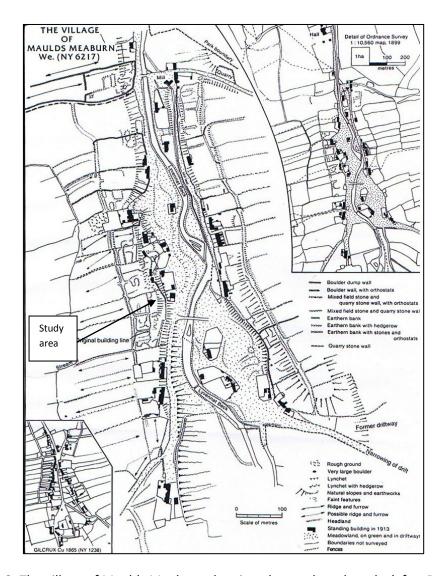
Figure 2. The village of Maulds Meaburn showing plots and earthworks (after Roberts).

Settlement in Maulds Meaburn is illustrated by raised earth platforms or tofts (Figure 2) upon which timber and stone structures were built with probable intervening tracks, streets or cobbled yards demarcating properties. Depending on the level of truncation encountered, structural features such as post-holes may be evident as well as outline features that include eavesdrops and gullies. Buried soils may also indicate the presence of a toft.

Maulds Meaburn is a significant example of a Medieval village and its accompanying agricultural landscape. Bounded by a former back-lane, each narrow allotment was divided ladder-wise into a set of smaller tofts or house plots allowing each tenant family access to the village common land and equal amounts of productive lowland ground that progressively became less productive further from the village centre. On the fringes of the village, the land developed into open moor and common land available to all (figure 2).

Based on detailed examination of the 19<sup>th</sup> Century Ordnance Survey and subsequent field survey, B.K.Roberts identified a long narrow enclosed block of land divided into a series of tofts or house plots. The result of this examination was that the village plan comprised of two long rather narrow compartments of tofts placed on the rising lands to the east and the west of the valley and bounded from the surrounding strip fields by a series of parallel back lanes no longer extant (Roberts 1996, 45-46).

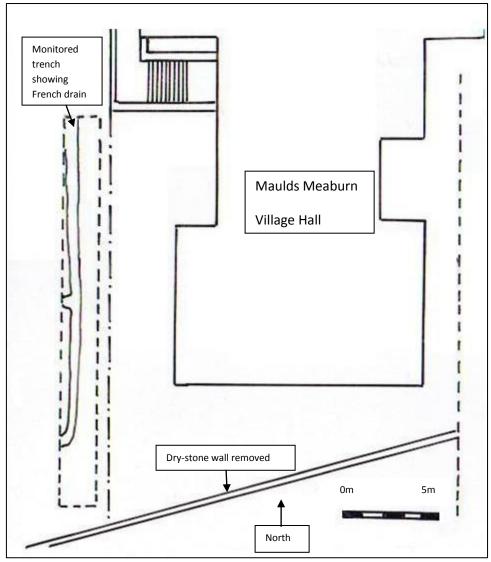
A machine excavated trench aligned north-south (NY 62492 16173 to NY 62494 16192) measuring 20m x 1.80m was inserted between 0.50-1.00m west of a modern dry-stone wall beside the western limit of the village hall to a depth of 0.50m (figure 4). This trench was monitored for archaeological deposits and then released to the contractors.

A single, modern French Drain was encountered (figure 4), up to 0.60m in width and filled with loose modern sub-base with at least three spurs advancing westwards

Figure 4. Site plan with reference to the village hall

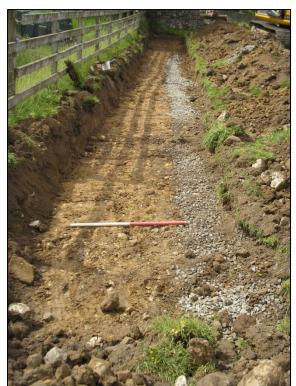
Figure 5. Western trench with french drain

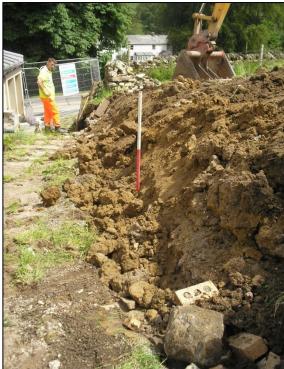
Within the 10m long trench (figure 6) formed from the removal of a dry-stone wall, only clean brown clay was observed that represented natural drift geology.

Figure 6. Removed southern wall

A returning wall at the southern end of the site was removed leaving a 45 degree angle of repose for the new groundworks.
