Cumbria County Council's Historic Environment Service (CCCHES) was consulted by Carlisle City Council regarding a planning application for planning permission for two townhouses at Rickerby Court, Rickerby, Carlisle as requested under Planning Application 1/09/0637

This document describes the results of that archaeological watching brief and its archaeological context within the desk-based assessment.

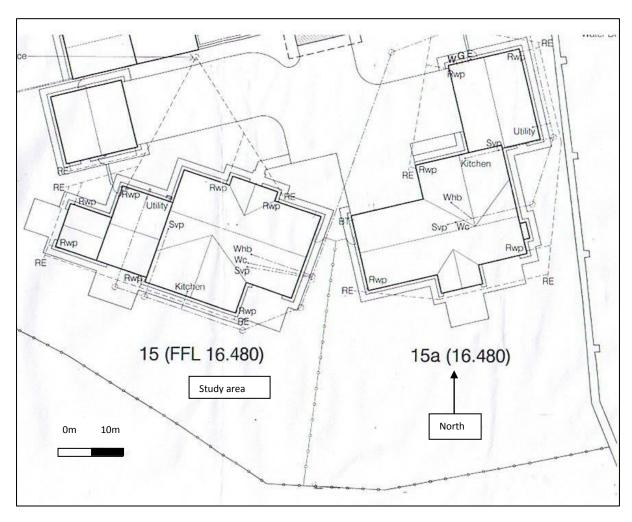
Figure 4. Ground plan regarding the proposed development

The development involves the construction of two townhouses with garages within plots 15 and 15a. Plot 15a was reviewed during excavation in 2002 and does not form part of this study. Plot 15, the study area, involved the excavation of foundations for the townhouse.

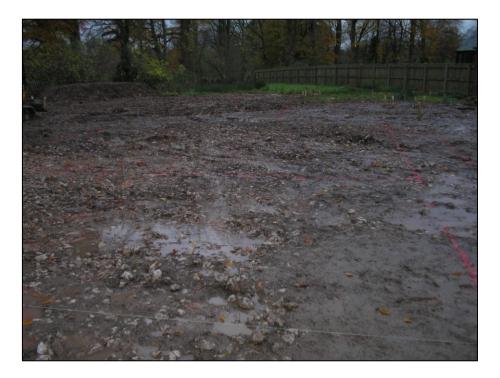
Figure 5. View of the study area prior to excavation

- The study area is located on a marginal area just above the River Eden
- That sub-base material from a previous development was extant indicative of a degree of truncation
- That modern debris and dumps of soil were present following the development in 2002

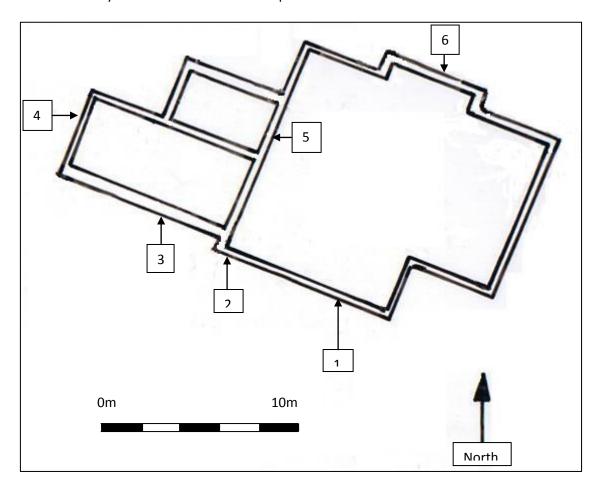
Figure 6. Footprint for the watching brief

Six specific observations were undertaken during the watching brief, none of which were indicative of any cultural antiquity. These were:

- 1. A deep modern intrusion 2.00m in width and 1.10m in depth penetrating 0.70m of made-up ground overlaying 0.40m of brown clay subsoil and resting above 0.20m of pink Boulder Clay
- 2. An observation of 0.20m of made-up ground overlying 0.40m of grey topsoil, sealing 0.40m of brown clay subsoil, capping 0.10m of pink Boulder Clay.
- 3. A large modern intrusion or pit 2.50m in width and 1.30m in depth
- 4. An observation of 0.20m of overburden, sealing 0.30m of dark grey silty clay topsoil with a high concentration of roots above 0.30m of yellow clay and sand
- 5. A large concrete slab on the surface

6. A raft of broken brick 0.30m in depth, overlying 0.30m of dark grey silty clay topsoil above a brown clay subsoil at least 0.30m in depth.

Within the study area, concrete surfaces and dwarf brick walls were present that may be synonymous with sheds or temporary outbuildings.

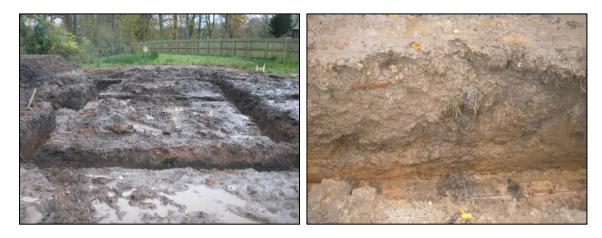
Figure 7. Plan of the excavated footprint

This material suggests that ground was made-up during the early 20th century in order to provide a flat surface. A remnant construction surface (a level of crushed brick and sub-base illustrated in figure 10) survived from the 2002 building phase.

Figure 8. Section in southern trench

Figure 9. Section in the central area

Figure 10. Section in the northern trench

All the sections within the foundation footprint revealed considerable overburden lain during the building programme of 2002 (figures 8-10). In places, this buried dark grey topsoil that overlay a subsoil of sand and clay before sealing glacial Boulder Clay.

Large cutting features were present on the south side of the building footprint necessitating extra concrete being poured but these were of definite 20th century date probably associated with Eden School suggesting this was a marginal area beside the southern limit of the property, land where waste was dumped or stored.

Based on the observations undertaken it appears highly likely that previous truncation had removed any putative archaeological deposits.

No sections revealed cutting features of any antiquity and no unstratified or stratified finds of antiquity were recovered.
