SUMMARY

The Level III building survey at Bluebell House, Dalston recorded a clay dabbins formed from three triangular cruck frames. This action probably occurred during the mid 17th Century to be replaced by a low stone building during the late 17th to early 18th centuries.

Cumbria County Council's Historic Environment Service (CCCHES) was consulted by Carlisle City Council regarding a planning application for the alteration of a single storey cottage adjacent to Bluebell House, Green Lane, Dalston, (NY 38530 49975), Planning Application No. 1/06/1445.

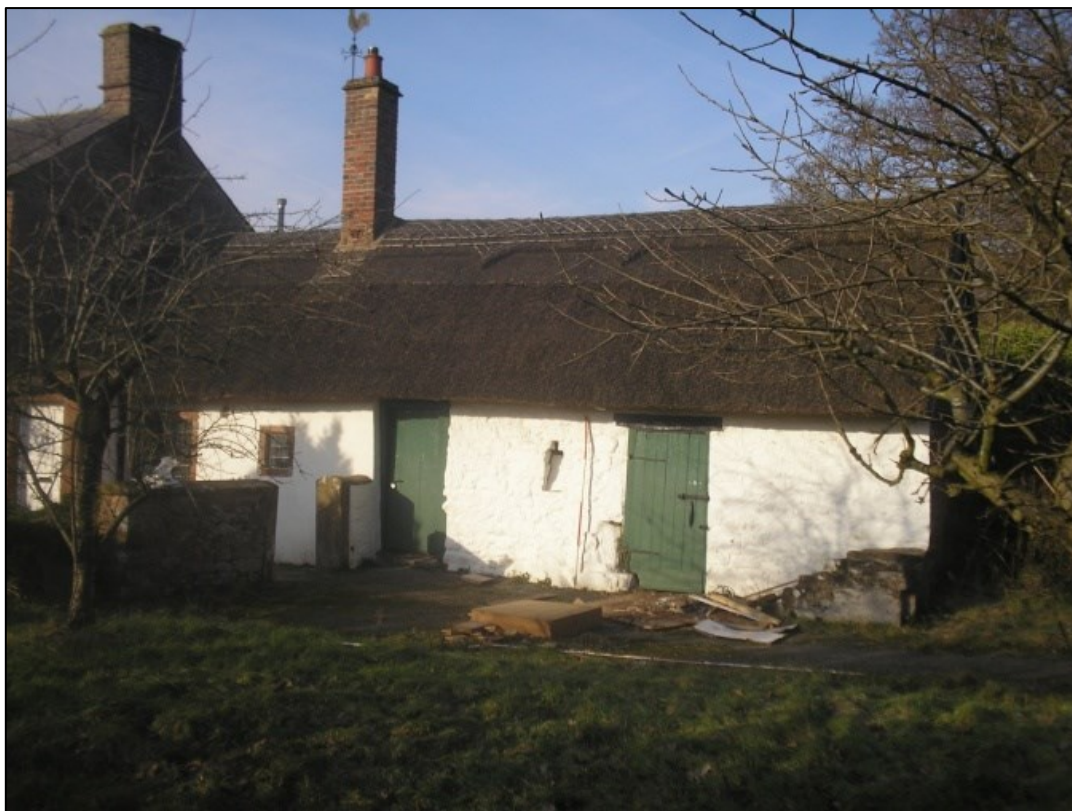
Figure 6. Southern elevation of cottage

The front elevation of the cottage (figure 10) displayed two timber doors measuring 1.80m x 1.00m with timber jambs and lintels. There appeared to be no formal stone jamb, merely that the thresholds had been formalised and dressed. Most probably these thresholds were introduced at a later date, although the doorway at the eastern end of the cottage was an original feature as it corresponded with the stone pathway within the cottage. Early thresholds were normally wooden and it is possible that the original jambs have not survived (Jennings 2003, 110).

Throughout the southern elevation, the cottage was constructed from roughly hewn stone and rubble stone, randomly coursed infilling a cruck frame (figure 7). This stonework replaced an earlier clay dabbins structure that can be observed on the eastern gable elevation (figure 10).

The cruck frame was visible as a timber protrusion standing to a height of 0.90m, resting above a stone padstone comprising of two large, flat stones (figure 9).

A single, small, informal rectangular ventilation slit was visible 0.60m x 0.25m.

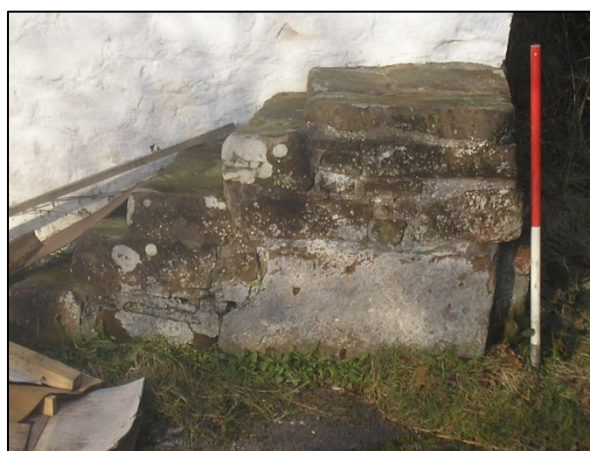
Figure 8. Flight of steps

- A rectangular plan set of stone steps (figure 8) measuring 1.60m x 0.80m x 1.00m consisting of five steps that we used for mounting horses or loading wagons.
- A red sandstone garden wall at right-angles to the cottage, 1.10m in height and 0.40m in width topped with a set of coping stones

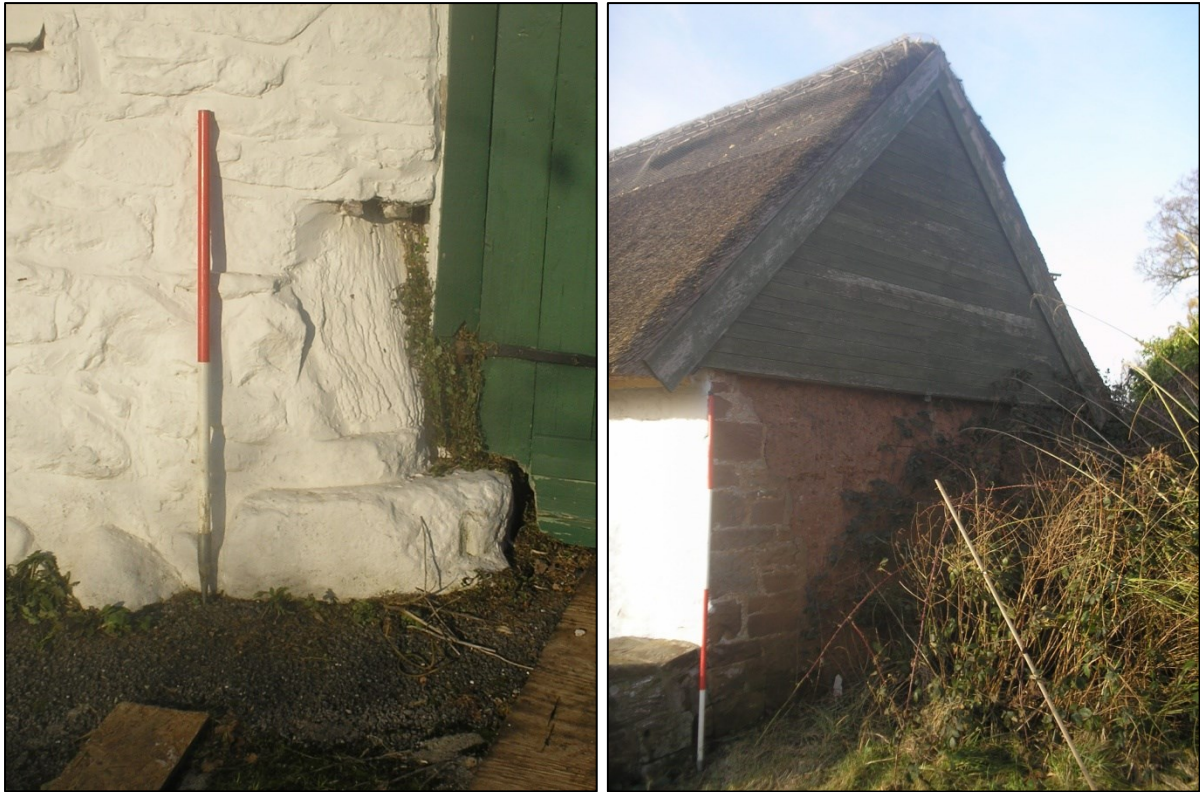
Figure 9. Cruck blade emerging through the wall Figure 10. Clay wall, eastern elevation

Overgrowth prevented access to the eastern elevation but figure 10 illustrates that this wall was of clay construction, verified by observations taken from within the cottage.

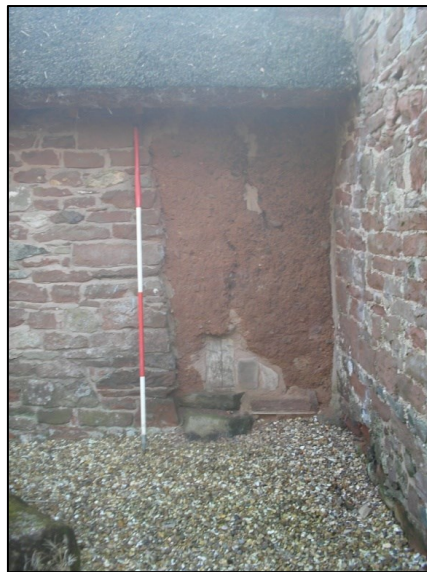
1. The earliest phase of wall was a short stub of clay wall (figure 12) 1.35m in length and standing to a height of 2.20m. This elevation illustrated a protruding timber that formed the cruck blade resting above a stone padstone comprising two flat stones (figure 13). No stone plinth for the clay wall was observed.
2. The eastern end of the elevation displayed a randomly coursed rubble-stone sandstone wall approximately 3.50m in length and 2.20m in height with decaying lime cement.
3. Approximately 4.00m of the central part of the elevation appears to have been rebuilt in randomly coursed roughly hewn red sandstone (figure 14). The elevation has been re-pointed and there appears to be a structural interface strongly suggesting this assertion.

Figure 12. First phase clay wall

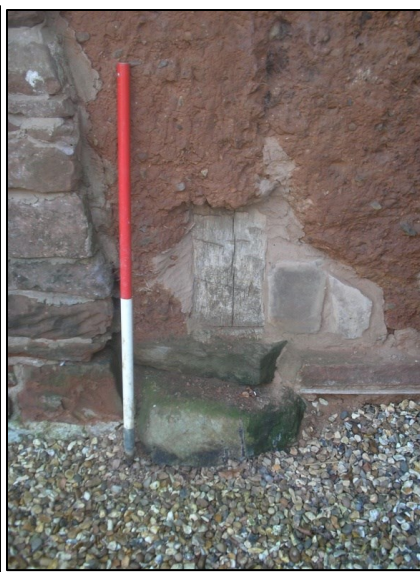
Figure 13. Base of cruck blade detail

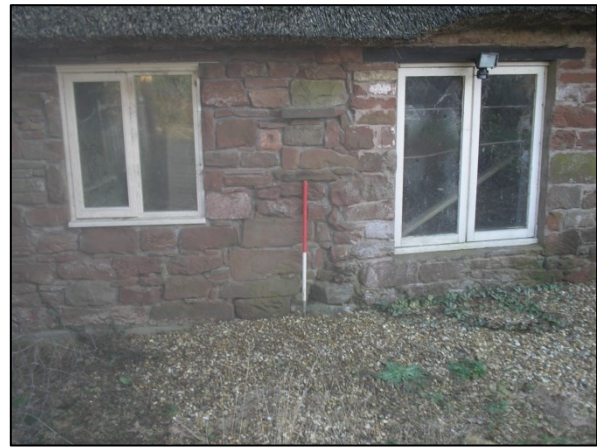
Figure 15. Interface, phase 2 and 3 stonework

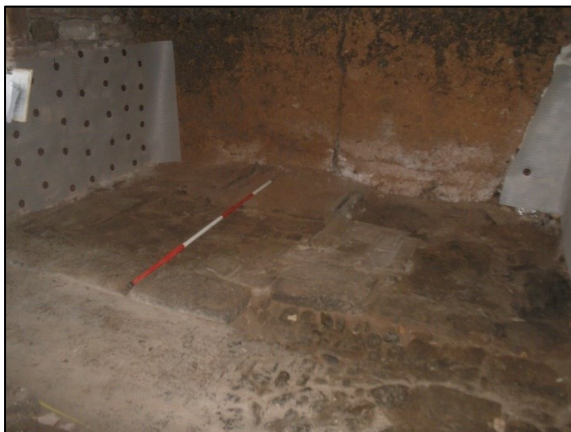
- Flagstone surface (9). This comprised large flagstones often broken and filled with smaller flat stones measuring 3.20m x 1.20m
- Pathway (3) and (10). This comprised of two sets of stone flagstones (10) forming kerbs that arced and narrowed towards the northern side of the room. The path was finished with rounded cobbles forming a concordant surface later overlain by concrete (11). The pathway measure 4.00m in length and between 1.10m and 1.60m in width.
- Cobbled surface (5). This consisted of large rounded cobbles set into the underlying surfaces covering an area approximately 3.90m x 3.80m. A central area approximately 3.60m x 1.60m was shorn of cobbles possibly suggesting that they had been grubbed out.

Figure 17. Flagstone surface (9)

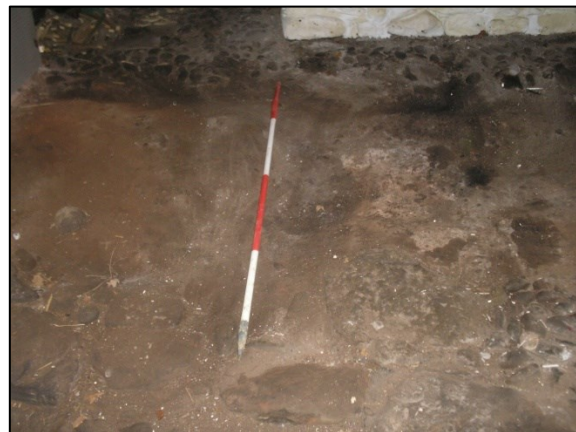
A clean, fine brown clay and silt surface (2) and (6) forming a compacted but rather uneven floor. A second earthen surface (4) overlay surface (6).

Figure 18. Earthen floors (4) and (6)

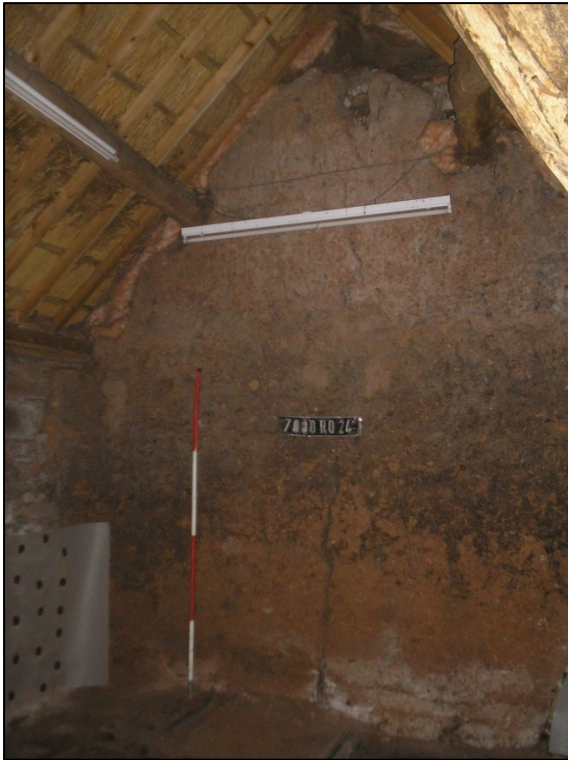
The eastern gable end comprised of a clay wall (figure 19) measuring 3.27m in width and 3.88m in height. It comprised of brown clay formed into blocks and laid in courses. Tufts of straw are visible within the fabric (figure 22). A crack was apparent at the midpoint of the elevation.

Figure 19. Clay wall eastern gable end.

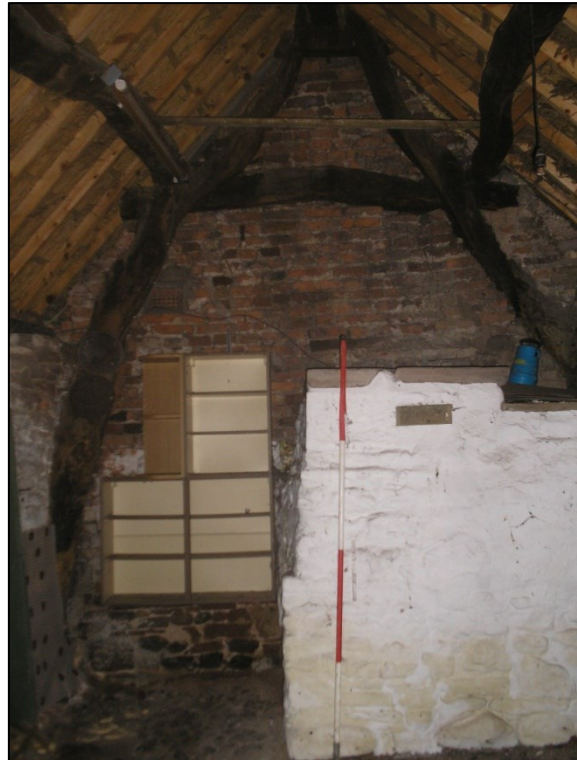
Figure 20. Brick western gable end.

The snug (Room 2) and the cottage (Room 1) were separated by a brick gable end (figure 20) that enclosed a brick oven and respected a cruck truss.

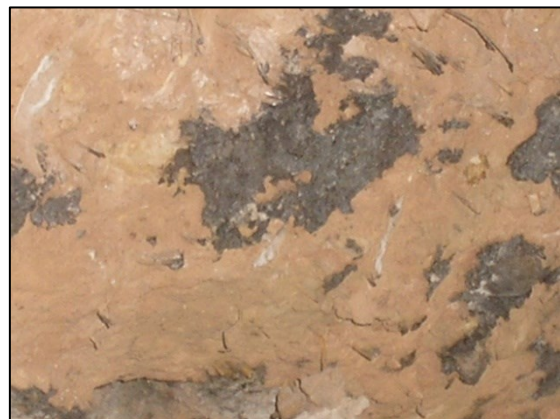
Figure 22. Detail of clay wall fabric

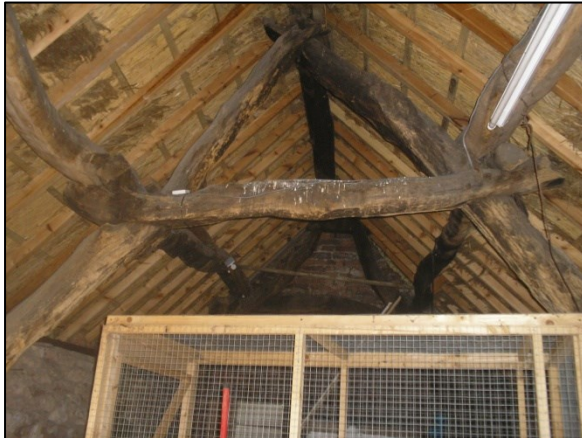
Three timber trusses (one visible in the snug, Room 2) were present at approximately 4.00m intervals.

Figure 24. Eastern roof truss within cottage

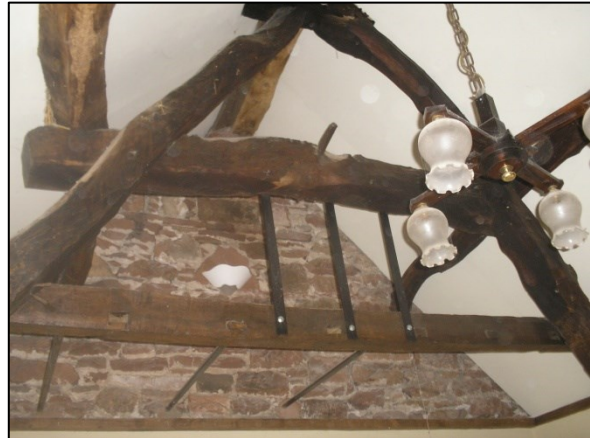
At approximately 2.65-3.00m in height the cruck frame was supported by a horizontal timber tie, bracing the two blades. These connections were secured by wooden dowels. The ledge created by the tie where it passed the blade, supported horizontal timber purlins approximately 0.20m in thickness that carried the roof and its rafters (figure 24). Within the snug, a further tie was applied to the cruck frame (figure 25).

Figure 25. Western roof truss within snug

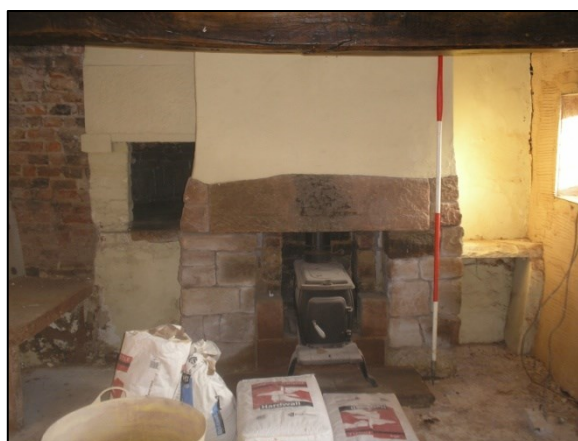
The interior of the snug (figure 27) contained a number of architectural elements described below:

- A brick bread oven that encroached into the ground plan of the cottage (see figure 5)
- A large stone fireplace with brick hood that has probably been considerably remodelled
- A stone bench seat (1.25m x 0.52m) that may be an original feature
- A recently constructed stone bench seat (0.72m x 0.31m) within a small alcove. This alcove will form the internal access into the cottage.

Figure 27. Fireplace, bread oven and bench seat

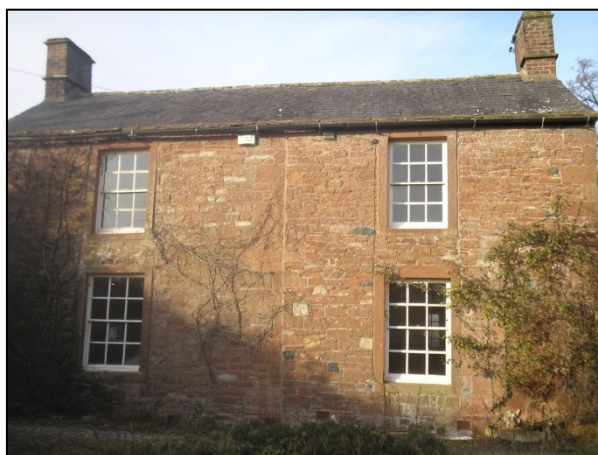
Figure 28. Bluebell House, south elevation

The frontage of Bluebell House (figure 28) although symmetrical has no central doorway, access being via a porch to the side that is a probable late addition, the timber door being a modern reproduction. Access via this route suggests that the original buildings still enjoyed a primary role within the dynamics and operation of the house.
