Four trenches were inserted, their spatial distribution ensuring that any monument approximating to the dimensions of a milefortlet would be encountered.

An archaeological evaluation has been requested by Cumbria County Council Historic Environment Service in order to ascertain whether sensitive past cultural features and deposits may be extant relating to the potential survival of Milefortlet 10. This putative fort formed part of the Roman coastal defences, protecting the Cumbrian coast from Bowness-on-Solway to Ravenglass, a fortification contemporary with Hadrian's Wall.

Gerry Martin has been commissioned by Mr Alf Bennett (the client) to prepare a Specification of Works for a Programme of Archaeological Evaluation Action relating to the redevelopment of land at 158 Skinburness Road, Silloth and following approval by the curatorial authority execute an archaeological evaluation.

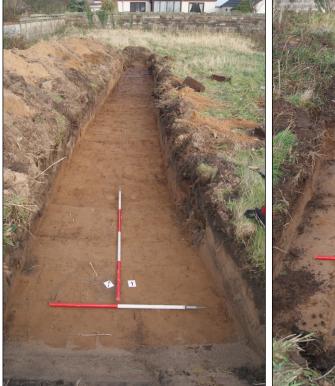
Figure 4. Trench 1

Trench 1 measured 15.00m x 1.80m (figure 4) and was located towards the north-west of the site reduced to a depth of 0.70m.

It consisted of 0.40m in depth of brown silty sand topsoil  $\underline{1}$  containing corrugated asbestos sheet overlying a further 0.20m thickness of loose buff sand, sealing orange sand reduced by 0.10m that develops into pinkish brown sand to the north.

No archaeological features were revealed and the trench appeared to be devoid of any past cultural contact.

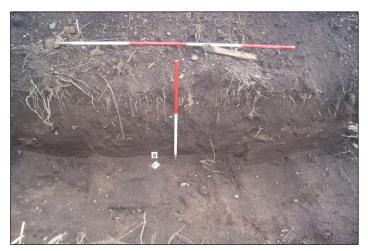
Figure 6. Pit 8 in section, Trench 2

Sealed by the topsoil was a dark brown silty sand  $\underline{7}$  containing modern brick and other building debris within an amorphous plan cut  $\underline{8}$  (figure 6) at least 0.80m in depth that was dug as a borrow pit for gravel around 1989 (Bennett *pers comm.*).

Pit <u>8</u> (Trench 2) was a borrow pit recognised on the surface by extant nettles and brambles, inserted for gravel extraction when the bungalows to the north were constructed during 1989.

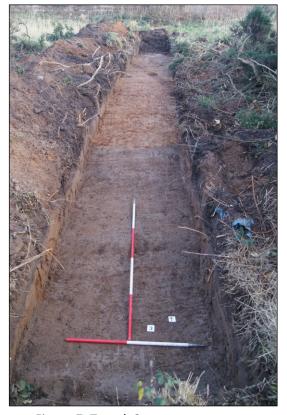
Figure 5. Trench 2

Trench 2 measured 15.00m x 1.80m (figure 5) and was located towards the centre of the site, reduced to a depth of 0.40m except above modern pit 8 which was excavated to a depth of 0.80m.

It consisted of 0.20m in depth of mid brown silty sand topsoil <u>2</u> overlying a further 0.20m thickness of yellow sand that developed into pale yellow gravel and clay strata.

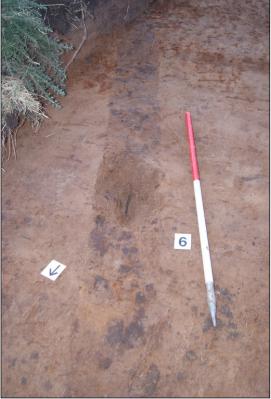
Figure 8. Cable trench <u>6</u> showing cable

Topsoil  $\underline{3}$  covered a south-east to north-west aligned linear cut  $\underline{6}$ , 0.25m in width, filled by mixed lumpy brown silty sand  $\underline{5}$  that bore a modern cable (figure 8).

Cable trench <u>6</u> (Trench 3) carried a live cable.

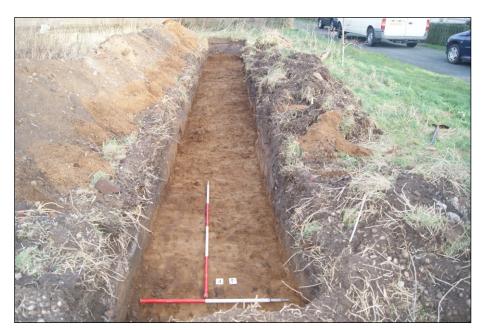
Figure 9. Trench 4

Trench 4 measured 15.00m x 1.80m (figure 6) and was located towards the south-east of the site reduced to a depth of 0.70m.

It consisted of 0.30m in depth of brown slightly silty sand topsoil <u>4</u>, overlying a further 0.10m thickness horizon of pebbles and cobbles, part of a hard-standing surface for the former holiday camp. Further soil was beneath the cobbling to a depth of 0.20m, sealing coarse orange-brown sand.

A concordant pebble spread in Trench 4 contained modern brick and was part of the lay-out for the former holiday camp.
