Roman deposits were found to be extant at the base of an approximately 3.00m deep sewer trench in St Cuthbert's Lane, Carlisle.

1. INTRODUCTION

Cumbria County Council's Historic Environment Service (CCCHES) was consulted by Carlisle City Council regarding renovation of a sewer in St Cuthbert's Lane, Carlisle.

As potential and significant archaeological remains may be encountered, an archaeological watching brief was requested.

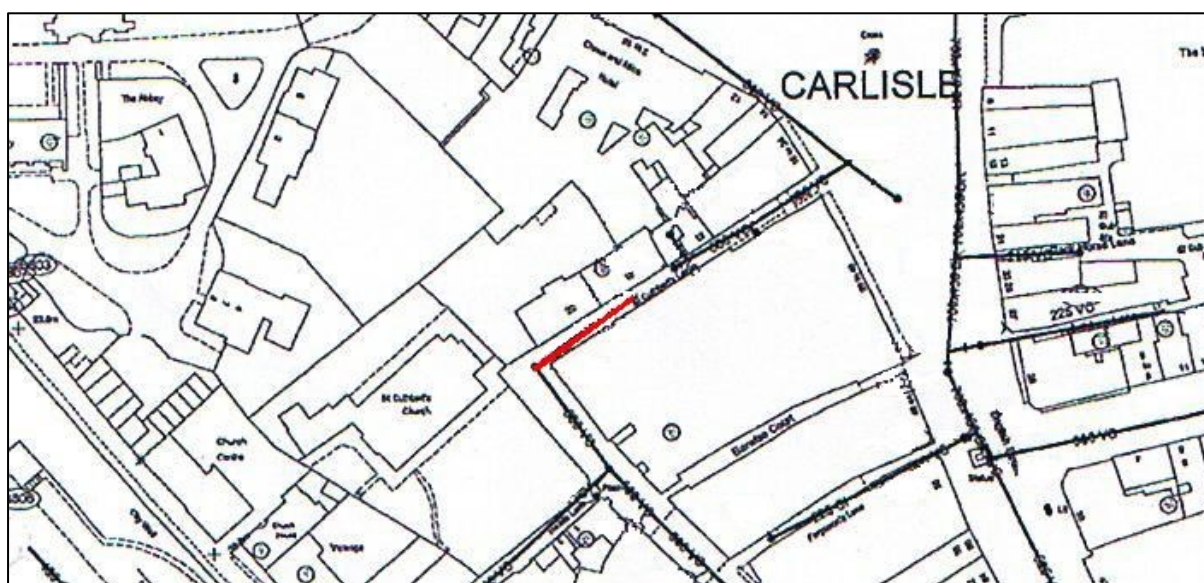
Figure 2. Location of sewer main in red outline

The study area lies (NY 40020 55880) to the north-east of St Cuthbert's Church within a narrow lane that reflects the roughly rectilinear spatial lay-out of the Medieval city (figure 2).

The new sewer links two extant manholes approximately 1.90m north of House of Fraser department store.

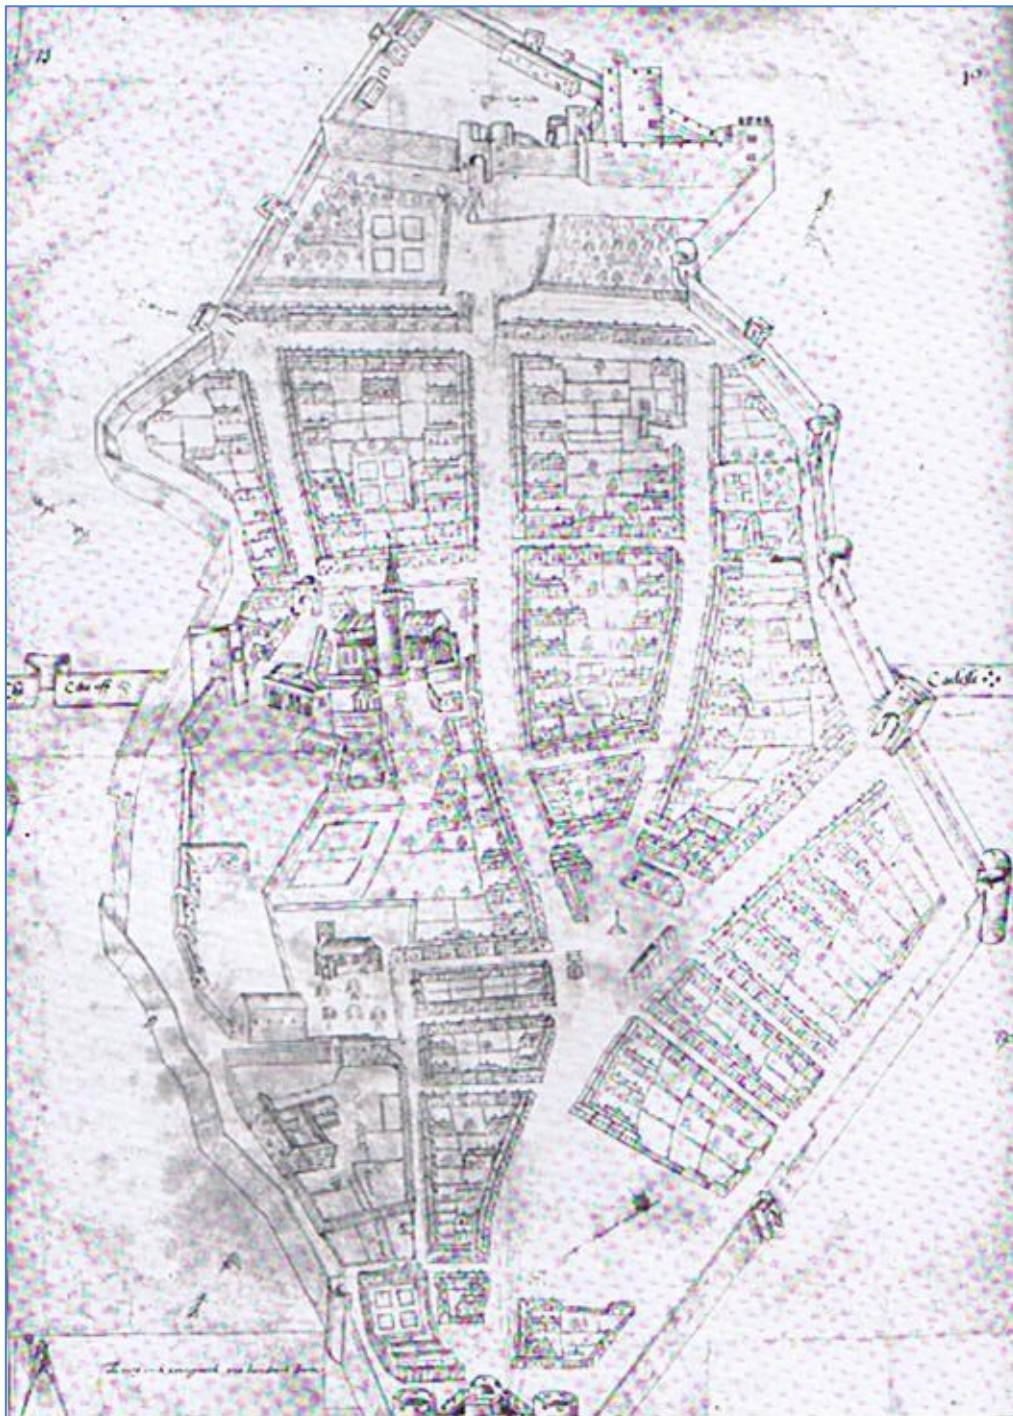
Figure 3. The earliest map of Carlisle circa 1560

The site is mentioned throughout the late Medieval period and has by 1560 developed into an ordered terrace with gardens (figure 3).

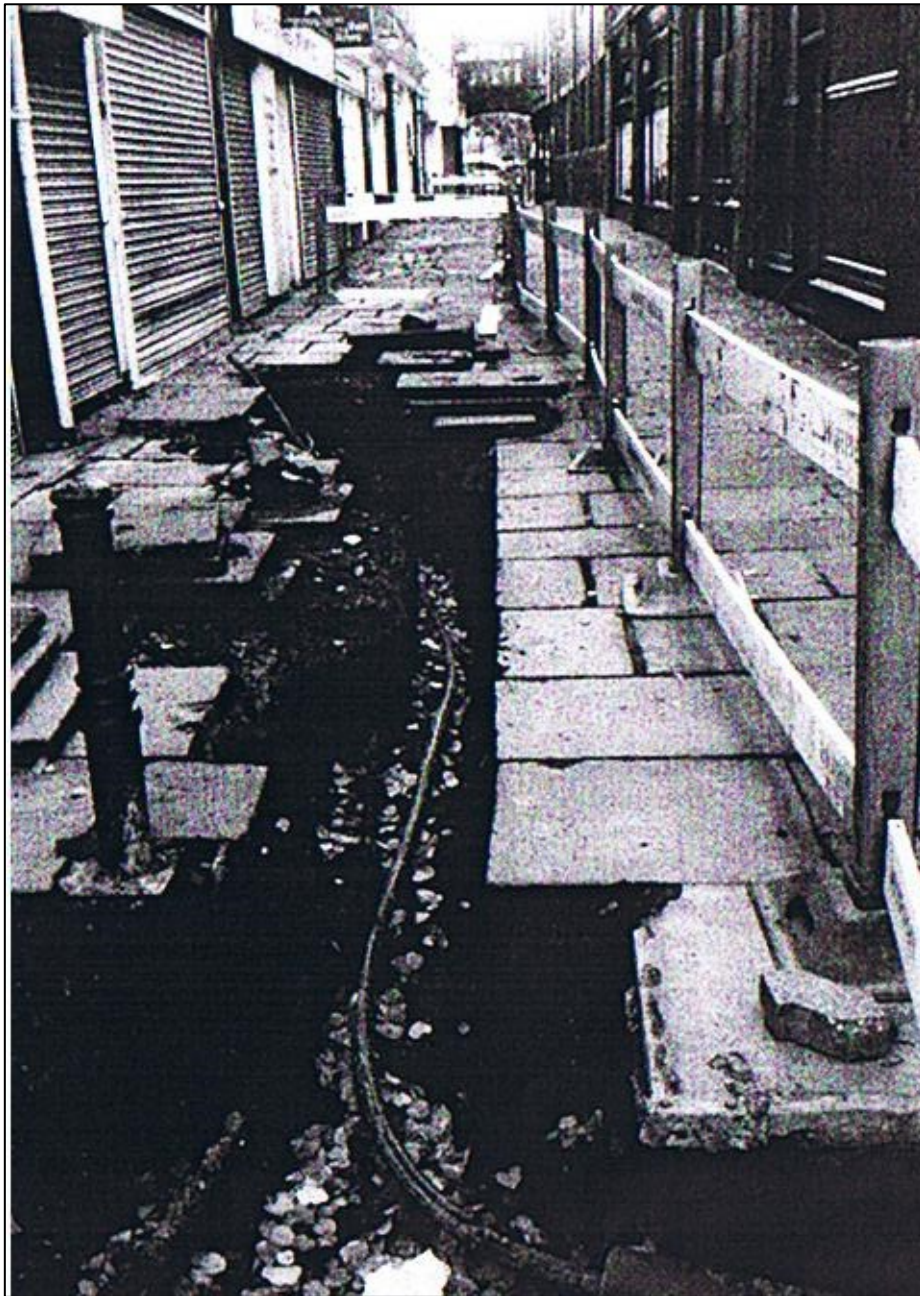
Figure 5. Watching brief when cable laid in 2010

In 2010, a watching brief was conducted in St Cuthbert's Lane when electric cables were inserted (figure 4). These cables remained in the modern overburden and did not compromise any extant archaeological deposits (Beaty *pers comm.*).

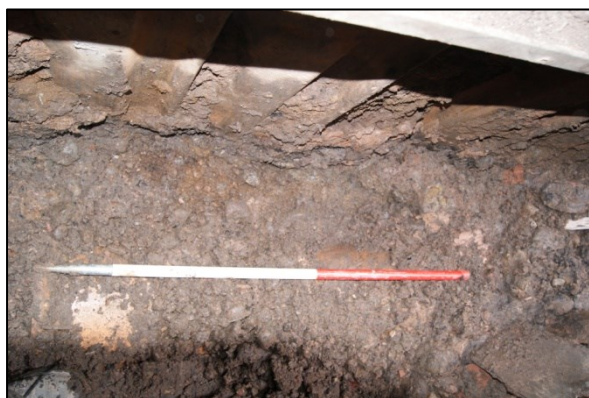
Figure 6. Section 1 cobbled surface

Section 1 measured 2.80m in length, 0.70m in width and was reduced to a depth of 2.60m and began at an existing manhole into which the new sewer main would discharge. The initial 1.20m of ground was formed from modern build-up and gravel.

The base of the trench revealed a cobbled sandy pebbly surface approximately 0.30m in thickness. This horizon was consolidated but not particularly hard overlying clean pink clay forming natural drift geology. The surface comprised rounded pebbles circa 0.10m in size within a greenish yellow coarse sand matrix (figure 6).

Overlying this surface was stiff mixed grey clay containing dark grey organic silt that then became obliterated by the earlier sewer main that was now subject to renewal.

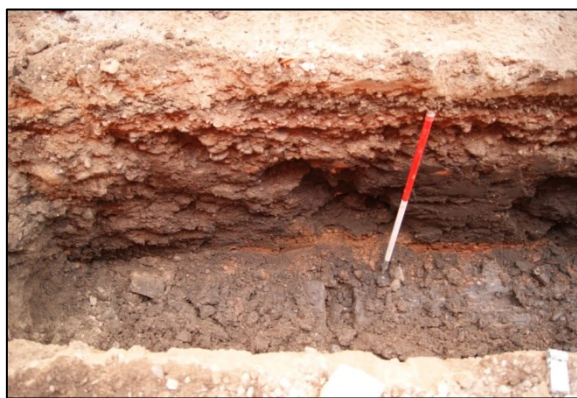
Figure 7. Section 2 Roman stratigraphy

The sheet piles were left approximately 0.60-0.75m above the base of the trench leaving an exposed section revealing the following stratigraphic sequence above pink Boulder Clay drift geology.

The earliest deposit was a concordant tightly packed, compacted green pebbly sand matrix 0.25m in thickness that continued from section 1 that appeared to be a) a road or lane, b) a yard or c) a coarse internal surface such as a stable. This material did not possess extraneous artefacts, probably representing a single act of deposition (figure 7).

Overlying this horizon was a mixed deposit of organic silt 0.30m in thickness but containing thin orange clay micro-laminations approximately 5mm in thickness. This banding may represent occupation deposits but more likely to be crude or casual acts of dumping or *ad hoc* resurfacing.

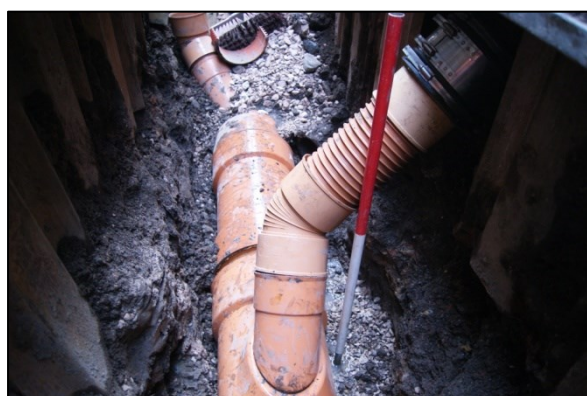
Figure 8. Section 3

Section 3 measured 3.00m in length, 0.70m in width and was reduced to a depth of 2.80m and conjoined section 2 to the east. The initial 0.70m of ground was formed from modern build-up and gravel into which sheet piles were driven and the internal area removed by machine. The trench was subject to flooding compromising the archaeological observation (figure 8).

This section of trench was heavily infiltrated by a series of three feeder drains discharging into the main sewer. The trench appeared to exist within the backfill for the former cut of the sewer, therefore only towards the base were extant archaeological deposits visible.

The earliest part of the archaeological sequence appeared to be a 0.20m thickness band of clay containing Samian pottery.

On the north side of the trench barely visible, was some green pebbly material, possibly a surface or road that was 0.35m in thickness.

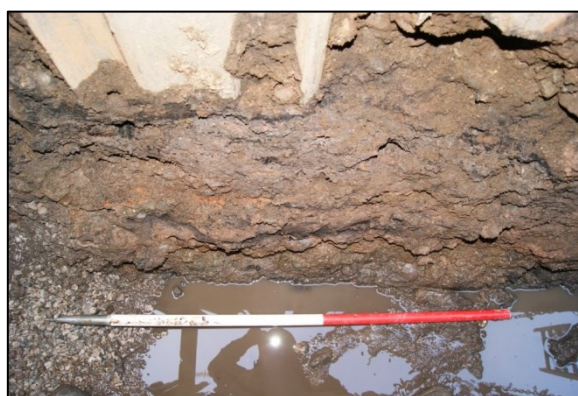
Figure 9. Section 4

Section 4 measured 3.60m in length, 0.70m in width and was reduced to a depth of 2.80m and conjoined section 3 to the east. The initial 0.50m of ground was formed from modern pink clay and gravel into which sheet piles were driven and the internal area removed by machine. Water flowed constantly at the base of the trench compromising the observations.

Whilst natural clay was not observed, the earliest deposit was pink sandy silt that remained unexcavated sealed by a 0.07m thickness of clean grey silt. A thin deposit (0.05m thickness) of charcoal-laden silt with red sandstone flecks lay beneath a band of crushed red sandstone containing coarse yellow sand with white plaster flecks measuring approximately 0.25m in thickness (figure 9). This deposit (0.70m in depth) was sealed by clean dark earth with yellow sandstone to the west and pink sandstone to the east.

At the base of the trench was black humic clay that may represent discharge from the former main rather than a cultural deposit.

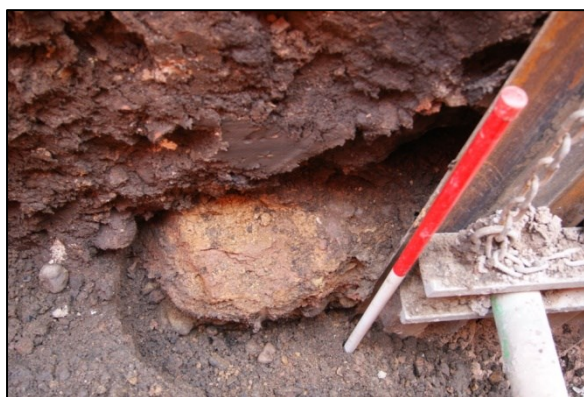
Figure 10. Section 5

At the eastern end, remnant Roman stratigraphy 0.80m in length appeared to exist. This comprised of a lens of compacted pebbles and yellow sand overlain by pink or maroon sandy clay 0.20m in thickness, beneath a clean yellow sand 0.07m in thickness covered by a thin stony surface 0.05m in thickness (figure 10).

This short length of stratigraphy was cut 12.60m from the eastern manhole by a large intrusion filled by clean silt that may be a large pit or foundation trench.

A wall 14.50m from the eastern manhole consisted of red sandstone shingles tightly packed with clay mortar and a rubble core over 0.50m in width. This wall penetrated pink clay (natural drift

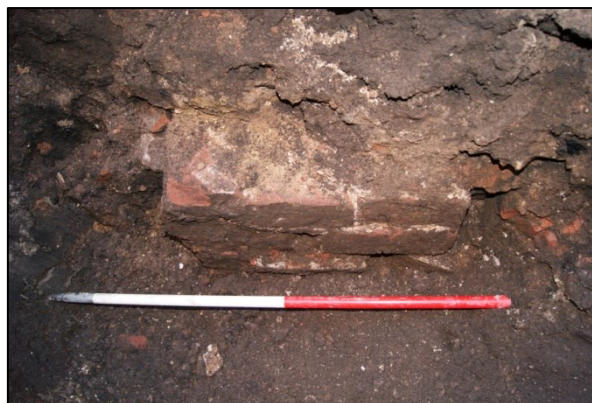
Figure 11. Section 6, manhole

The trench was truncated on both sides by a former sewer trench and a BT cable duct leaving a small slither of archaeological stratigraphy 0.15m in width.

On the south side of the trench 16.70m from the eastern manhole, there existed a stone manhole comprising a sandstone base 0.95m in width surmounted by mortared sandstone blocks forming a chamber 0.45m in width (figure 11).

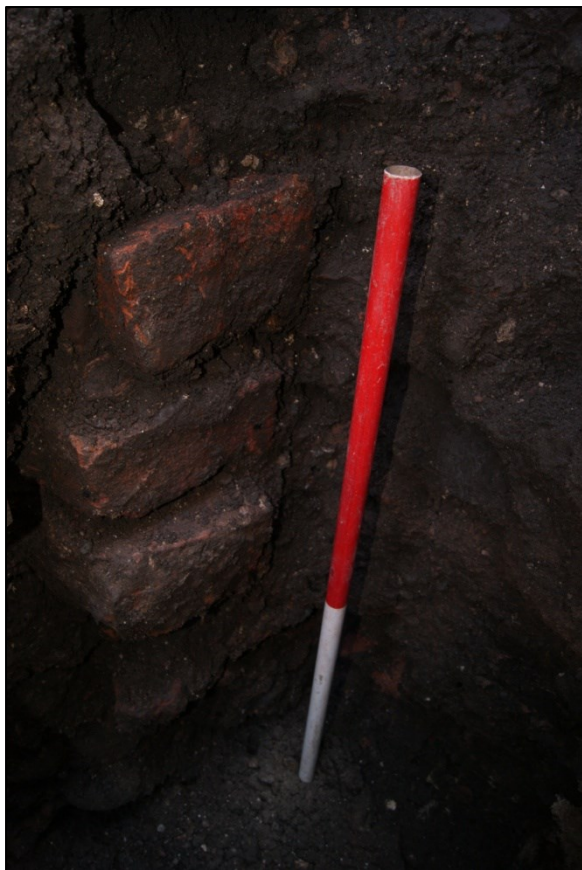
Figure 12. Section 7

For a depth of 1.00m below the overburden was a stone and brick wall of probable 18th or 19th century date the rest of the trench being heavily disturbed by relatively modern intrusive action (Figure 12).

At the base of the trench a heavily mixed "Roman" level was probably extant but it was not possible to isolate the elements apart from a generic description of pink clay mixed with charcoal.

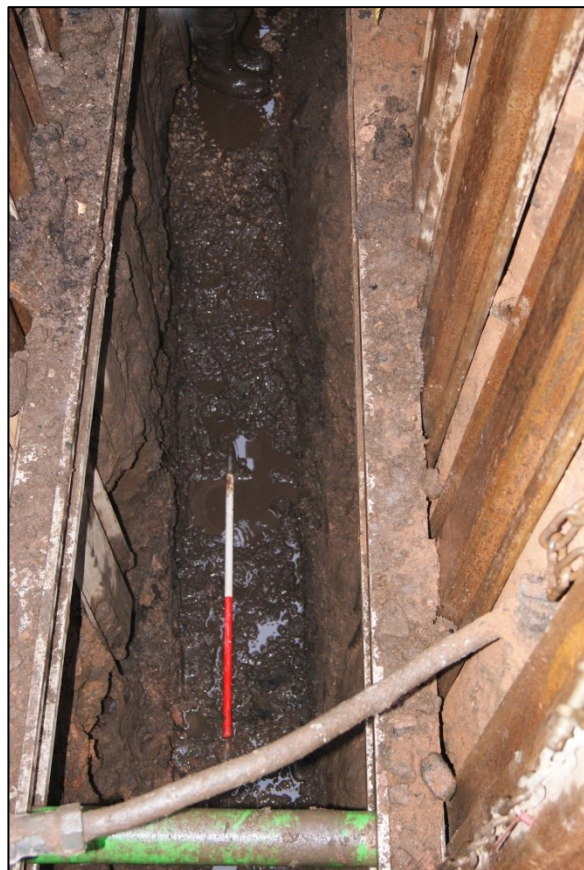
Figure 13. Section 9

The ground was heavily disturbed with water pipes and an electric cable traversing the trench.

The base of the trench comprised of clay (probably natural) and some cobbles mixed into the clay. It was not possible to enter the trench due to considerable toxic seepage from the sewer pipe (figure 13).

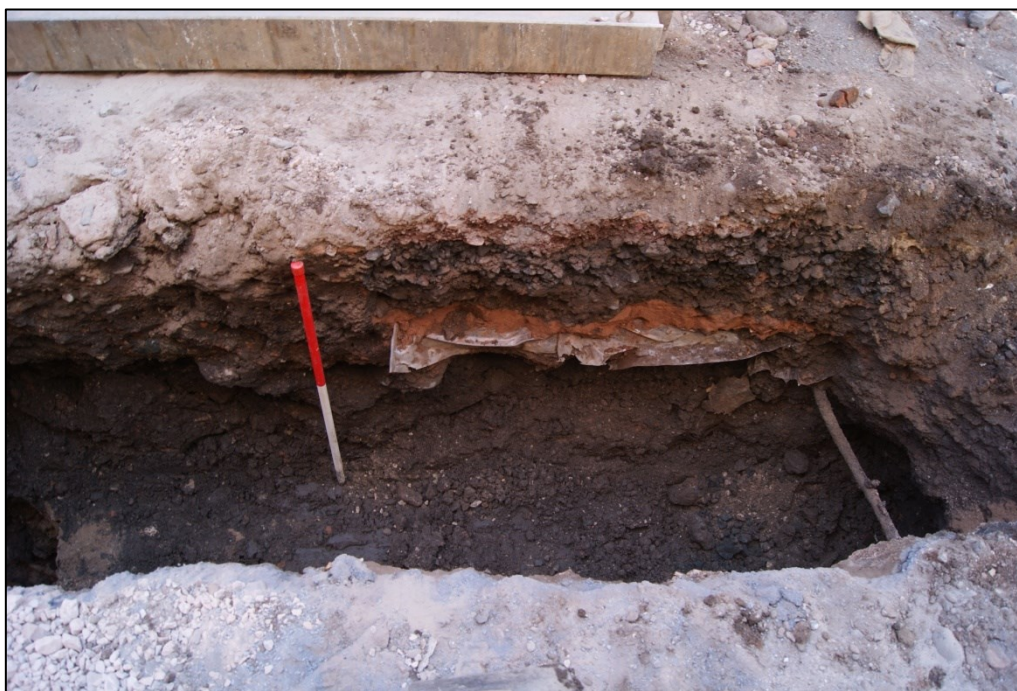
Figure 14. Section 8

The trench displayed dark grey silt to each side, gas and electricity trenches and a salt glazed pipe trench leading to the manhole in Section 7.

At the base of the trench was greenish brown clayey silt containing tiny fragments of twigs and decayed wood, overlying organic dark grey silt with charcoal (figure 14). This may represent seepage from the various pipe trenches.
