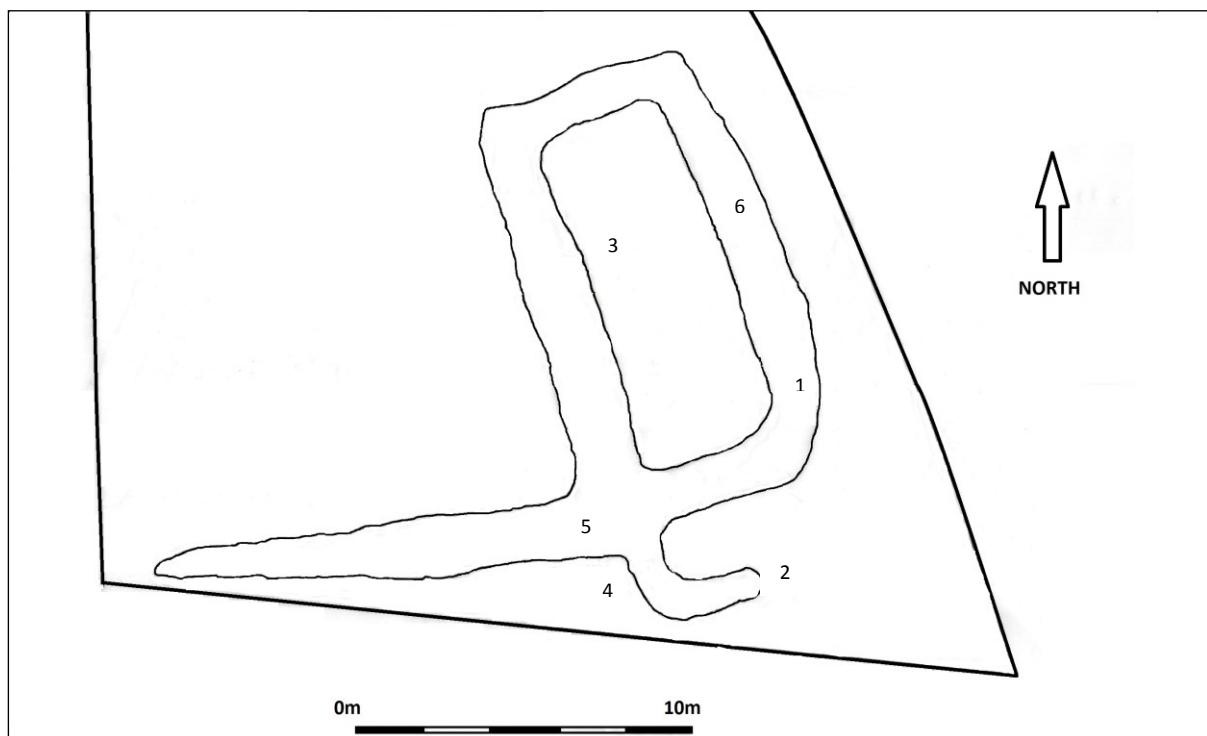
Figure 5. Ground plan of the extant blackhouse prior to removal

The first archaeological operation conducted was to answer a series of questions arising from the standing building survey (figure 5).

1. The eastern limb of the southern wall was cleaned in order to observe whether a doorway existed in the south-eastern corner of the building. The internal face was seen to be roughly faced consistent with a later breach in the wall (figure 6).
2. There was no return on the southern annex wall indicating either a doorway or open space that probably served as a cart shed or store (figure 7).

3. An internal buttress was not keyed into the western wall and was therefore a later support for the roof or to staunch a bowing wall (figure 8).
4. The stone southern annex was a later addition butting the blackhouse.
5. A coarse rubble-stone wall butted the main building and was a later addition.
6. Larger stones were used on the eastern exposed wall where it was subject to driving rain (figure 9). Smaller stones were used on the internal faces probably to negate draughts caused through small cracks.

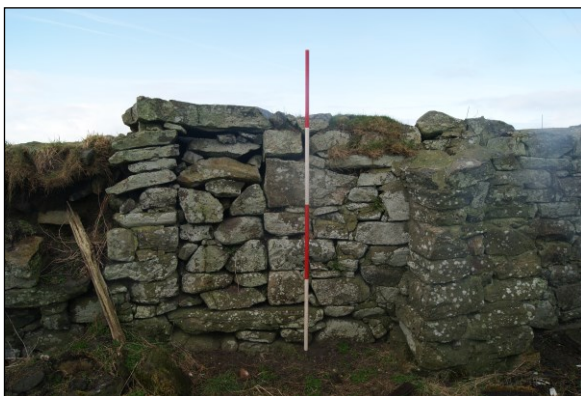
Figure 8. Buttress with blocked door

A rear blocked doorway was reduced (figure 8) confirming that this was a rear entrance leading to a back garden. Soil and other discarded material built up beside the western wall establishing a ground level almost as high as the wall head (figure 11).

Original doorways were formed from larger roughly shaped stones to form crude quoins (figures 9 and 11) with stone lintels. The rear door had a small step (figure 8) leading from the chamber but no formal threshold remained or existed for the front door (figure 9).

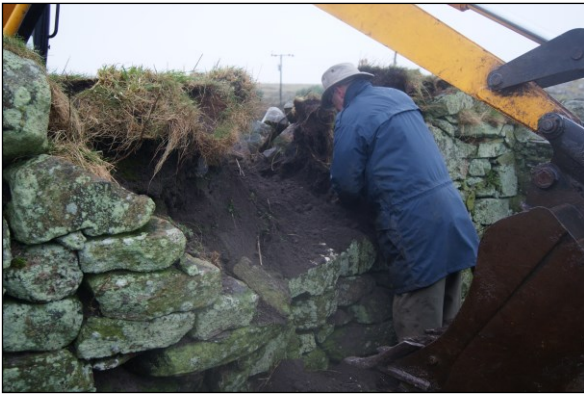
Figure 10. Reduction of stone by hand

The second operation was the hand reduction of the existing stonework (figure 10).

This process revealed that larger stones were used on the facing side of any exposed wall with smaller stones employed on the internal faces.

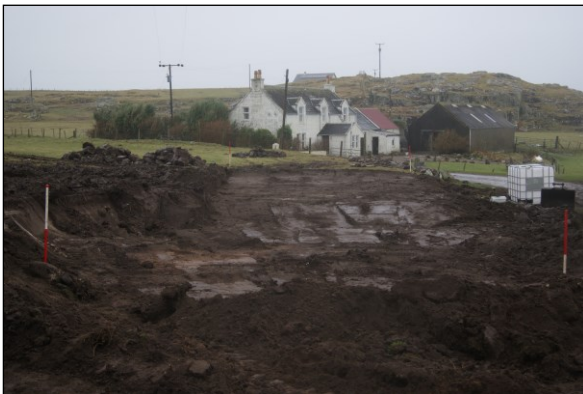
Figure 12. The site following building removal

After three days, the walls were reduced to ground level where it was clear that no foundations existed (figure 12)

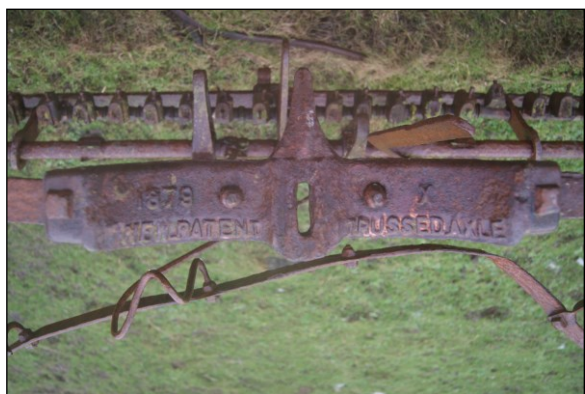
Figure 13. Agricultural equipment dated 1879

No dating or diagnostic evidence was recovered from the core of the wall that may have suggested a date for construction. Circumstantial evidence from nearby unsecure contexts included farm machinery built in 1879 (figure 13), an undated but hand-made glass float with an anchor motif recovered from behind the western wall (figure 14), a circular stone disc with a central hole (figure 15) formed from a slab (toilet seat?) and occasional fragments of rusty iron, the remains of former tools and part of a cast iron range.

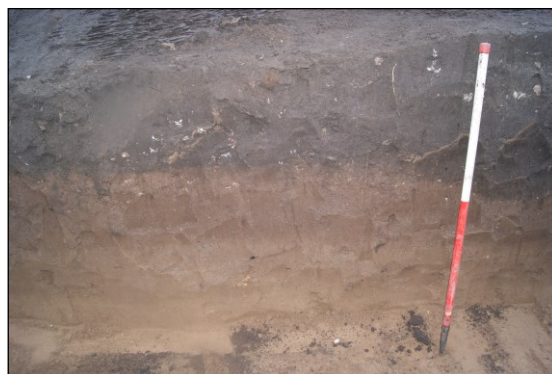
Figure 16. Soil profile towards the west

Natural drift geology consisted of clean light brown sand (figure 16). Overlying this horizon were spreads of occasional crushed shell. Shallow and nebulous deposits of dark brown earth (sandy silt) were also prevalent. These contexts were non-cultural, the result of processes associated with dune formation and shifting sand, geo-morphological conditions that can accrue over a short period of time (figure 16).

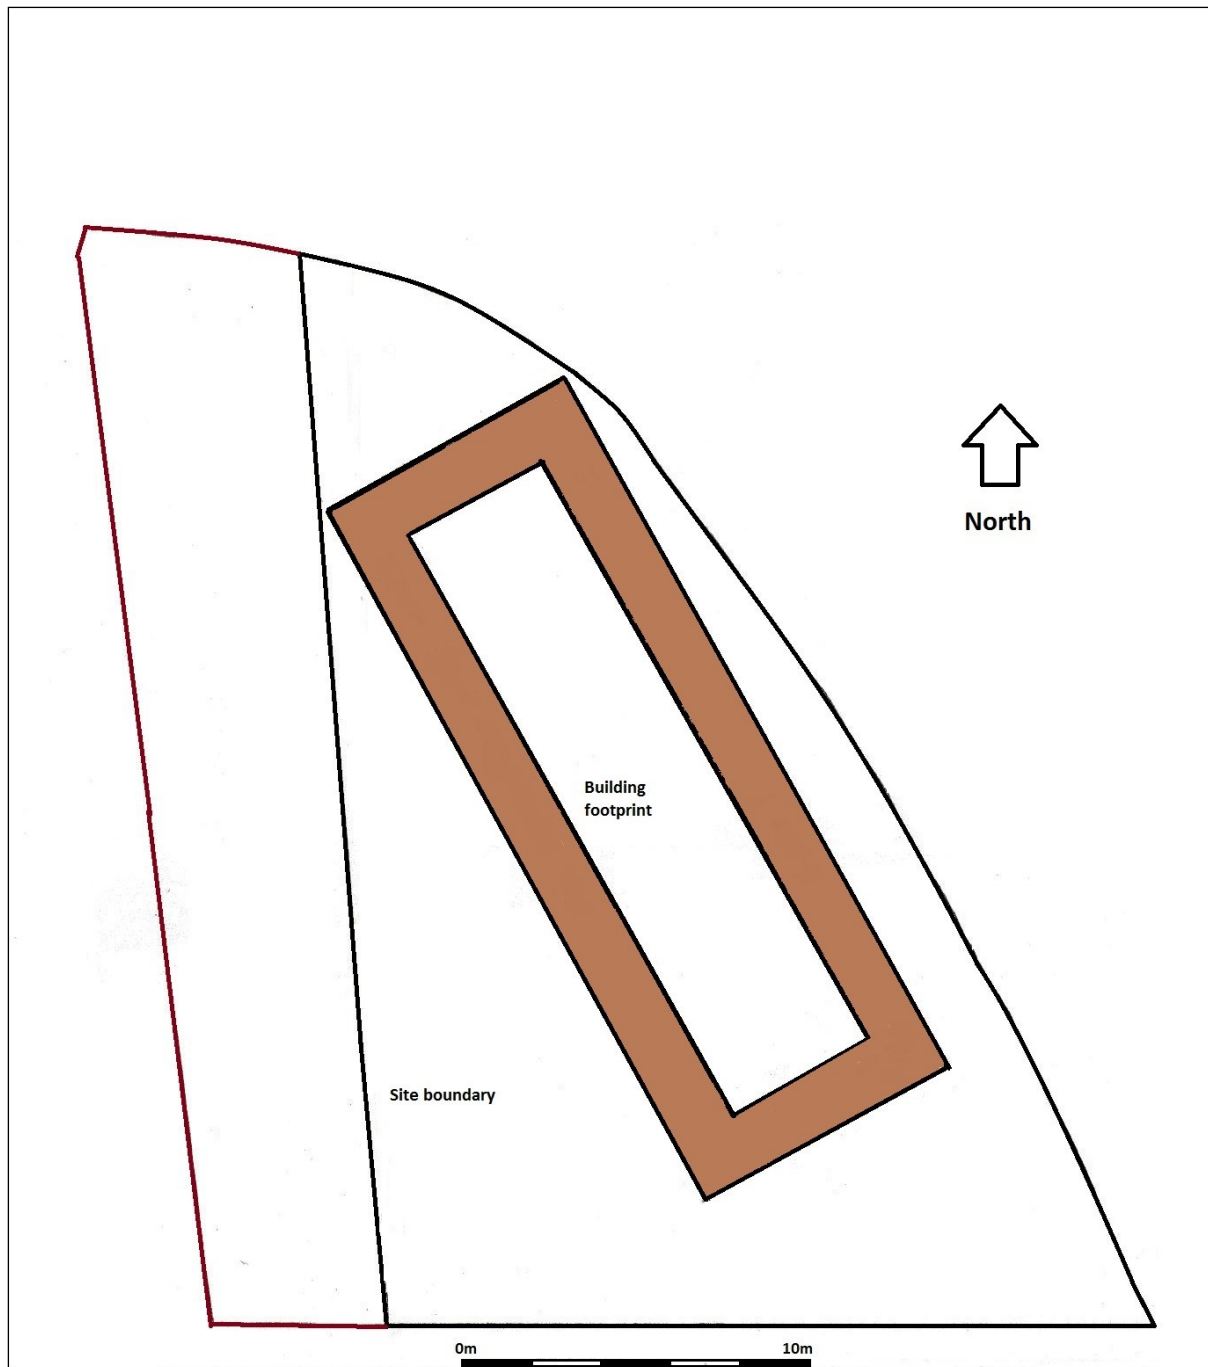
Figure 17. Plan of finished footprint

The fourth operation involved the insertion of foundation trenches for the footings. These footings measured 1.70m in width and up to 0.90m in thickness forming a rectangle 22.80m x 7.87m (figure 17). The footings penetrated what was observed to be archaeologically sterile ground (figure 18). As there existed a remote possibility of encountering prehistoric deposits such as middens, buried below shifting sands and dunes, a watching brief was maintained.

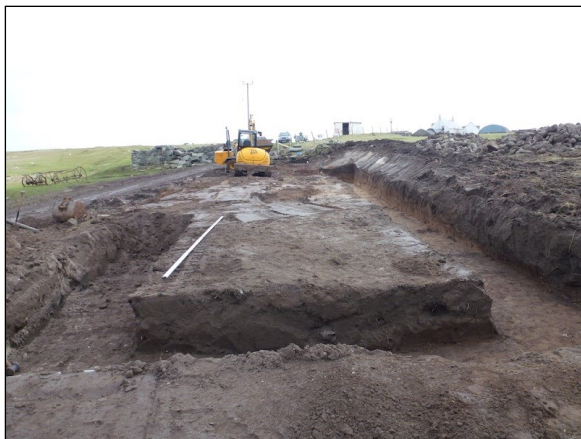
Figure 19. Northern footing

The northern footing traversed a modern water pipe requiring re-routing of the pipe (figure 19).

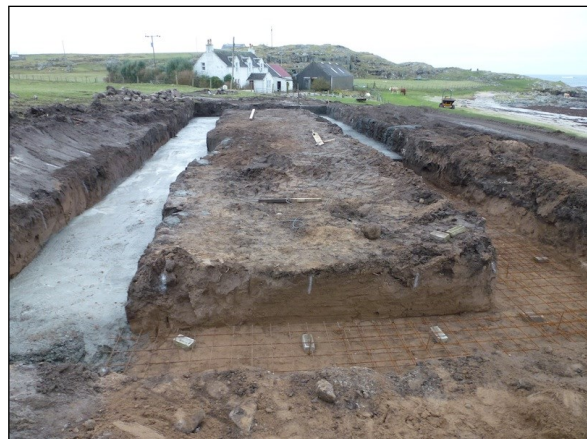
Figure 20. Footprint fully excavated

No archaeological deposits pre-dating the building were encountered (figure 20).
