Northern Gas Networks

Eastgate, Hexham

Archaeological Watching Brief Report

P190395

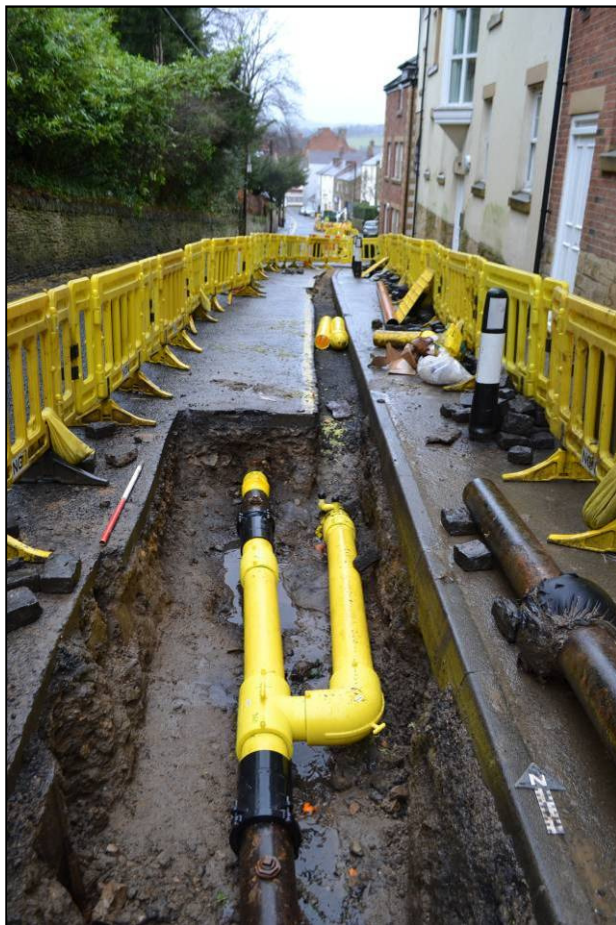
Figure 2 - Excavations in Eastgate

Eastgate is a narrow road bordered by dwellings to the east and a steep bank to the west. The eastern carriageway required partial closure as the work proceeded. At the junction of Eastgate and Cattle Market, the road was closed for a short period of time during February 2014 (Figure 2).

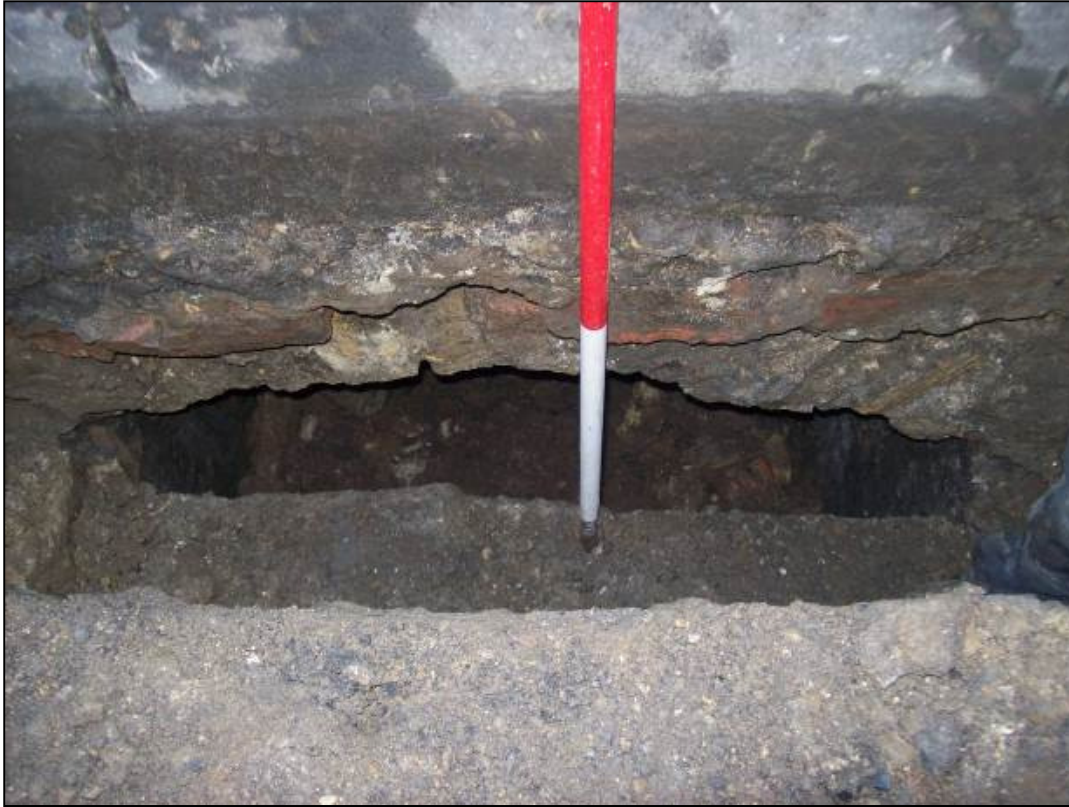
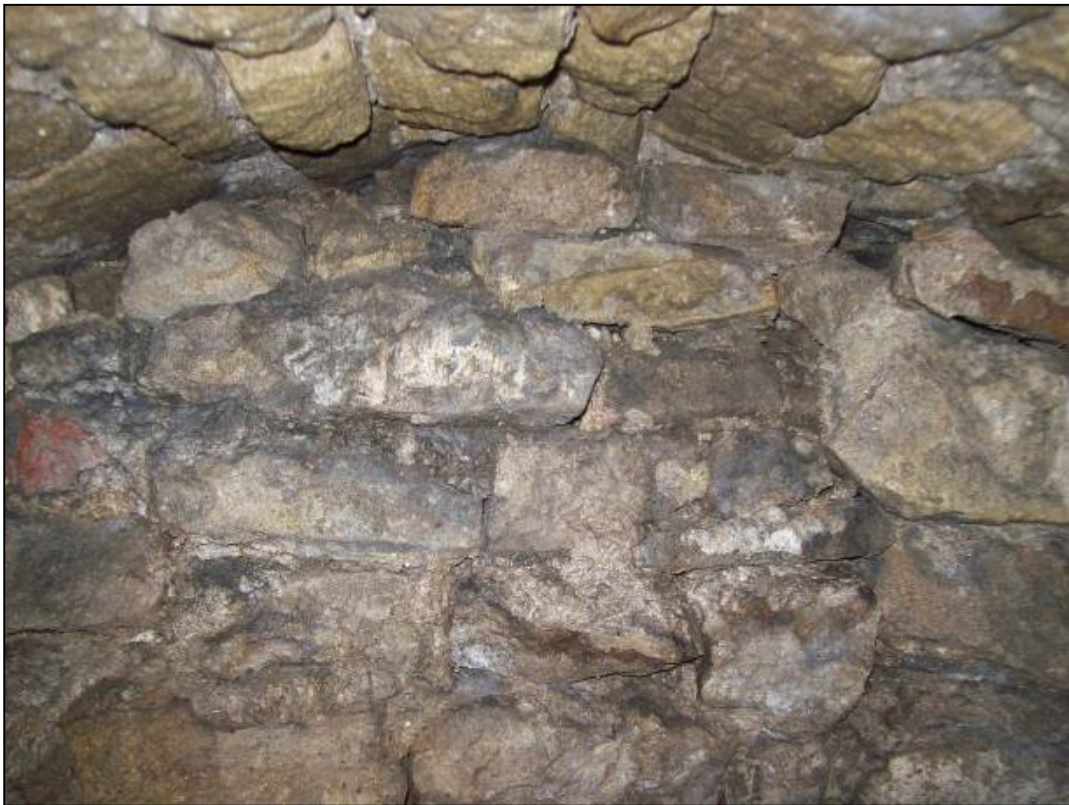
Removal of a sandstone block during excavation of the pipe trench revealed the presence of a sandstone built, double-vaulted cellar formed from rough-hewn stone blocks underneath the adjacent pavement (Figure 11). The western end of the cellar was encountered in the pipe trench containing a north-south aligned wall. The southern vault (Feature 1) had a void space at least 0.90m in height. The northern vaulted part of the cellar (2) was partially filled with rubble. The eastern end of the cellar was blocked by a later wall (Figure 12). The vault consisted of a double skin of rough-hewn stones held in place by a keystone (Figure 13) with rubble fill above the arch. The cellar measured 3.30m in total width (north – south) with walls approximately 0.40m thick. Entry to the cellar was not permitted on health and safety grounds. No dateable diagnostic architectural features were observed and no associated artefacts were identified.

Figure 11 - Void Revealing Southern Vault

Figure 12 - Blocked Rear Wall in Cellar (Southern Vault)

Figure 13 - Elevation Showing Cellar Southern Vault

As the vaulted cellar was underneath the pavement and not actually in the trench, after consultation with highway engineers from Northumberland County Council it was agreed that the vault was structurally sound and could be left untouched in-situ. The hole into the cellar was blocked using a metal shutter to prevent the trench backfill falling in to the cellar and causing subsidence in the road at a later date.

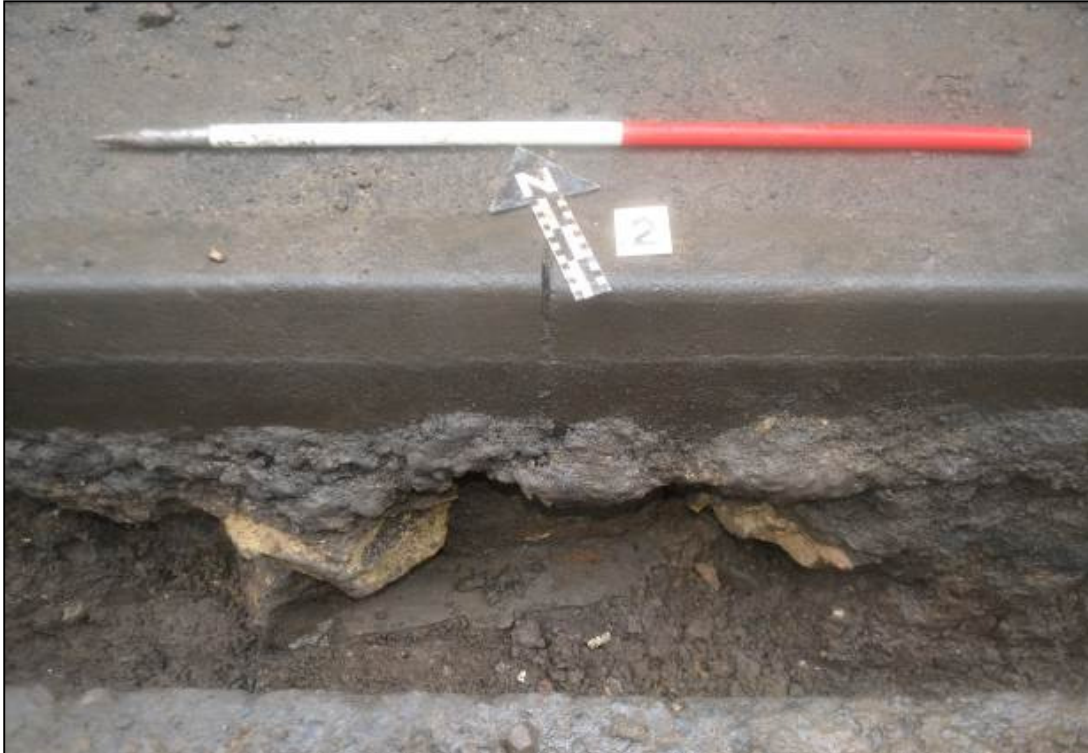
Figure 14 - Wall Base 2

At this location, part of a coursed sandstone wall (Figure 14), that sat on a small stone plinth was interpreted as a wall foundation or the base for a drain. The wall appeared to have a southeast-northwest alignment that did not respect the alignment of the walls of cellar 1 (see Figure 10). Although unclear, wall 2 may link with wall 4 located across the pipe trench and be part of a possible drain or culvert.

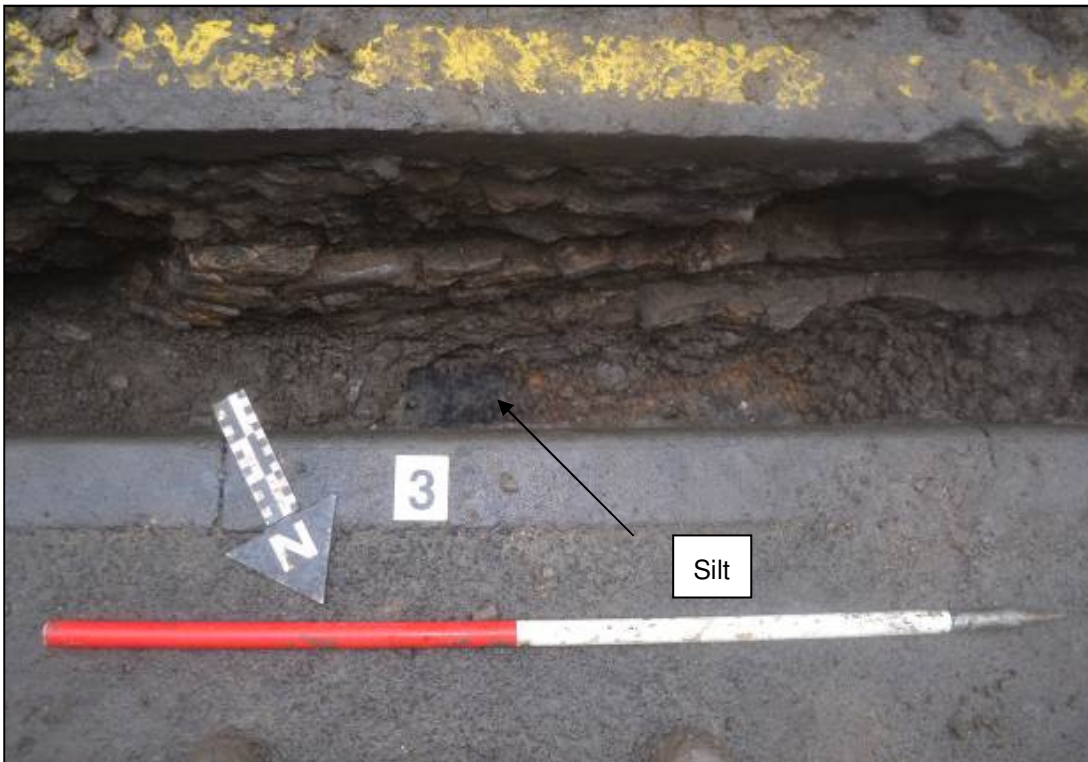
Figure 15 - Silt 3

A spread of dark grey organic-like silt **3** appeared at first to be an intrusive feature (Figure 15) but was probably either accumulated topsoil above either a track or natural geology. Unstratified and undated off-cuts of leather were just visible within this horizon that may have been associated with adjacent leather trades.

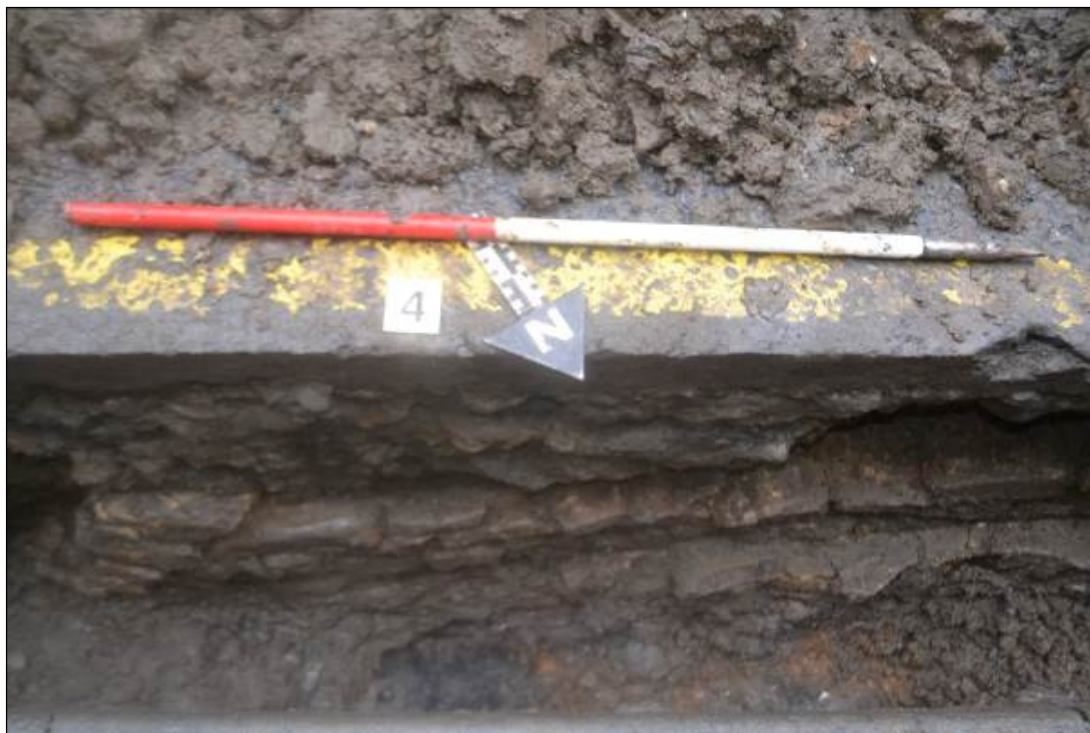
Figure 16 - Wall 4

An east facing north-south aligned wall **4** formed from rough-hewn sandstone blocks (Figure 16) amounting to four courses and sitting on a stone flag plinth resting on a shallow footing of rounded pebbles and stone debris approximately 0.30m in depth.

Later intrusions have truncated the wall with its probable relationship with wall **2**. Possibly, the wall represents the western wall of a building formerly indicated on Wood's 1826 map although its alignment would have been further west of cellar **1**.

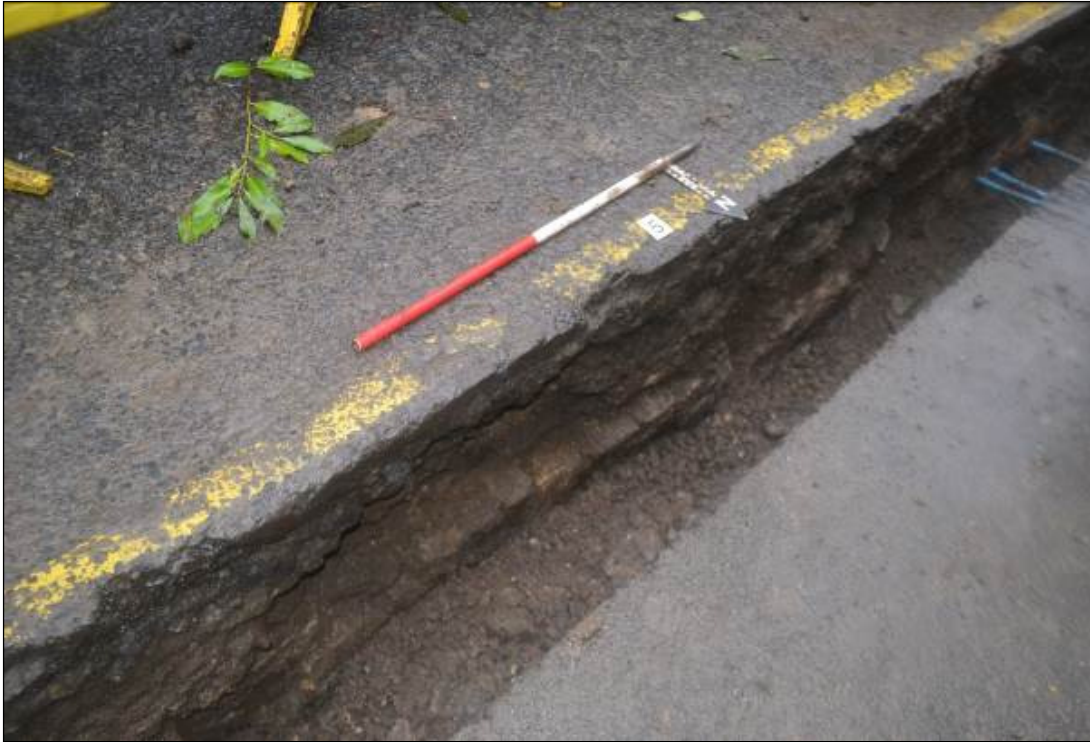
Figure 17 - Wall 5

A north-south aligned wall **5** formed from rough-hewn sandstone blocks (Figure 17) amounting to four courses with a vertical face was observed in the western edge of the trench. The wall possessed no plinth and was not entirely consistent with the alignment of wall **4**.

This may be the western wall of a building formerly indicated on Wood's 1826 map and a continuation of wall **4** which would constitute a stretch of wall at least 10m in length.

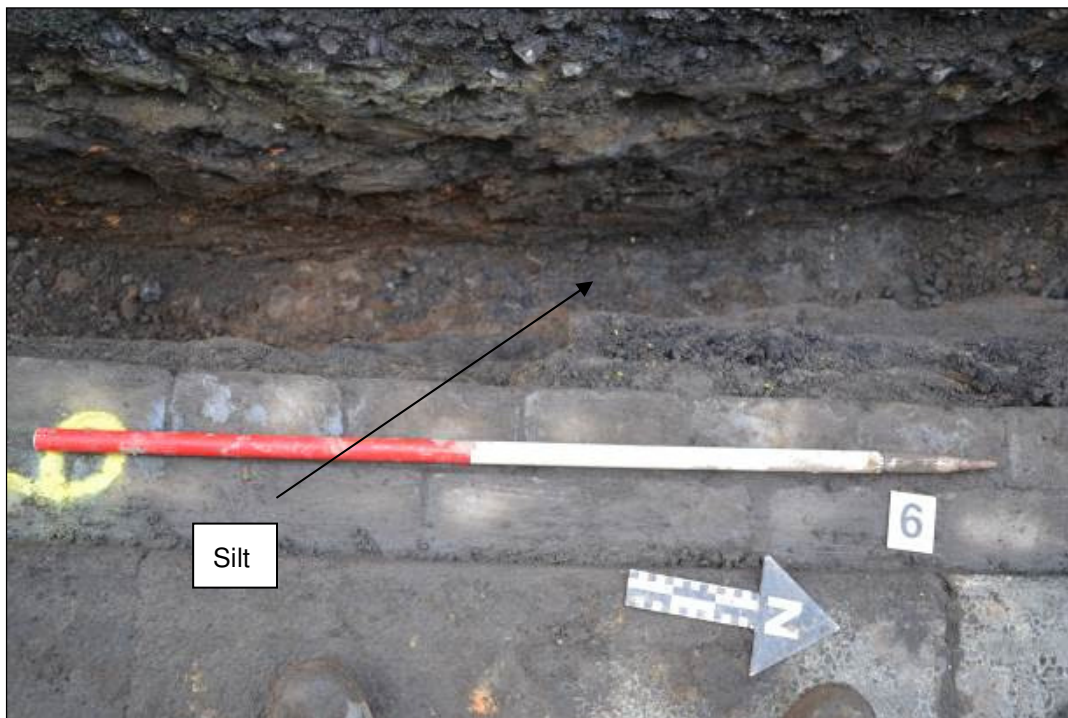
Figure 18 - Silt 6

At this location there was a clean, light grey silt **6** (Figure 18) resting above orange sandy clay gravel (natural drift geology). Due to the narrow confines of the trench it was not possible to determine the nature of this deposit.

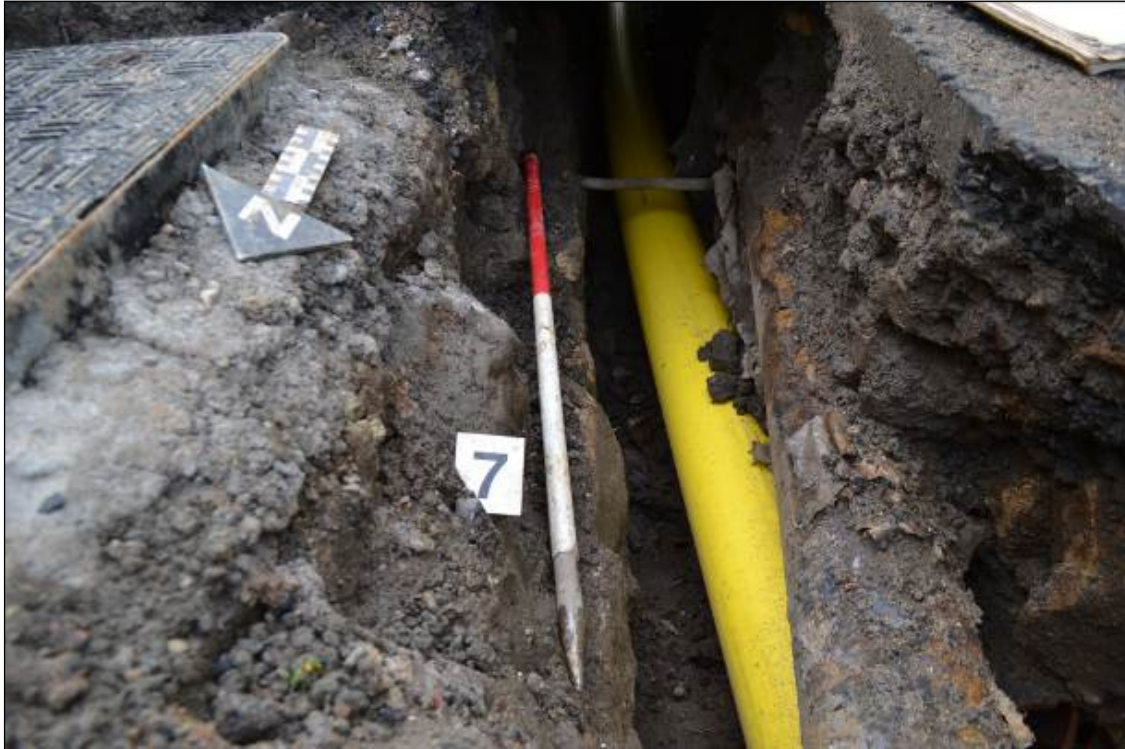
Figure 19 - Culvert 7

The western wall **7** of a north-south aligned stone culvert was encountered adjacent to an existing gas pipe (Figure 19). The culvert was at least 1.00m in height of which 0.45m of wall was observed. A dressed stone face developed into a coarse stone elevation with grey ashy cement seeping through the bond suggesting that the construction trench was cut flush to and alongside the southern end of the culvert.

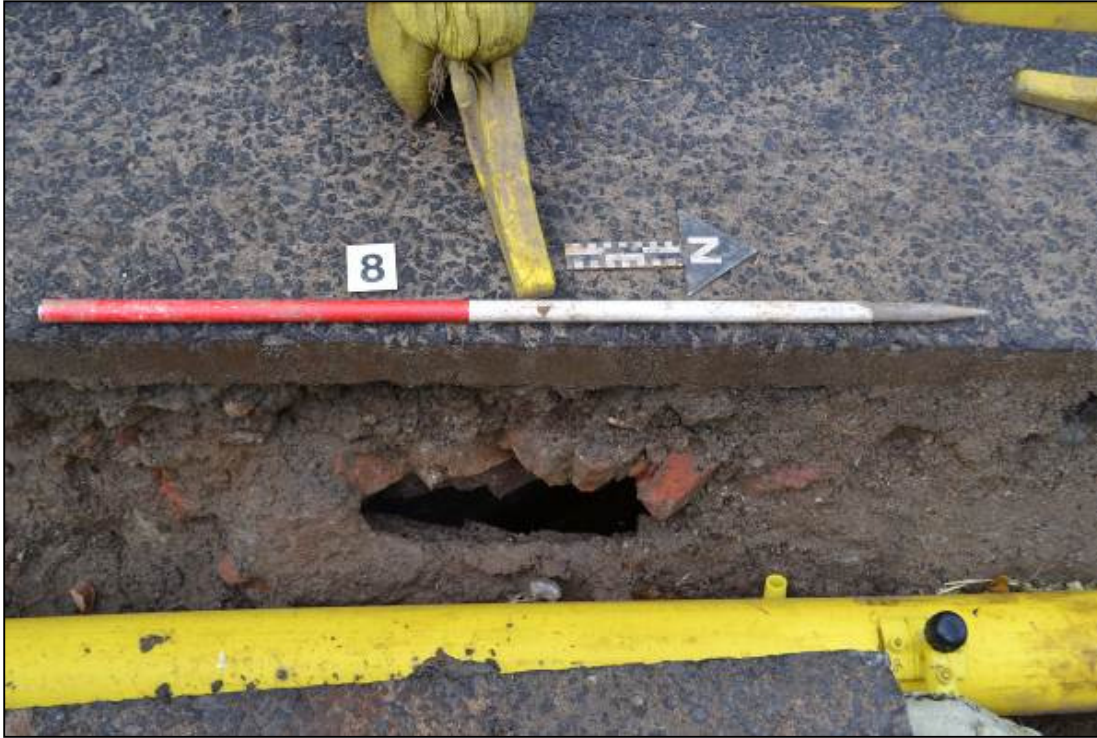
Figure 20 - Culvert 8

Just to the north of culvert **7** (approximately 4m and passing through an extant manhole), culvert **8** traversed the road in a north westward direction. Culvert **8** was a northward extension of culvert **7**. Its eastern side was exposed in the pipe trench (Figure 20).

The roof of the culvert was 0.25m thick and was constructed from red bricks that formed an arch (Figure 20). Peering into the culvert, it was clearly live, discharging water towards the town centre (Figure 21). The culvert was formed from dressed sandstone blocks re-pointed with grey ashy cement. The concave base of the culvert was constructed from sandstone.

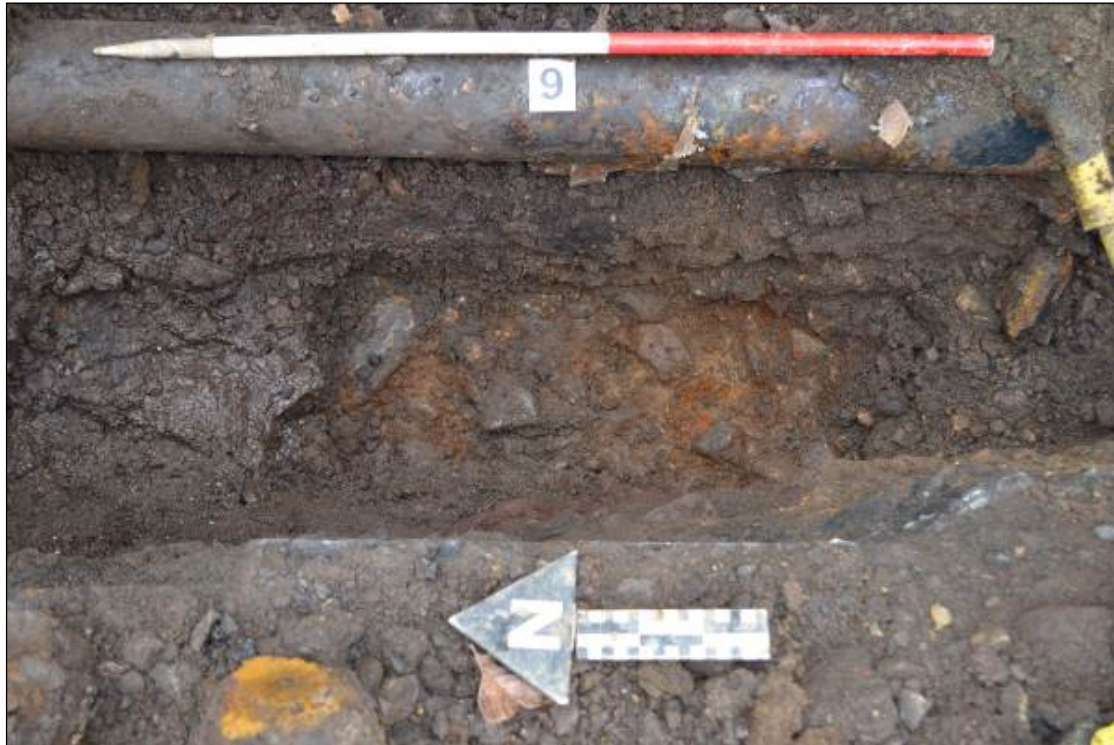
Figure 22 - Surface 9

Natural consisting of yellow-orange coarse sand **9** was observed beneath a single coarse of intermittent rounded cobbles. This stony horizon may have been part of a crude former road surface predating the modern road (Figure 22).

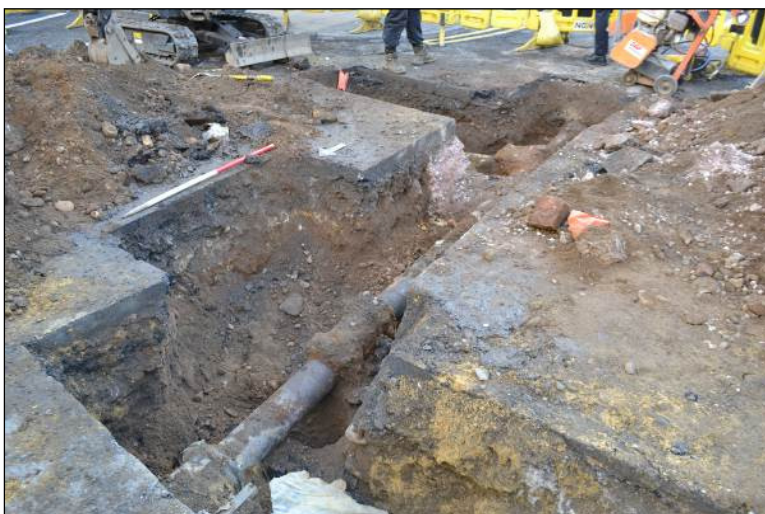
Figure 23 - Junction with Cattle Market

Overlying surface **9** was a horizon of flecked grey clayey silt sealed by loose yellow sand. This loose sand extended into the area exposed in Battle Hill (Figure 23) an area riddled with previous services. Naturally deposited gravel drift geology could not be discerned despite the machine removing overburden to a depth of 0.60m.
