Within the study area, an archaeological brief for an evaluation was set by Northumbria County Council to try and locate the course of Hadrian's Wall and any associated features such as a counterscarp.

In total, two archaeological trenches and three test pits were excavated within the study area at Green Croft, Gilsland, Northumberland.

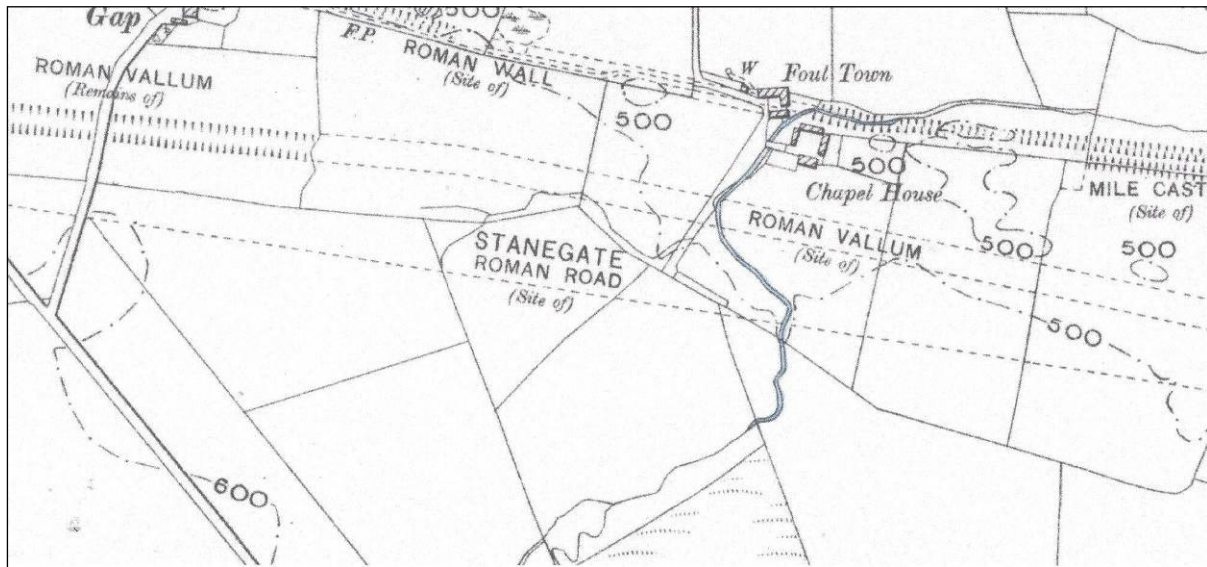
Figure 5. Second edition Ordnance Survey map of 1898

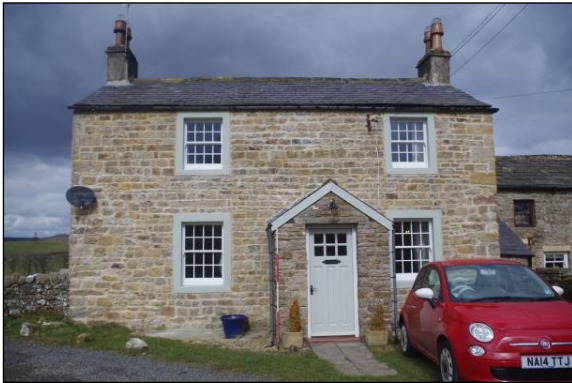
The existing farmhouse appeared to obey a typical Cumbrian two unit house current between 1650 and 1810. It originally consisted of a large room or kitchen containing the principal hearth and a space in which food preparation, domestic tasks and crafts were conducted. A second lesser room served as a parlour in which the main bedroom was located. Uniting the two rooms was a roof-space that later had the walls heightened in order to provide extra bedrooms (figure 6) served by an external staircase (Brunskill 2002, 64-67).

Figure 6. Elevation of farmhouse

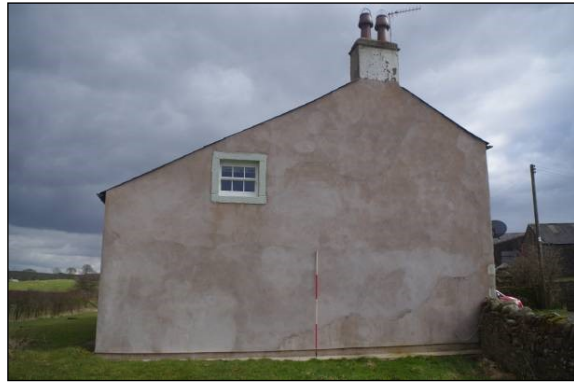
An outshut with cat-slide roof (figure 7) was probably added in the second half of the 18th century when the present windows of the original farmhouse were also installed.

Figure 7. Outshut housing staircase

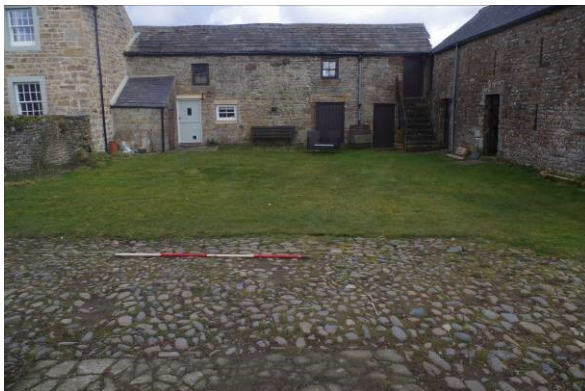
The farm buildings formed a central cobbled courtyard now largely grassed over (figure 8). Courtyard lay-outs suggested in North Cumbria were for large farms over 250 acres (101.8 ha) with the buildings in this case the byre attached to the farmhouse as a contiguous arrangement (figure 8) and at right-angles to other structures (Ibid, 101).

Figure 8. Cobbled courtyard

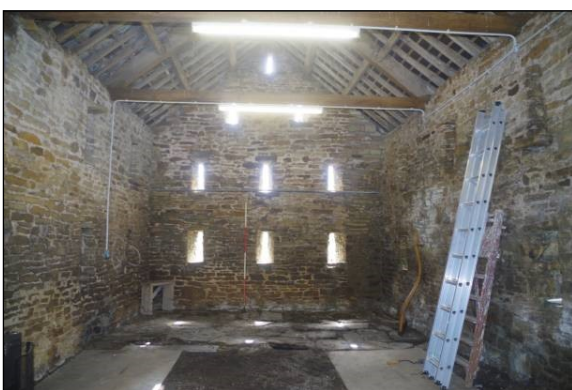
Figure 9. Threshing barn

Farm lay-outs were usually an accretion of buildings especially with land under Lowther control as slowly more land was enclosed and taken into cultivation. This included a threshing barn executed in stone with added porch (figure 9) and an ornate arrangement of air vents in the southern gable end (figure 10). There was no evidence for joists supporting a hayloft suggesting that this was an earlier barn possibly confirmed by a stone flag floor essential for winnowing the sheaths. The propensity of ventilation slits suggests that the barn was not used for storage, the crop either stored externally in stackgarths or sent to be milled.

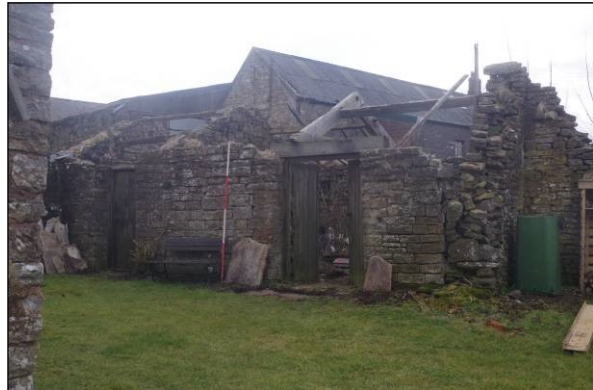
Figure 11. Derelict southern stores

The farm arrangement was completed with a southern range of stone buildings (stores) that currently are adjacent to a long distance footpath and a burn (figure 11). This was a larger structure that extended to a farm track but around twenty or thirty years ago was demolished and roofs were removed from the pigsty and the remaining store (figure 12).

This linear feature may veer northwards to overcome a burn as an arched bridge (figure 16) before resuming a westward course though a derelict range of stores (figure 11).

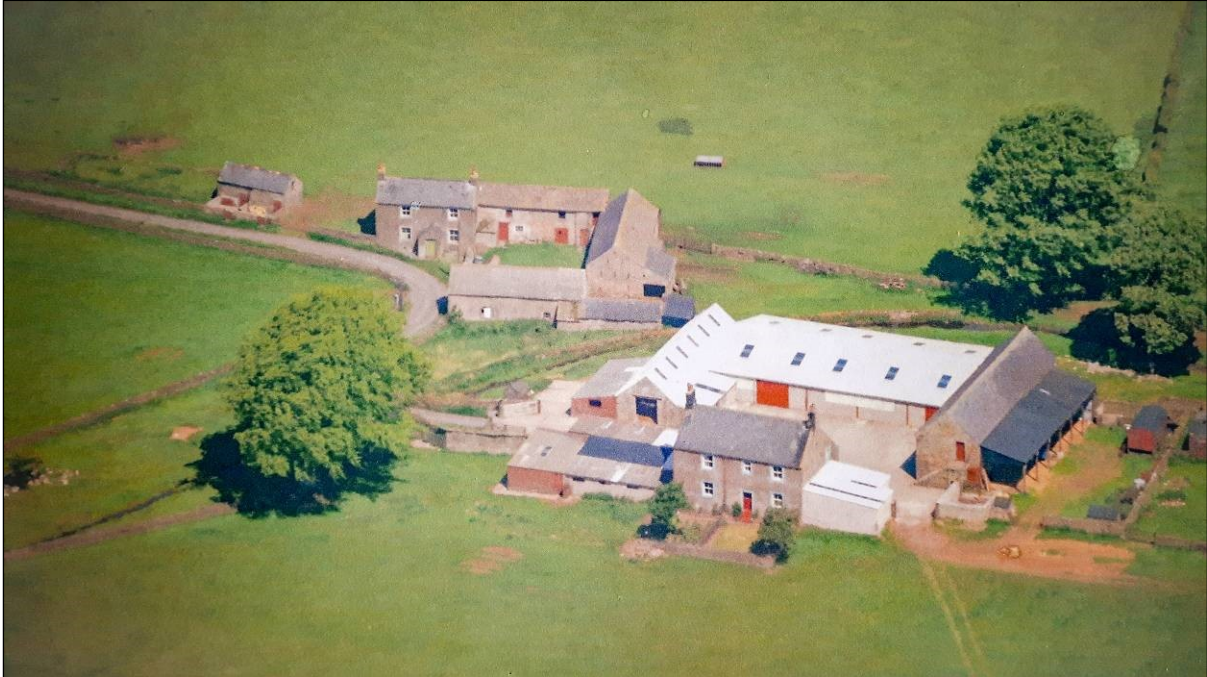
Figure 12. Aerial view of Green Croft showing buildings with extant roofs

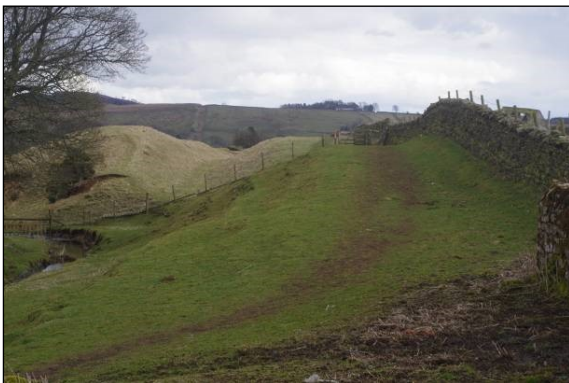
One hundred metres east of the study area, the Wall ditch is well-articulated by a pronounced linear depression with the adjacent Wall represented by a ridge upon which a dry-stone wall has been supplanted (figure 13), an account similar to Rev. Skinner in 1801.

Figure 13. Wall ditch east of the study area

To the east (figure 13), the Wall ditch is pronounced but remains close to the course of Hadrian's Wall with no evidence for *glacis* or counterscarp. The Wall ditch was then intercepted by the northerly progress of a burn before the fortifications resume to a familiar Wall ditch and Wall arrangement west of Green Croft (figure 29).

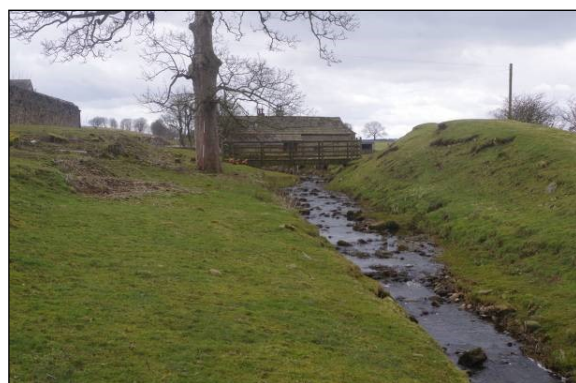
Figure 14. Possible Wall ditch impinged by burn

The Wall ditch dissipates towards the study area (figure 15) impinged by a burn that may have adopted the course of the Wall ditch at a later date although in 1829 the course of the burn was the same as now (figure 14).

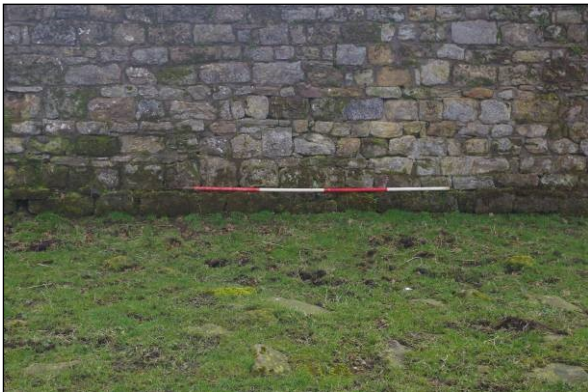
There is some possible evidence for a remnant wall as an adjacent stone agricultural building appears to sit on a shallow plinth of dressed stone that accords with the projected course of the Wall (figure 15). This observation appears to validate the Rev. Skinners account of 1801 where he noted what he believed to be a new wall built upon the bed of Hadrian's Wall (op cit, 10).

Figure 15. Stone plinth representing the Wall

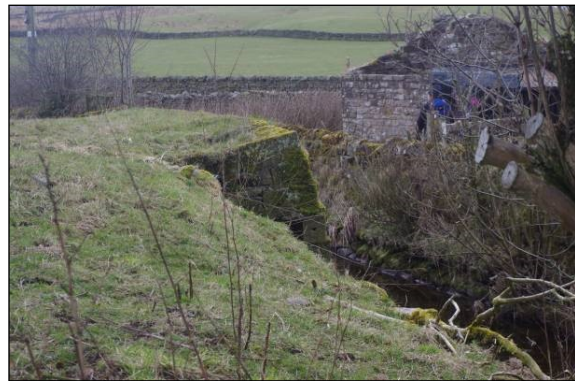
The course of the Wall was compromised by the presence of a burn. Assuming that this was not a post-Roman topographic feature, the Wall engineers would have had to deal with this encumbrance. The easiest solution would be to bridge over at right-angles with presumably a grille within the stream bed prohibiting clandestine access. The course of the Wall would "kink" over the burn resuming a linear course westwards.

Figure 16. Bridge abutment for possible Wall

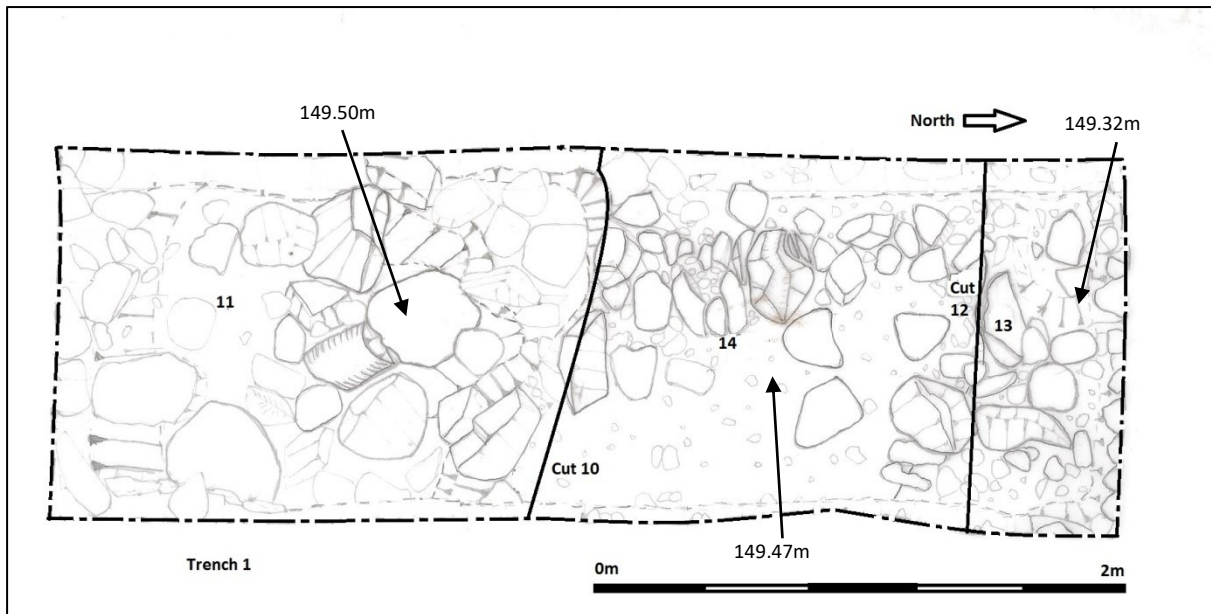
A linear east-west alignment of angular and ovoid stones **13** approximately 0.10m-0.20m in size filled a poorly defined east-west aligned linear cut **12**. This feature marked the post-medieval or 18th century foundation for the demolished store. A north-south aligned spread of stones **14** probably represented an internal partition within a former stone store.

Figure 19. Trench 1 showing the fill of the course of Hadrian's Wall and remnant store foundations

The course of Hadrian's Wall was almost certainly identified within Trench 1 represented by a rubble horizon **11** within an east-west aligned cut **10**. A later stone building had probably utilised the Wall foundation as part of its floor and therefore the Wall foundation was heavily obscured.

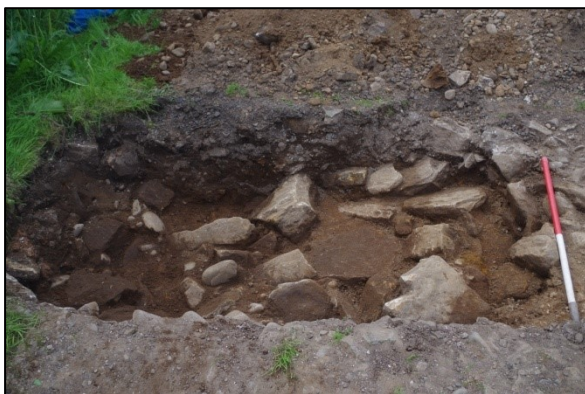
In trench 1, the denuded traces of stone rubble **11** marked the former core of Hadrian's Wall and followed the predicted course of the Wall.

Figure 20. Core of Hadrian's Wall 11

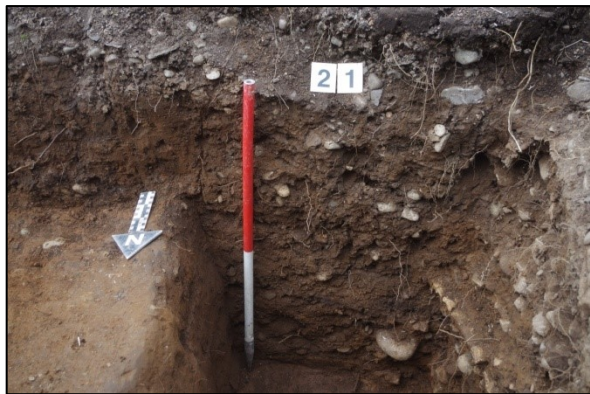
Figure 21. Cut 21

To the west, layer **24** was truncated by a north-south aligned cut **21** filled by dark grey-brown silty clay **20** that contained the articulated remains of a pig skeleton (figure 21).

Both cuts **21** and **22** were probably relatively recent acts associated with the pigsty hence the pig skeleton in fill **20**.

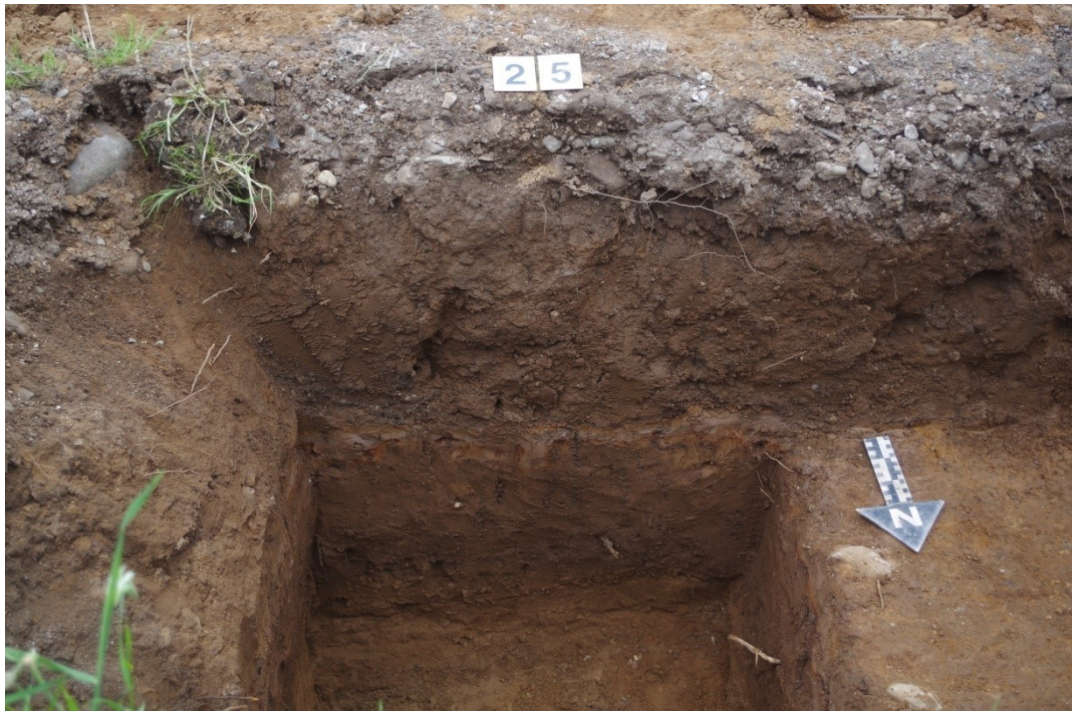
In Trench 2, a possible bank formed from clean soil **26** and sealed by a clay membrane **24** may represent a berm or *glacis* that rested behind a putative albeit unobserved Wall ditch.

Figure 23. Section through intervention **25** showing clay membrane **24**

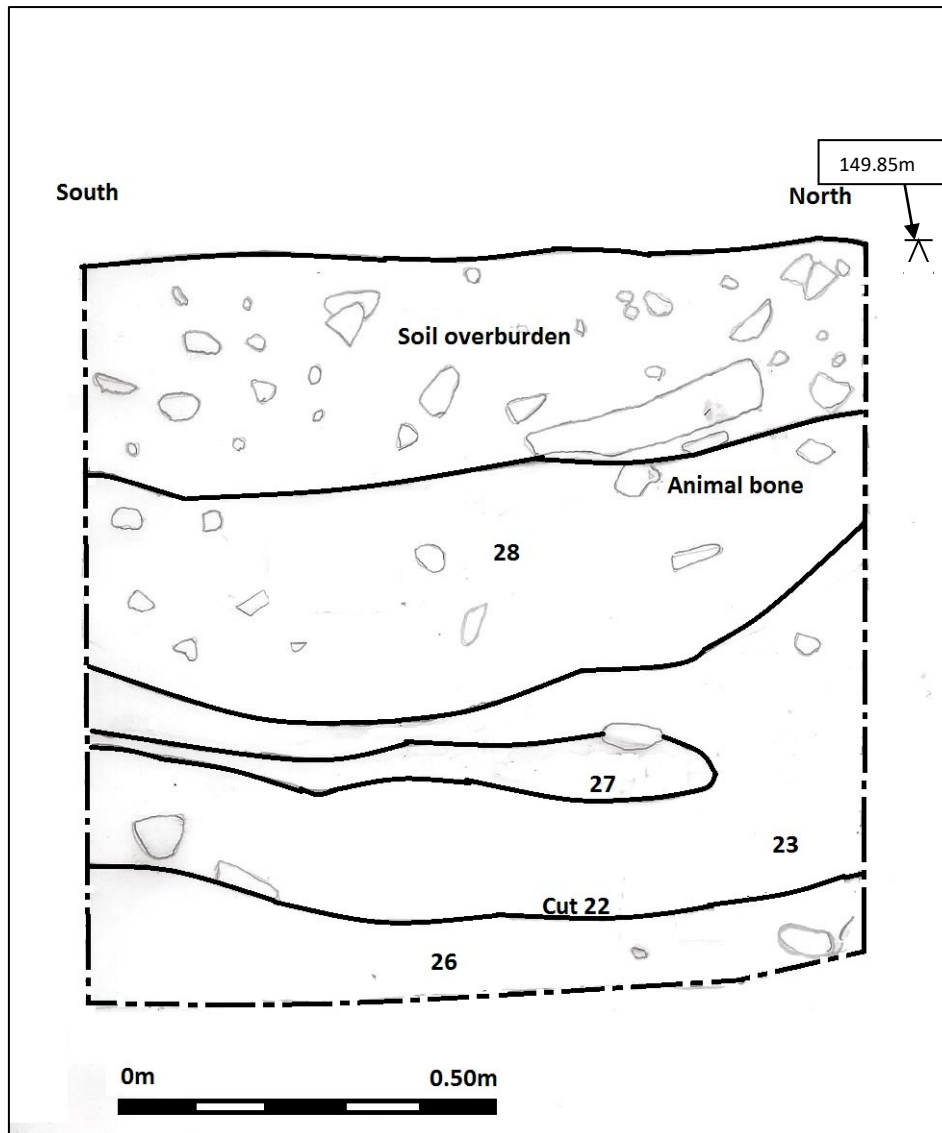
Cut **21** in turn truncated a probable unseen cut **22** that contained a basal fill of medium grey-brown silty clay **23** that was penetrated by a lens of orange-brown sandy clay **27** that probably represented root or animal bio-turbation overlain orange-brown silty clay **28** with a high propensity of angular stones (figure 24).

Figure 24. Section through cuts 21 and 22

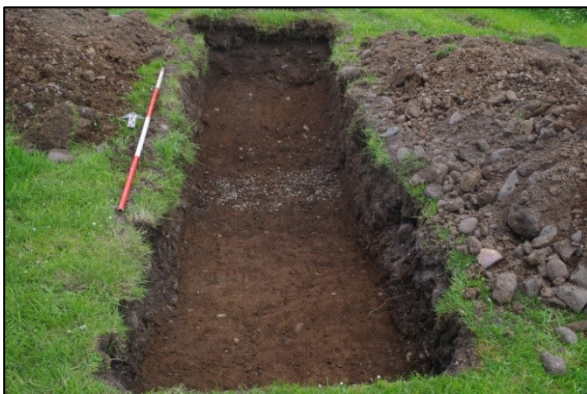
Figure 25. Plan of Trench 3

The trench declined in gradient from south to north terminating where a modern water pipe and gravel back fill were located (figure 25).

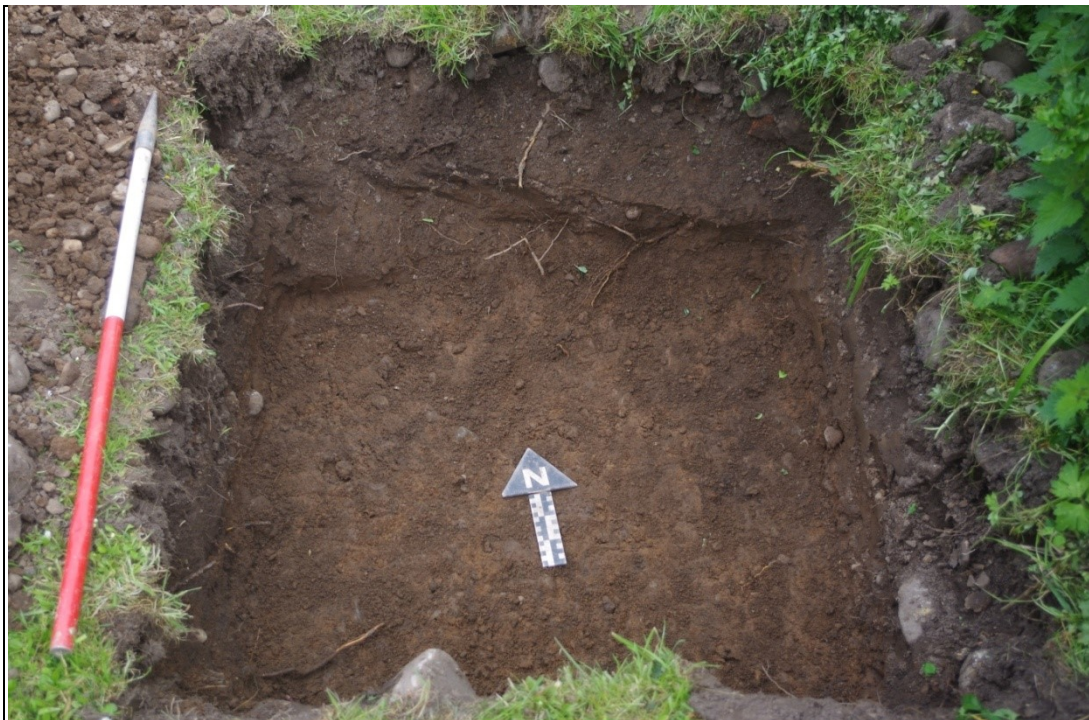
Natural drift geology consisting of coarse brown sand and gravel was encountered that was sealed by brown clayey sand topsoil (figure 28).

There was no evidence for any cultural remains of any antiquity within this Trench.

Figure 28. Test Pit 5

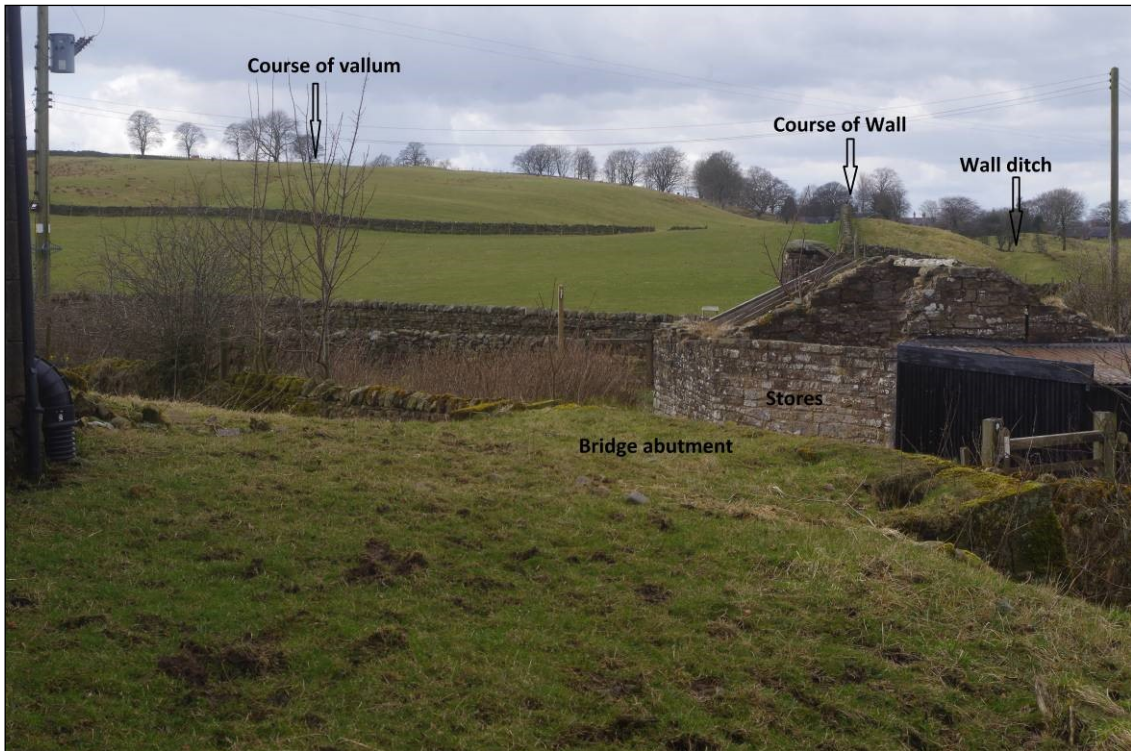
Figure 29. Disposition of topographic features west of Green Croft

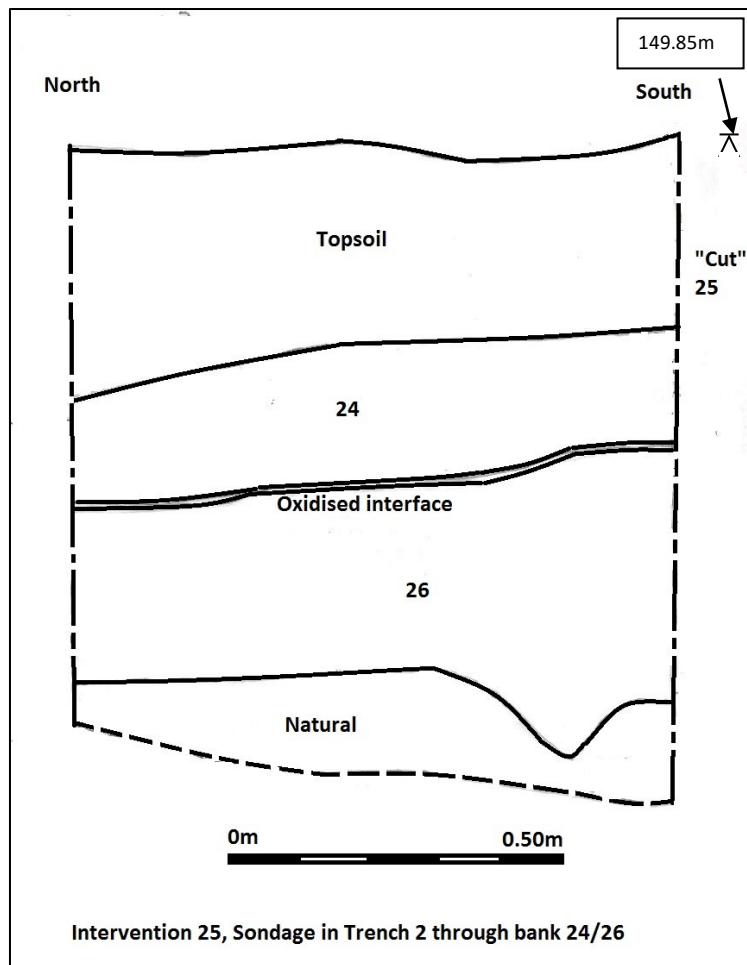
At the western margin of the study area, the forward defences re-emerge as a shallow bank **26** sealed by a clay membrane **24** (figure 30).

Figure 30. Section through bank 24 and 26

The closest parallel would be the *glacis* identified at Appletree, Cumbria in Wall Mile 50 where the 16.50m wide mound stood to a height of 0.49m resting on natural drift geology following removal of the turf (Wilmott 2009, 108).
