Recent archaeological reconnaissance identified a deep east-west aligned linear cut that corresponded to the plotted course of the vallum. This had previously been misidentified in 2009 as a modern intrusion associated with construction of the bungalow in 1964. It would appear highly likely that this landscape feature represents the vallum and that the course identified by English Heritage and Ordnance Survey remains correct.

In 2014 Cumbria County Council's Historic Environment Service (CCHES) was consulted by Carlisle City Council regarding planning permission for an extension to a dwelling at Braeside, Monkhill (figure 1). The planning application covering this fieldwork was No. 1/14/0413.

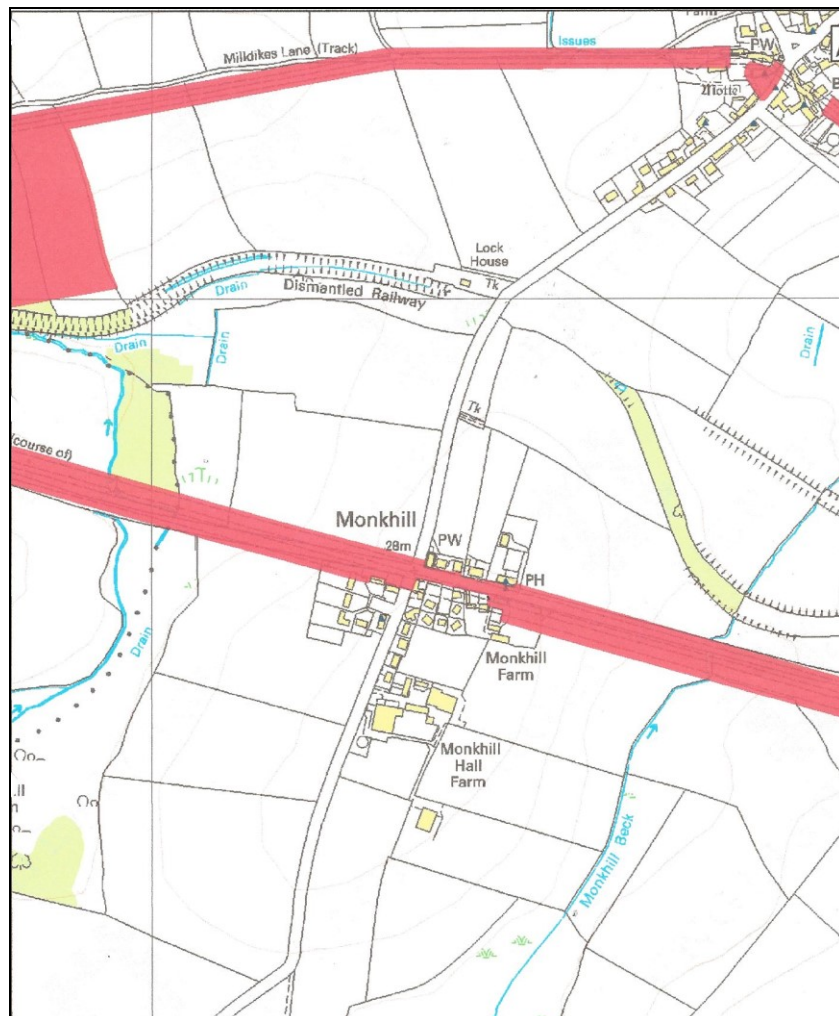
Figure 2. Scheduled area (shaded red)

The study area is exempt from designated Scheduled Monument status as administered by English Heritage (figure 2)

Revisiting the 2009 watching brief, six observations have now been taken of the southern edge of the vallum and one observation of its northern limit within Monkhill. Allowing for minor recording error, plotted out, these points appear to form a straight line (figure 14) with a very close concordance to the English Heritage designation (figure 2).

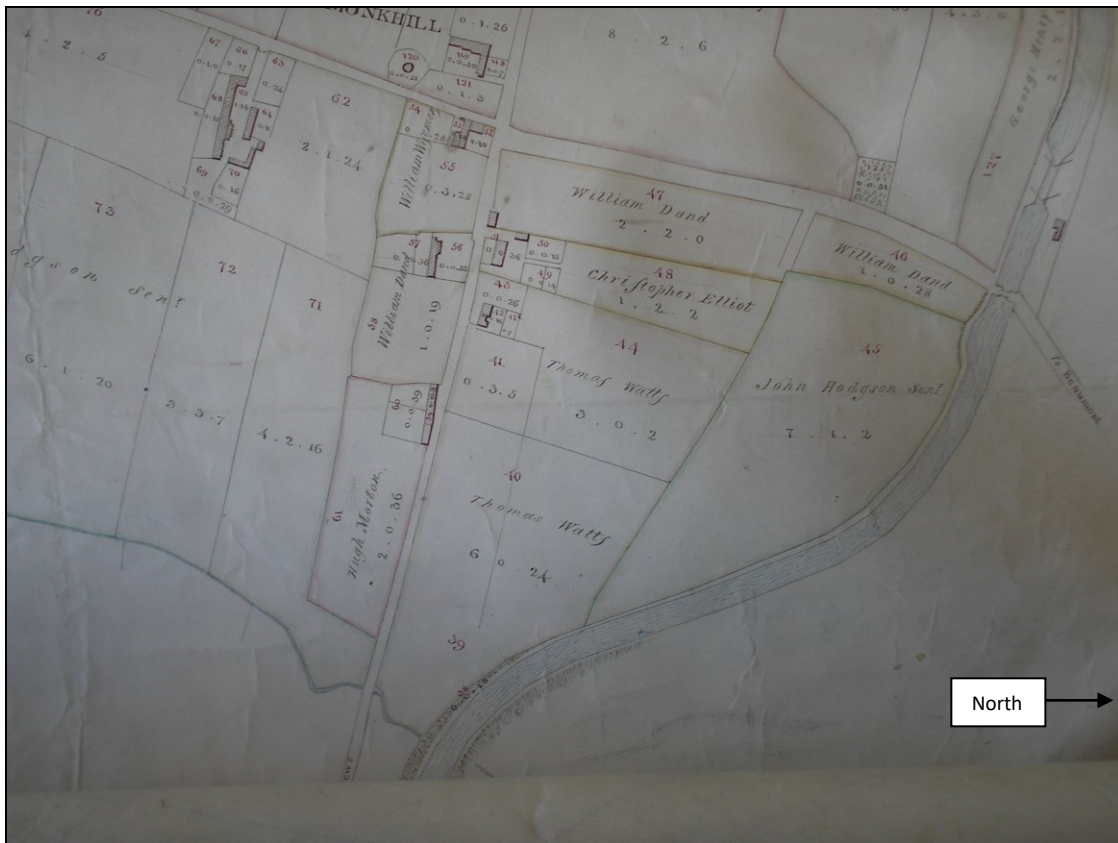
Figure 5. 1831 Tithe map DRX/769/22

The 1831 tithe map DRX/769/22 (figure 5) denotes that the property was owned by William Wiseman who resided at the adjacent house. The study area measured three rods and twenty five perches and the proportions of the field remained unchanged until around 1964 when the current development took place.

Interestingly, the vallum is not depicted on the tithe map whilst at least one building in Monkhill straddled the course of the ditch. This suggests that a significant proportion of the vallum must have been backfilled by 1831.

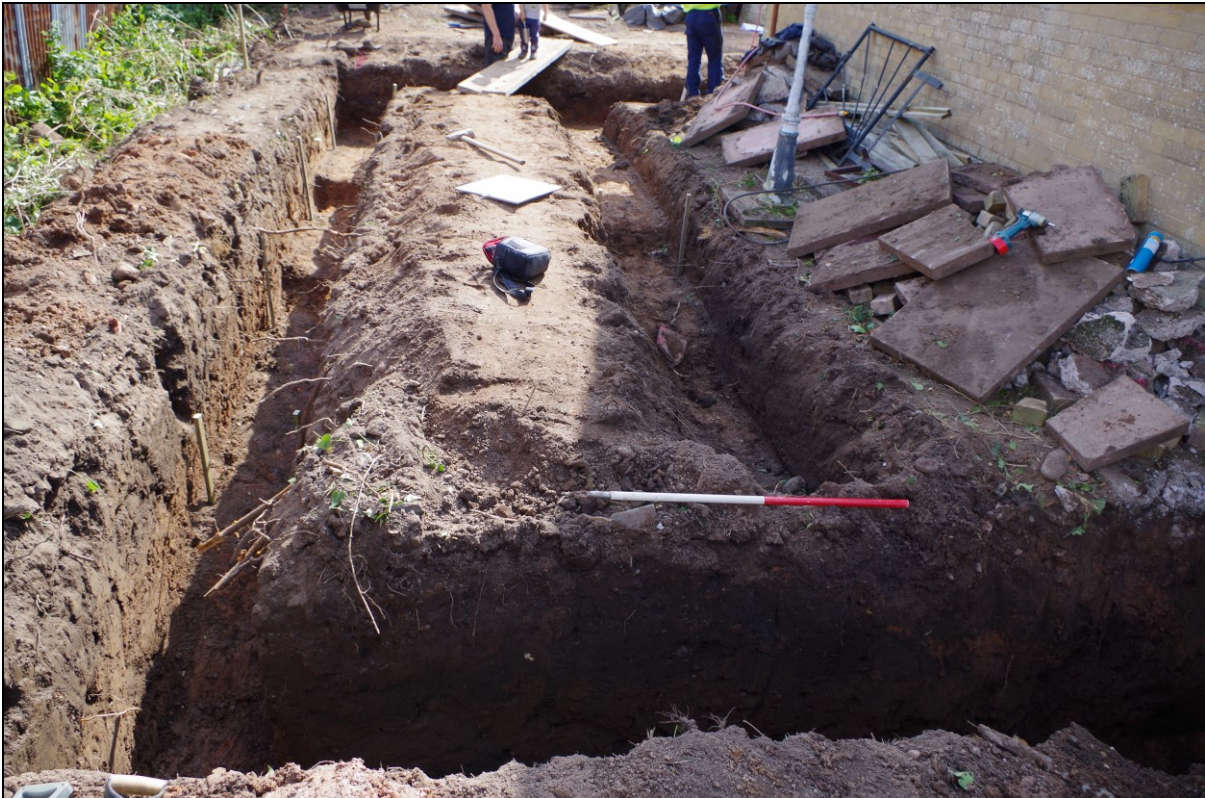
Figure 8. Trench configuration

The edge of a very large cut was seen in Trenches 2 (figure 8) and 4 and almost certainly corresponded to the vallum. Excavation was maintained to a depth of 1.50m, but at the northern end of Trench 3, natural was not observed.

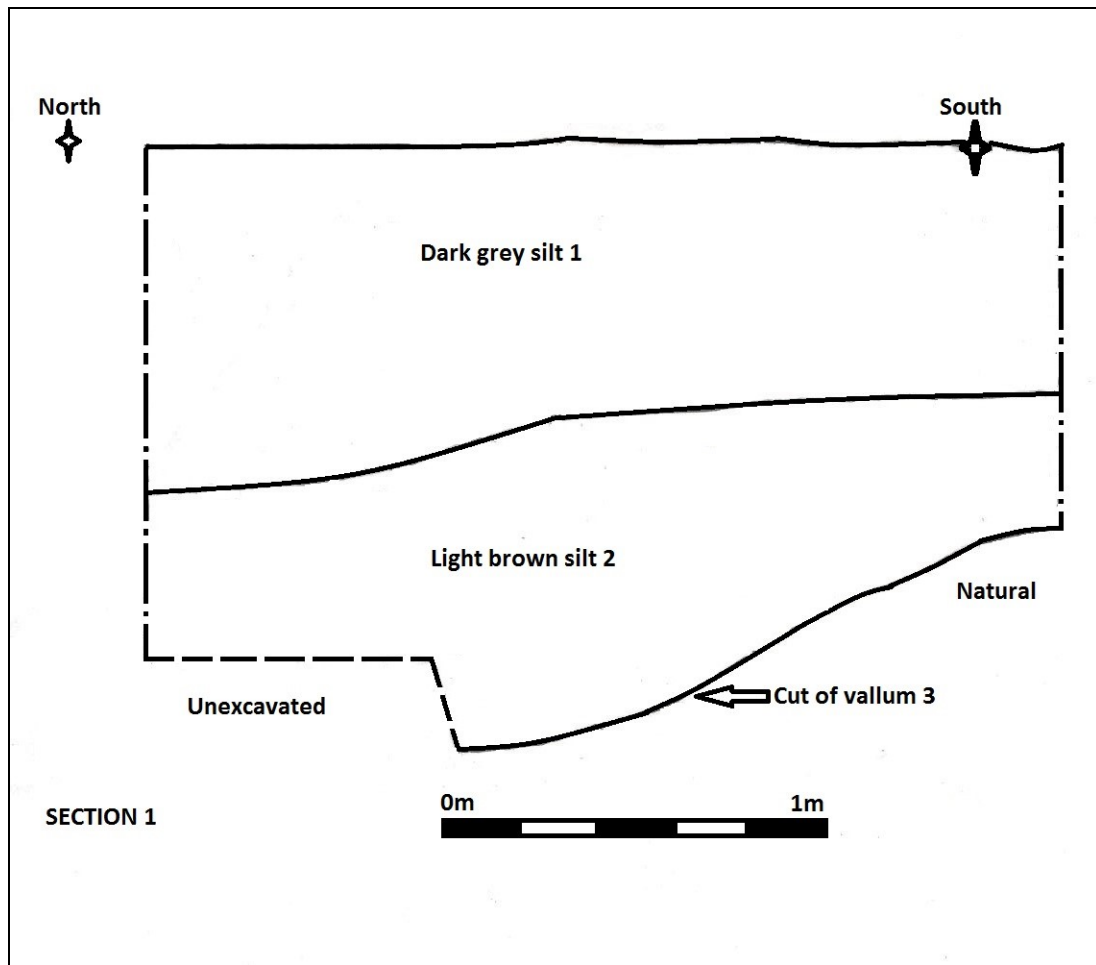
Figure 9. Section through southern edge of the vallum

The upper fill comprised dark grey silty sand **1** that was 0.70m in depth and was essentially a levelling deposit. This material sealed light brown silty sand **2** that butted the side of a steep cut **3** revealing natural Boulder Clay (figure 9).

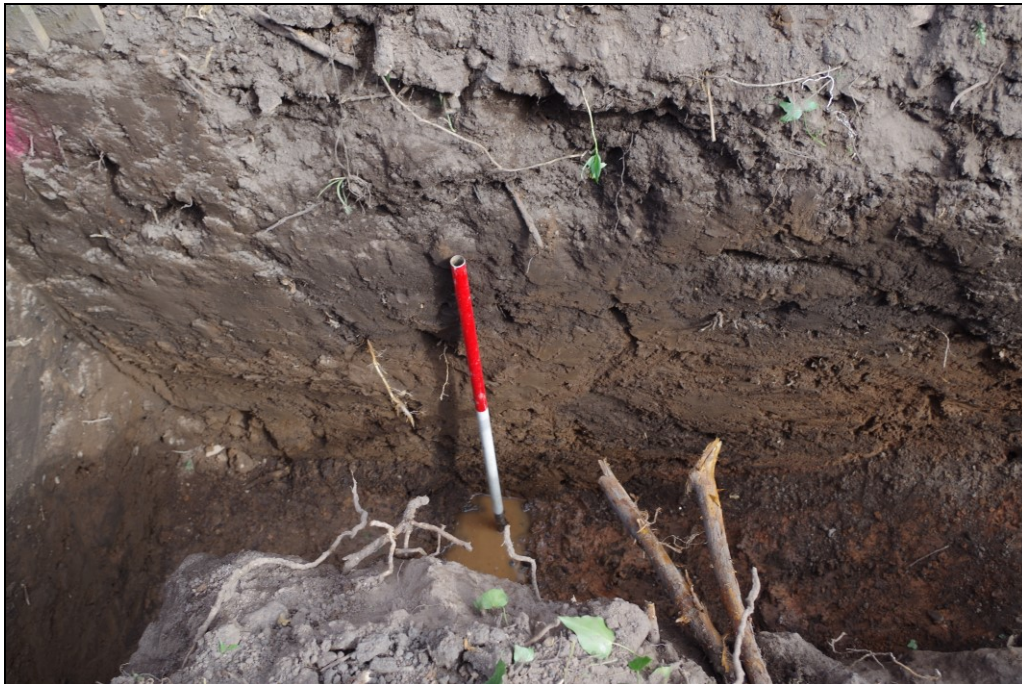
Figure 10. Section through southern margin of the vallum

The fills were clear of extraneous modern material but displayed no significant soil development or profile probably the culmination of tertiary deposition after a gradual accumulation within the ditch (figure 10).

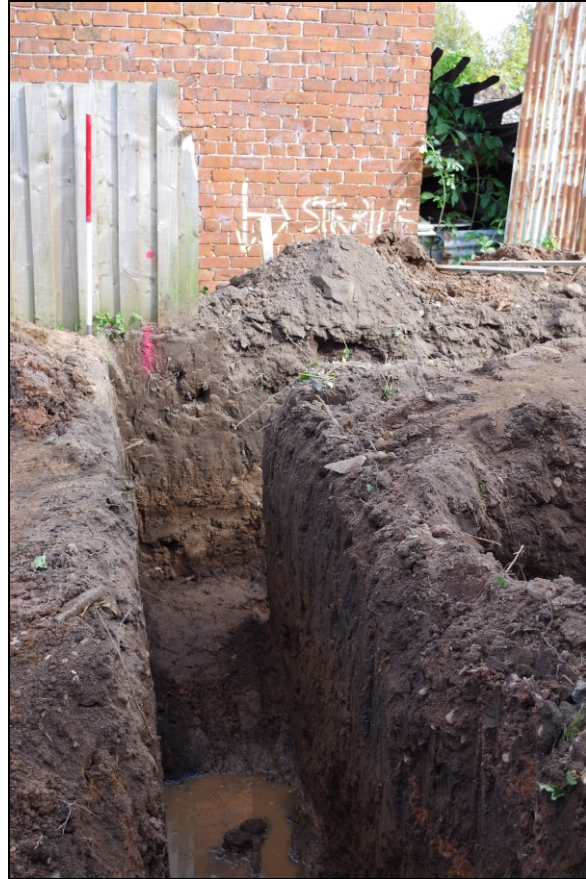
Figure 12. Predicted course of vallum (arrow on wall)

- Cut 3 was close to the boundary with Monkhill Farm and only 2.30m from a brick outbuilding in Monkhill Farm. Slightly surprisingly, the brickwork for this building was in good order with no signs of subsidence from the underlying vallum.
- Fieldwork undertaken at adjacent Monkhill Farm predicted the course of the vallum to pass through at this position marked by a yellow arrow painted on a brick wall (figure 12).
