SUMMARY

Lea End Farm contained a clay dabbins cottage and part of a possible clay dabbins barn that was supplanted by a red brick barn of probable 19th century date. There exists strong evidence that corresponding to the current building footprint was a suite of linear aligned buildings dating to at least 1762. The lay-out of the farmstead has a strong correlation with a typically small Cumbrian farm of around thirty acres prevalent in the 18th century.

1 INTRODUCTION

1.1 Project origins

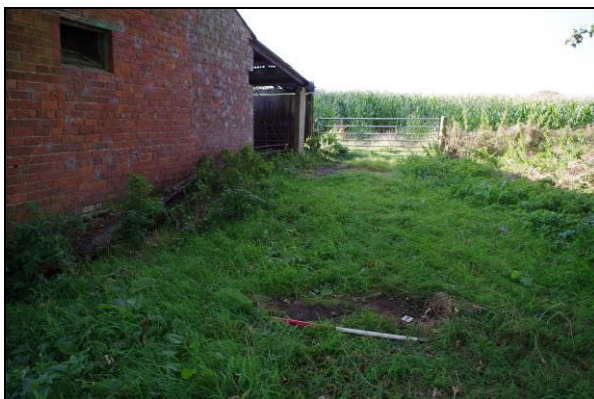
Figure 3. Location of buried wall

Between the extant brick barn and the road (figure 3) was a stretch of sub-surface red sandstone wall 0.70m in length x 0.18m in width aligned east-west (figure 4) that may possess a structural form rather than debris laid down for field access.

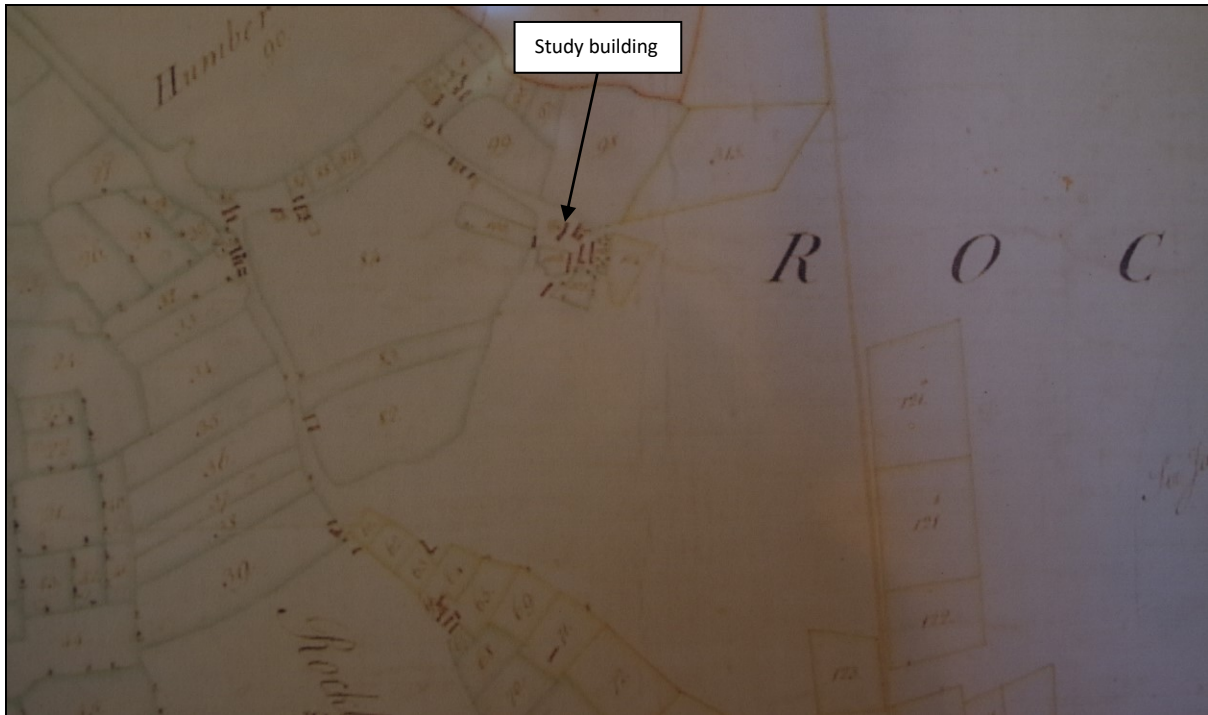
Figure 5. Estate map of 1762-63 held by Castletown Estate

The earliest cartographic reference for a structure appears to be located on an estate map of 1762-63 held by Castletown Estate (figure 5). This is a copy of George Wheatley's Survey of 1762 and 1763 for the Barony of Burgh (2/32/2/7 and D/LONS/L 2 Rockcliffe) that depicts two long buildings, one possessing a slight kink northwards.

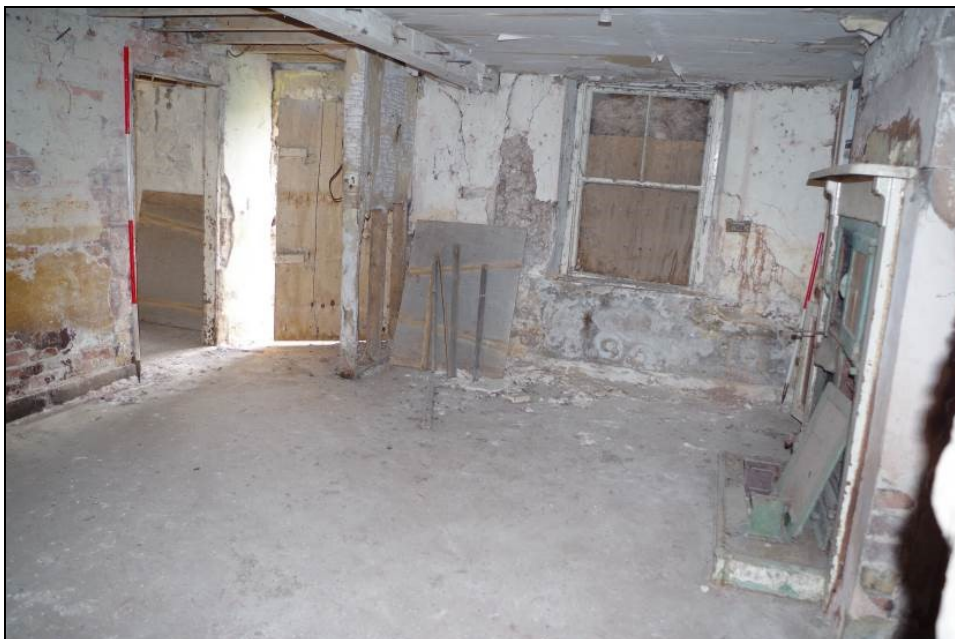
Figure 8. Interior of Room 1

Room 1 (figure 8) measured 4.56m in length (north-south) and 4.42m in width with a height of 2.11m to the ceiling. Wall thickness measured 0.50m comprising of clay dabbins on three sides (all originally exterior walls) built upon a cobble plinth 0.50m in height.

The room possessed a concrete floor with a single skin eastern brick wall 0.13m in width dividing the original living space in order to form a parlour (Room 2). The ceiling and timber joists were not part of the original building fabric.

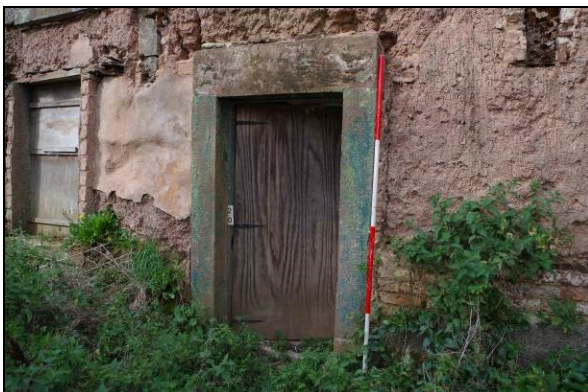
Figure 9. Doorway 20, Room 1

- Door 20 provided entry directly into the room. The doorway measured 0.81m in width and 1.84m in height with flanking sandstone jambs measuring 0.21m in width, 0.17m in depth

and 1.84m in height. The masonry was hand-sawn, without embellishment surmounted by a sandstone lintel measuring 1.31m in length, 0.33m in height and 0.16m in depth (figure 9)

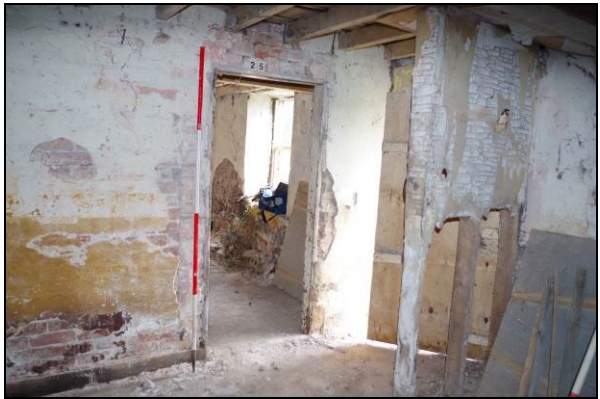
Figure 14. Doorway 25, Room 1

- Doorway 25 (figure 14) leading to parlour 2 lacked a door and measured 0.80m in width, 0.13m in depth and 1.87m in height

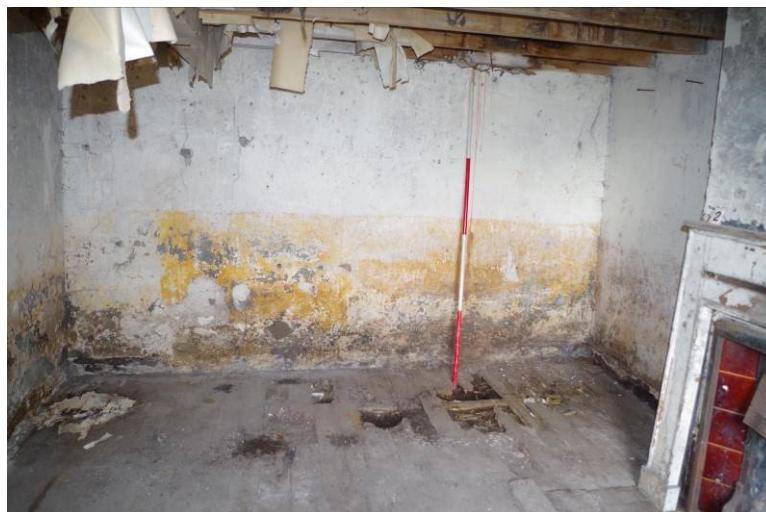
Figure 15. Interior of Room 2

Living room 2 (figure 15) measured 4.51m x 3.58m with a height of 2.13m to the ceiling. It was formed on three sides by clay dabbins walls overlying a cobble plinth. The eastern wall was the probable gable end to the original building. The floor comprised timber floorboards whilst the ceiling was the same as Room 1.

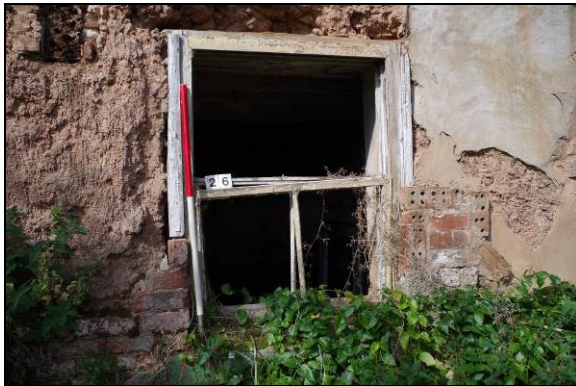
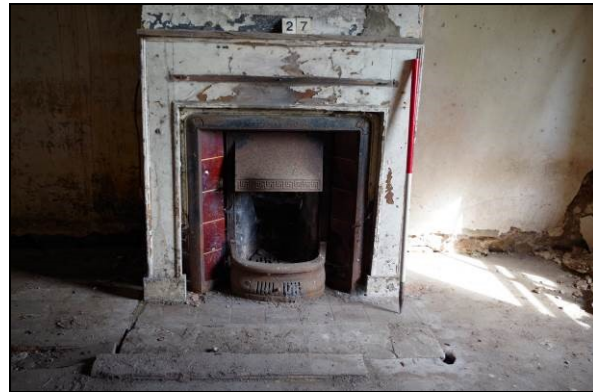
- Window 26 (figure 16) was a timber sash window lacking glazing measuring 1.33m in height and 1.00m in width
- Fireplace 27 (figure 17) measured 0.90m in width and 0.91m in height and was connected to a chimney breast measuring 1.20m in width, 0.48m in depth and 2.13m in height. The base of the fireplace was formed from stone with a wooden surround and an iron grate with tiled finish

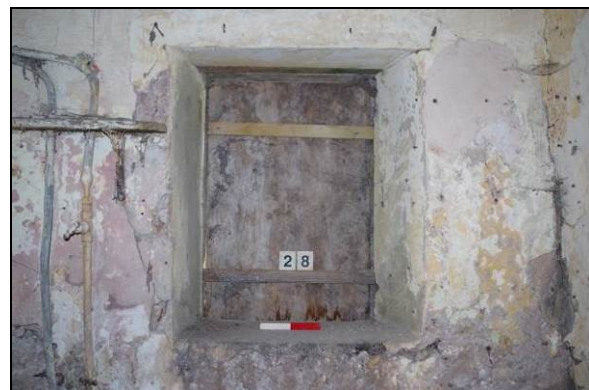
Figure 19. Window 28, Room 3

- Window 28 (figure 19) was missing its surround and measured 0.62m in width, 0.99m in height and 0.30m in depth. This window looked westwards

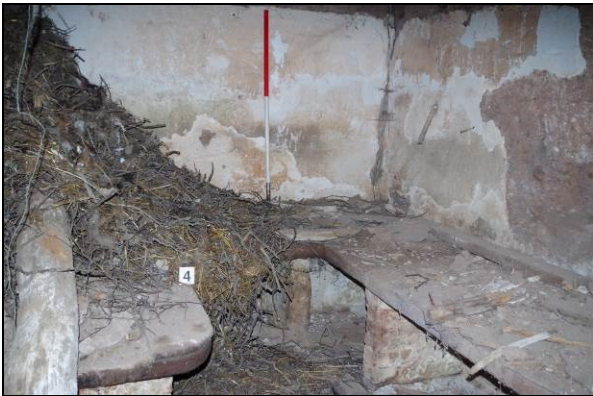
Figure 26. Interior of the larder showing benches

The larder (figure 26) measured 3.00m in length, 2.13m in width and stood to a height of 1.81m. A ceiling was missing that once was accessed via door 33. All the walls were formed from clay dabbins although on the exterior northern wall there has been a modern repair in breeze blocks (figure 27). The interior consisted of a series of stone benches measuring 0.74m in width and 0.62m in height.

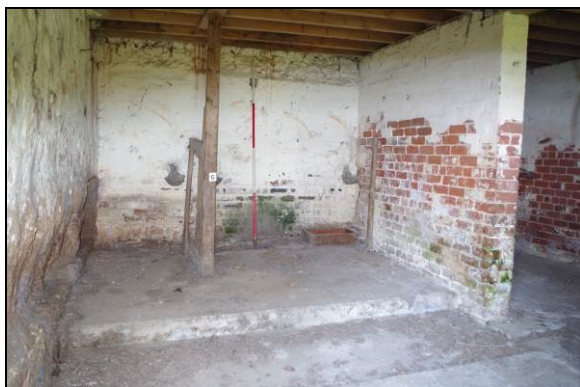
Figure 28. Stall 1, Room 6

The room (figure 28) measured 4.84m in length, 3.02m in width and stood to a height of 2.38m.

Clay dabbins walls form the northern and western sides of the room the remaining walls being red brick. The unit divides into two stalls finished with a split level concrete floor that falls 0.19m. The ceiling is modern with an asbestos roof. Access into the room was via a doorway measuring 1.20m in width and 2.00m in height.

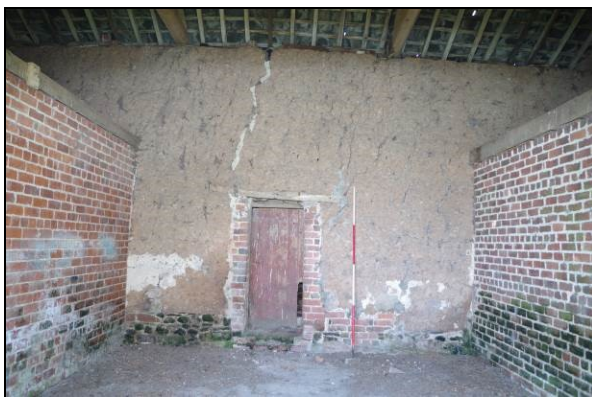
Figure 29. Stall 2, Room 7

The room measured 4.84m in length, 1.96m in width and stood to a height of 2.57m (figure 29). Clay dabbins wall form the northern side of the room the remaining walls being red brick. The unit represents a single cattle stall finished with a concrete floor. The ceiling is modern with an asbestos roof.

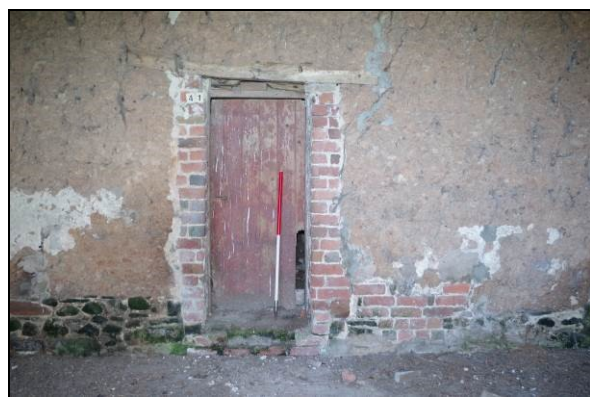
Figure 31. Door 41, Room 8

- Doorway 41 (figure 31) measured 0.74m in width, 1.80m in height and 0.42m in depth, surmounted by a window lintel measuring 1.72m in length, 0.21m in width and 0.12m in depth that contained a tongue and groove planked door

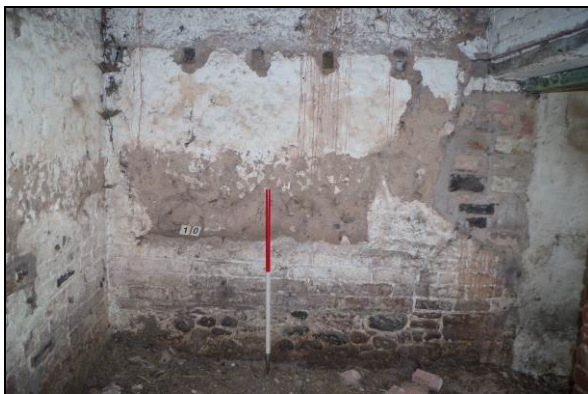
Figure 33. Interior of stall 4, Room 10

The room measured 3.14m in length, 2.23m in width and stood to a height of 3.81m (figure 33). The southern wall was formed from clay dabbins as was the western end which possessed a cobble plinth. The remaining walls were brick partition standing to the height of the corrugated iron roof, 1.94m. Modern roof joists were present bearing a corrugated iron roof. The floor was formed from concrete.

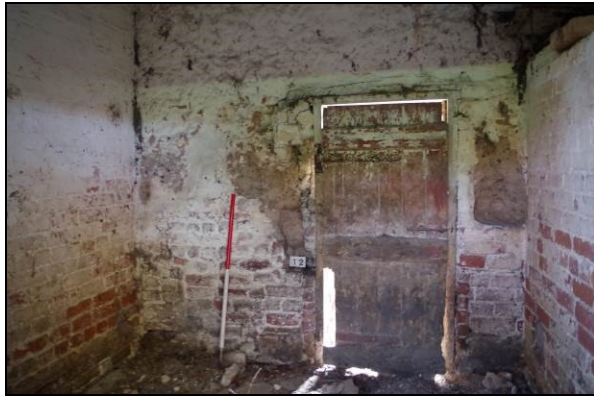
Figure 35. Interior of stall 6, Room 12

The room measured 2.55m in length, 2.24m in width and stood to a height of 3.87m (figure 35). The southern wall was formed from clay dabbins. The remaining walls were brick partitions. Modern roof joists were present, the floor formed from concrete. A tongue and groove timber door (41) accessed the threshing barn (Room 8).

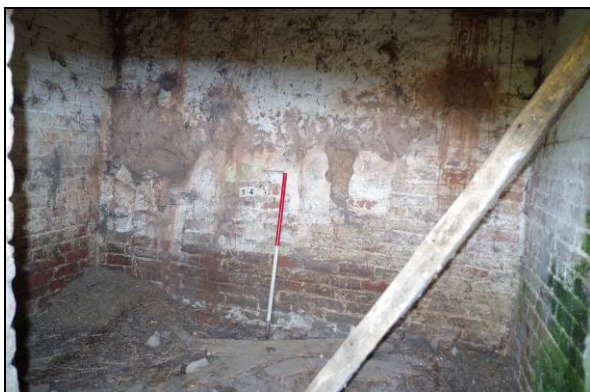
Figure 37. Interior of stall 8, Room 14

The room measured 2.99m in length, 2.23m in width and stood to a height of 3.63m (figure 37). The southern wall was formed from clay dabbins. The remaining walls were brick partitions standing to the height of the corrugated iron roof. Modern roof joists were present, the floor formed from concrete.

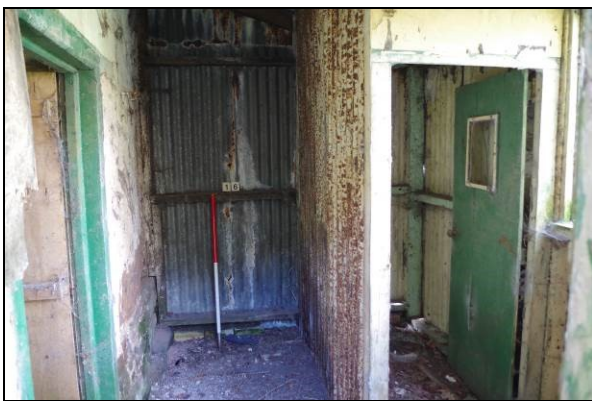
Figure 39. Toilet 16

The room measured 2.70m x 2.18m and stood to a height of 2.83m (figure 39). The area divided into three areas; a toilet closet (without a toilet pan), cloak room and vestibule. The structure was constructed from corrugated sheet and accompanying concrete floor.

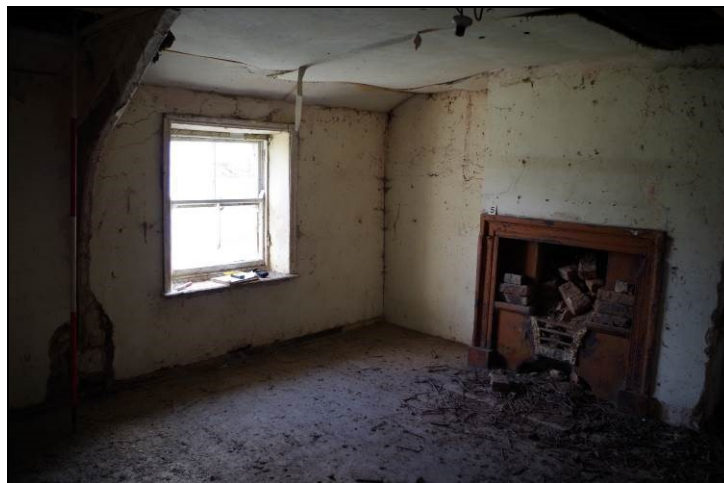
Figure 42. Interior of Room 5

Room 5 represented bedroom 1 and measured 4.63m x 4.45m with a height of 2.10m to the hardboard ceiling (figure 42). The roof comprised Welsh slates fastened onto timber purlins (figure 43). One set of cruck blades was visible within the northern and southern clay dabbins wall. The floor comprised timber floorboards.

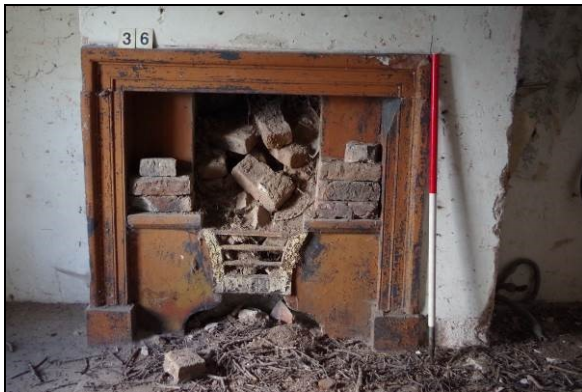
Figure 45. Fireplace 36, Room 5

- Fireplace 36 (figure 45) bearing a chimney breast 1.57m in width, 2.10m in height and 0.39m in depth that contained a cast iron fireplace measuring 1.25m in width, 1.14m in height and 0.44m in depth
- Timber door 37 (figure 46) measuring 0.80m in width and 1.86m in height leading to Room 18 (bedroom 2)

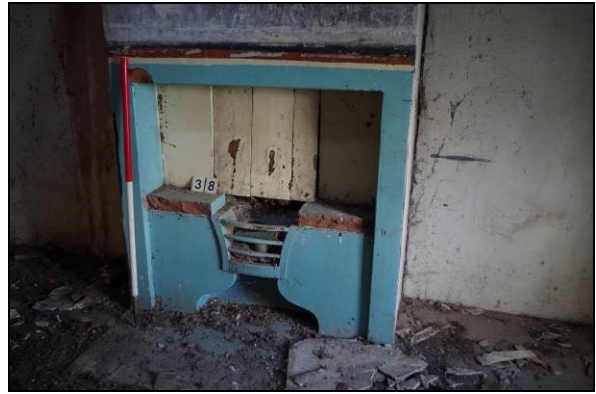
Figure 48. Fireplace 38, Room 18

- Fireplace 38 (figure 48) bearing a chimney breast 1.21m in width, 2.10m in height and 0.43m in depth that contained a cast iron grate measuring 0.99m in width, 1.06m in height and 0.19m in depth within a painted sandstone surround
- Sash window 39 (figure 49) measuring 0.87m in width and 1.10m in height that faced southwards
- Timber door 40 (figure 50) measuring 0.80m in width, 1.88m in height leading onto the landing within Room 3

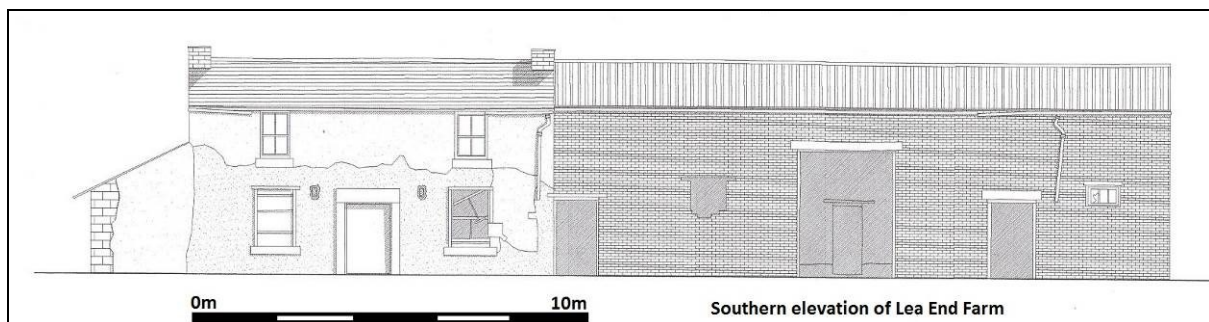
Figure 51. Front or southern elevation of the study building

The front or southern elevation illustrated the original cottage and barn, part of a group of buildings that forms Lea End Farm (figure 51). The elevation measured 24.70m in length and stood to a maximum height of 5.82m with a wall height of 4.00m.

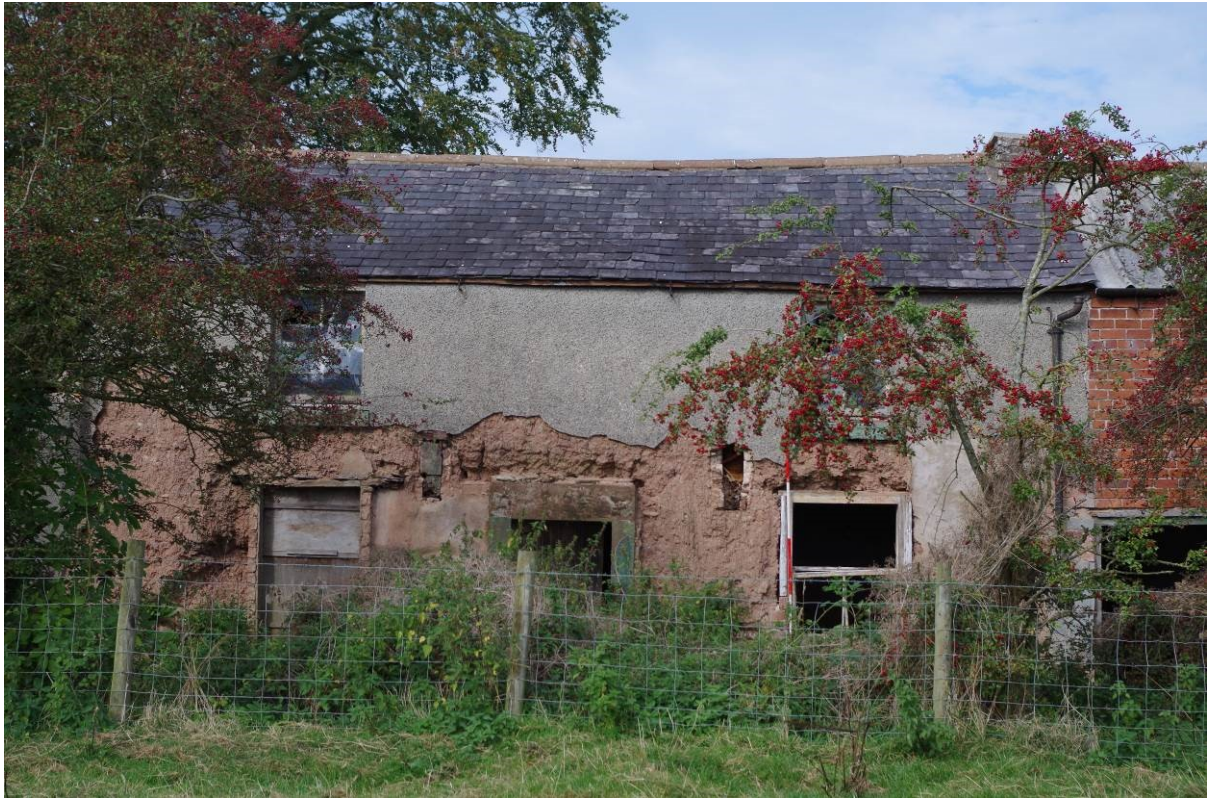
Figure 52. Clay dabbins cottage, southern elevation

The cottage (figure 52) had a cement render applied to the clay dabbins fabric and composed of a central doorway with flanking double sets of symmetrical windows. The Welsh slate roof appeared to be in reasonable condition with a stone ridge. Two chimneys had been truncated and probably disused.

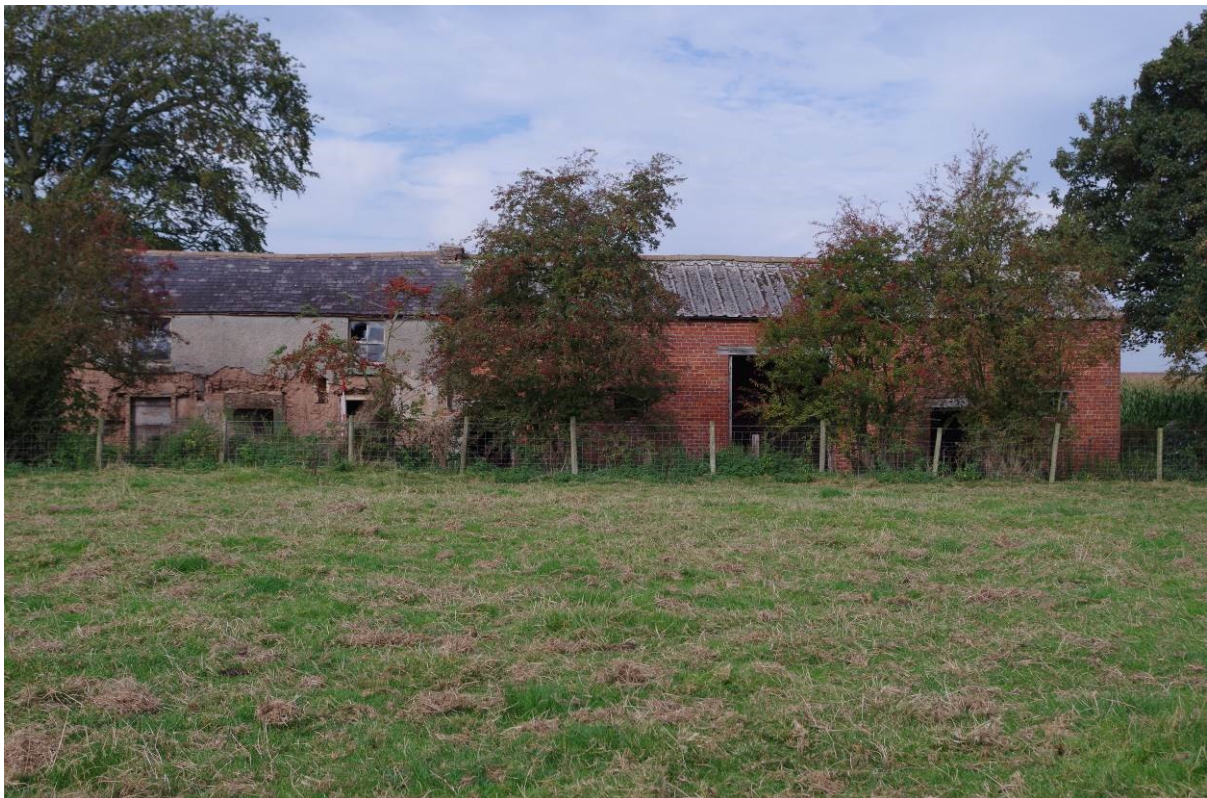
Figure 53. Brick barn southern elevation

The barn (figure 53) was built from red brick probably of late 19th or early 20th century date. The façade was plain and utilitarian and possessed an asbestos roof.

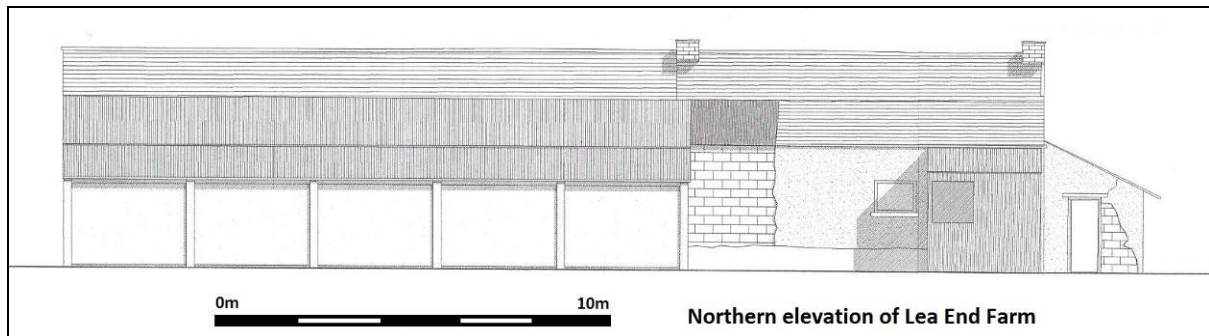
Figure 54. Rear or northern elevation of the study building

The rear elevation (figure 54) possessed restricted access but consisted of two elements; the original clay dabbins cottage and a modern lean-to shed. The overall elevation measured 24.70m in length with the shed being 15.60m in length and the cottage 9.10m in length.

An outshut added to the cottage was partly repaired with modern breeze blocks, conjoining a cement rendered clay dabbins wall.

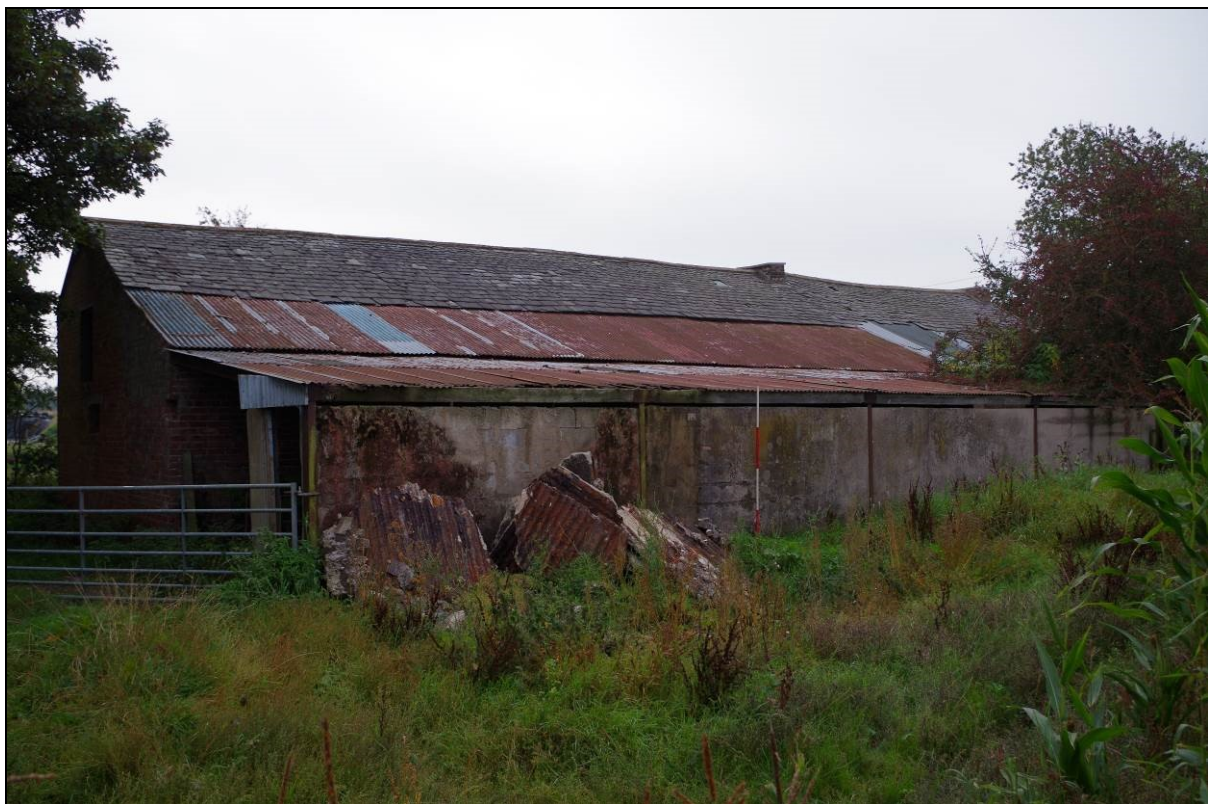
Figure 55. Barn and shed, northern elevation

The shed possessed a corrugated roof that partly extended over the outshut attached to the barn. The walls were formed from pre-fabricated concrete slabs (figure 55).

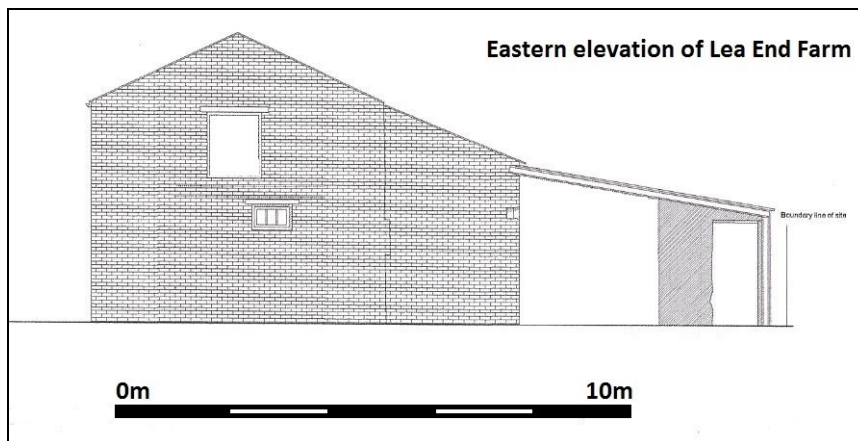
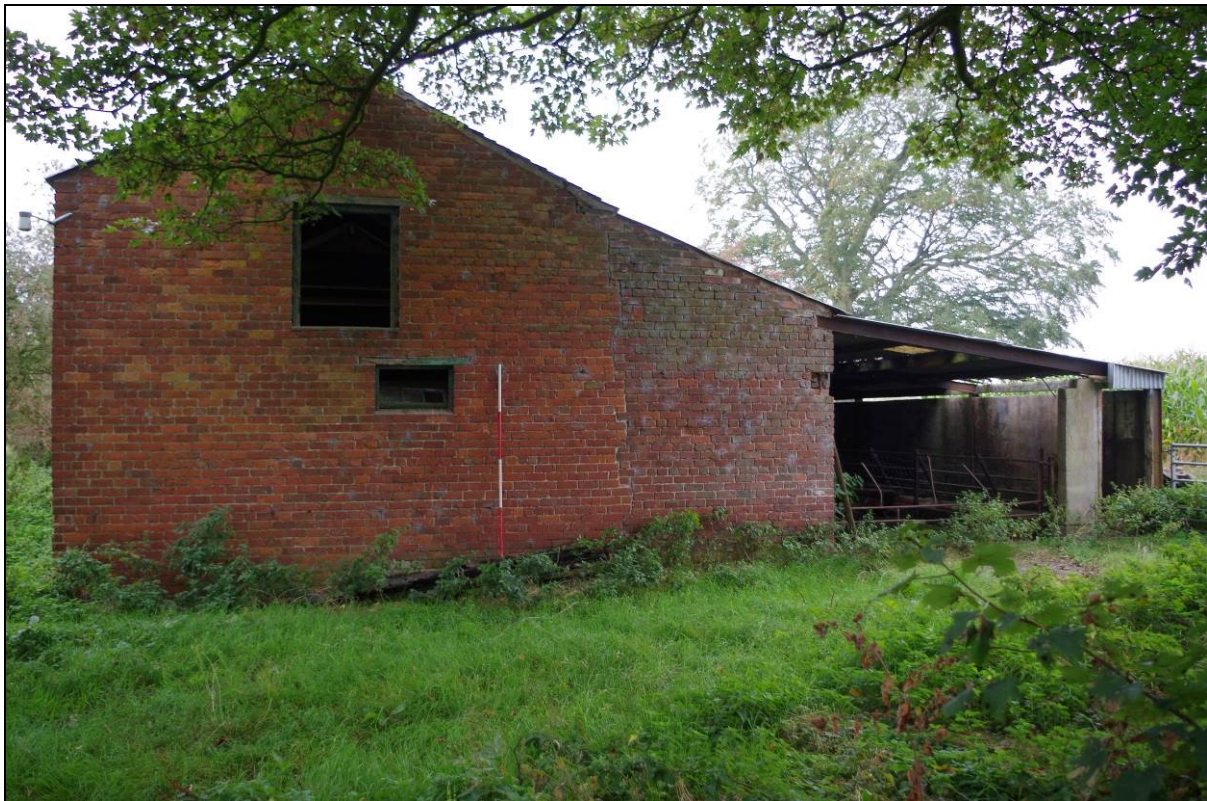
The other buildings did not have dedicated first floor space apart from the roof space above Room 9 that had been used as a hayloft (figures 56 and 57).

The overall elevation measured 12.98m in length and included a brick outshut 2.48m in width and a shed 4.70m in width. The outshut has been added to a central clay dabbins wall which also served as the northern side of the brick barn. The shed was open at the eastern end.

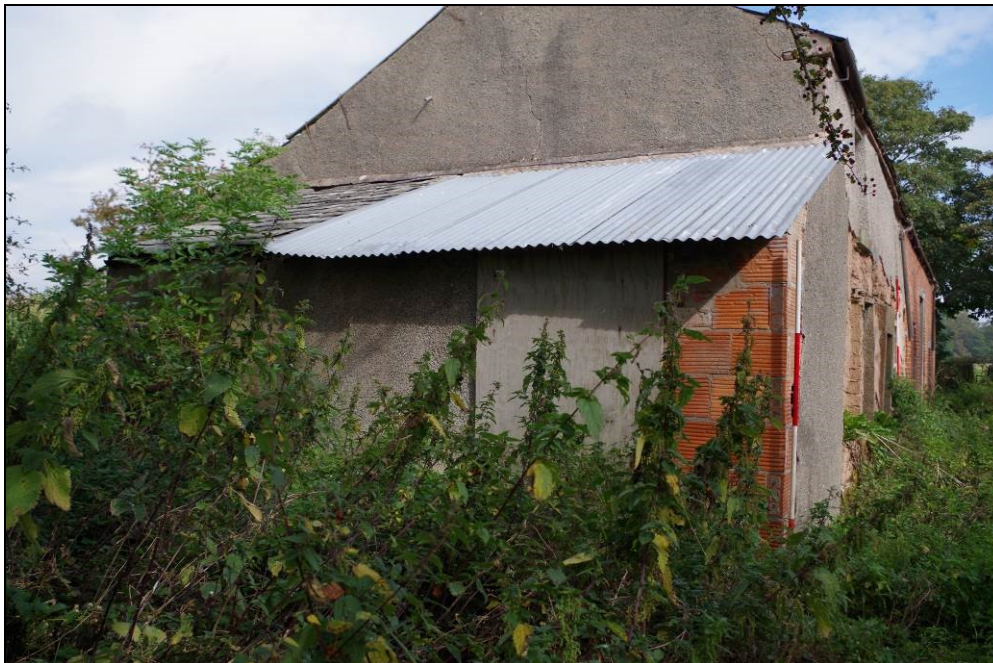
Figure 59. Cottage, western elevation

A modern lean-to was added to the gable end of the cottage (figure 59) as was a corrugated sheet outside toilet.
