## **SUMMARY**

An archaeological watching brief was conducted by Gerry Martin Associates on behalf of RSK Environment Ltd. along the Quay Walls area in Berwick-upon-Tweed (beginning of Quay Walls: NT 99730 52784; Gable end of 23 Quay Walls: NT 99866 52554) for Northern Gas Networks during an essential gas main replacement. This work took place between the 19<sup>th</sup> May and the 24<sup>th</sup> June 2014. The gas main was replaced by insertion of a new plastic pipe into the former metal one for a length of approximately 300m along the street. Observations were made in 29 small hand dug pits along the new main and at connections to individual properties.

The following document presents a summary of the watching brief undertaken during the gas mains replacement.

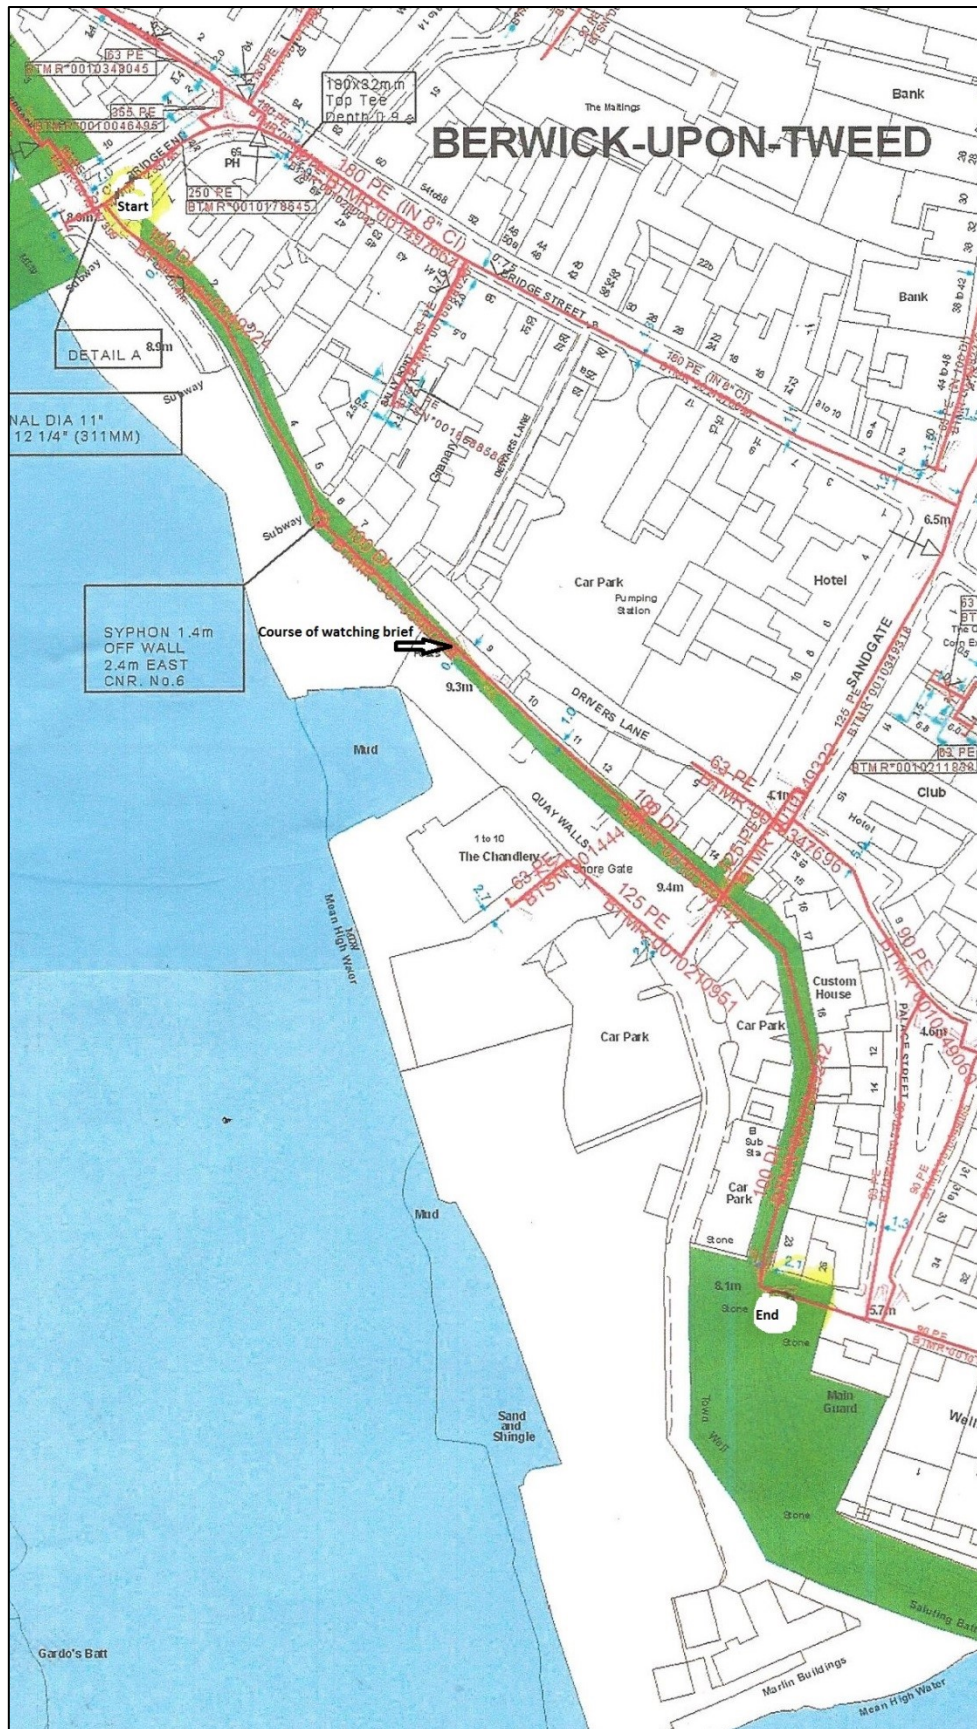
Figure 1. Course of the gas main subject to the watching brief

The work programme involved replacement of the former iron pipe with a plastic pipe inserted within the existing metal pipe and new gas connections to each of the 23 properties along the pedestrian-only walkway of Quay Walls for a distance of 289m. The study area was located along Quay Walls (Figure 1).

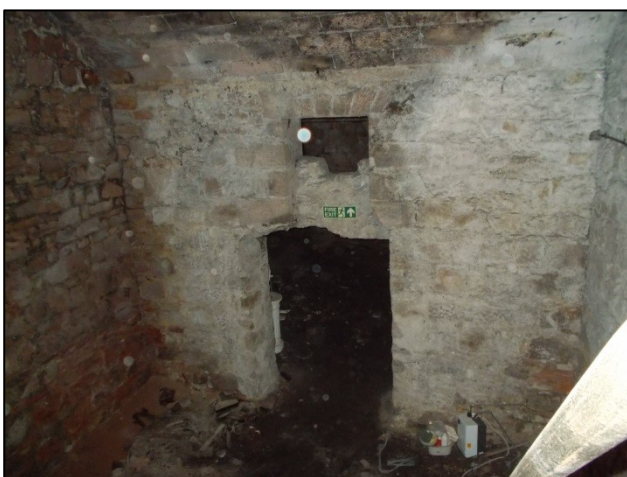
Beneath many of these structures, now used primarily as domestic dwellings, are large basements or cellars (figure 4) that once stored salmon and other perishable goods bound for the London market.

Figure 4. Cellar within 18 Quay Walls

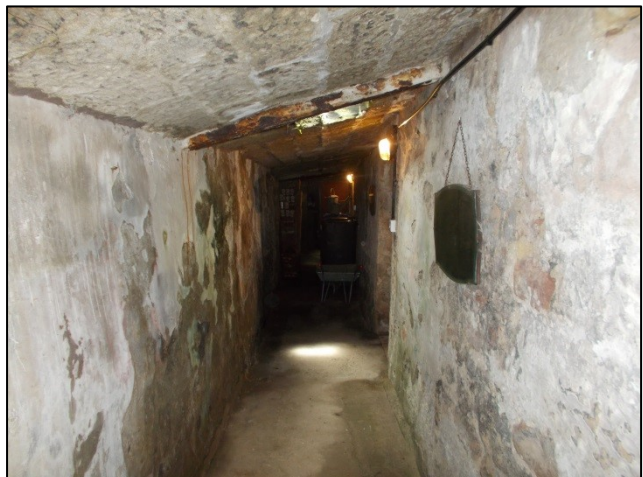
Figure 5. Passage between defences and 23 Quay Walls

In order to allow access to these structures from the harbourside, the town wall was widened to produce a promenade. The underlying pathway therefore became a series of service passages accessing the cellars to these buildings (figure 5).

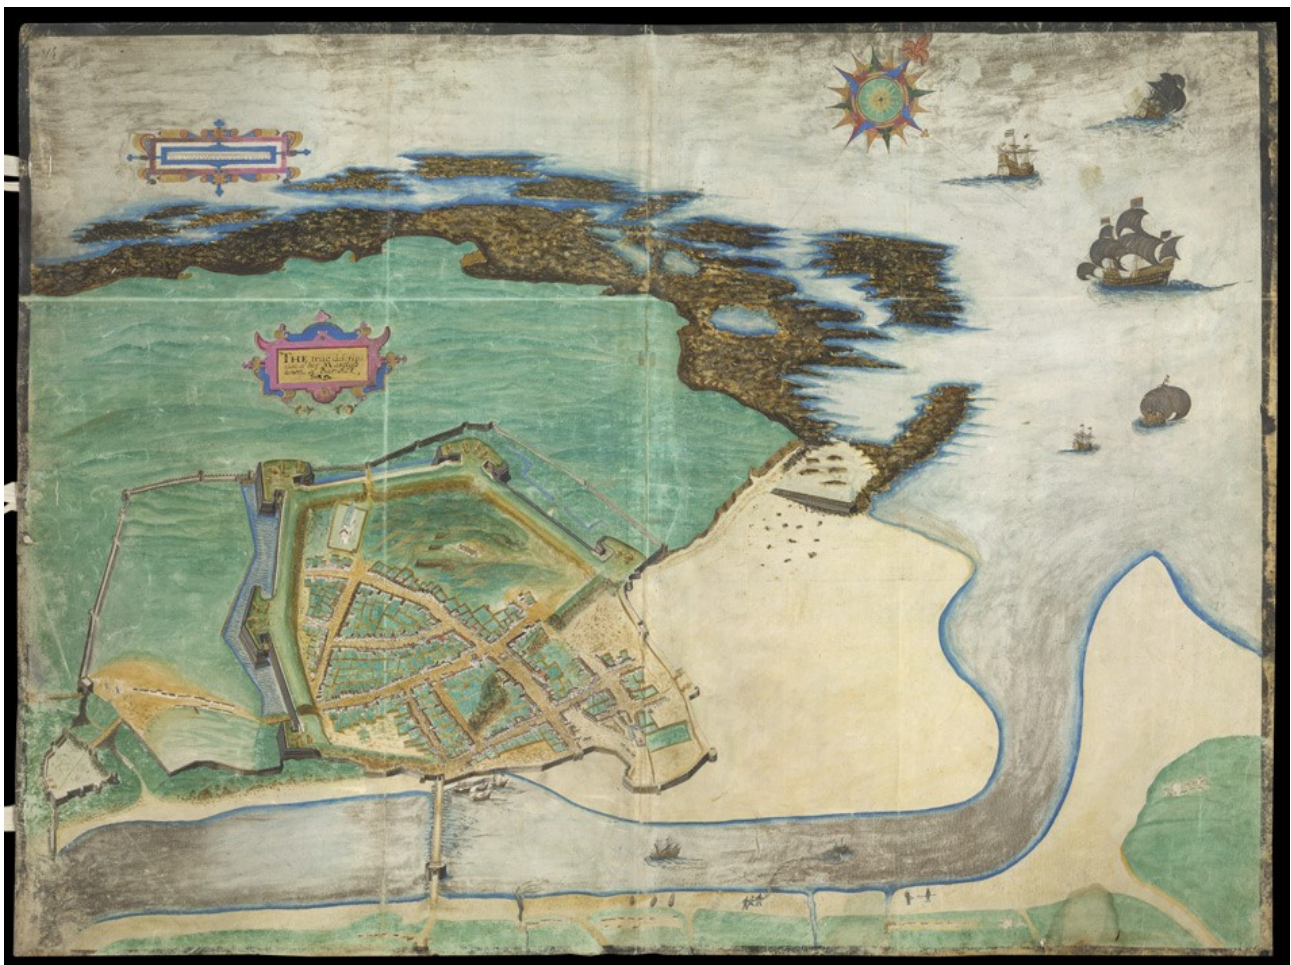
Figure 7. Map of Berwick, 1580

One of the earliest maps illustrating the town of Berwick dates back to *circa* 1580, showing the Elizabethan defences under construction (Figure 7). Although this bird's eye view is not a faithful plan, Quay Walls and a bridge are recognisable. Buildings seem to be located along Bridge Street and Sandgate.

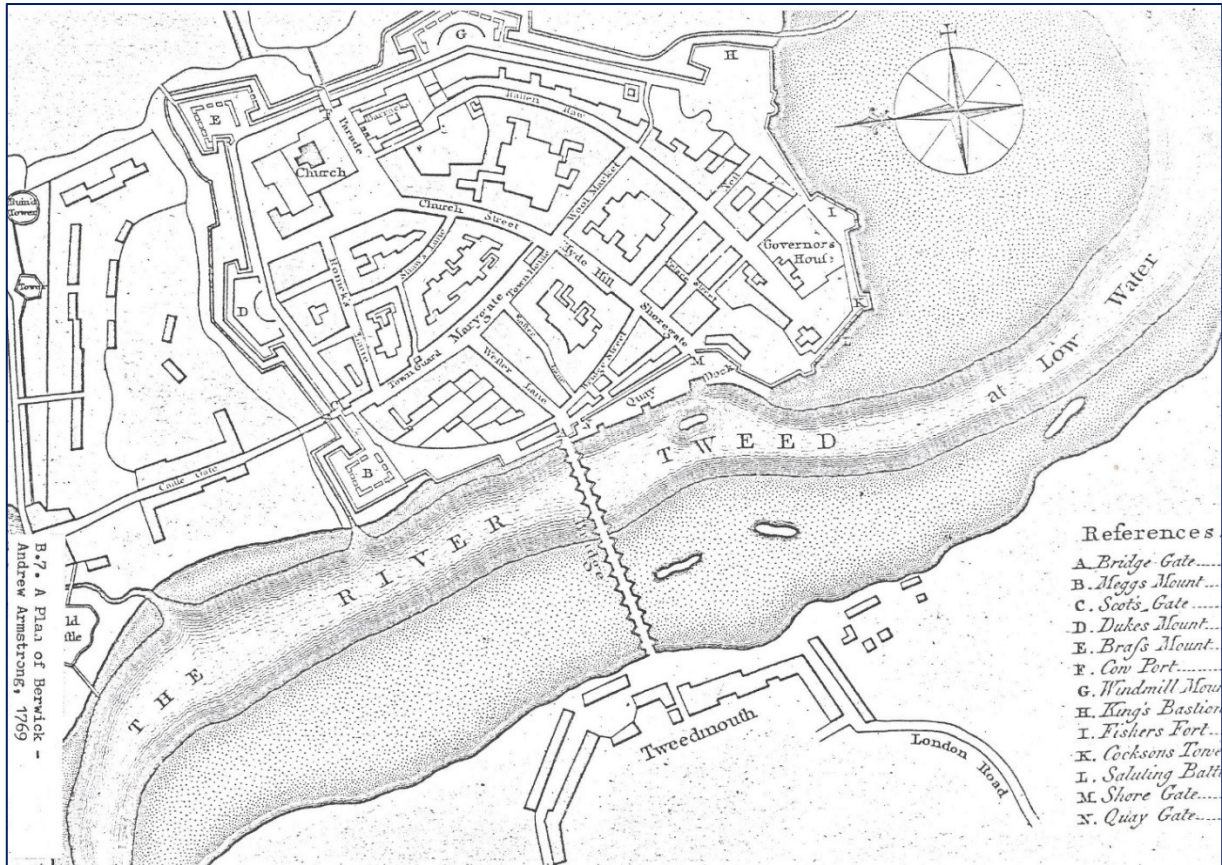
Figure 9. Armstrong's map of 1769

The Armstrong map of 1769 illustrates that buildings were erected alongside Quay Walls but a narrow path separated the wall from the encroachment (figure 9). It is unclear if these structures possessed a residential or industrial purpose (Menuge & Whitey 2005, 27). Most probably the development served both functions serving a burgeoning maritime trade with London.

A dock or basin is illustrated on the 1769 map, a feature that re-occurs in all maps up to the present. A quay is also mentioned demonstrating that a formal waterfront and harbour had been established.

In order to access the houses, a wide stone-built promenade was established on the crest of the wall enclosing the intra-mural path below converting that route into a series of passages. This action probably took place during the late 18<sup>th</sup> century as a map of 1799 (figure 10) appears to depict both the Wall and a suite of houses conjoined whereas an earlier map of 1769 (figure 9) illustrates a spatial division.

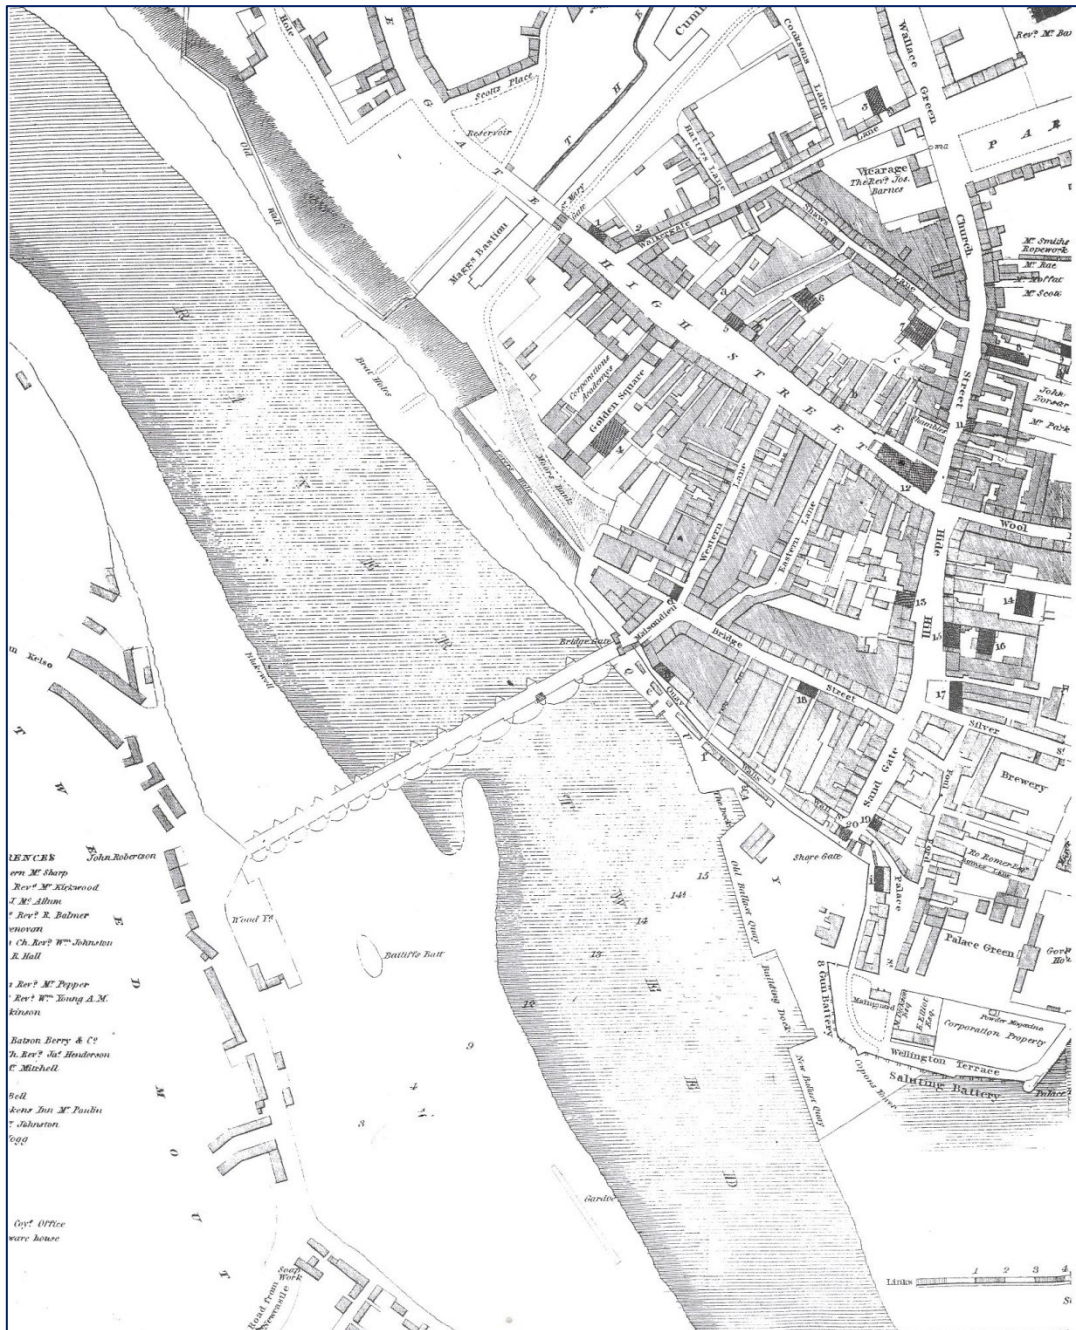
Figure 11. John Wood's Map, 1822

John Wood's 1822 map depicts individual properties that have been fully developed, buildings extending back to Bridge Street (figure 11). This process appeared to be repeated elsewhere in the town suggesting rapid expansion within a generation. However, under-representation on the 1799 map may also explain this difference.

By that time the Quay Walls already had achieved its built-up character, even if buildings appear to be smaller or different in size compared directly to the present urban landscape.

The 1822, 1850 and 1852 maps and the 1862 and 1898 Ordnance Survey maps (figures 11-15) all illustrated buildings on the seaward side of Quay Walls suggesting that the harbour had become formalised by the early 19<sup>th</sup> century.

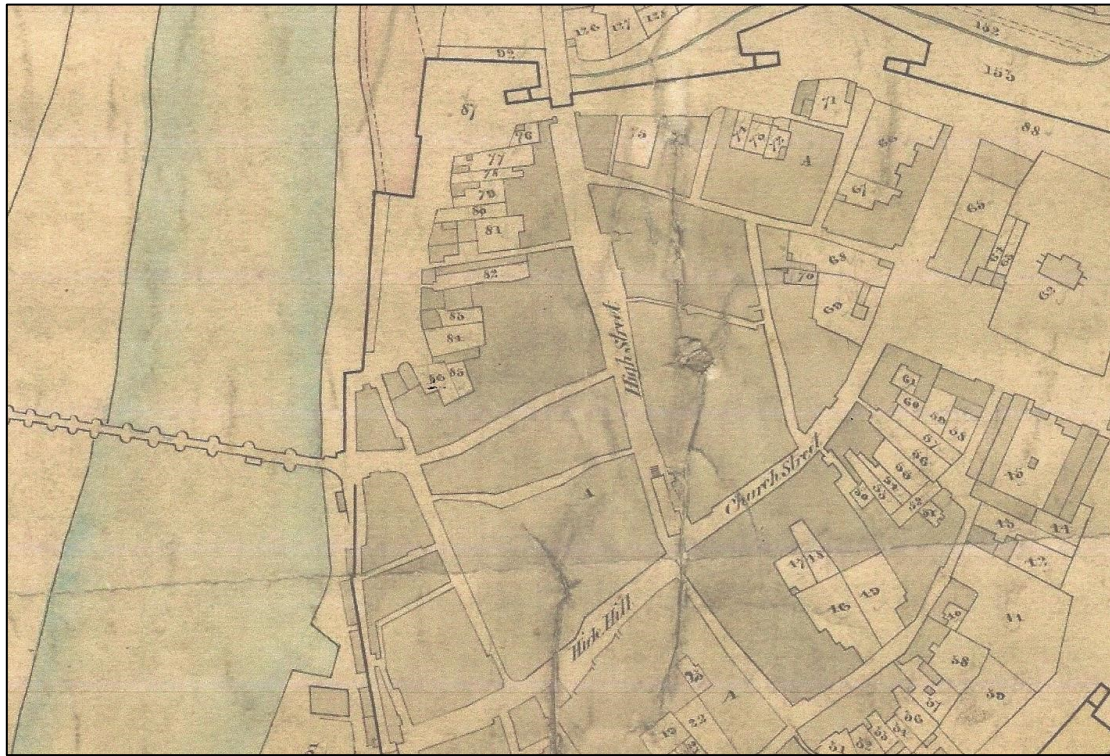
Figure 12 Tithe map of 1850.

The tithe map of 1850 (figure 12) does not list ownership of properties along Quay Walls and only illustrates generic occupation, presumably because the area was exempt from church tithes that were to be commuted to rates.

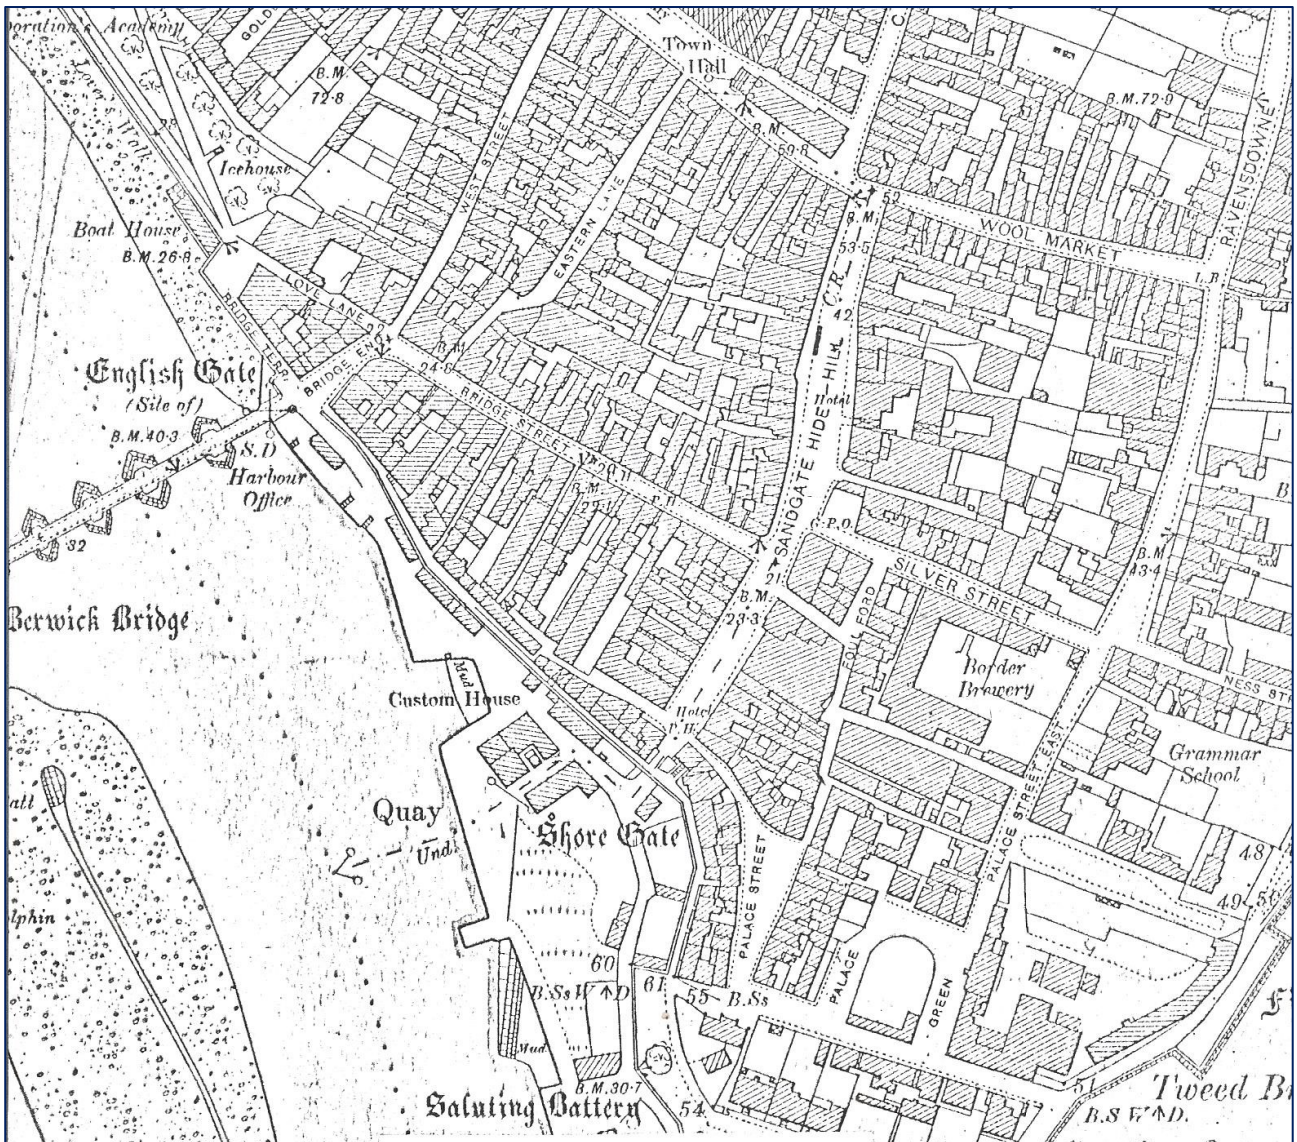
Figure 15. Ordnance Survey second edition map, 1898

The Board of Health 1852 plan (figure 13) together with the 1862 and 1898 Ordnance Survey maps (figures 14 and 15) displayed no substantial changes for the Quay Walls area from the early 19<sup>th</sup> century.

The present disposition of houses along Quay Walls had become established as articulated in the later Ordnance survey maps of 1862 and 1898 (figures 14 and 15).

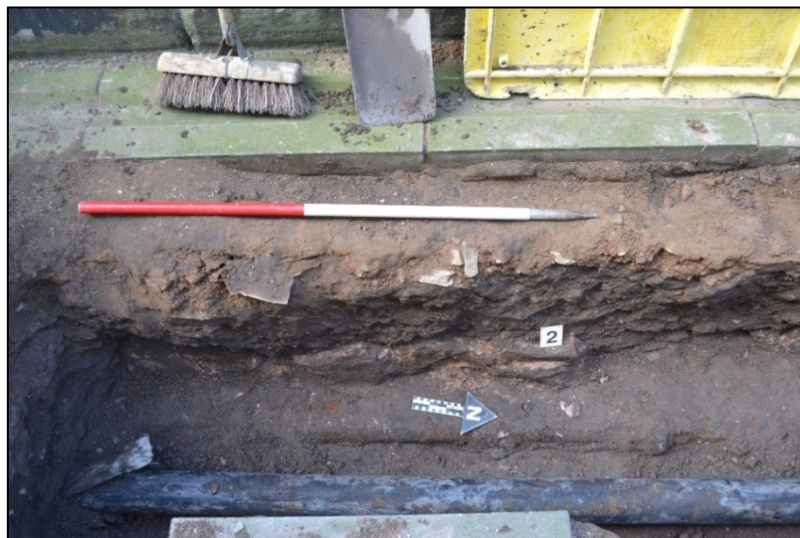
Figure 17. Wall 2

### **Pit 2. Stone Wall**

A yellow sandstone wall, bonded with pink sandy mortar (figure 17). The feature ran along the western side of the pit and was exposed 0.25m below a former cast iron gas main.

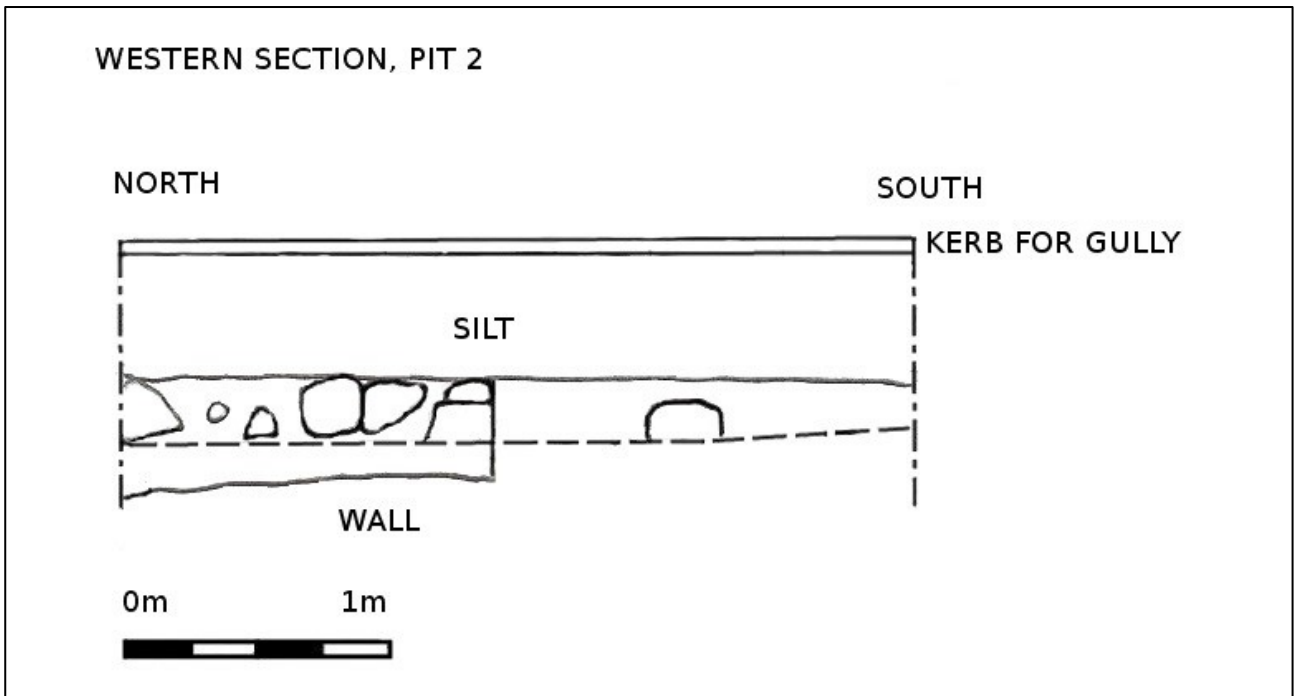
Figure 18. Elevation showing wall 2

The wall measured 3.00m in length and 1.56m in width (figure 18). It represents the inside face of the wall which forms the upper part of Quay Walls walkway. A date between 16<sup>th</sup> to the 17<sup>th</sup> centuries would be consistent with this action.

Wall 2 formed a skin to Quay Wall itself. Possibly, the presence of soil rather than a stone core within the wall was to absorb a shockwave caused by heavy artillery using cannonballs, a development that could be dated to the 16<sup>th</sup> or 17<sup>th</sup> century. This may indicate a later refurbishment of the town defences as military technology and tactics changed.

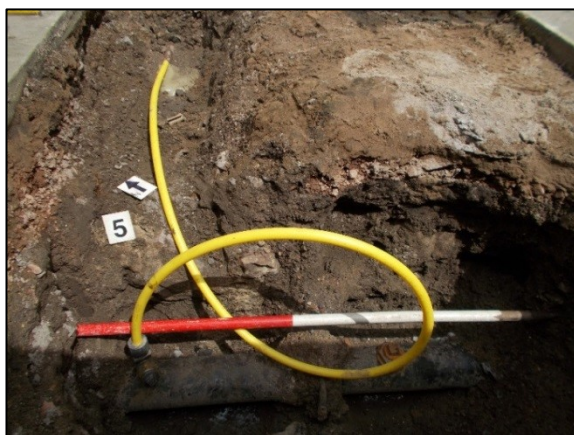
Figure 19. Wall portion 5

An east facing yellow sandstone wall bonded with pink sandy mortar, with a north-south alignment (figure 19).

The remains of this wall probably formed the stone ceiling to an underlying extant passage connecting Quay Walls with cellars or former warehouses.

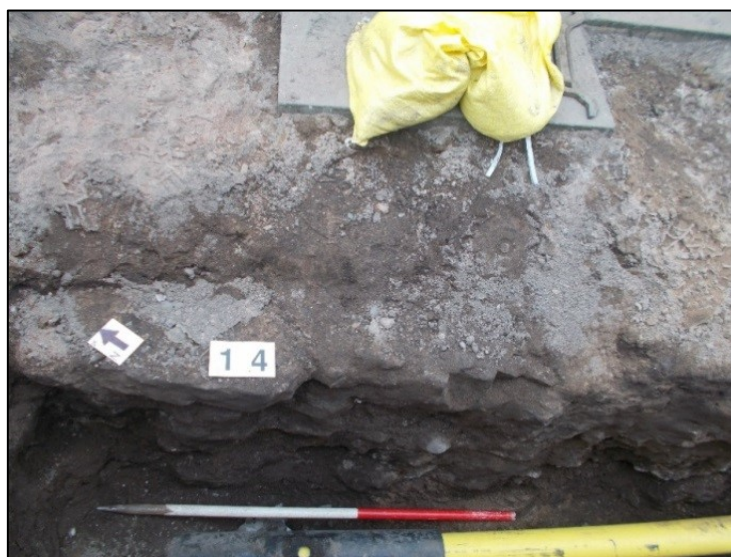
Figure 21. Wall 14

A yellow sandstone wall bonded with pink sandy mortar, running along the eastern side of pit, orientated north-south slightly damaged by later intrusions (figure 21).

The remains of this wall probably formed the stone ceiling to an underlying extant passage connecting Quay Walls with cellars or former warehouses.

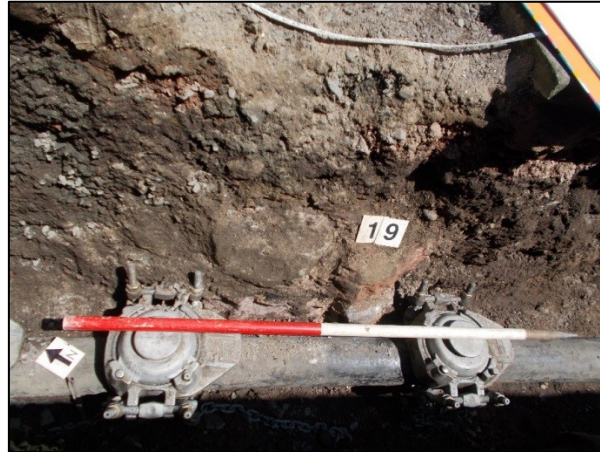
Figure 23. Wall 19

**Pit 19. Stone Wall Portion**

A portion of a stone wall facing eastwards. The feature possessed a north-south orientation consisting of sandstone boulders bonded together with pink sandy mortar (figure 23). It measured 0.50m in length and 0.37m in width, located 0.40m below current ground surface.

The remains of this wall probably formed the stone ceiling to an underlying passage connecting Quay Walls with cellars or former warehouses.

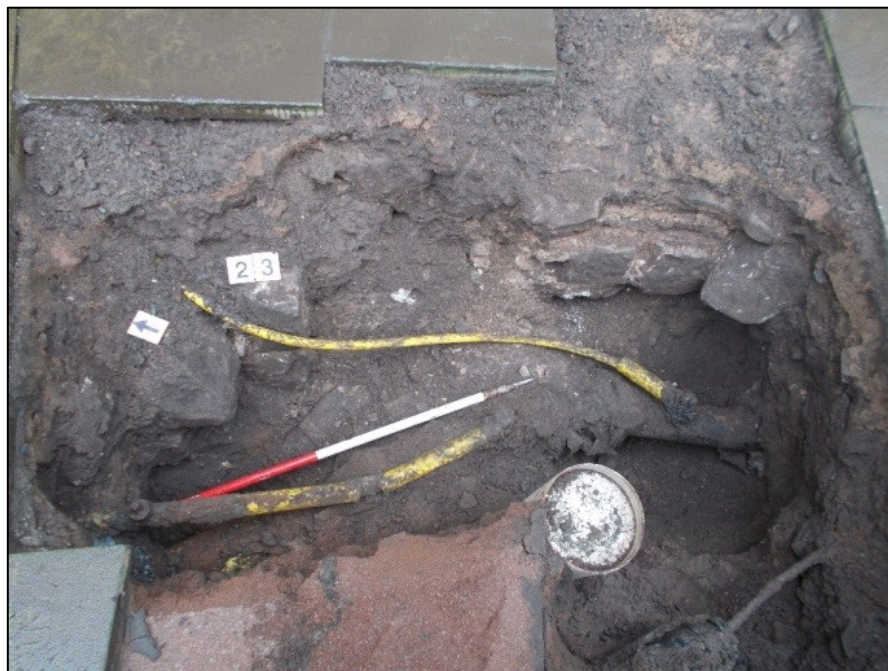
Figure 24. Wall 23

**Pit 23. Stone Wall**

This wall represents the ceiling to a tunnel connecting Number 23 Quay Walls Cellars.

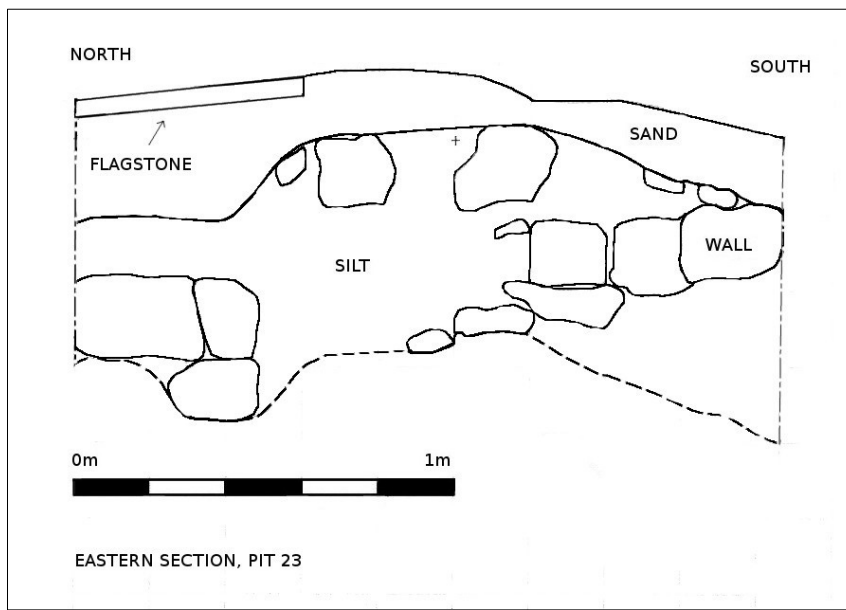
Figure 25. Elevation showing wall 23

The wall was not preserved in its entirety. Parts of the wall had been probably removed and replaced by silt backfill (figure 25).

The pattern and configuration of the stones at the southern end of wall may suggest the presence of a vault.

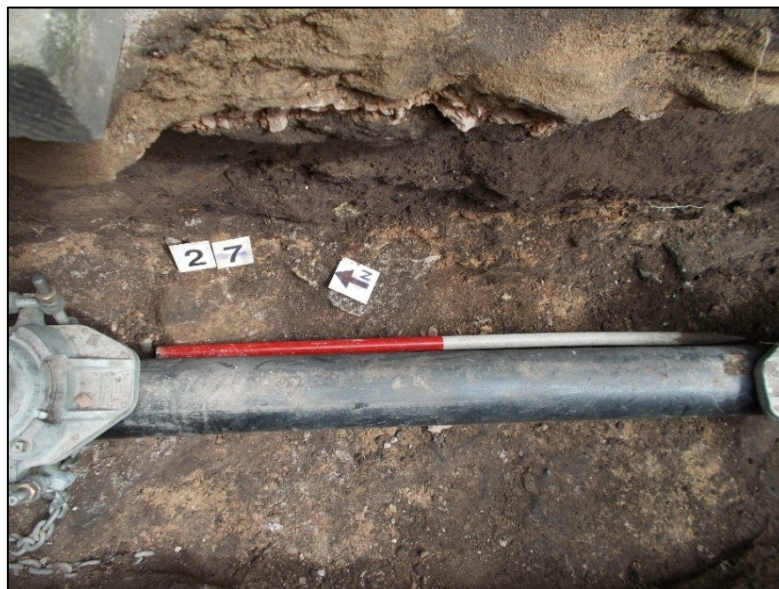
Figure 26. Wall 27

#### **Pit 27. Stone Wall**
