The major topographic feature that was encountered was a north-south aligned track **11/40/50** that sat within a narrow holloway.

Gerry Martin was commissioned by Mr Edmond Jackson, (the landowner) to prepare a Specification of Works for a Programme of Archaeological Evaluation within fields at Belle Mount, Papcastle.

This report describes the results of that archaeological reconnaissance and its archaeological context summarised in the following report.

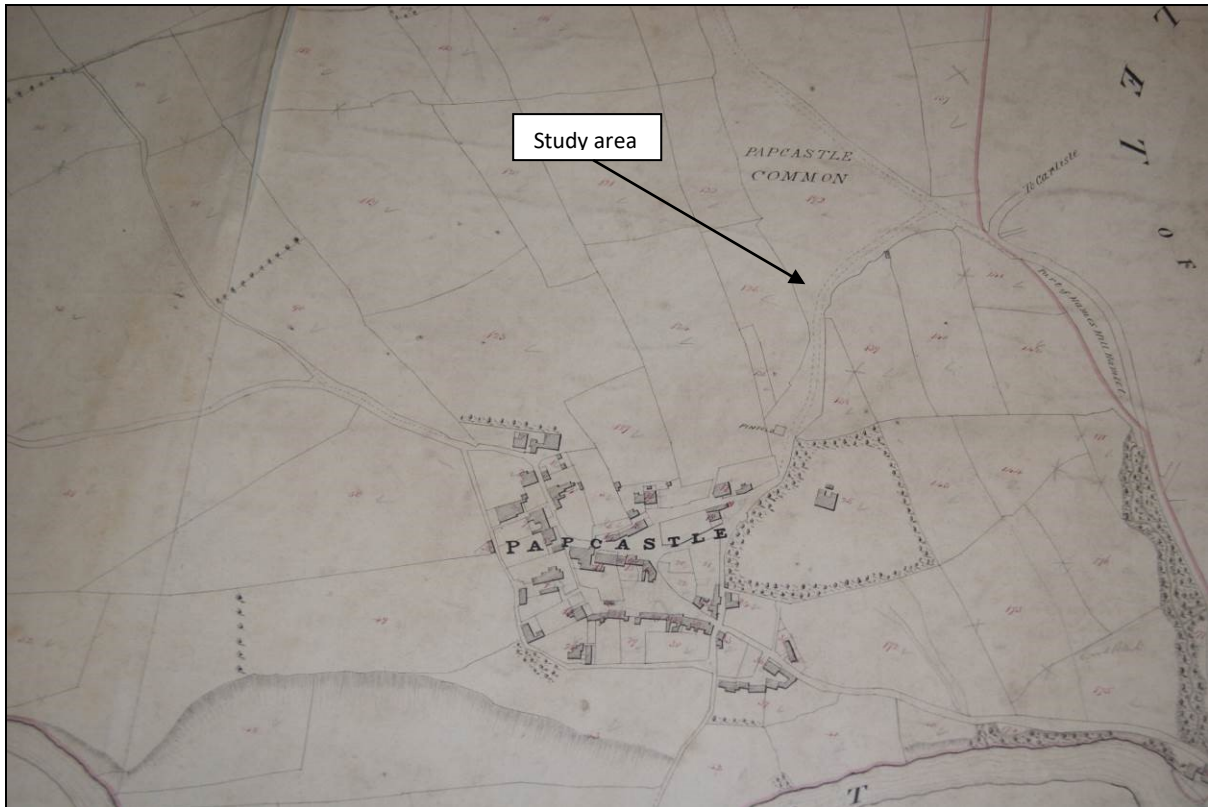
Figure 3. Tithe map depicting possible spatial anomaly

The 1838 Tithe Map (figure 3) depicts a series of rectangular fields, almost certainly the result of agglomeration of Medieval strip fields. However, there is a wide “funnel-like” strip of land that includes the road from Papcastle to Belle Vue and then splays northwards as an arcing boundary before encompassing Papcastle Common. This does not appear on later Ordnance Survey maps.

John Wood's map of 1832 is a slightly more schematic version of the Tithe Map initiated in 1838 (figure 3) and lists owners of properties. Occupation of the study area in both versions appears to be non-existent and that the land was vacant.

A wall **10** and underlying bank **13** represented a major topographic feature that appears to respect the western extent of Papcastle Common (figure 3). This feature was observed on a Google Earth image (figure 6).

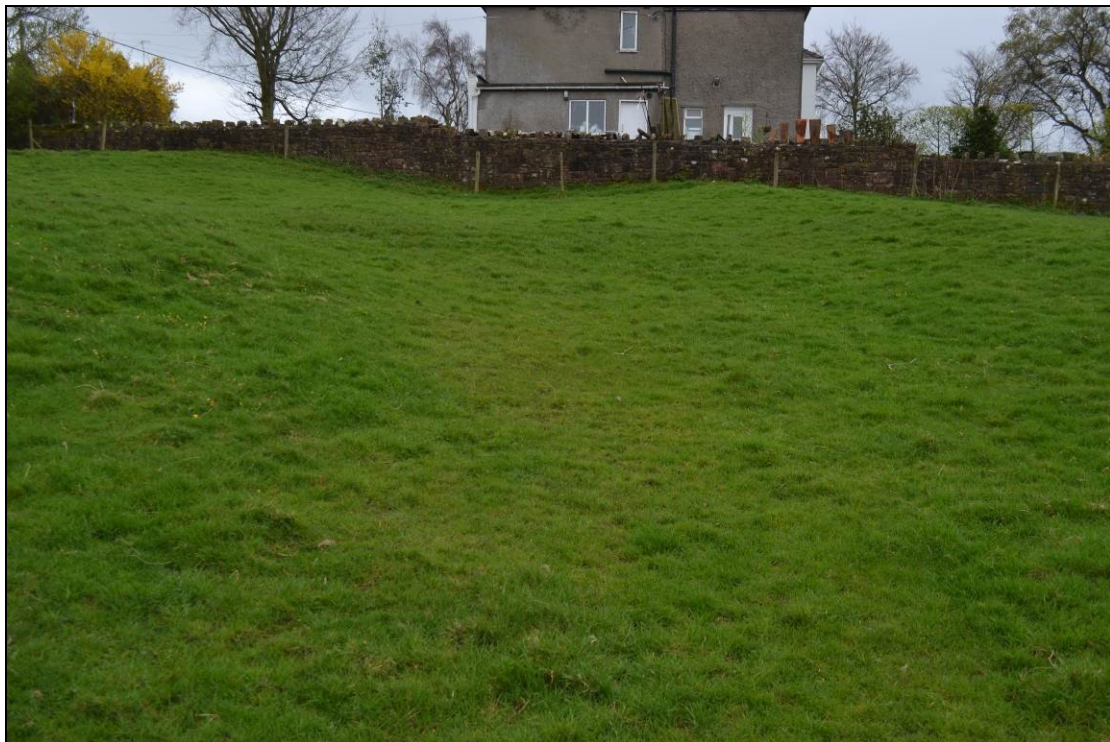
Figure 4. Possible holloway or sunken track with Belle Mount in the background

At first sight, there is no obvious reason for this variation but during the walk-over of the site conducted on April 12th 2014 a possible holloway and track may have been identified (figure 4). It appears feasible that the arcing boundary on the Tithe Map is the western bank of a putative road or track.

There is no direct evidence that this topographic feature may have a Roman origin and it could even be a natural runnel, but it may explain the absence of a road that would link the fort at Papcastle with Carlisle, predicted in the field opposite Belle Mount.

A possible holloway or sunken track with adjacent banks appeared to head directly towards Belle Mount (figure 4). Other smaller outcrops could also represent earthworks (figure 5). The area has in the past been subject to strip field agricultural practice, but the close proximity to the fort may also indicate extra-mural Roman activity.

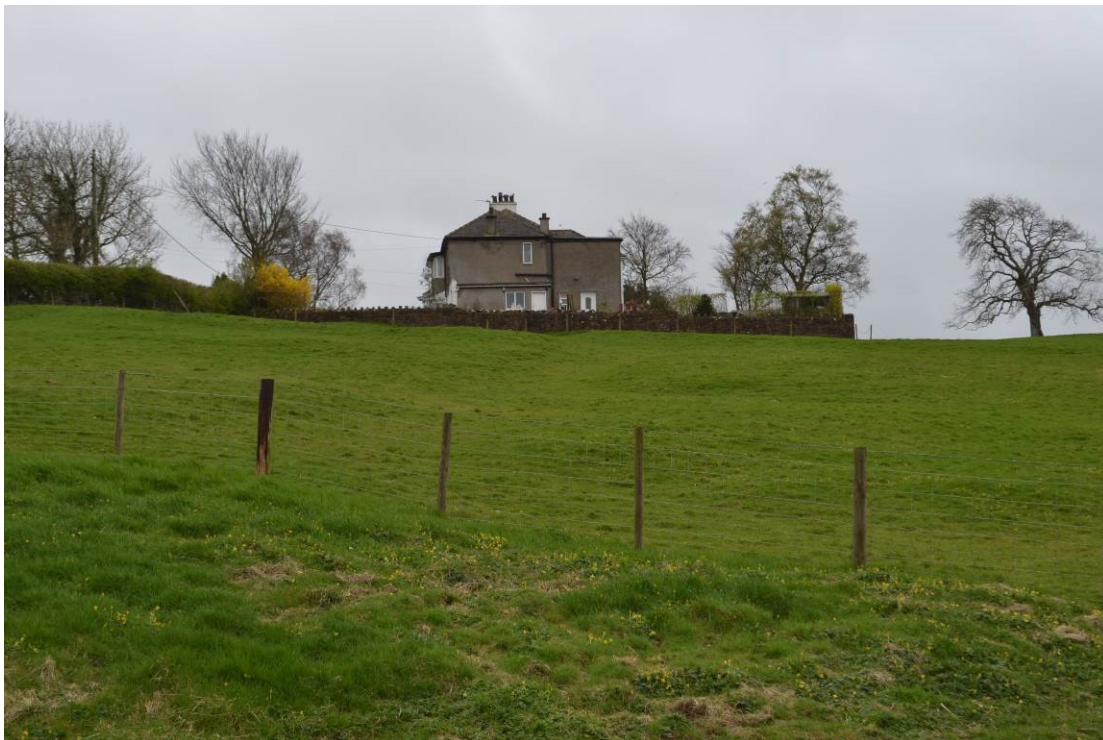
Figure 5. Aspect showing unidentified features

Complicating the study area, was the presence of a high-pressure sewer main that pumps sewerage to an outfall just to the left of Belle Mount marked by a yellow shrub or tree (figure 5). An exclusion zone of 4m either side of the pipe had to be respected when fieldwork took place. This could represent a serious impediment for understanding the relationship of any features with the current road frontage.

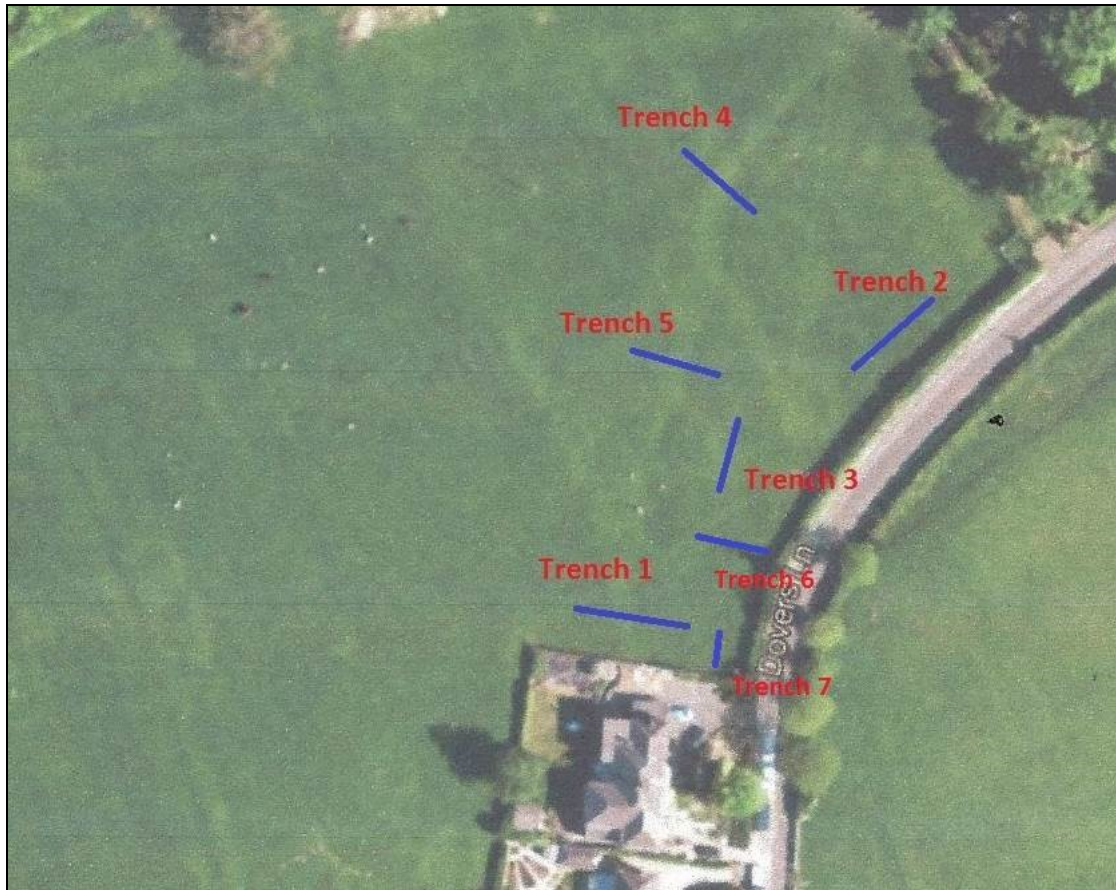
Figure 7. Location of trenches

All the seven trenches rested above undisturbed ground comprising gravel till, pink Boulder Clay and sandy outwash and were located in the following configuration (figure 7).

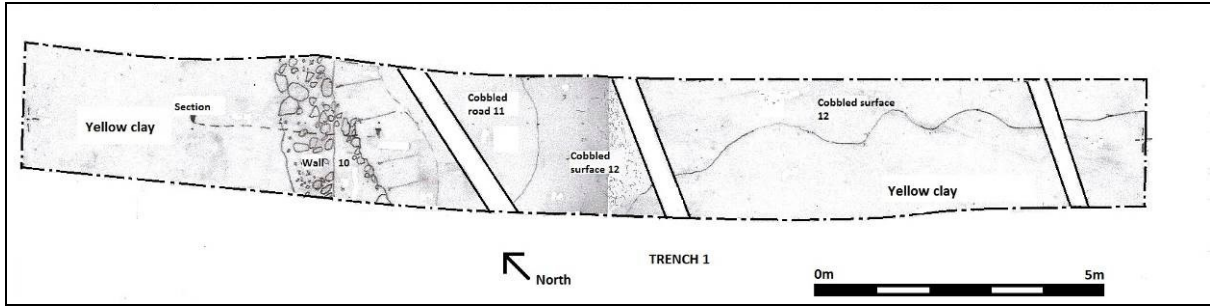
Figure 8. Plan of Trench 1

Trench 1 (figure 7) measured 20.00m x 2.00m, located at the southern end of the study area at NY 11106 31640, reduced to a depth of 0.60m.

The following key observations were undertaken within Trench 1 (figure 8)

1. Overburden. This consisted of brown silty clay that contained a high proportion of rounded, small pebbles to a depth of 0.60m.
2. Bank. At the western end of the trench there existed a north-south alignment of large, rounded boulders (up to 0.44m in size) that had been deliberately placed above each other without a bonding matrix to form a probable field wall **10** (figure 10). These stones rested on a bed of yellow brown silty clay **13** that formed an earthen bank 0.35m in height and spread over cobbled surface **11** (figures 9 and 11).

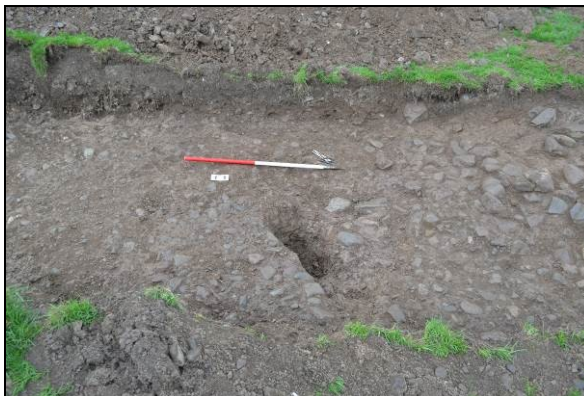
Figure 12. Cobbled road 11

3. Road. Respecting bank **10** was a cobbled surface **11** within a yellow brown silty clay matrix, aligned north-south that measured 3.50m in width (figure 12). The track was well-articulated beside wall **10** but dissipated to the east merging with cobbled surface **12**.

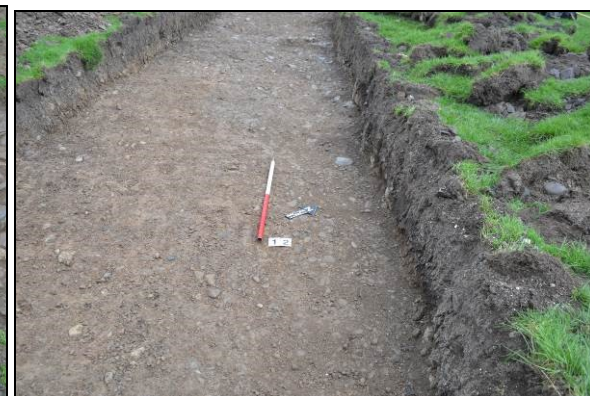
Figure 13. Cobbled surface 12

4. Cobbled surface. A surface of small rounded pebbles set directly onto the underlying yellow brown gravelly clay that formed a surface of uncertain form **12** (figure 13). Its alignment remains unknown but probably continued into Trench 3, whilst a similar spread did not continue west of wall **10**.

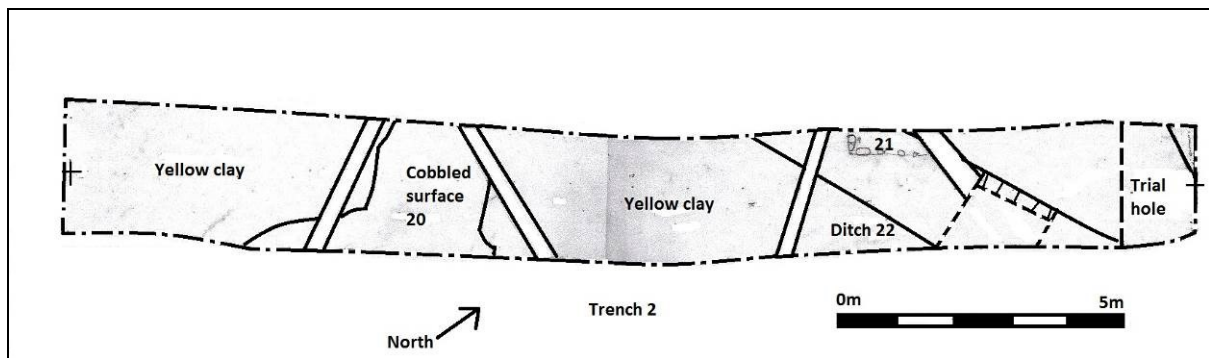
Figure 14. Plan of Trench 2

Trench 2 (figure 7) measured 20.00m x 2.00m at NY 11123 31675 and was located parallel to the eastern bend in Dovers Lane, reduced to a depth of 0.40m.

The following key observations were undertaken within Trench 2 (figure 14):

1. Cobbled surface. A concordant cobbled surface **20** formed from a single course of pebbles (figure 16). No structural elements were observed within the cobbled surface.
2. Stone setting. A possible rectangular plan stone setting **21** aligned approximately north-south. Upon excavation, it appears probable that this feature represented a relatively recent feature cutting the backfill of ditch **23** and in turn cut by a 19th century land drain.
3. Ditch. A shallow east-west aligned ditch **22** (figure 17) approximately 0.40m in depth filled by light brown slightly silty clay with occasional rounded pebbles **23** (figure 15).
4. Overburden. This consisted of brown silty clay that contained a large proportion of rounded, small pebbles to a depth of 0.32m.

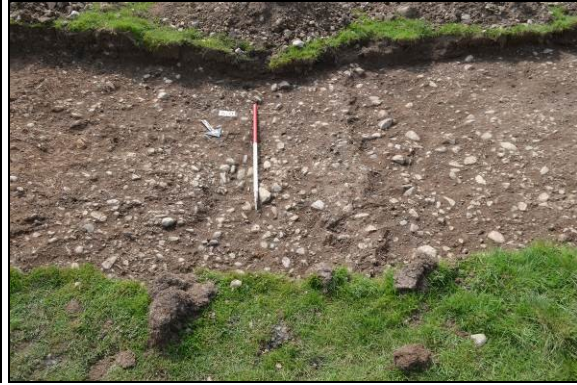
Figure 22. Cobbled track **50**

1. Cobbled road. A roughly concordant cobbled surface **50** formed from a single course of pebbles (figure 22). This featured sat in a slight holloway approximately 3.00m in width and was part of the same track articulated by contexts **11** and **40**.
2. Overburden. This consisted of yellow brown silty clay that contained a moderate amount of rounded, small pebbles to a depth of 0.30m, reducing to 0.20m in depth above track **50**.

A cobbled track consisting of surfaces **11**, **40** and **50** nestling within a shallow hollow could be traced for 57 metres in a generally northwards direction (figure 28). This track confirmed the cropmark illustrated on a Google Earth image (figure 6).

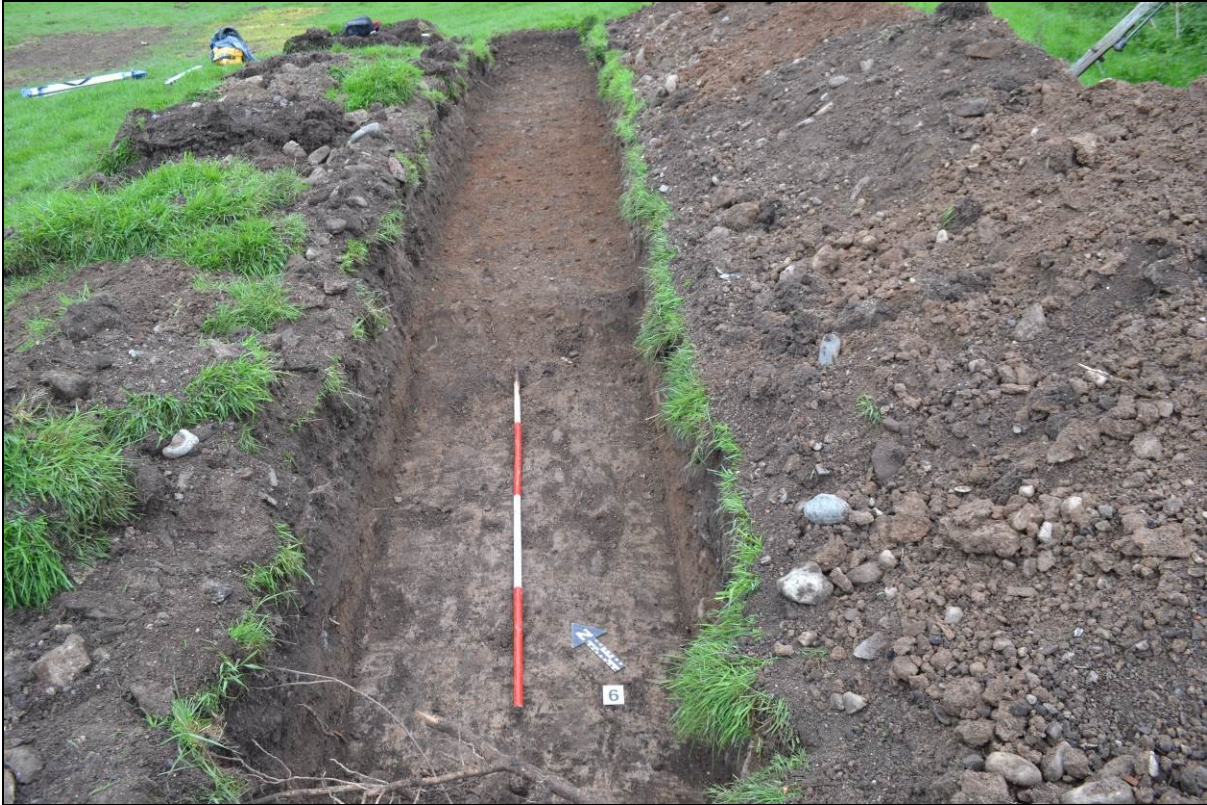
Figure 24. Trench 6

Trench 6 (figure 7) measured 10.00m x 1.10m at NY 11105 31647 and was located across a slightly raised piece of ground, reduced to a depth of 0.80m.

The following key observations were undertaken within Trench 6 (figure 24):

1. Overburden. This measured 0.70m in depth comprising 0.20m in thickness of dark brown clean silt, overlying 0.25m in thickness of cream mortar and stone debris with occasional brick, sealing brown clay silt 0.20m in thickness representing a buried agricultural horizon. A further 0.10m of orange-brown silty clay was removed (figure 25). This action was initiated no earlier than the 19th century.
2. Archaeologically sterile. No cobbles were present.

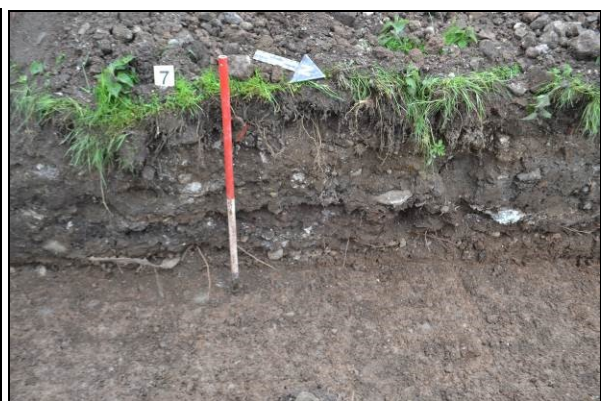
Figure 26. Section in sterile Trench 7

1. Mound. This feature measured 0.75m in height comprising cream mortar and stone debris, brick and other building waste, sealing light brown clay with occasional pebbles. A further 0.10m of light brown clay representing drift geology was removed (figure 26). This deposition action was initiated no earlier than the 19th century
2. Archaeologically sterile. No cobbles were present.

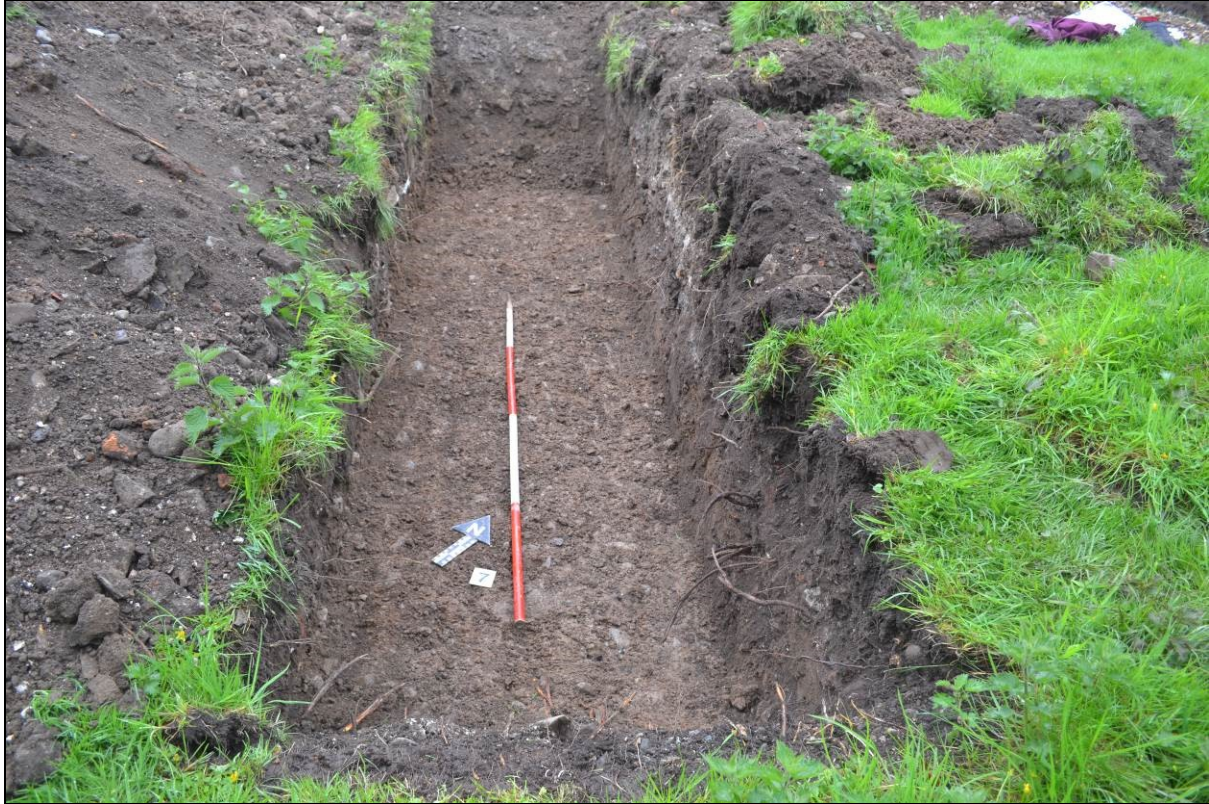
Figure 27. Plan of Trench 7

Trench 7 (figure 7) measured 5.00m x 1.10m at NY 11106 31638 and was located on a raised piece of ground, reduced to a depth of 0.85m.

The following key observations were undertaken within Trench 7 (figure 27):
