Within the footprint of the demolished building, the watching brief action revealed that no cultural deposits of any antiquity existed.

Cumbria County Council's Historic Environment Service (CCCHES) was consulted by Carlisle City Council regarding planning permission for a replacement building at Rickerby Cottage, Rickerby, Carlisle (figure 1). The planning application is number 2012/0835.

Gerry Martin Associates Ltd has been commissioned by Mr Simon Price, the client, to undertake a Programme of Archaeological Watching Brief relating to the ground works for this development.

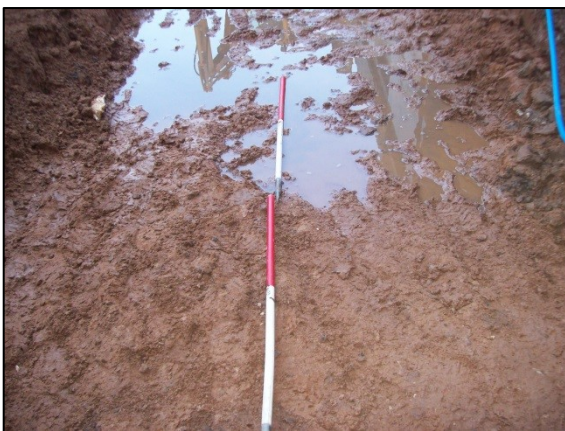
Figure 7. Natural alluvium

Once the heavy debris was removed, a toothless bucket removed the remaining spoil to reveal a clean horizon of orange clay sandy silt that represented a natural alluvial deposit lain in the distant past prior to cultural engagement in this area (figure 7).

Alluvium was encountered at a depth of 0.50m below current ground height.

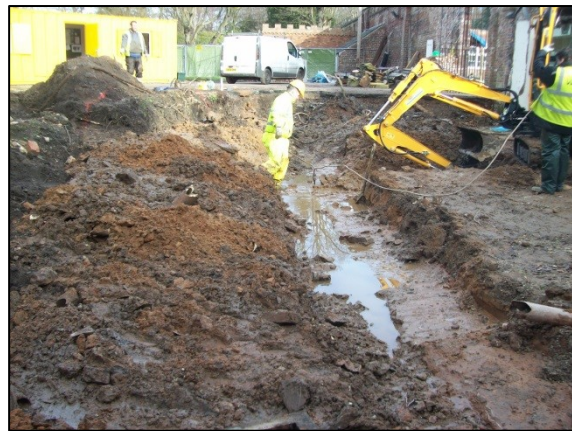
Figure 8. Excavation of footings

New footings 0.70m in depth from the height of the driveway were inserted by machine using a toothless bucket. Once more only natural alluvial geology was encountered (figure 8).
