The barn surveyed at Hayrigg Farm, Pelutho comprised of three units: a cart shed, cow shed, and byre with dovecote. The barn was architecturally plain, constructed from local red sandstone and displaying few if any architectural embellishments that characterised vernacular style and consequently period.

The study building was located at NY 12579 50653 and is part of planning application 2/12/0083.

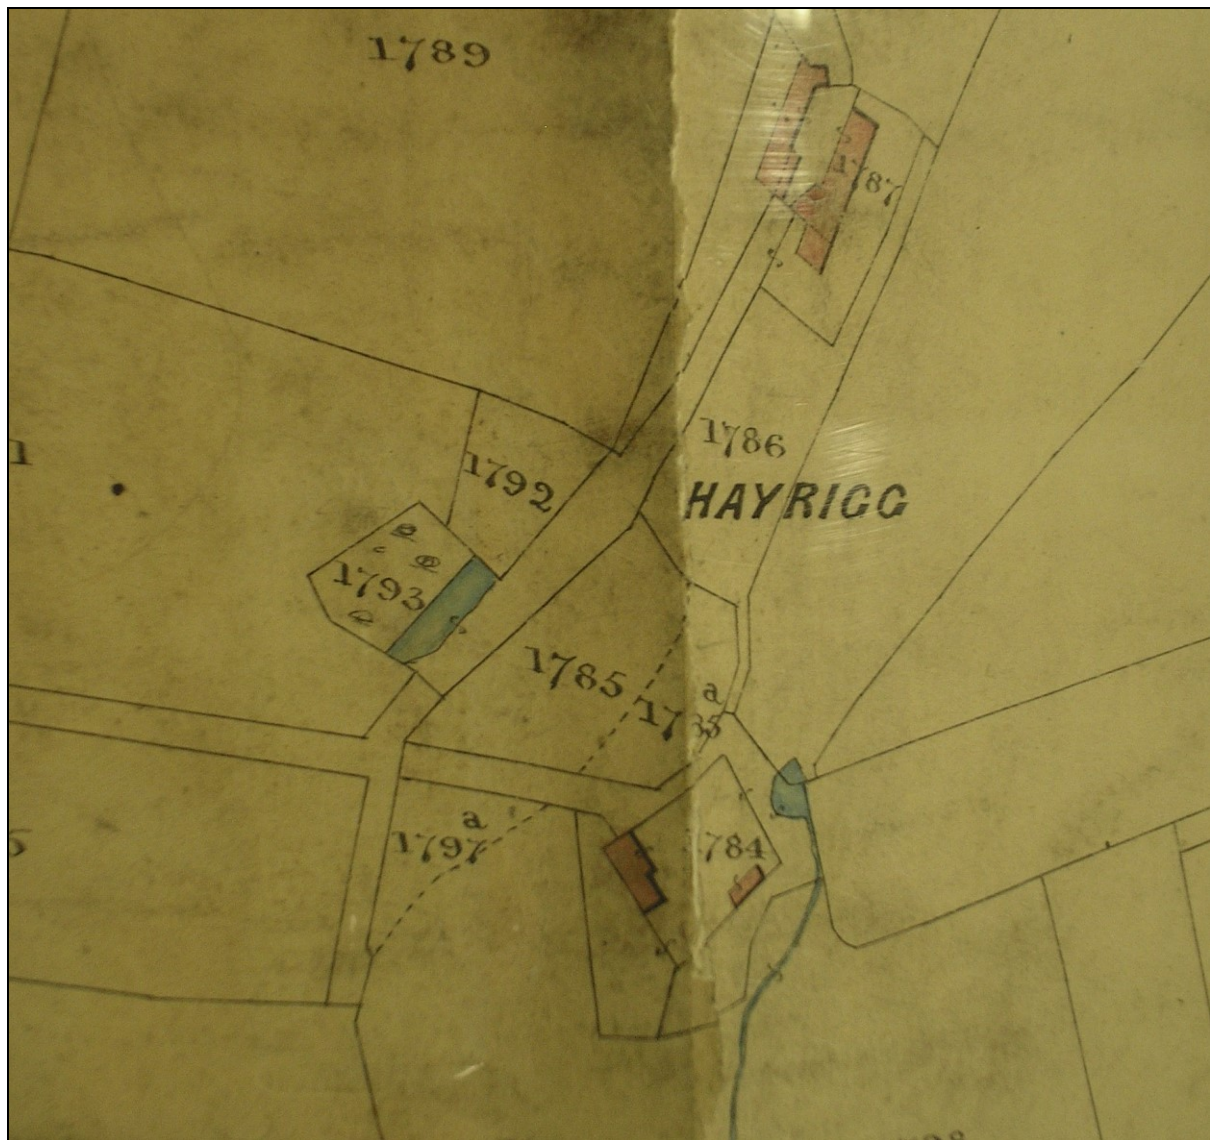
Figure 4. Tithe map of 1850 DRC/8/93/2 showing the study building

Following enclosure, two large units were established at this location; Hayrigg Hall just to the south and Hayrigg Farm (figure 4).

A large, rectangular plan, open building constructed from red sandstone was introduced in 1853 (figure 5) that probably served as a corn mill replacing a curiously triangular-shaped building illustrated on the tithe map (figure 4).

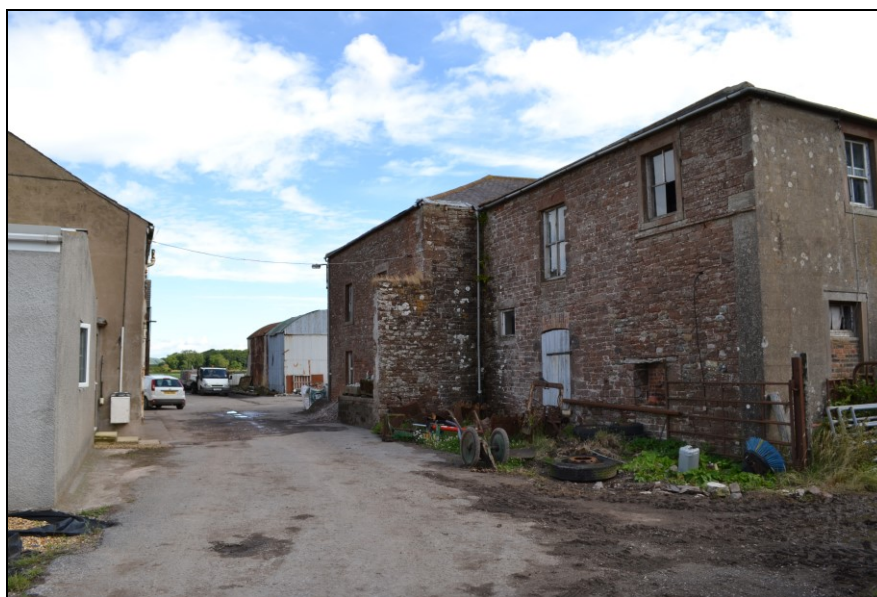
Figure 5. Probable corn mill built in 1853

This building possessed a date-stone engraved 1853 and consisted of neatly dressed sandstone blocks, partly cement-rendered for weather-proofing. This building is depicted on the 1868 Ordnance Survey map (figure 6).

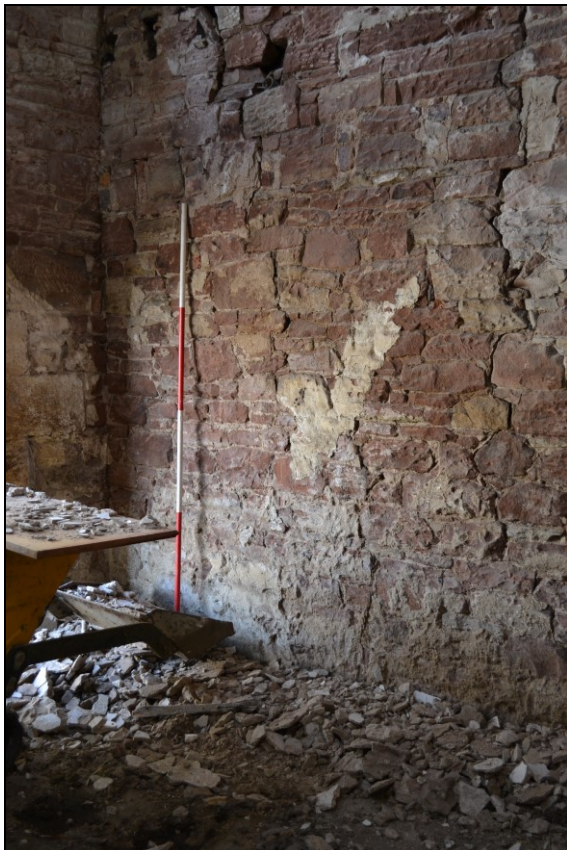
Figure 8. Interior of the cart shed

The interior walls had been plastered but the plaster had been largely removed leaving a surface of dressed, rubble-stone bonded by a lime mortar (figure 8). The principal ingress was from the north through a large opening 2.20m in width.

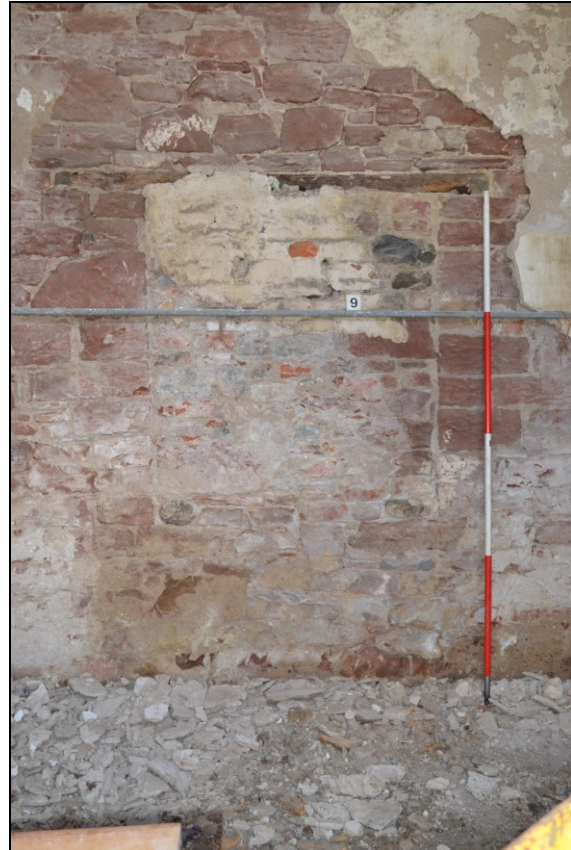
Figure 9. Filled window (9)

On the southern wall was a filled window (9) measuring 1.20m x 1.20m possessing a decayed timber lintel with dressed red sandstone blocks forming the surround. The filled window was covered with cement render.

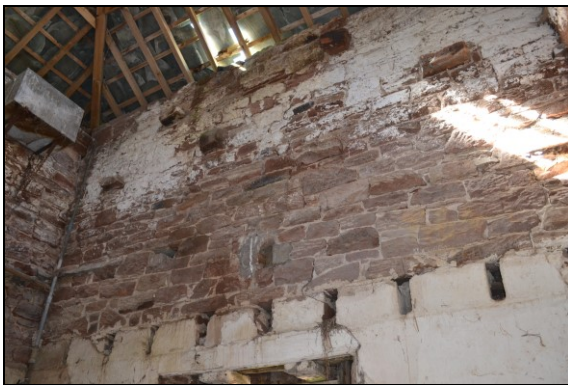
Figure 10. Roosts for birds

A series of stone offsets provided roosts for birds (figure 10) whilst an owl-hole (6) comprising of two ledges provided access for the birds (figure 11).

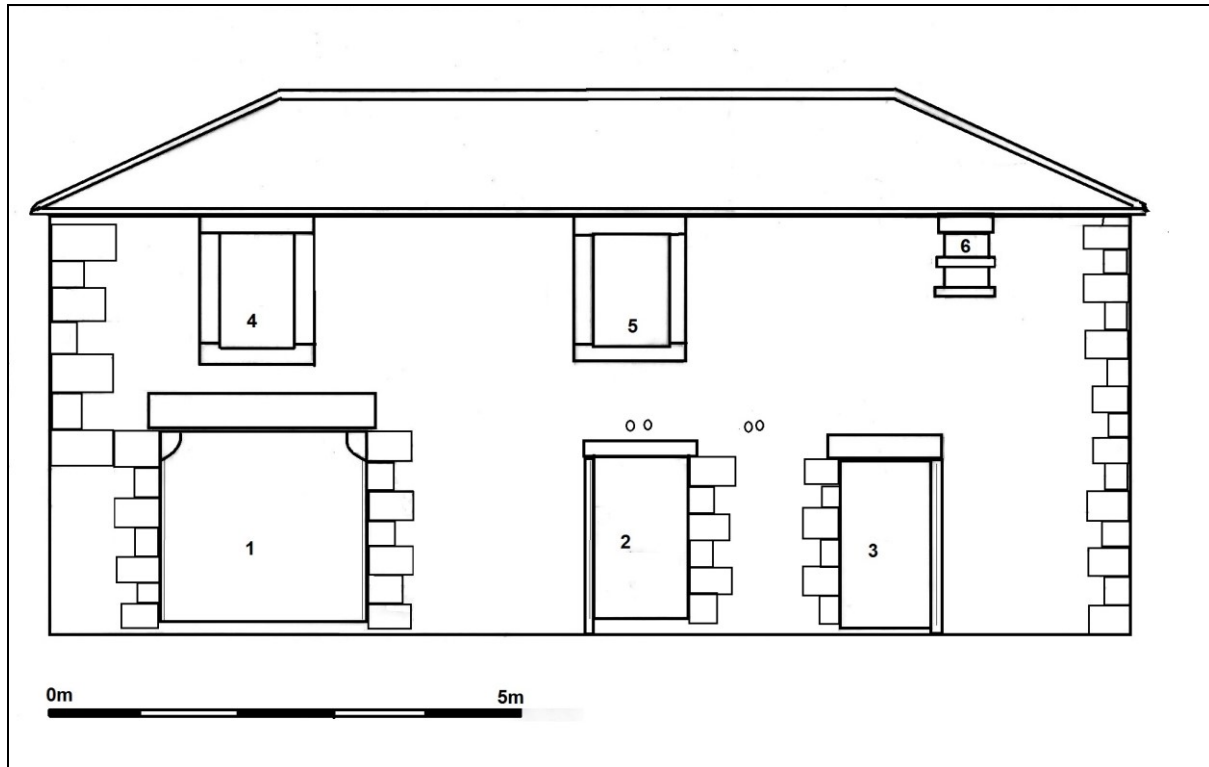
Figure 12. North elevation of subject building

The northern elevation (figure 12) measured 11.50m in length and was 5.50m in height and comprised of a single structural phase. It contained three rooms: the cart shed, the cow shed and the byre and dovecote. Both ends of the elevation were framed by red sandstone quoins.

Ad hoc interventions were two sets of air vents above door (2) and just before door (3).

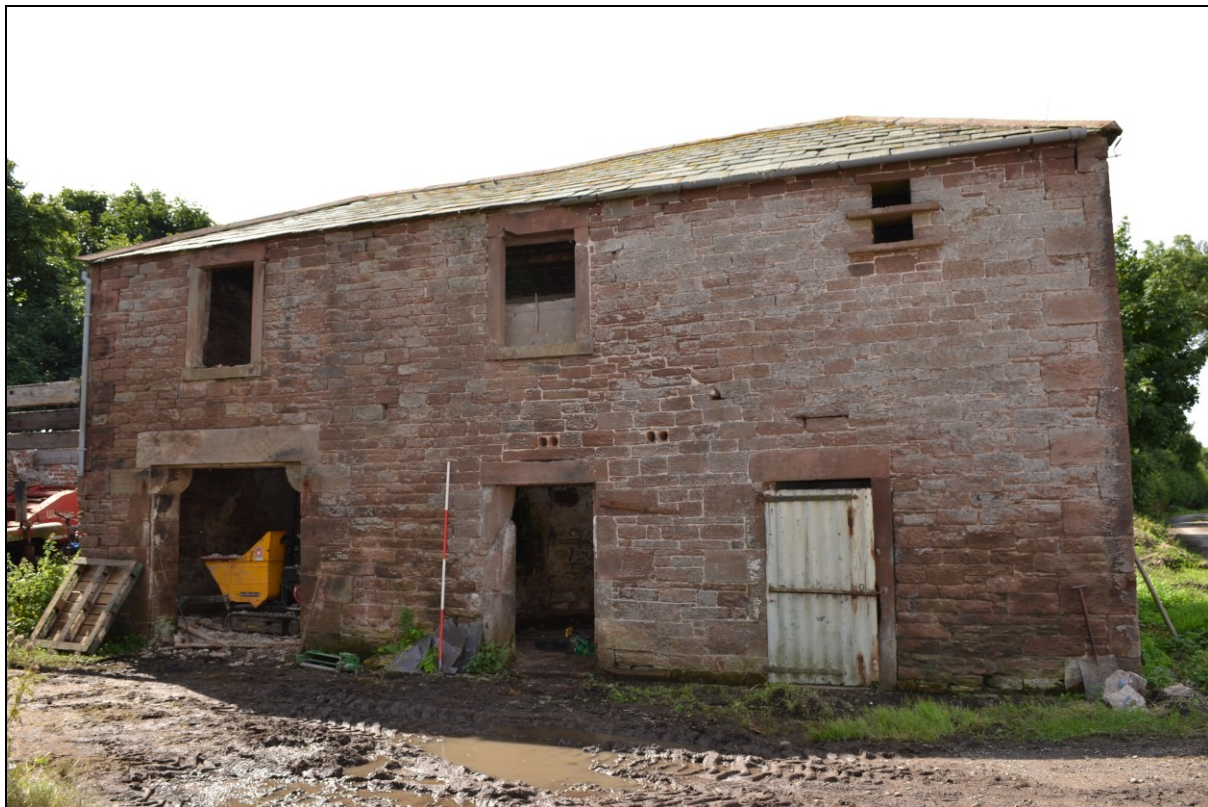
Figure 13. Northern elevation of stone barn

The stonework forming the fabric comprised partially dressed red sandstone blocks, lain in concordant courses with neatly pointed lime mortar (figure 13).

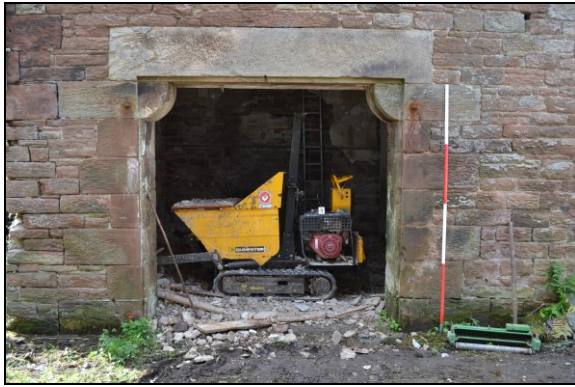
Figure 14. Doorway (1)

- A doorway (1) measuring 2.34m x 2.12m in height that provided the ingress into the cart shed. Lacking a door, it formerly held a double door with hinges on both sides of the door jamb that possessed a rebate 0.05m in width and 0.04m in depth. The doorway had two stone quadrants measuring 0.24m in radius and 0.30m in height located below a large stone lintel measuring 2.65m in length, 0.45m in height and 0.25m in thickness. A replacement

timber lintel was behind this feature. Framing the doorway were two sets of red sandstone quoins formed from blocks 0.65m x 0.34m x 0.30m in size (figure 14).

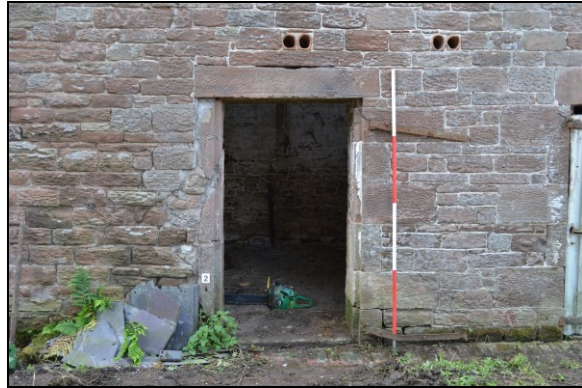
Figure 15. Door (2)

- A doorway (2) measuring 1.02m x 1.86m in height that provided the ingress into the cow shed (figure 16). Lacking a door, the feature possessed a red sandstone lintel measuring 1.39m x 0.40m x 0.25m and a door jamb with a rebate 0.05m in width and 0.05m in depth. The western jamb was formed from six stone quoins measuring 0.57m x 0.25m x 0.30m (figure 15).

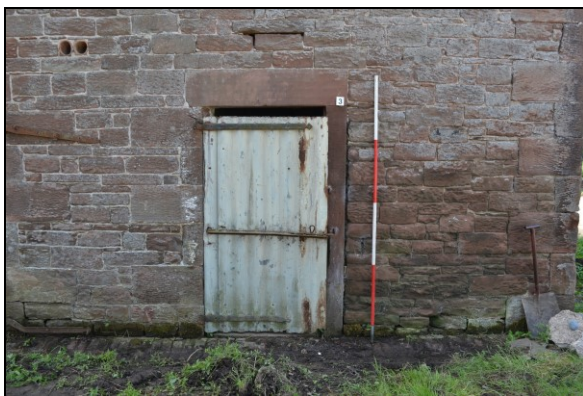
Figure 16. Door (3)

- A door (3) measuring 1.00m x 1.85m in height complete with red sandstone lintel and complementing western red sandstone jamb 0.20m in thickness that serviced the byre. The eastern part of the jamb was formed from six stone quoins measuring 0.57m x 0.25m x 0.30m and bearing a slight rebate 0.02m in width and 0.05m in depth. The door consisted of a corrugated metal sheet (figure 16).

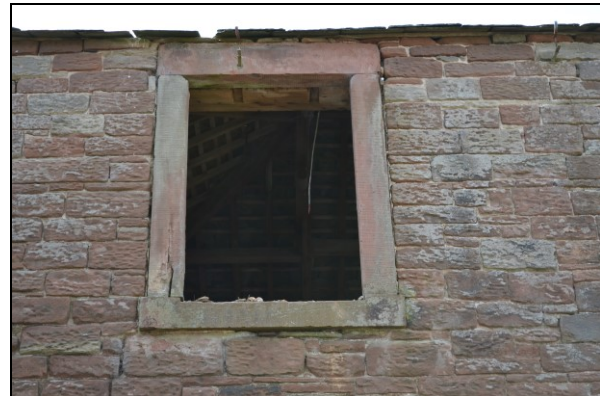
Figure 17. Window (4)

- Window (4) was 0.60m above door (1). No glazing was present within a window opening measuring 0.80m x 1.20m. The jamb and lintel were machine-sawn from red sandstone (figure 17).

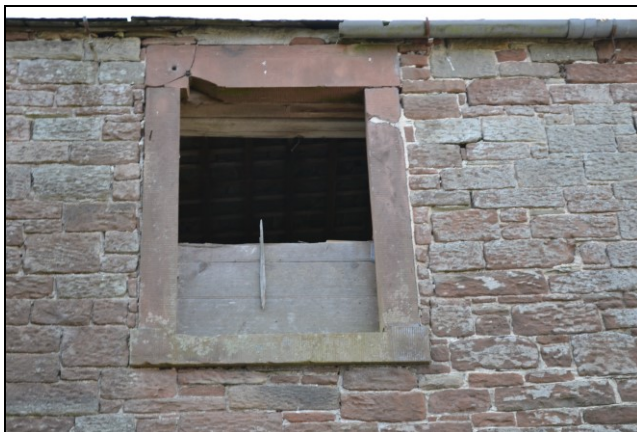
Figure 18. Window (5)

- Window (5) was 1.05m above the lintel to door (2). No glazing was present within a window opening measuring 0.80m x 1.20m. The jamb and lintel were machine-sawn from red sandstone (figure 18).

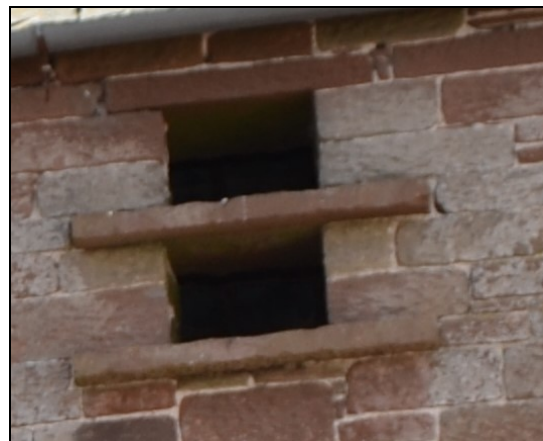
Figure 19. Owl-hole (6)

- Owl-hole (6) measured 0.40m in width with two 0.25m deep apertures formed by two red sandstone ledges 0.80m in length and 0.08m in thickness (figure 19). This feature led into the dovecote above the byre.

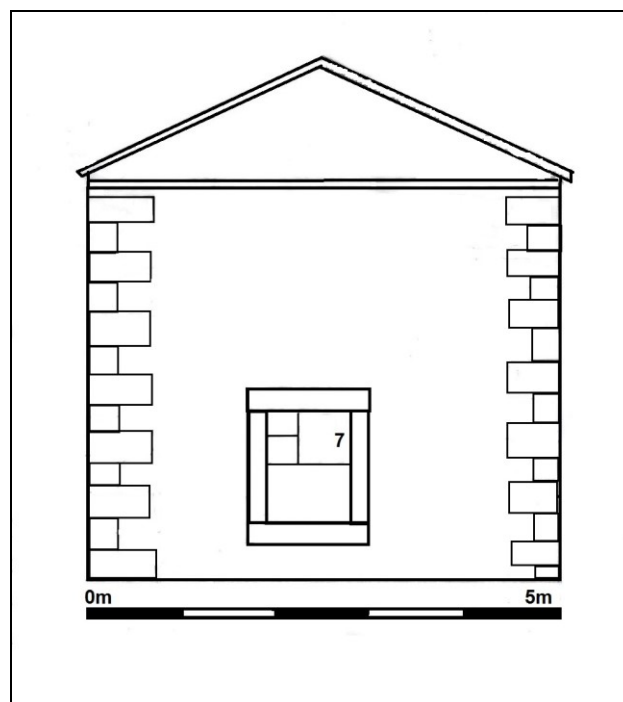
Figure 20. Western elevation

The western elevation measured 5.00m in width and 5.60m in height and was plain, finished in coarse red sandstone with flanking stone quoins (figure 20).

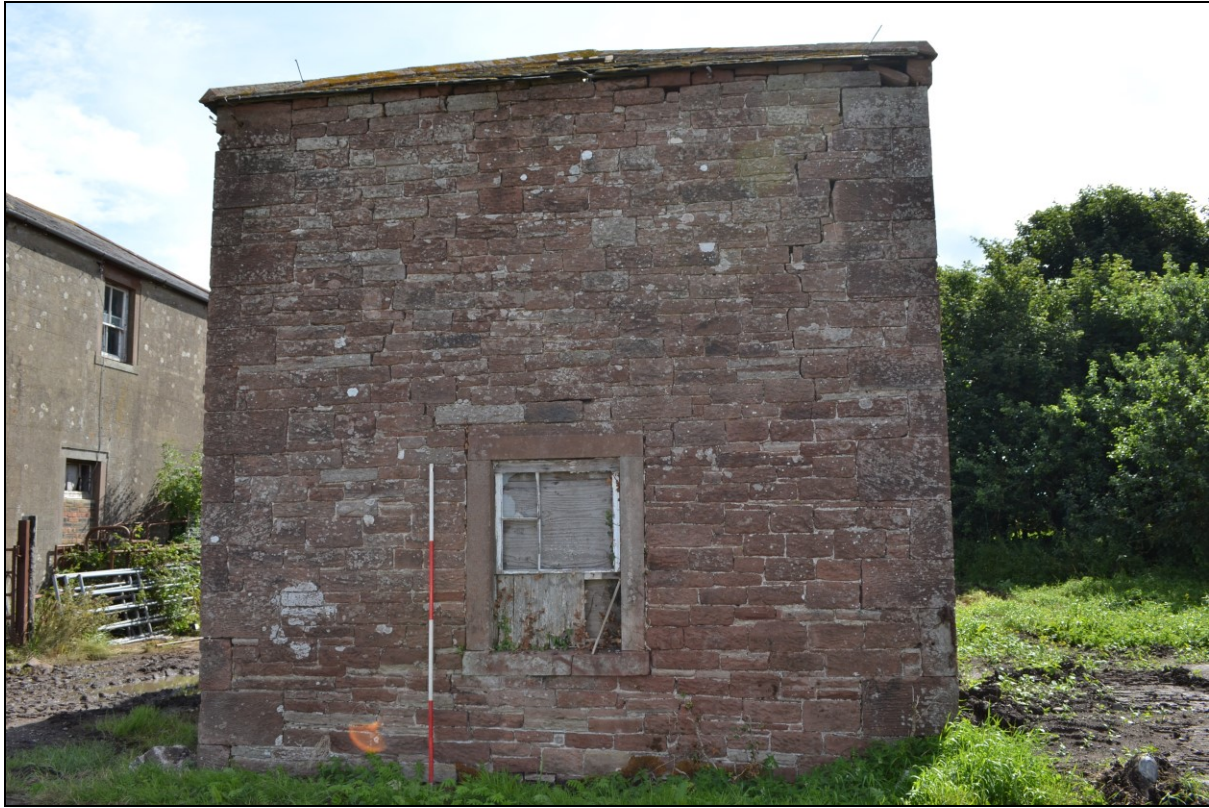
Figure 21. West elevation of stone barn

The walls comprised of small, concordant red sandstone blocks left with a coarse finish, bonded by limestone mortar. The southern end of the gable has a significant crack where the quoins met the stonework (figure 21).

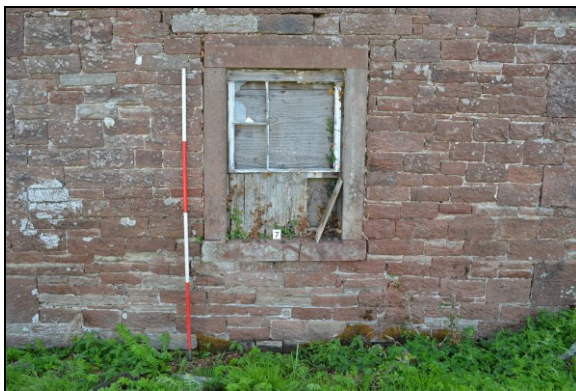
Figure 22. Window (7)

- A window (7) measuring 0.85m x 1.25m in height possessing a red sandstone sill 0.12m in thickness and a red sandstone lintel 0.22m in thickness. Glazing had been broken and now only vestiges of the timber frame remains (figure 22).

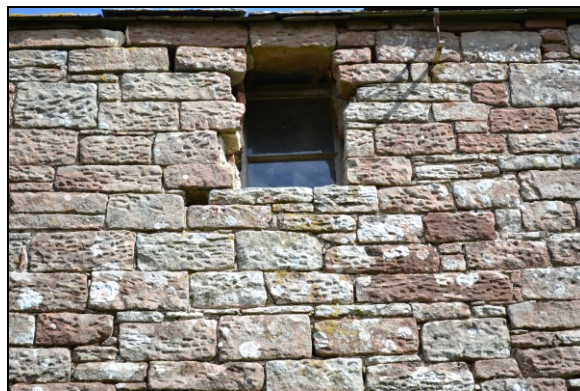
Figure 23. Window (8)

- A crude window (8) 0.60m in height and 0.40m in width servicing the former room above the cow shed (figure 23).
- A filled window (9) bearing a red sandstone lintel 1.20m x 0.10m and a sill 0.90m above the ground. This window serviced the ground floor to the cart shed (figure 26).
- A small *ad hoc* vent (10) measuring 0.30m in height and 0.15m in width servicing the cow shed (figure 25).

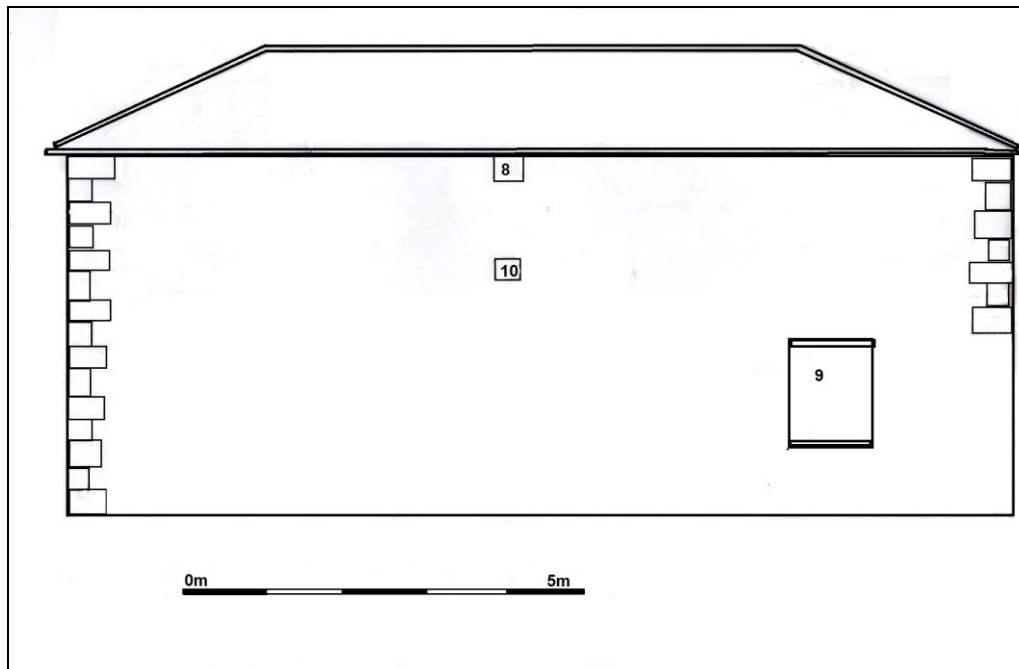
Figure 24. Southern elevation

The southern elevation (figure 24) measured 11.70 in length and was 5.80m in height. It comprised of concordant, fairly neatly finished red sandstone blocks framed by larger red sandstone quoins at each end.

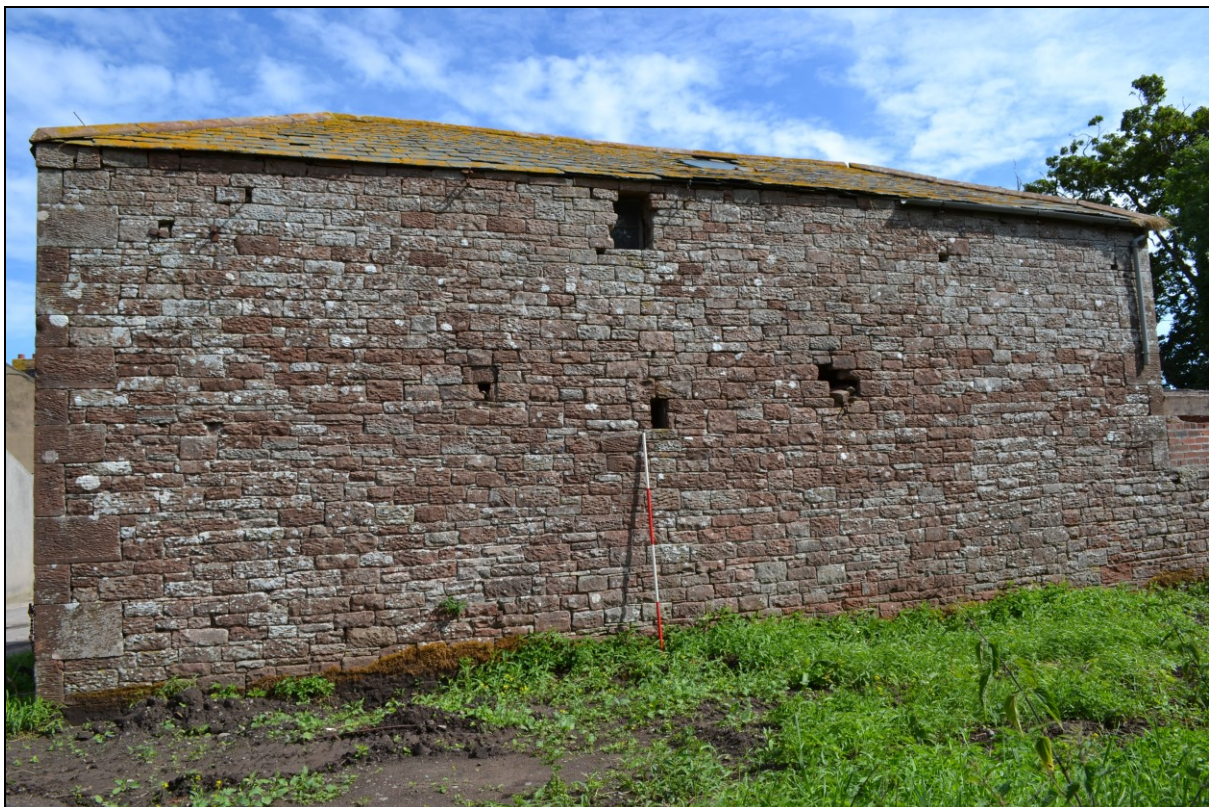
Figure 25. Southern elevation of the barn

Three architectural features were visible within the façade (figure 25).

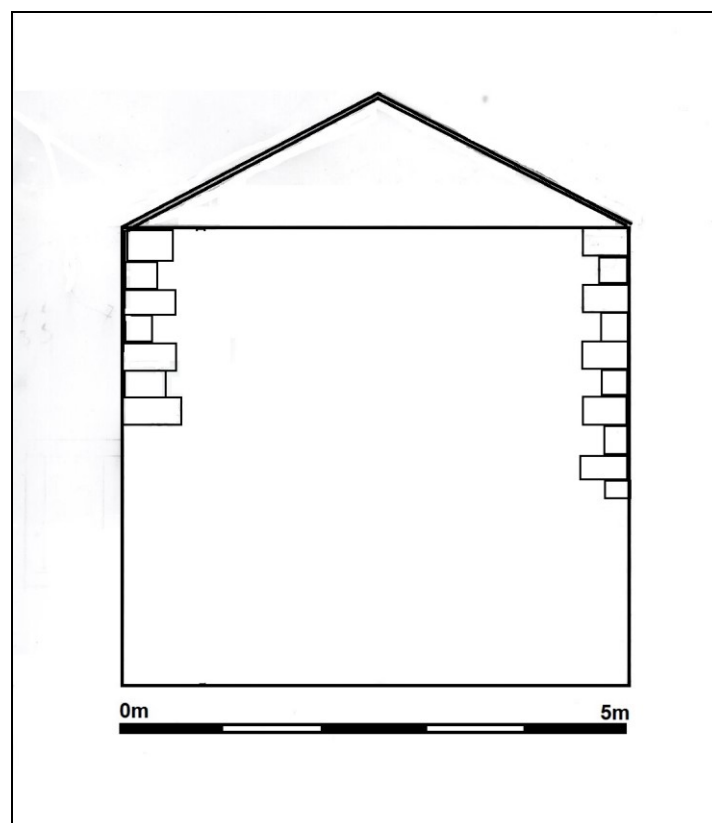
Figure 27. East elevation

The eastern gable was formed from red sandstone rubble to form a wall 0.45m in thickness that measured 5.00m in width and stood to a height of 5.80m. The elevation was complemented by dressed sandstone quoins measuring between 0.30-0.60m in length and between 0.25-0.30m in thickness (figure 27).

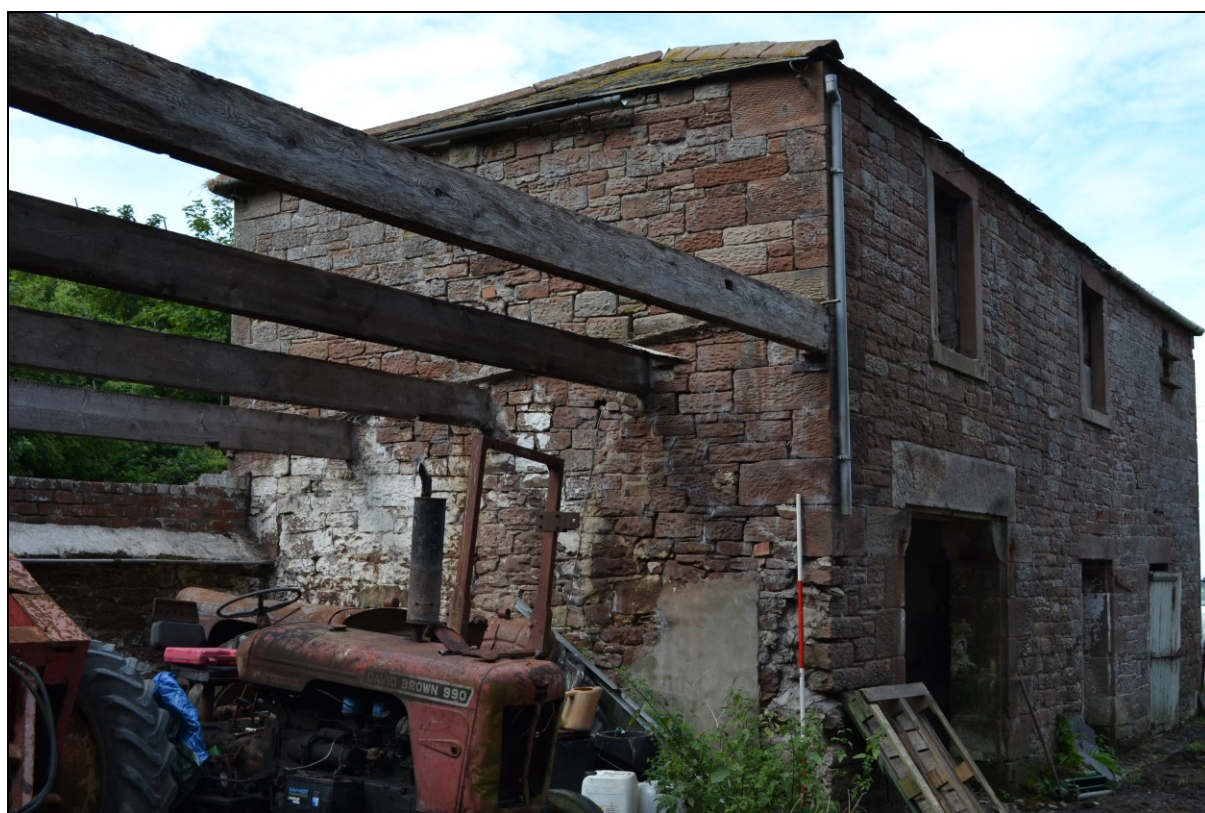
Figure 28. Eastern elevation of stone barn

A lean-to had been added to the eastern end of the barn (figure 28) comprising of a back wall 2.08m in height built from red sandstone blocks.

The joists belonging to the lean-to were still present, but the roofing fabric had been removed.
