Cumbria County Council's County Historic Environment Service (CCHES) was consulted by Allerdale District Council regarding a planning application for the demolition of a barn at Holly House, Thursby, near Carlisle; Planning Application No. 2/11/0732.

The study building was located at NY 32568 50100.

Level II Building Survey Holly Bush House, Thursby, Carlisle

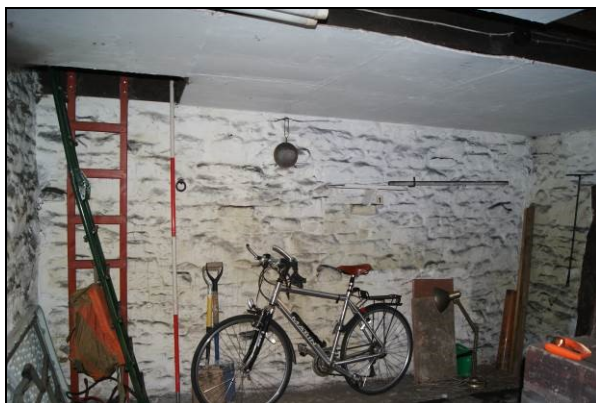
Figure 9. Interior of Room 1, Building 1

Room 1 possessed an internal area measuring 4.15m x 3.97m comprising randomly coursed rubble stone walls measuring 0.40m in thickness, bonded with yellow, sandy mortar. The interior (figure 9) has been white-washed throughout in order to improve waterproofing and maintain the integrity of the building fabric.

The floor comprised flags with a spatial division that once may have represented stalls for two animals.

A modern mezzanine floor had been added producing a room height for the ground floor of 2.14m from an overall height of 5.22m.

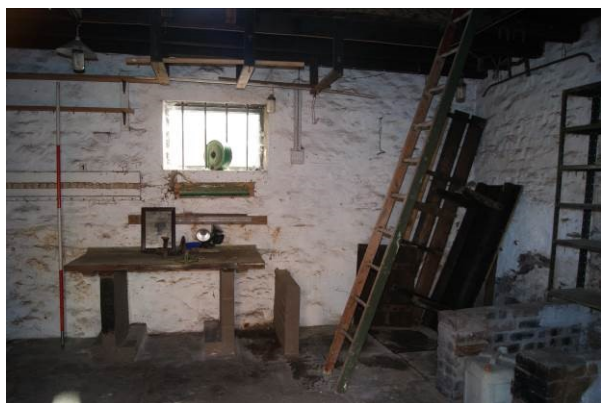
Figure 10. Interior of Room 2, Building 1

Room 2 possessed an internal area measuring 4.81m x 3.90m comprising randomly coursed rubble stone walls measuring 0.40m in thickness, bonded with yellow, sandy mortar. The interior (figure 10)

had been partly white-washed throughout in order to improve waterproofing and maintain the integrity of the building fabric. The ceiling was at a height of 2.54m where it formed an attic space.

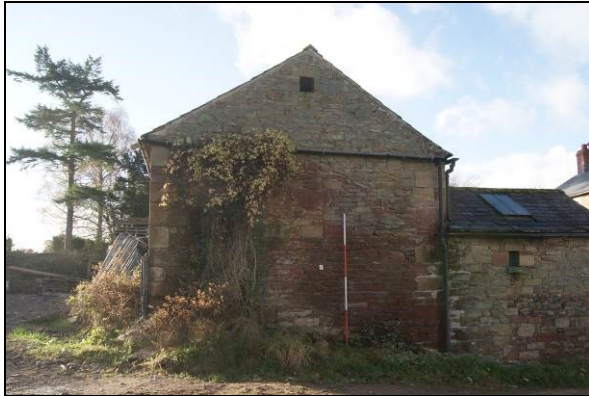
Figure 11. Eastern elevation of Building 1

The roof was of slate surmounted by a stone ridge (figure 11) with re-used trusses and modern purlins forming the roof structure. A recent skylight had been added on the south side.

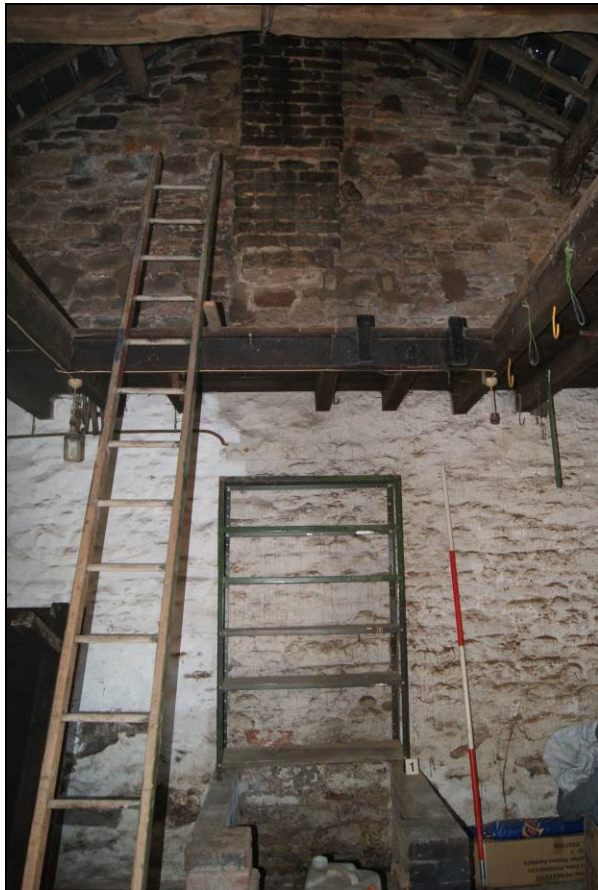
Figure 15. Chimney stack in Building 1

The main feature was a stone-filled hearth and red sandstone chimney breast (figure 15). The fireplace measured 0.80m in width and stood to a height of 1.10m in height whilst the chimney was a further 0.99m in width and 1.65m in height. There was no ornamentation associated with the hearth the feature being purely utilitarian (figure 16).

The earliest structure was Building 1. Building 2 had a chimney built into the western wall of Building 1 (figure 15) whilst Building 3 butted Building 1, whereby the pitch of the roof obscured a sandstone sill (figure 25).

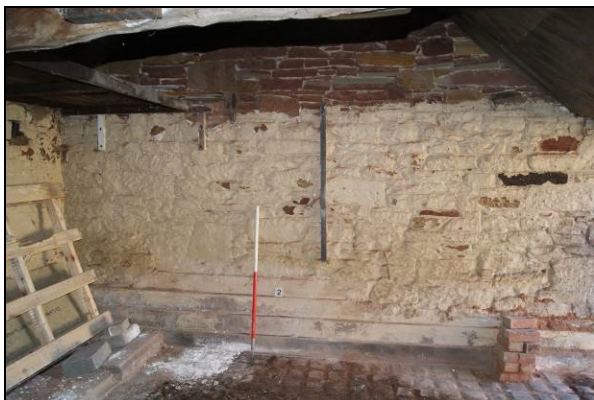
Figure 17. Internal area Room 2, Building 2

Room 2 possessed an internal area measuring 4.50m x 3.96m comprising randomly coursed rubble stone walls measuring 0.40m in thickness, bonded with yellow, sandy mortar. The interior had been partly white-washed (figure 17) in order to improve waterproofing and maintain the integrity of the building fabric except on the eastern party wall (figure 18) with Room 1 which was left untouched.

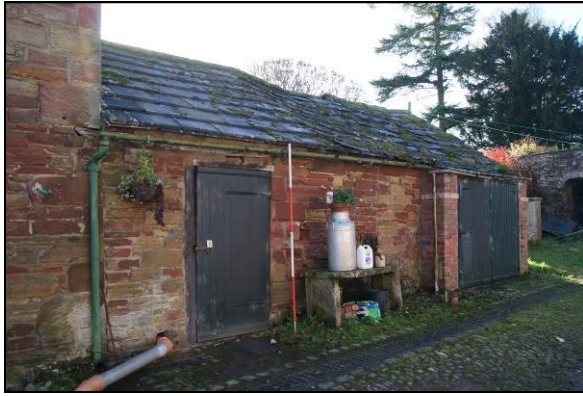
Figure 19. Northern elevation Building 2

The roof was in a poor state of repair and had begun to sag (figure 19). Constructed from stone shingles surmounted by a stone ridge and standing to a height of 1.60m, the roof was formed from re-used wooden trusses with the rafters and purlins suffering from dry-rot and decay.

The northern elevation (figure 19) possessed originally two doors of which the eastern door is now only extant replete with tongue and groove timber door (0.97m x 1.83m) and crude *ad hoc* jamb. The western door (1.10m x 1.92m) was filled with red sandstone probably as a result of a refurbishment in 1976 that added two brick piers (figure 20) and a set of tongue and groove timber double doors 2.29m in width to form a garage (inscribed on door "G.G.G. 1976" by the former owner).

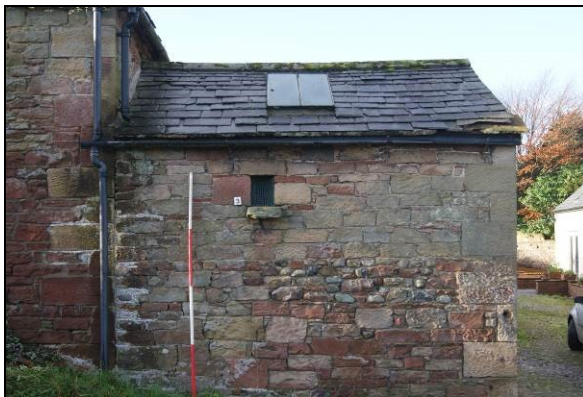
Figure 21. East elevation, Building 3

Measuring 3.60m x 2.70m in plan, Building 3 located at NY 32568 50104 was added to the northern side of Building 1 (figure 23). Building 3 was formed from concordant rubble stone courses (0.36m in width), standing to a height of 2.80m with an additional 1.00m to the ridge. Stone red sandstone quoins (blocks approximately 0.50m x 0.32m x 0.24m) were slight architectural embellishments to the northern-eastern corner of the building (figure 21).

A circular air vent 0.30m in diameter had been added at a later date (figure 23) as had a skylight (figure 21) that was located within a stone shingle roof supported by modern timber joists.

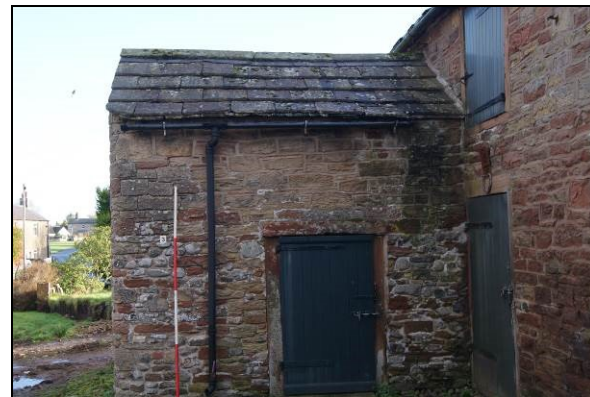
Figure 22. West elevation, Building 3

The building had not been repointed but repairs appeared to consist of rounded large boulders replacing rough-hewn sandstone blocks (figure 22).

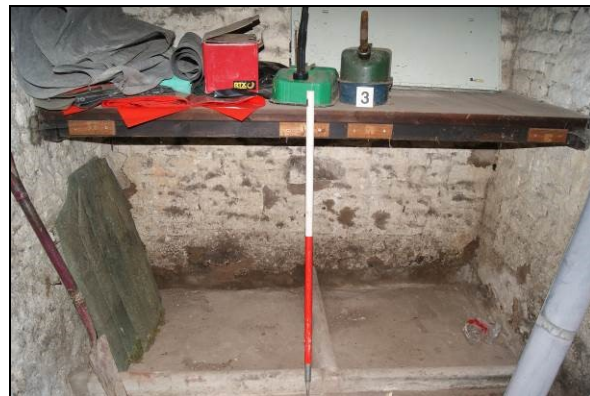
Figure 24. Interior of Building 3

Internally, Building 3 yielded a floor plan measuring 2.00m x 3.32m standing to a height of 3.38m. This single room possessed a concrete floor with a series of joists forming shelves either side of the entrance (figure 24).
