## **SUMMARY**

Recent archaeological reconnaissance identified a corridor of soil that corresponded to the plotted course of the vallum in close proximity to the road between Burgh-by-Sands and Carlisle. It would appear highly likely that this landscape feature represents the vallum and that the course identified by English Heritage remains correct.

In 2007 Cumbria County Council's Historic Environment Service (CCHES) was consulted by Carlisle City Council regarding planning permission for a series of dwellings at Monkhill Farm, Monkhill, (planning application 1/07/0134).

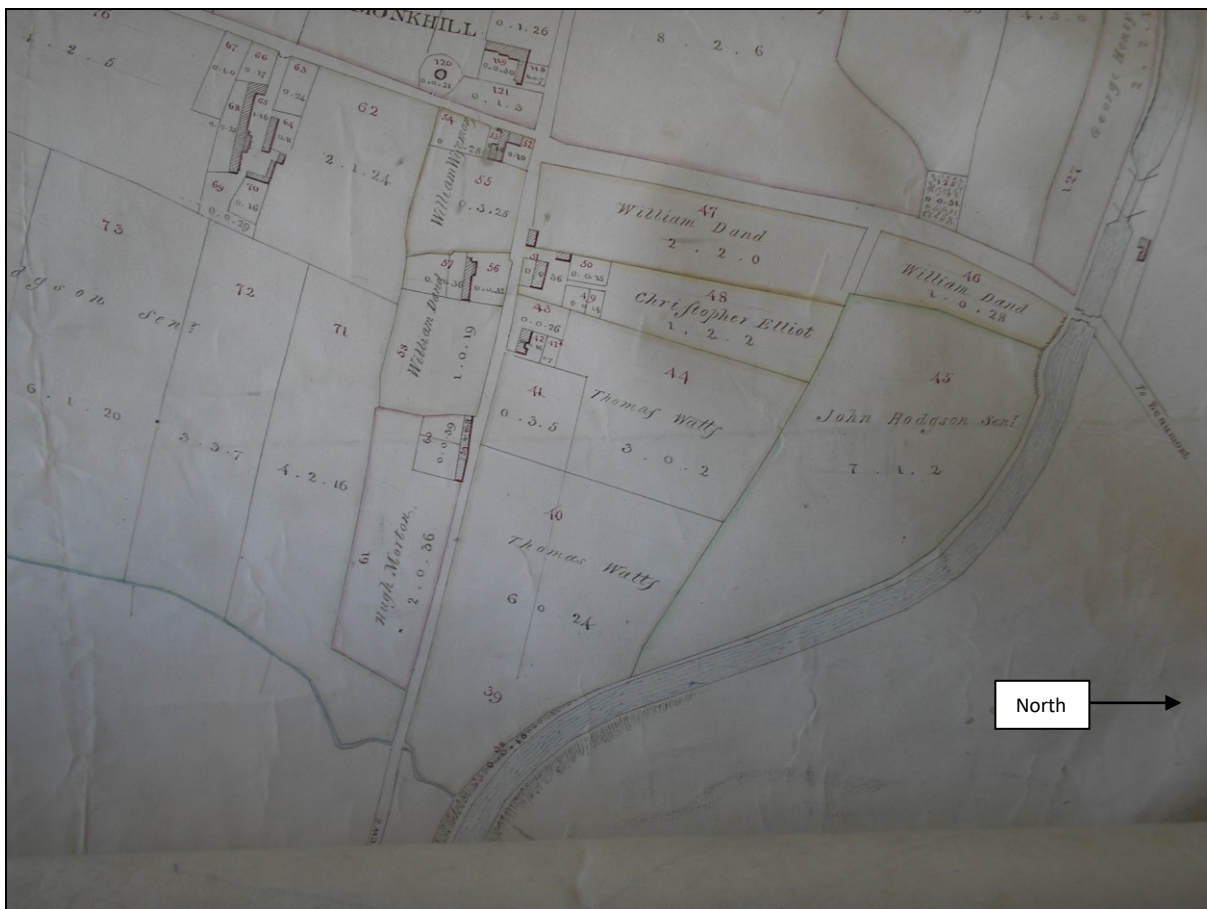
Figure 4. 1831 Tithe map DRX/769/22

The 1831 tithe map DRX/769/22 denotes that the property was owned by William Dand who resided at the adjacent farmhouse, Monkhill Farm. The study area measured one acre and nineteen perches and the proportions of the field remained unchanged to the present day, albeit the boundary between the house and the study area has been removed.

Interestingly, the vallum is not depicted on the tithe map whilst at least one building in Monkhill straddled the course of the ditch. This suggests that a significant proportion of the vallum must have been backfilled by 1831.

Cartographic evidence (figure 4) illustrates that the route was not extant in 1831, replaced by the current road from Carlisle to Burgh-by-Sands. Moreover, as the field system did not respect holloway **30/40** it can be assumed that the metalled track pre-dated this organisation of space.

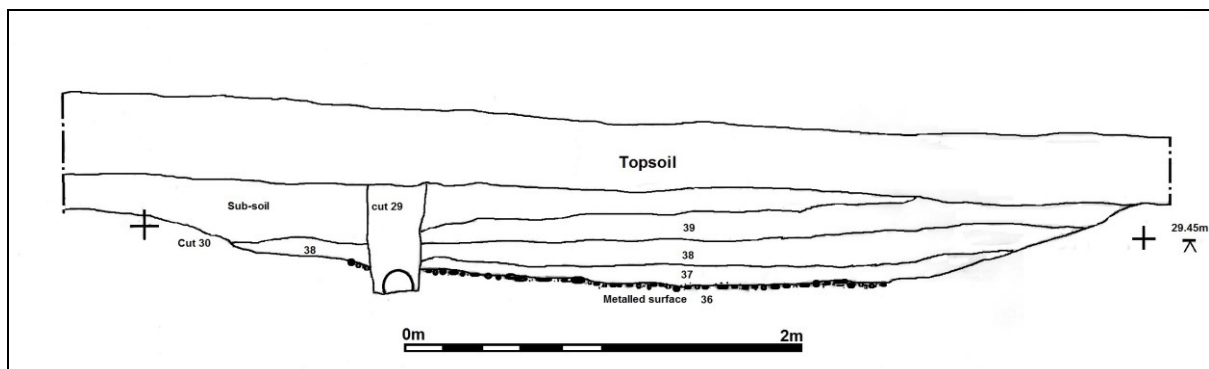
Figure 7. Section across road 30, Trench 3

30. Within an east-west aligned linear cut **30** measuring 4.50m in width and 0.46m in depth was a compacted single skin of small rounded pebbles 0.05m in thickness in a pale grey silt matrix overlying pink clay, forming a flat, metallised surface **36** measuring 2.70m in width (figure 9). Directly overlying a putative road or track was dark grey silt **37**, sealed by light grey-brown silt **38** that was covered by slightly pinkish brown sandy clay **39**. A land drain **29** complete with ceramic tile cut this sequence but was sealed by dark brown topsoil (figure 7).

However, traces of a pink sand and clay **39** incoming from the north may tentatively indicate a former bank that when denuded began to drift into the holloway, as the track fell into disuse (figure 7).

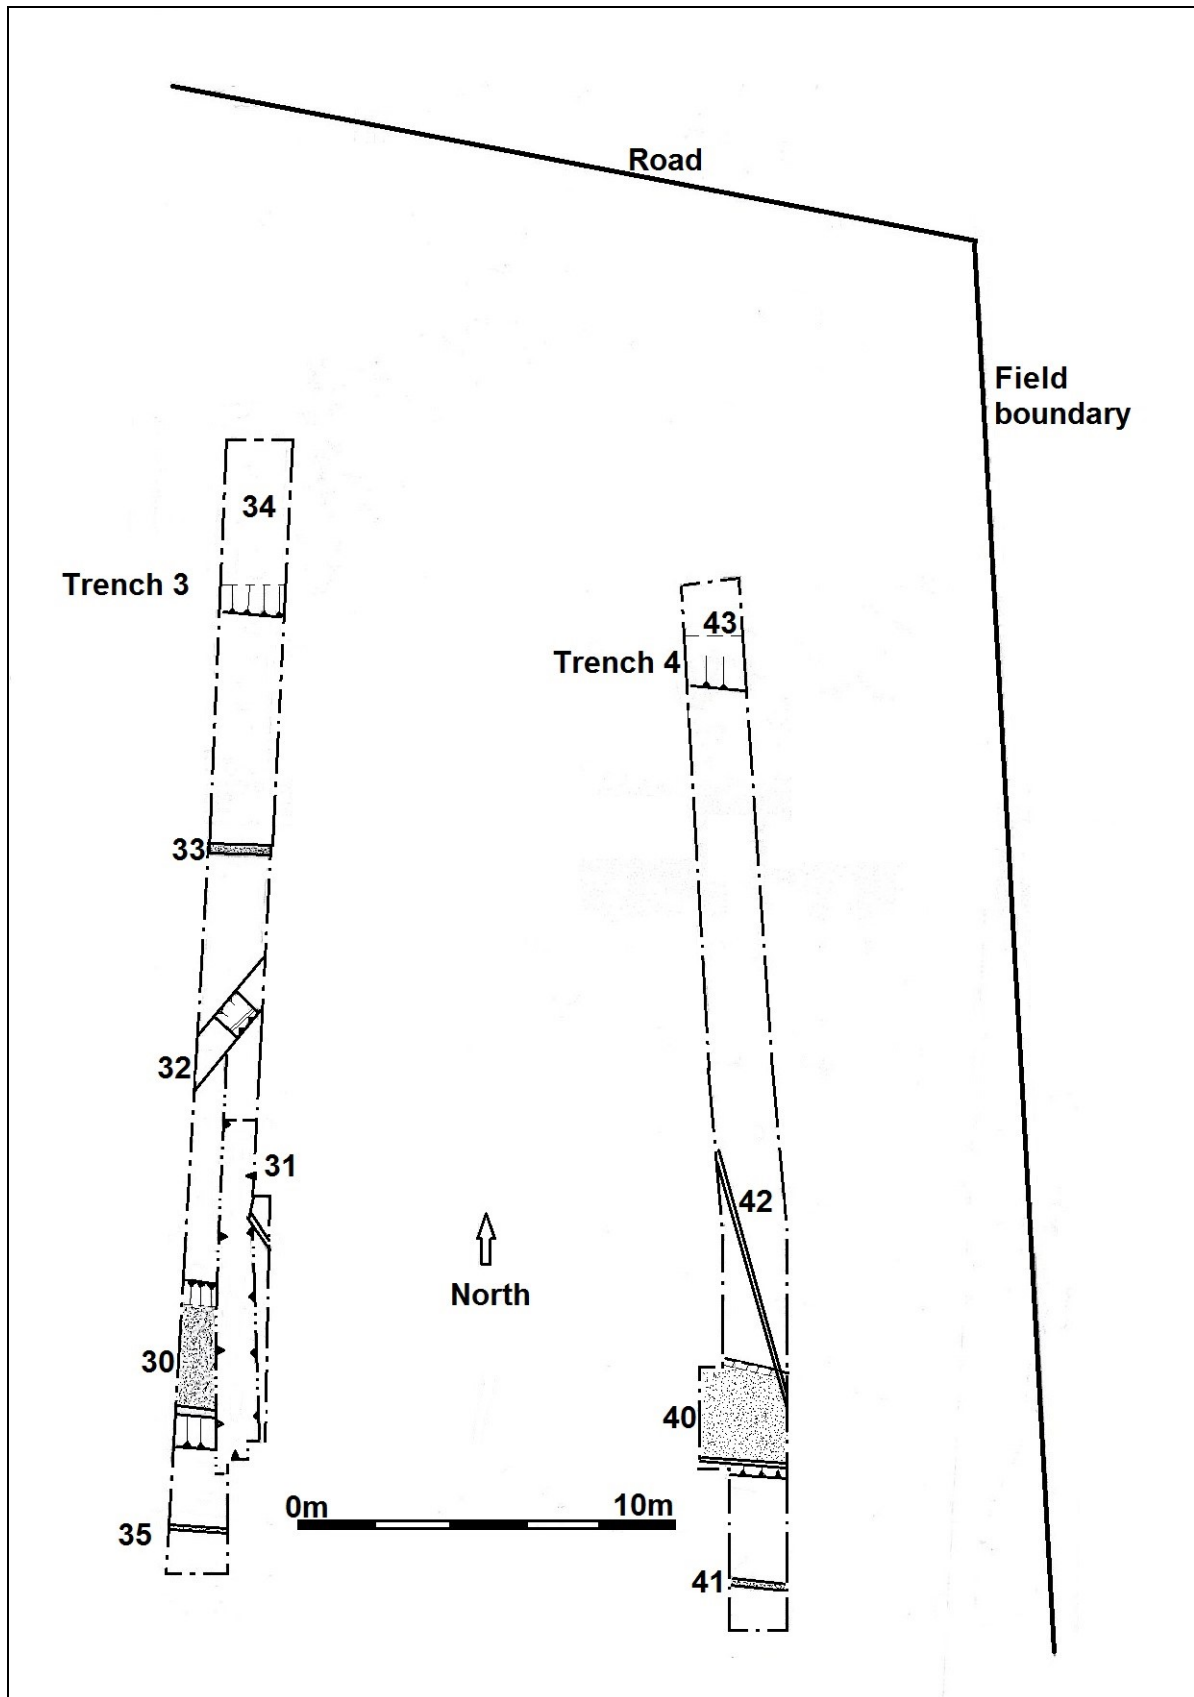
Figure 8. Plan of Trenches 3 and 4

The following key observations (30-35) were undertaken within Trench 3 (figure 8)

The following key observations (40-44) were undertaken within Trench 4 (figure 8).

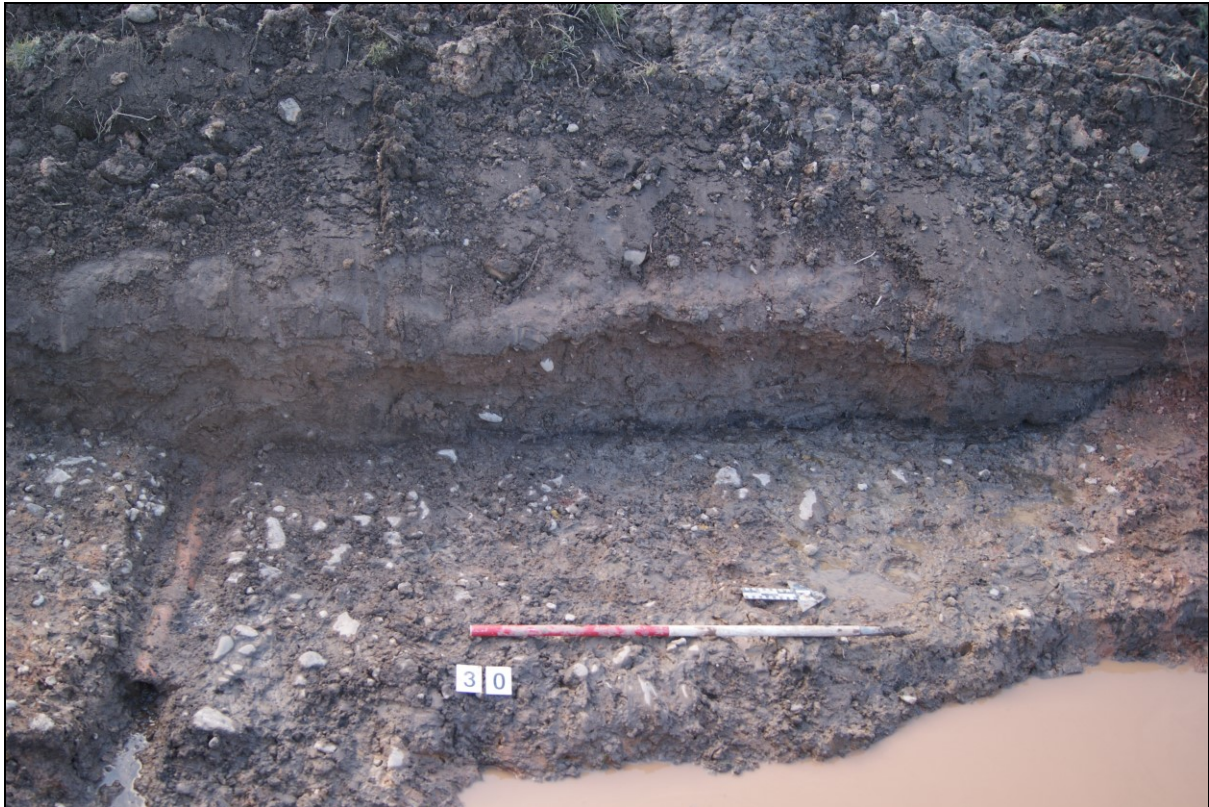
Figure 9. Holloway 30, Trench 3

There appeared to be no evidence for a bank or berm between the holloway **30** and the vallum **34** although tenuously the pinkish brown sandy silt **39** emanating from the north side of track **36** could represent wash from a putative bank.

The only feature of potential antiquity encountered was an east-west aligned linear metalled track that filled a holloway **30** and **40**.

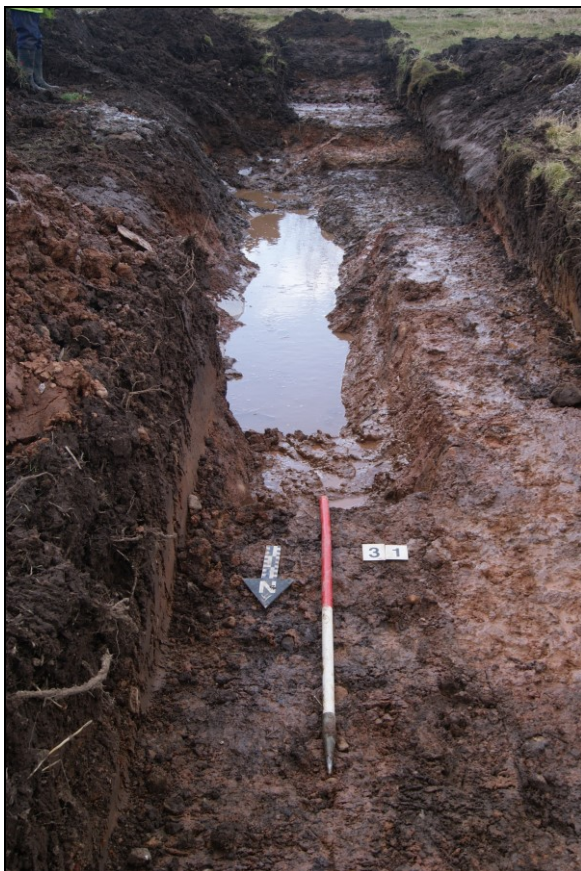
Figure 10. Pipe Trench 31, Trench 3

31. Fill **28** of land drain **29** was penetrated by a modern north-south aligned intrusion **31** (figure 10). This feature was at least twelve metres in length and approximately 0.80m in width and comprised re-deposited pink clay **22** burying a flattened plastic land drain. Evidently, this was an *ad hoc* repair robbing a former ceramic land drain as the effectiveness of the drainage system deteriorated.

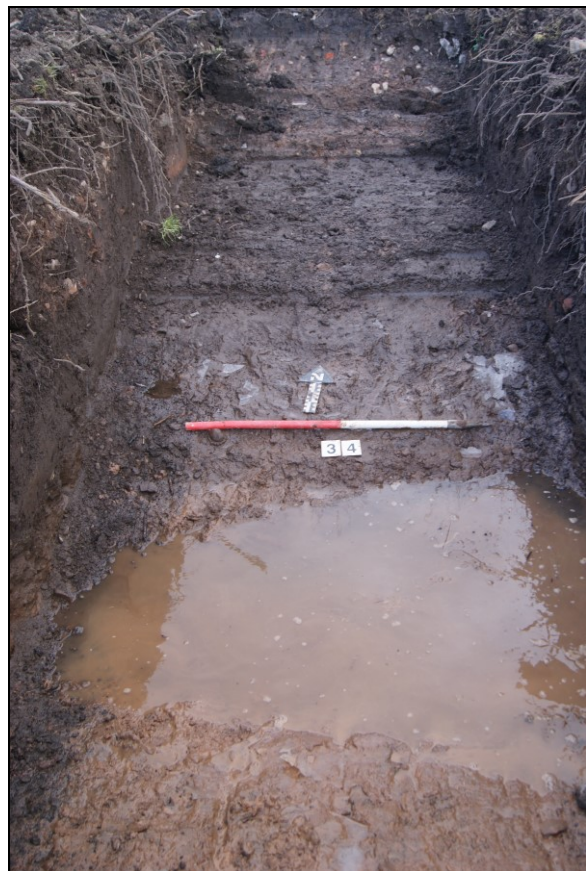
Figure 11. South side of vallum 34, Trench 3

34. The southern edge of the vallum **34** filled by a tertiary fill of dark brown sandy silt **25** (figure 11).
35. An east-west aligned stone land drain cut **35** filled with loose rounded pebbles **24**; no soil matrix present (figure 14).

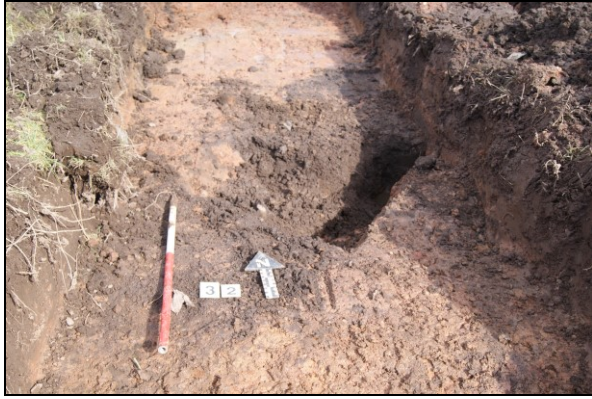
Figure 12. Pipe trench 32, Trench 3

32. A northeast-south-west aligned cut **32** containing a plastic land drain backfilled by dark grey-brown sandy silt **27** (figure 12).
33. An east-west aligned stone land drain cut **33** filled with loosed rounded pebbles **26**; no soil matrix present (figure 13).

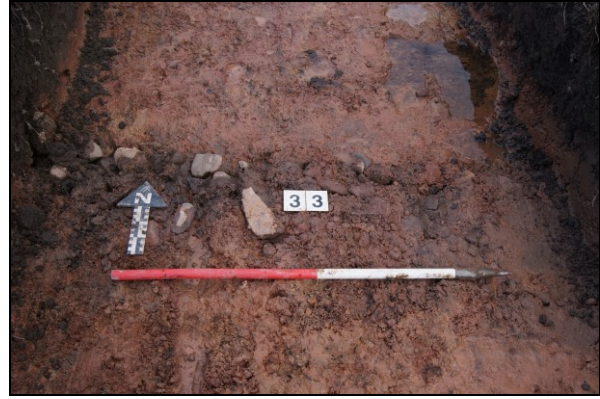
Figure 13. Stone land drain 33, Trench 3

The trench did reveal a system of ceramic land drains and *ad hoc* repairs **31-33** and **35** inserted in the 19<sup>th</sup> century and maintained since that date. This system had fallen into disrepair. Understanding this connectivity was difficult, the configuration appearing not to obey the natural fall of the land and the usual intervals between lines of tiles.

Former land drains within the study area no longer function and will require replacement in order to avoid soft or wet spots developing.

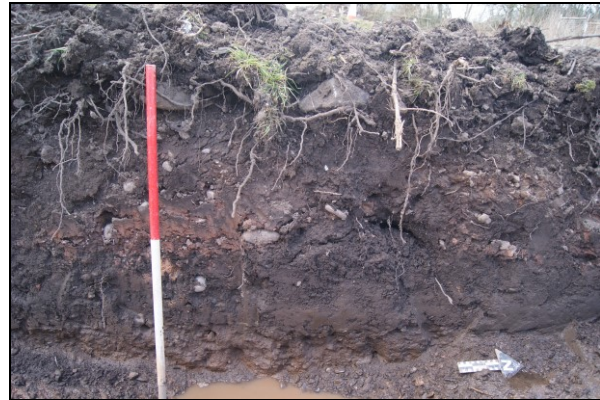
Figure 15. Overburden above the vallum 34

Overlying the vallum, the cover measured 1.10m in depth comprising of 0.30m of topsoil, 0.20m of grey pebbly silt, 0.20m of made ground formed from clay and 0.30m of re-deposited brown soil containing modern glass from former greenhouses (figure 15).

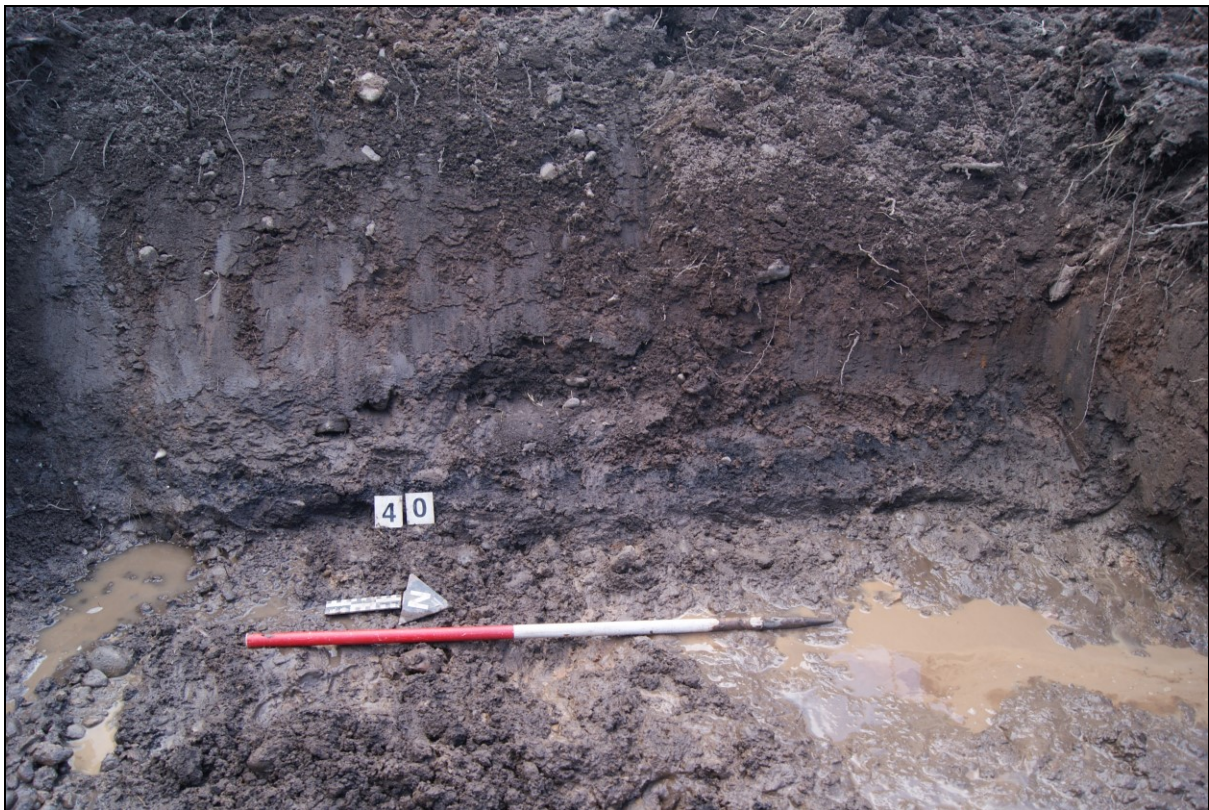
Figure 16. Holloway 40, Trench 4 in section

40. Linear cut **40** corresponded to holloway **30** in Trench 3. The holloway was less pronounced approximately 3.50m in width and 0.30m in depth. Detailed observation was hindered following inundation by water but consisted of a metallated surface **46** formed from small rounded pebbles compacted to form a level surface. No roadside gully was present. Overlying the metallating was the same sequence as in Trench 3; dark grey silt **47**, sealed by light grey-brown silt **48** that was covered by slightly pinkish brown sandy clay **49**. A land drain **45** (the same as land drain **29**) complete with ceramic tile cut this sequence but was sealed by dark brown topsoil (figure 16).

There appeared to be no evidence for a bank or berm between the holloway **40** and the vallum **43**.

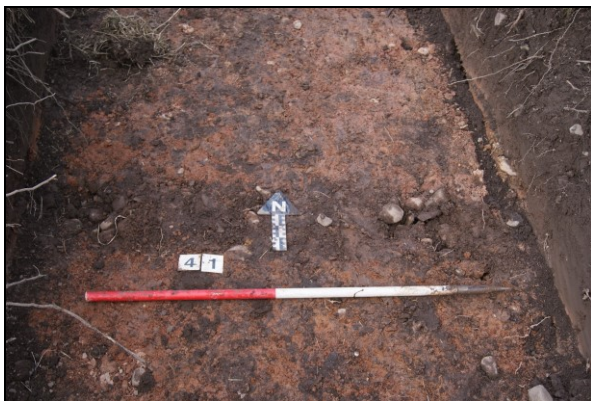
Figure 17. Stone land drain 41, Trench 4

41. An east-west aligned linear stone land drain **41** filled with loose rounded pebbles **23**; no soil matrix present (figure 17) being the same as land drain **35** in Trench 3.

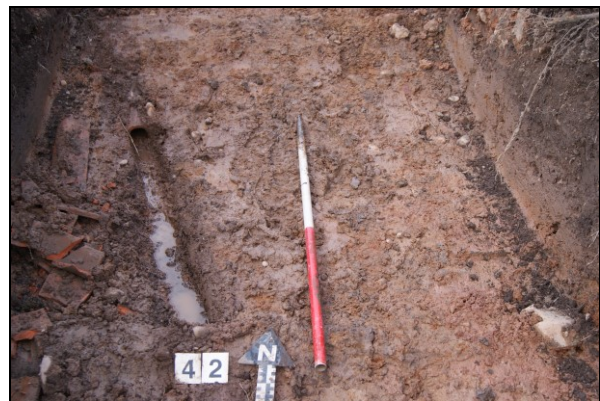
Figure 18. Ceramic land drain 42, Trench 4

42. A northwest-southeast aligned linear land drain **42** filled with extant ceramic tiles **23** (figure 18).
43. The southern edge of the vallum **43** filled by a tertiary fill of dark brown sandy silt **44** (figure 19).

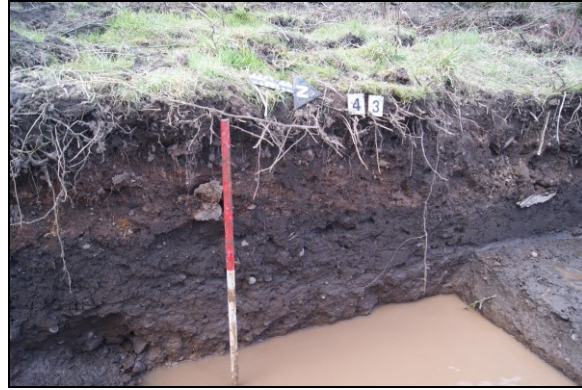
Figure 20. Overburden above the vallum 43

Overlying the vallum, the cover measured 1.10m in depth comprising of 0.30m of topsoil, 0.20m of grey pebbly silt, 0.20m of made ground formed from clay and 0.30m of re-deposited brown soil containing modern glass from former greenhouses (figure 20).

At the mid-point of the trench, clay and debris had been deposited within the overburden.

If further spoil from the buildings' footings is deposited above the vallum, this should provide a substantial margin to protect the monument from clandestine interventions such as root activity or shallow features such as post-holes.

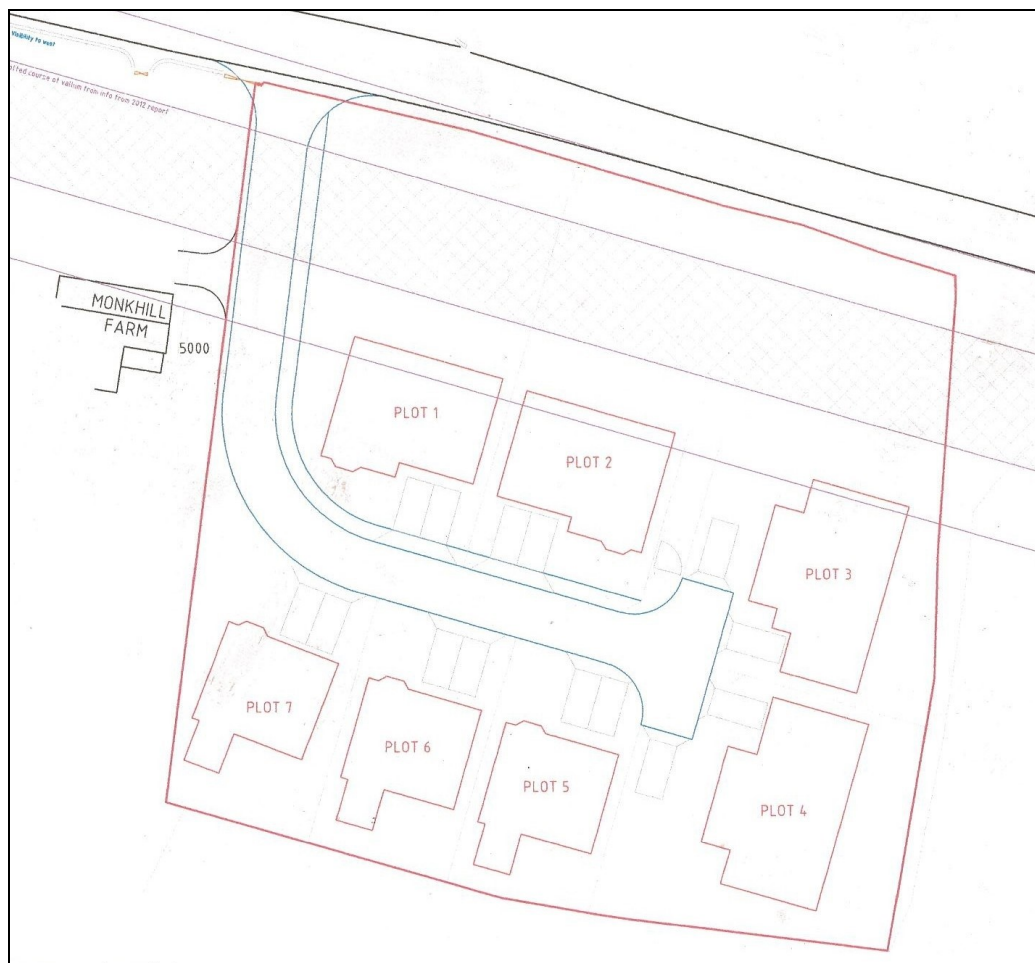
Figure 21. Lay-out for the proposed development

The metalled track appears to pass within the proposed buildings in Plots 1 -3 (figure 21) and the access road.

Landscape feature will require monitoring such as a watching brief or limited excavation preceding the development. There is no direct evidence linking it to the initiation of the military frontier system, but it appears likely that it was current when the ditch was a major landscape feature. Undoubtedly, the metalled track respected the spatial arrangement of the vallum.

The intention of the developer is to build seven houses as part of a staged programme beginning with the plots on the southern side of the development. This will involve the insertion of footings and foundations excavated from ground level rather than wholesale clearance of the sites' topsoil.
