The surveyed barn at Rushgill House, Skelton comprised of four principal units: a threshing barn, stable, store and bothy. The barn was architecturally unremarkable constructed from local red sandstone and displaying few architectural embellishments that characterised vernacular style and consequently period.

The study building was located at NY 40550 38525 and is part of planning application 10/0729, an extension to planning application 7/0716.

The stone barn (NY 40550 38525) was rectangular in plan, aligned northeast-southwest and measured 28m x 6.10m and consisted of four units: Barn, Stable, Store and Bothy (figure 6).

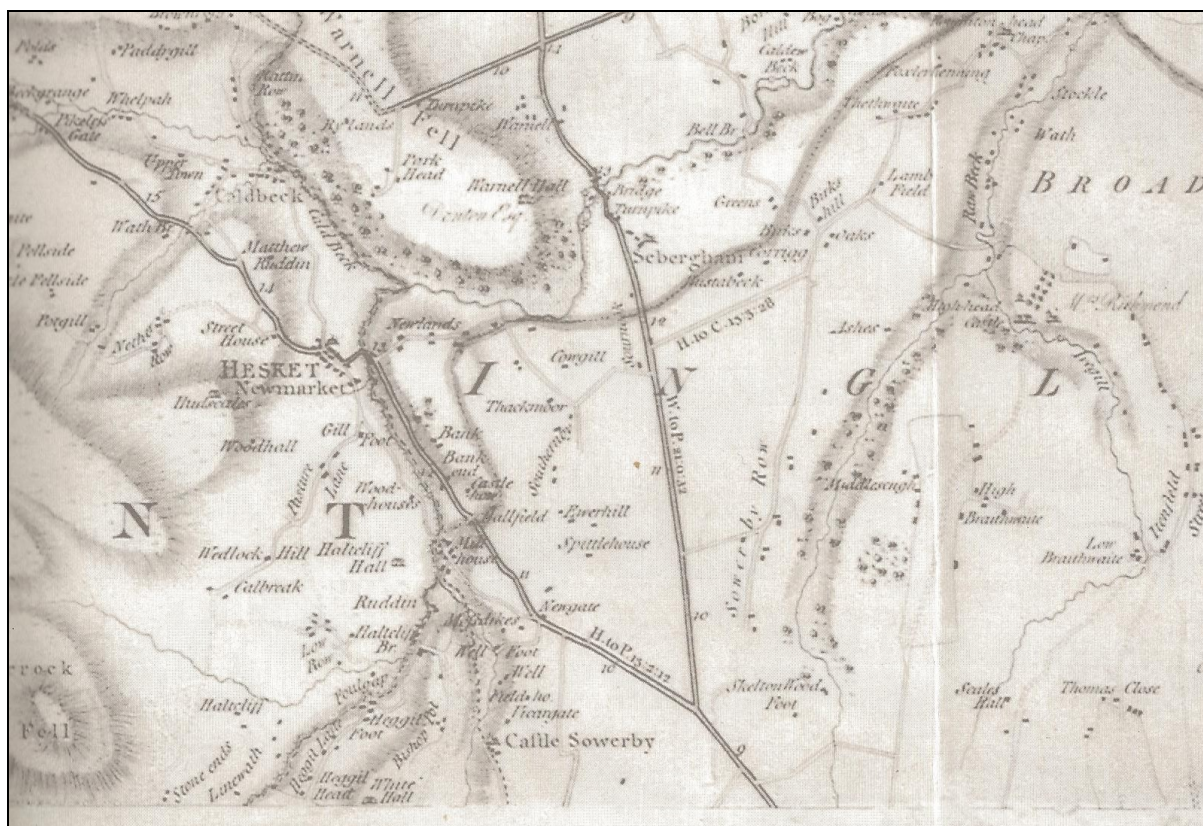
Figure 3. Donald map of 1774

The 1774 Donald map appears to show the study area as the last speck at the end of the no-through road from Sowerby Row.

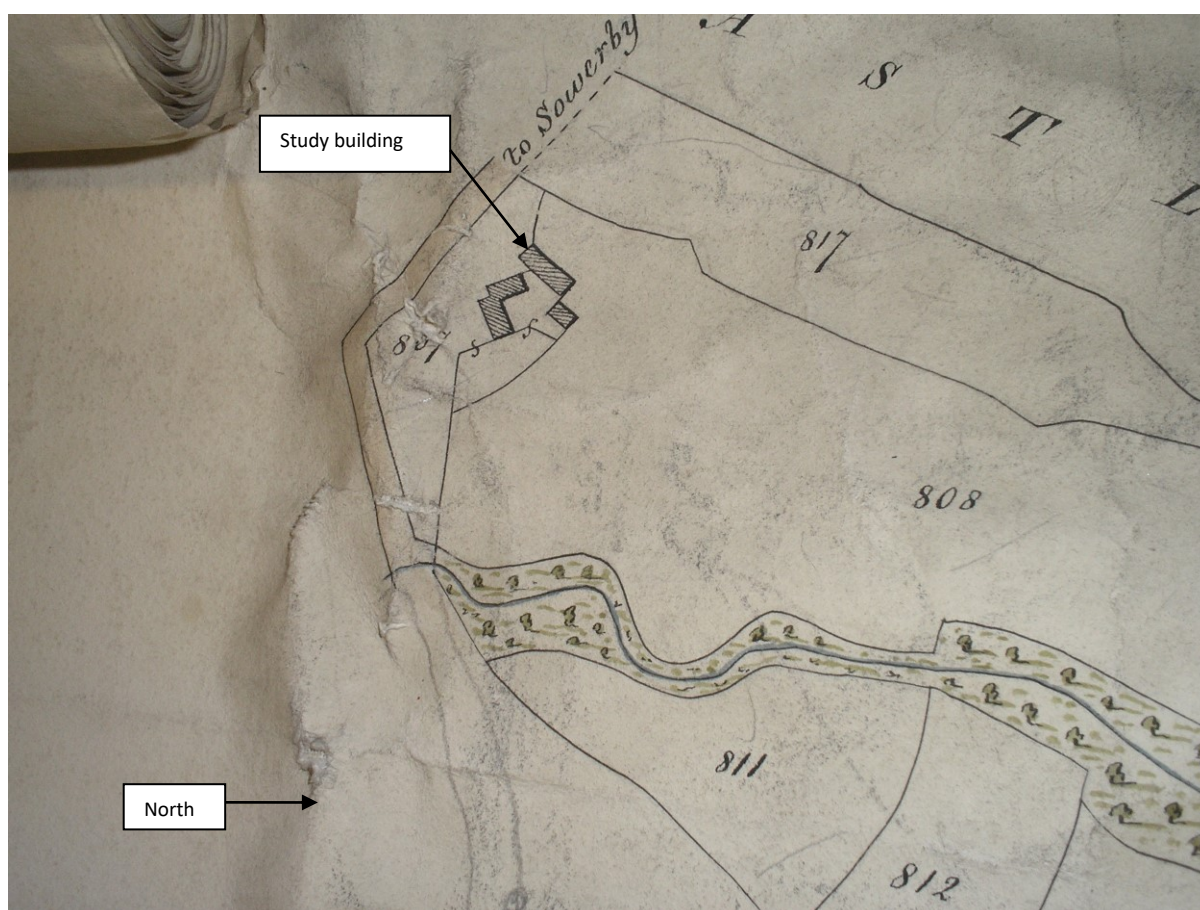
Figure 4. Tithe map of 1840 showing the study building

The tithe map (figure 4) illustrating the parish of Skelton was completed by 1840. This document depicts the study building as being extant and probably comprising the barn and the bothy on account of an extant small outbuilding being in very close proximity to the bothy and barn suite of buildings. The road to Skelton remained incomplete, access appearing to be from Sowerby Row immediately westwards.

The study building was situated within Plot 807 (figure 4) measuring one acre, 1 rod and 3 perches and having a taxable rate of two shillings in lieu of tithes, commuted to cash payments. The landowner was credited within the Indenture as being Wells Fletcher and was occupied by Stephen Mounsey.

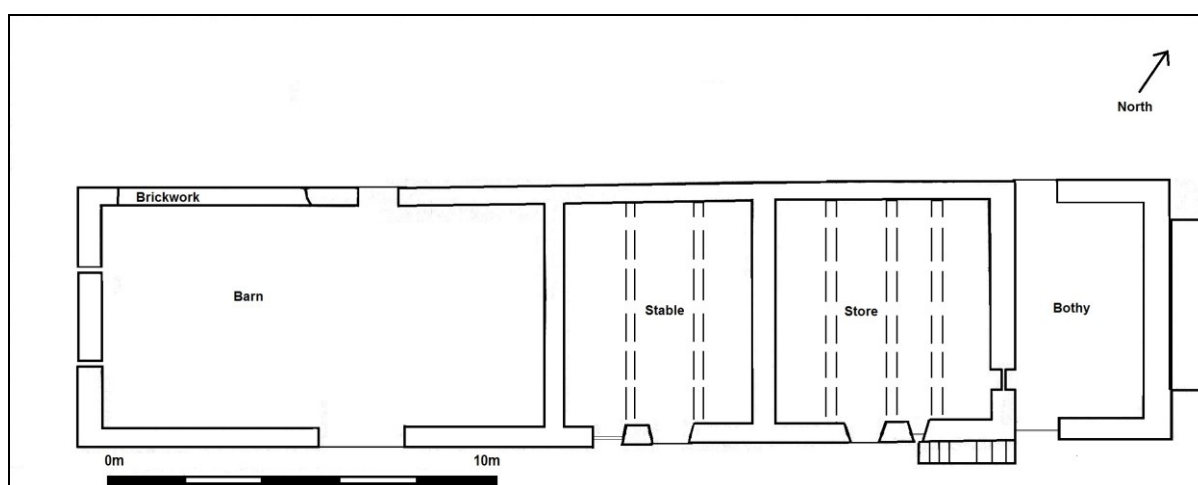
Figure 6. Floor plan of stone barn

Repairs to the building fabric consisted of a modern brick wall that extended from the western gable almost to a small door (figure 6).

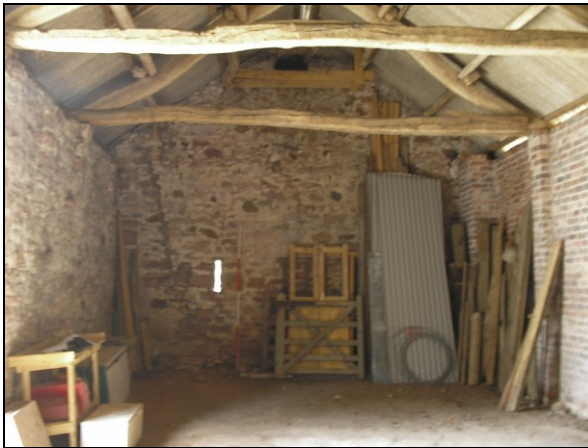
Figure 7. Interior of the Barn

The interior walls had not been treated leaving a surface of rough, rubble-stone bonded by a lime mortar (figure 7). The principal ingress appeared to be from the south-west with a large door 2.40m in width.

The barn was supported by four hand-made wooden roof trusses that rested on slight stone buttresses built into the stone fabric (figure 7).

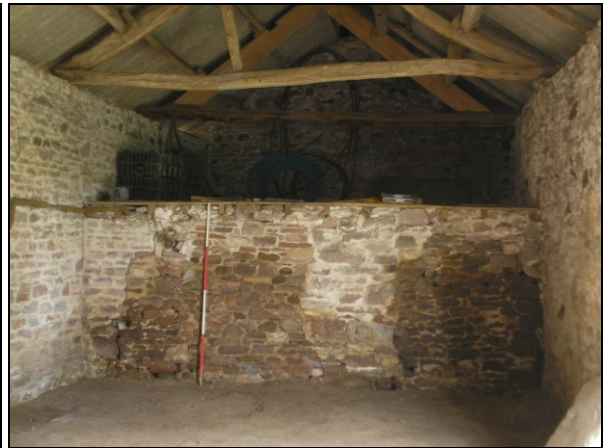
Figure 8. Interior of the Barn with partition wall

A coarse rubble-stone partition wall between the barn and the stable stood to a height of 2.00m and formed a loft above the stable (figure 8). The partition wall was not keyed into the shell of the building and appears to indicate a revised spatial arrangement within the barn.

A fifth timber roof truss had replaced an earlier support at the eastern end of the barn (figure 8).

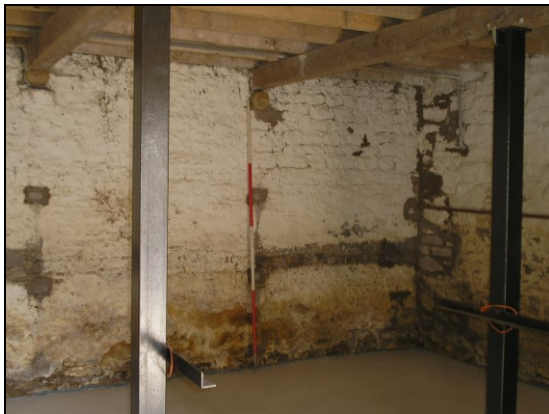
Figure 9. Interior of stable

Formerly, three stalls were arranged along the northern wall fed by chutes from above that delivered the hay (figure 9).

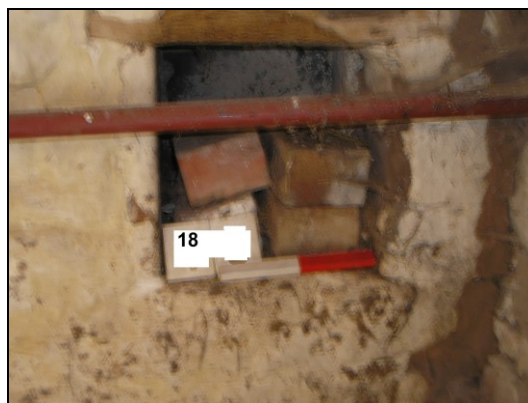
Figure 10. Cupboard (18)

A small cupboard (18) measuring 0.30m in height, 0.28m in width and 0.32m in depth was surmounted by a timber lintel and set into the eastern wall (figure 10).

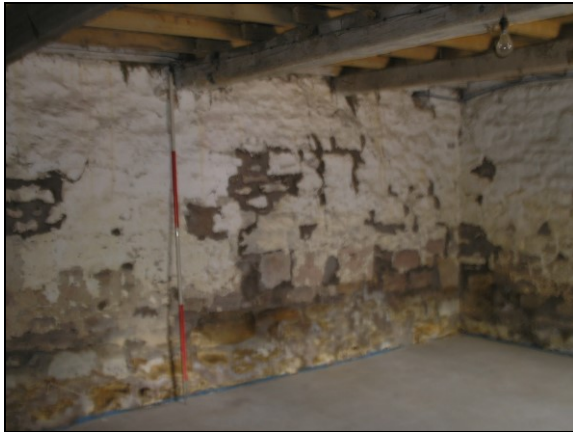
Figure 11. Store interior

The floor of the store was recently surfaced in concrete, whilst the rubble-stone walls were largely white-washed (figure 11).

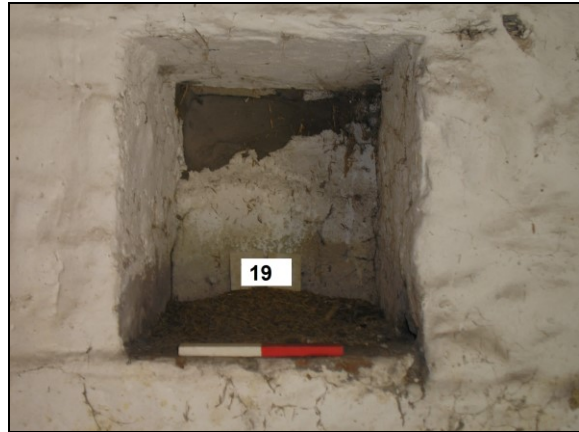
Figure 12. Cupboard (19)

A small cupboard (19) measuring 0.41m in height, 0.38m in width and 0.37m in depth was surmounted by a timber lintel and set into the western wall (figure 12). This feature may have originally conjoined with cupboard (20) within the bothy.

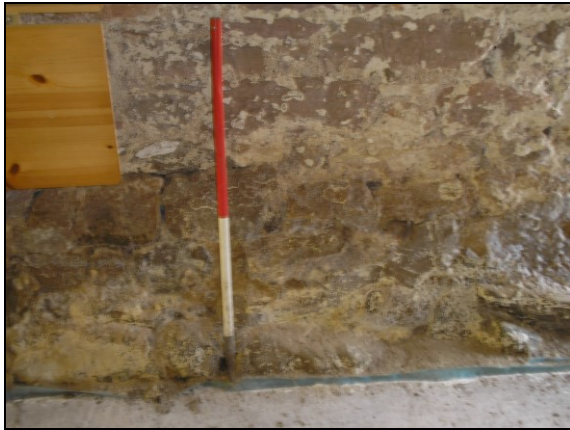
Figure 13. Stone plinth within the bothy

The western wall dividing a store and the bothy was originally the gable end of the original barn and appeared to be built on a plinth of large rubble-stones (figure 13) that projected out from the wall.

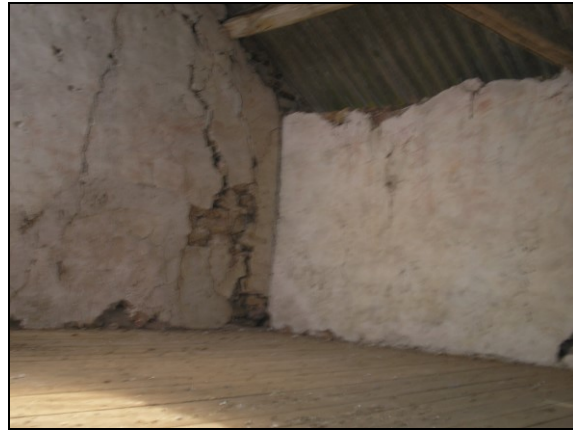
Figure 14. Dormitory above the store

The dormitory measured 5.55m x 5.17m and was open to the roof a maximum height of 3.50m. All four walls were rendered in a pinkish, white plaster forming panels that had been subject to considerable graffiti in the past (figure 14).

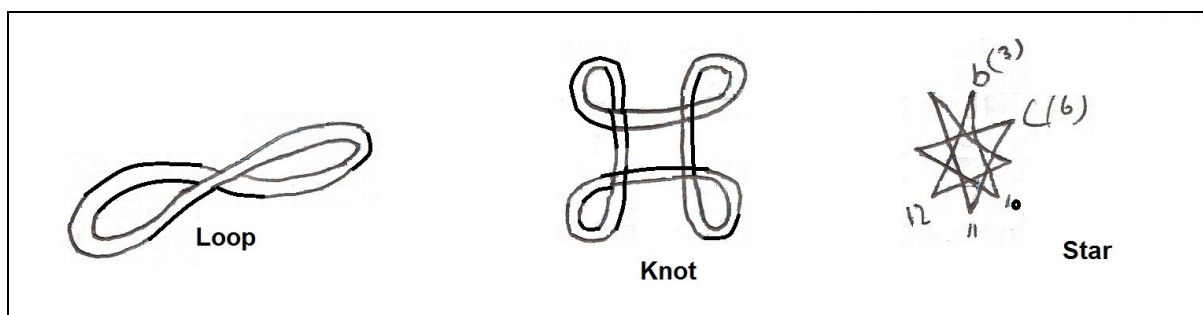
Figure 16. Popular motifs found on the plastered walls

The second major element comprised geometric motifs that frequently re-occurred (figure 16).

- The simplest motif was a loop of which there were at least four examples.
- A sophisticated “knot” occurred at least three times.

- Variations on an irregular shaped star and in one case had numbers or letters at each terminal.

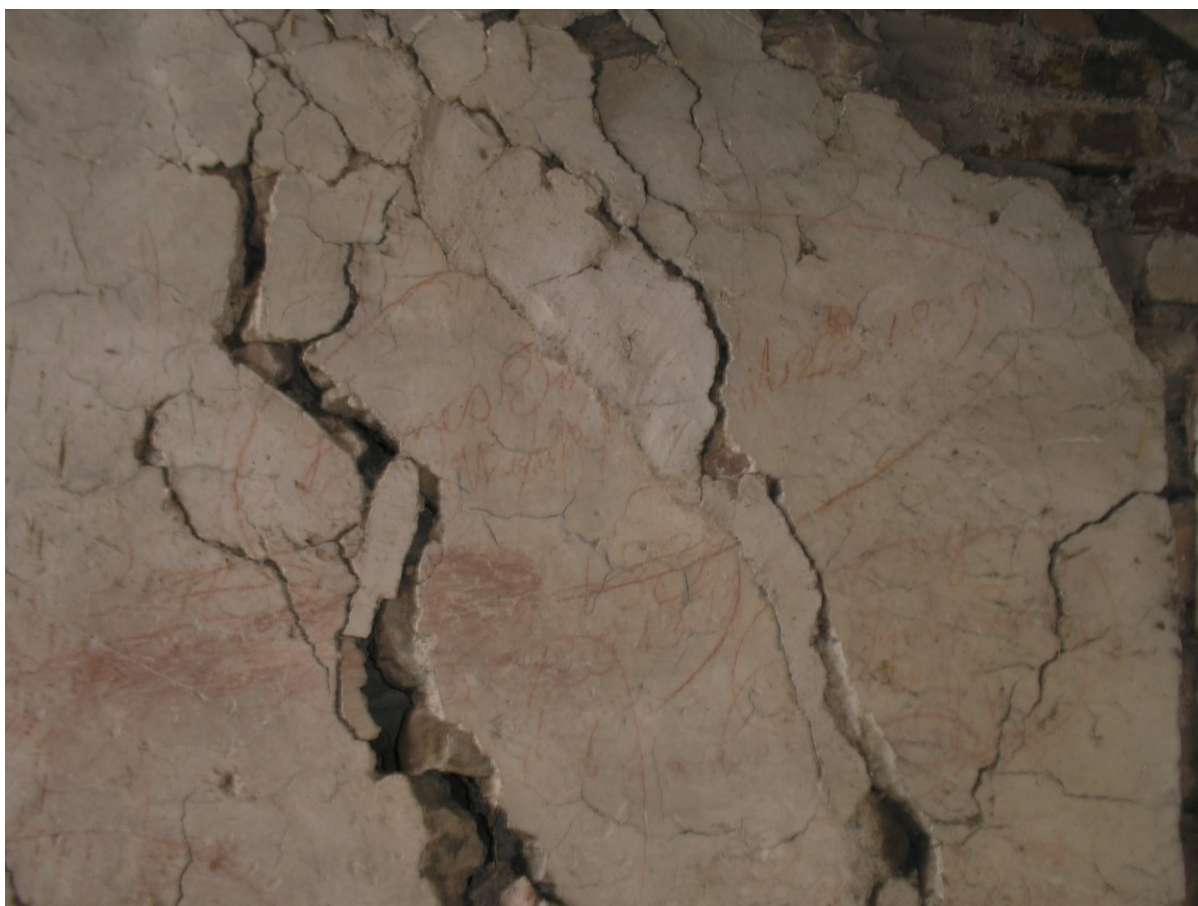
Figure 17. Western panel bearing graffiti

The graffiti was hard to discern due to a combination of erratic handwriting, poor light, poor definition and uncertain subject matter (figure 17). Its authenticity and provenance based on contemporary handwriting style appear to be genuine, while under close scrutiny, certain patterns began to emerge that formed the following narrative.

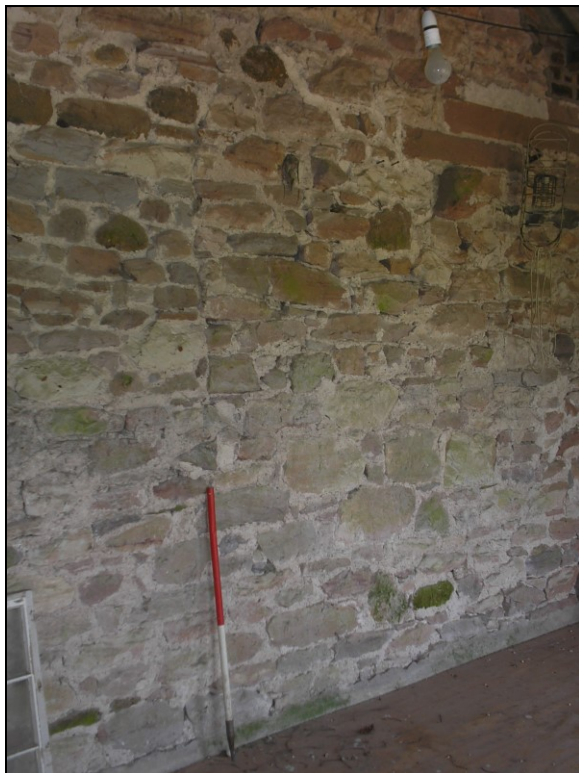
Figure 18. Filled window within bothy

Within this wall was an offset, filled window measuring 1.06m in width and 1.20m in height (figure 18). This window was clearly visible in the adjacent dormitory.

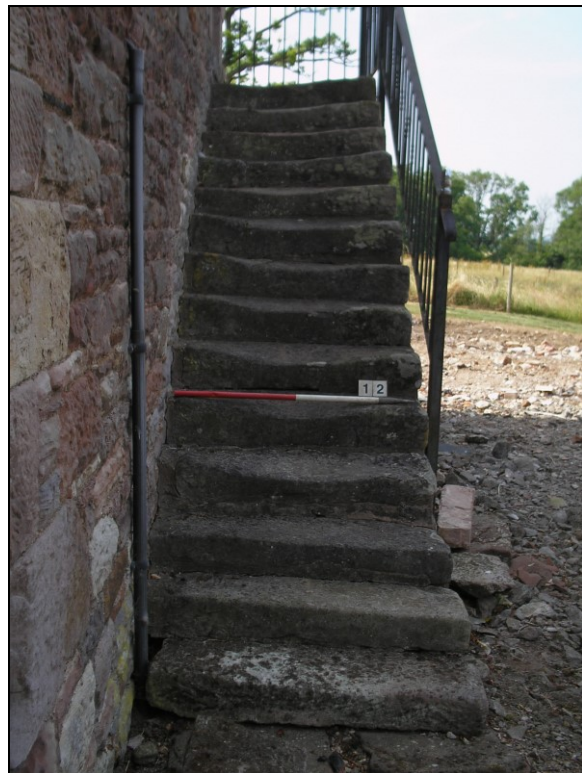
Figure 19. Steps leading into the bothy

- The upper storey was reached by a flight of fourteen stone steps (figure 19), 1.10m in length and approximately 0.20m in thickness. These steps (12) formed a rectangular appendage 3.86m in length and 2.16m in height surmounted by a metal rail (figure 21). These steps were added after 1868 as they do not appear on the first edition Ordnance Survey map.

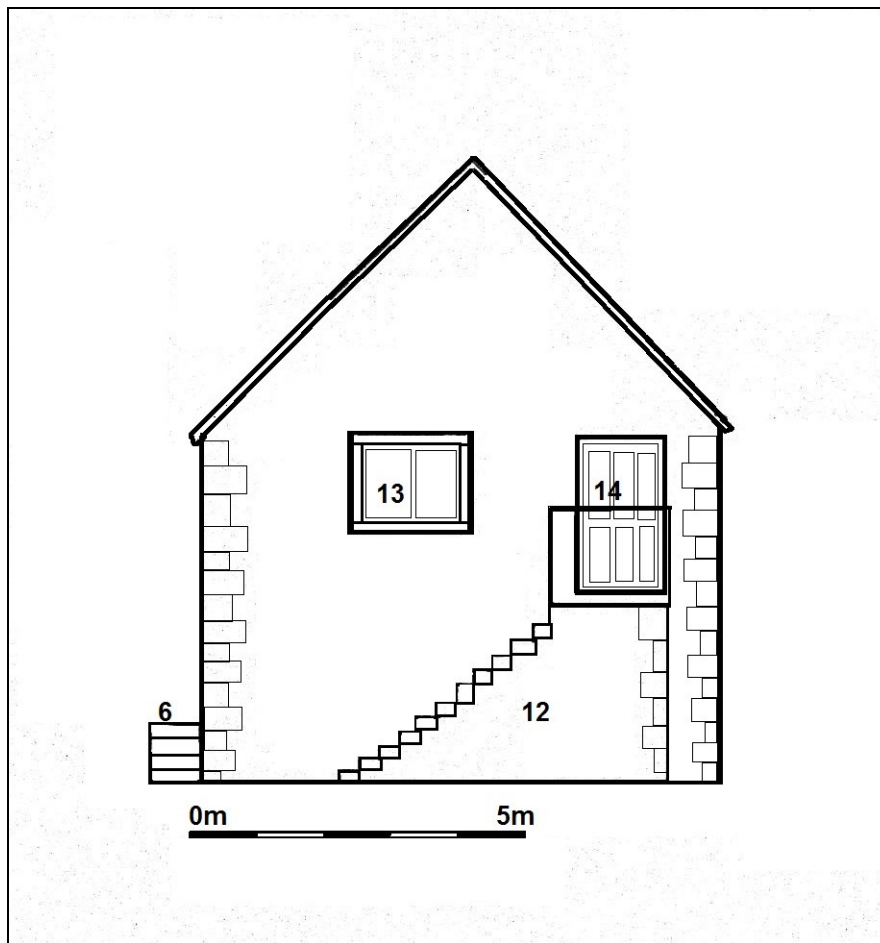
Figure 20. Eastern elevation of stone barn

The eastern gable was formed from rubble-stone to form a wall 0.45m in thickness and measured 6.10m in width and stood to a height of 8.20m. The elevation was complemented by dressed sandstone quoins measuring between 0.30-0.60m in length and between 0.25-0.30m in thickness (figure 20).

- A window (13) measuring 1.45m x 1.25m in height filled the upper storey to the bothy. It possessed a red sandstone surround but the window casement was a modern replacement (figure 22).
- The bothy was entered through a wooden door (14) measuring 1.00m in width and 1.98m in height. The door was modern but distressed comprising twin panes and double wooden panels. The door was within a red sandstone surround formed from stone quoins (figure 20).

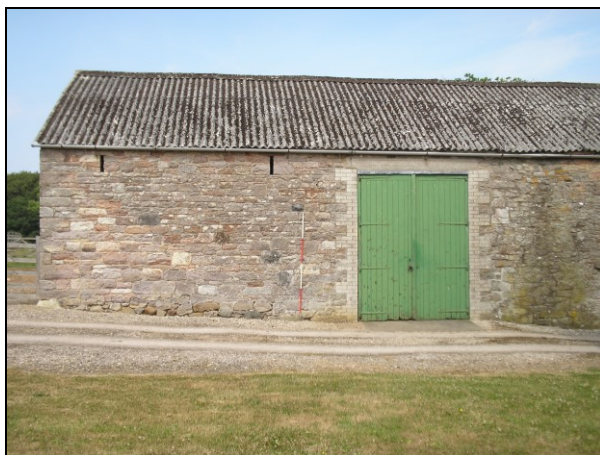
Figure 24. Western end of southern elevation

There is some suggestion that the western part of the elevation was also extended west of door (1). This part of the building fabric was built on a plinth of large boulders that slightly projected (figure 24). The elevation contained two ventilation slits measuring 0.40m x 0.10m (figure 24).

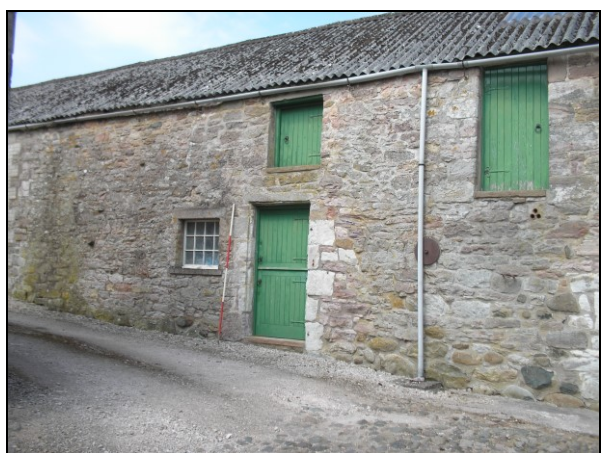
Figure 25. Central area of southern elevation

The earliest phase was the central part of the barn formed from rubble-stone walls (figure 25) measuring 0.60m in thickness and finished with red sandstone quoins at each gable end. The quoins forming the façade were approximately 0.56m x 0.30m x 0.29m in size and hand finished.

The elevation was in a generally good state of repair with the plastic guttering working. Part of the central stonework just below the roof-line had been repaired and repointed (figure 25).

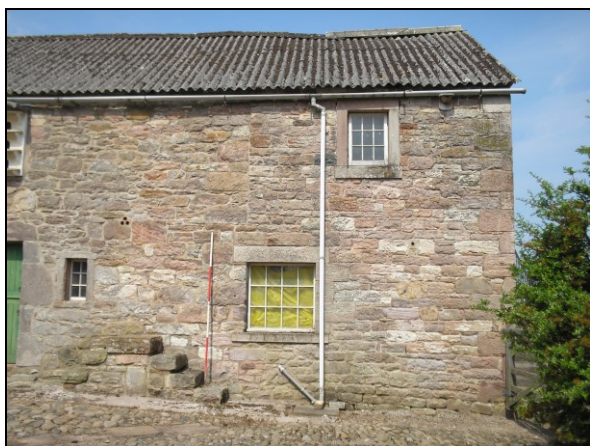
Figure 26. Eastern end of southern elevation

The latest phase was the addition of a stone bothy at the eastern end with walls measuring 0.45m in thickness (figure 26).

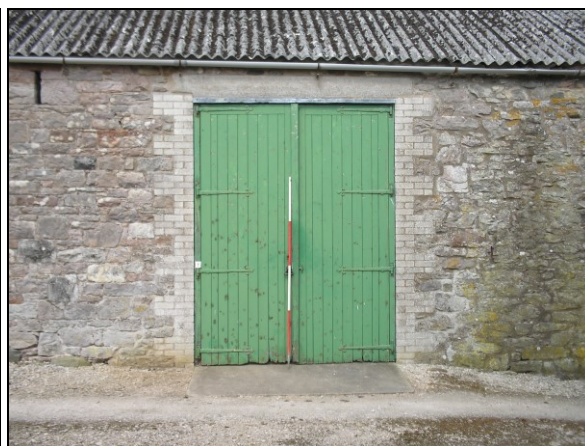
Figure 27. Door (1)

- Door (1) led into the barn. It was a relatively modern Tongue-and-Grooved wooden double-door measuring 2.50m in width and 3.00m in height. The door was surmounted by a replacement concrete lintel, whilst the surround was replaced in light grey brick produced during the mid to later 20th century (figure 27).

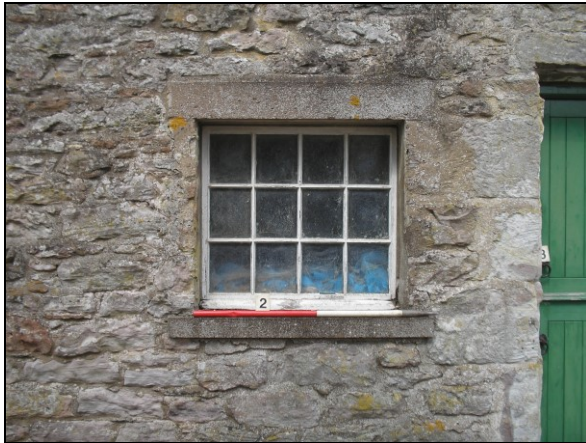
Figure 28. Window (2)

- Window (2) lit the stable. It measured 0.88m x 0.81m in height and consisted of twelve panes of glass 0.18m x 0.22m within a timber frame. The surround was replaced in concrete (figure 28).

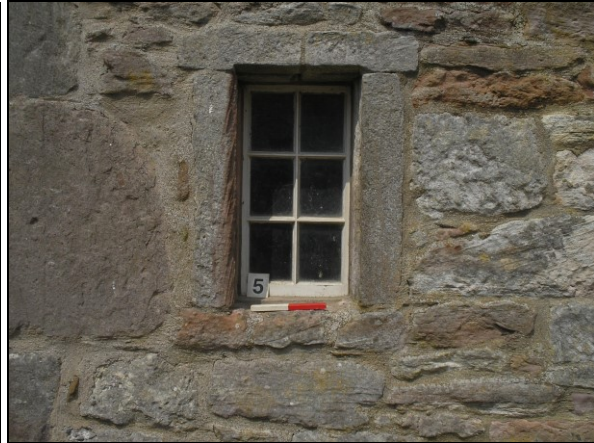
Figure 29. Window (5)

- Window (5) provided light into the store. The window (figure 29) measured 0.30m x 0.64m in height and contained six glazed panes measuring 0.13m x 0.17m within a timber frame. The stone surround possessed a rebate 0.08m into the light, a groove that formerly served as a possible glazing bar.

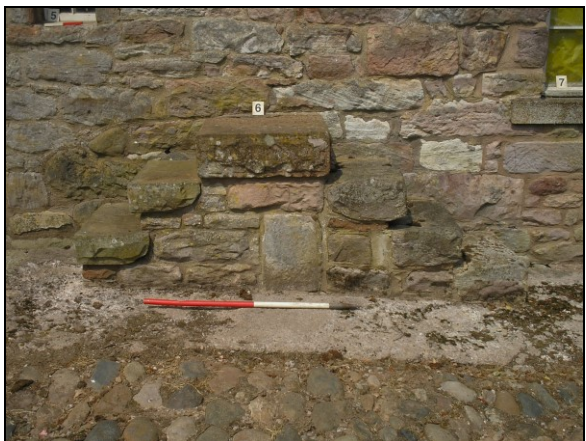
Figure 30. Steps (6)

- Steps (6) butted the building and were used for mounting horses. This set of steps (figure 30) measured 0.78m in height, 2.14m in length and 0.65m in width and was formed from

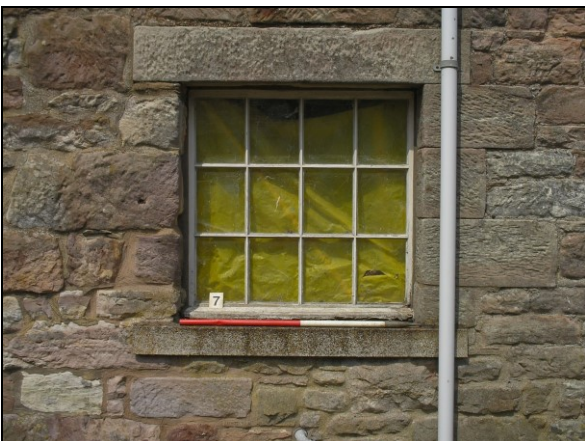
Figure 31. Window (7)

- Window (7) served the ground floor of the bothy. It measured 1.00m x 1.01m in height. The timber casement was a replacement, glazed with twelve small glass panes measuring 0.21m x 0.29m. The exterior surround comprised neatly dressed red sandstone jambs except where it utilised the existing sandstone quoins from the corner of the original stone barn.

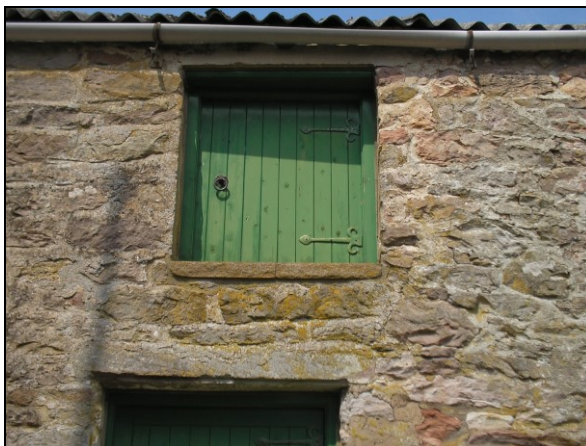
Figure 32. Loft door (8)

- Loft door (8) accessed the space above the stable. It measured 0.90m x 1.10m and consisted of a relatively modern Tongue-and-Grooved wooden door. No formal surround existed and it appears probable that this feature was enlarged from a former window (figure 32).
- Door (9) accessed the dormitory and measured 1.00m x 1.70m. It comprised a relatively modern Tongue-and-Grooved wooden door sitting within a formal surround consisting of stone quoins (figure 33).
- Dovecote (10) was a modern addition (figure 34) filling a former window measuring 0.70m x 0.90m (figure 35) servicing the dormitory.
- Window (11) measured 0.70m x 0.90m in height and lit the upper floor of the bothy. It possessed an interior timber lintel whilst the window frame was modern. The exterior red sandstone surround was machine-sawn (figure 36).

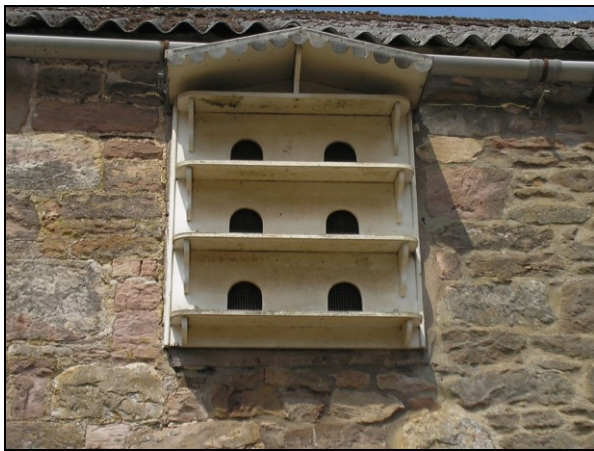
Figure 34. Former window now a dovecote (10) Figure 35. Interior of former window (10)

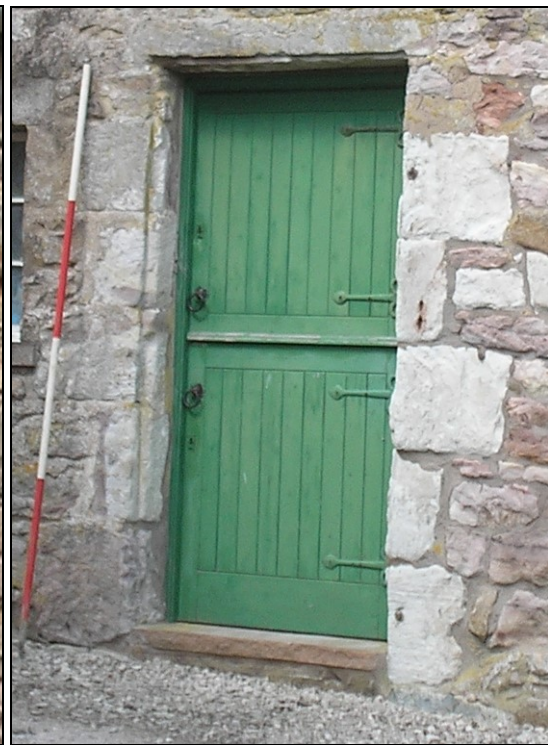
Figure 37. Door (3)

- Access into the stable was through a relatively modern Tongue-and-Grooved wooden Dutch door (3), [sometimes known as a stable door], measuring 1.00m x 1.98m in height. The door surround was formed from a red sandstone step, dressed stone quoins and a stone lintel. Within the surround was a slight rebate 0.03m in depth that accommodated a former external door secured by lead-filled mounts for bolts and hinges (figure 37).

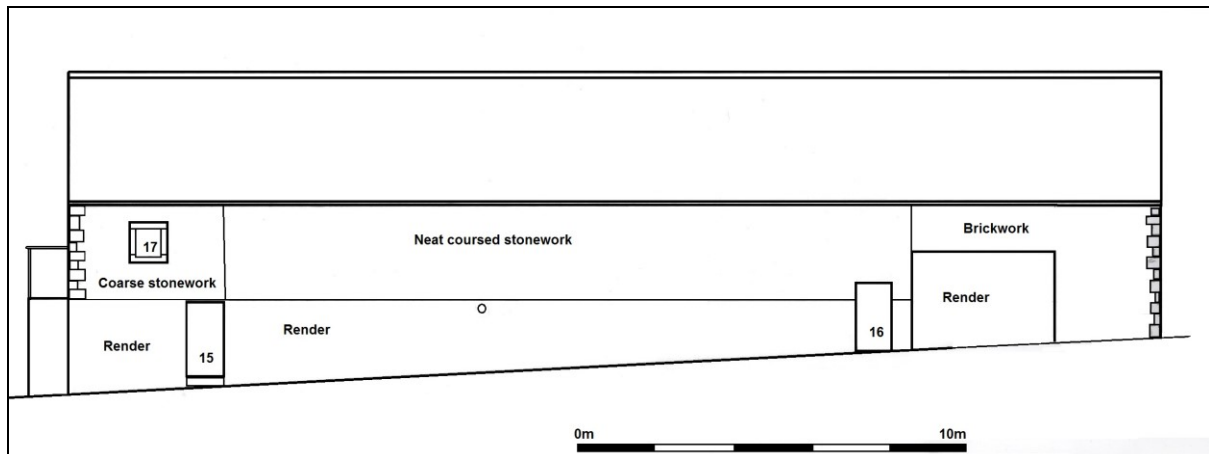
Figure 38. Northern elevation of stone barn

The northern elevation (figure 38) measured 28.00m in length and was up to 8.00m in height and comprised two major structural phases; the stone barn and the bothy described above. Both ends of the elevation were framed by stone quoins.

A lean-to adopted as a dairy formerly butted the stone barn. A cement render 1.82m in height denoted the vertical limit of the milking area, whilst a circular iron plate 0.33m in diameter indicated a substantial reinforcing bar.

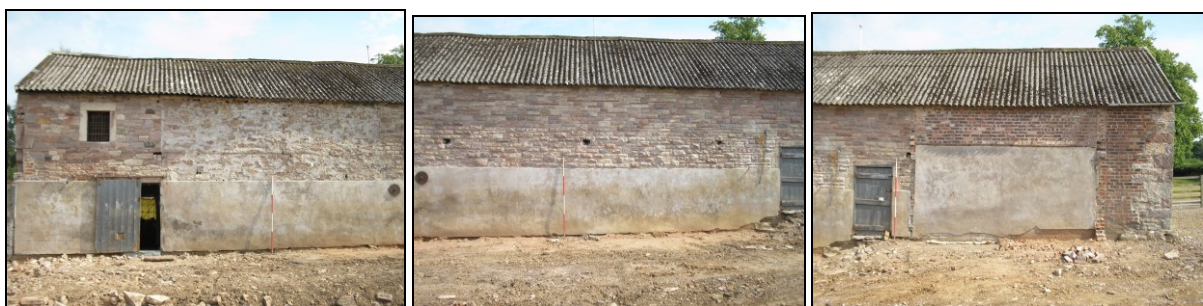
Figures 39-41. Eastern, central and western ends of the northern elevation

The stonework beside the bothy was coarse (figure 39), whereas the remainder of the building was formed from tightly bonded stone blocks, neatly pointed with a rough relief (figure 40). This style is not in keeping with the southern elevation and probably represents a refurbishment of the northern elevation, quite possibly at the same time as the erection of an adjacent replacement stone barn built in 1902 and which depicts a similar late Victorian taste in masonry.

A modern repair at the western end of the elevation was formed from red bricks (figure 41).

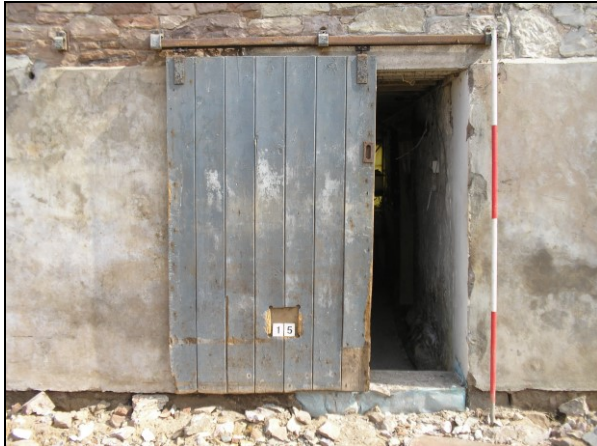
Figure 42. Door (15)

- A 20th century sliding Tongue-and-Grooved door (15) measuring 1.00m x 1.84m in height that provided the ingress into the ground floor of the bothy (figure 42).

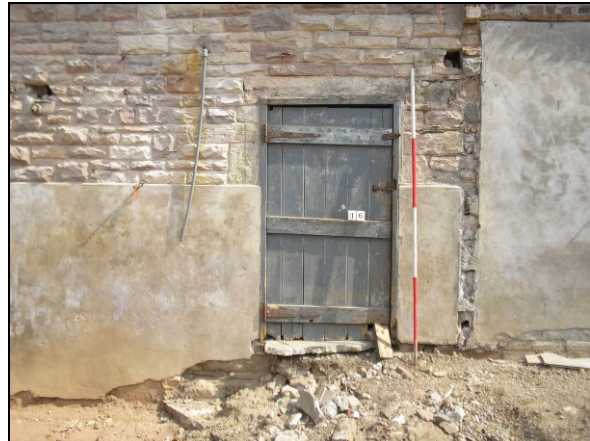
Figure 43. Door (16)

- A 20th century Tongue-and-Grooved door (16) measuring 1.00m x 1.80m in height that provided the ingress into the barn (figure 43). This doorway may have possessed a former purpose in order to create a draught into a threshing barn.
- An unglazed window (17) measuring 0.76m x 0.90m in height with complementary red sandstone surround that serviced the upper floor of the bothy. The uprights had a slightly bevelled internal frame creating a slight rebate (figure 44).

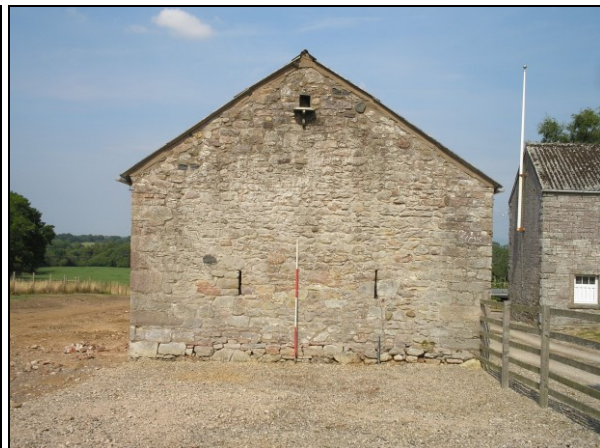
Figure 45. Western gable end

Approximately 1.16m above ground level were two ventilation slits measuring 0.06m x 0.52m in height and an owl-hole complete with ledge just below the apex of the roof (figure 45).

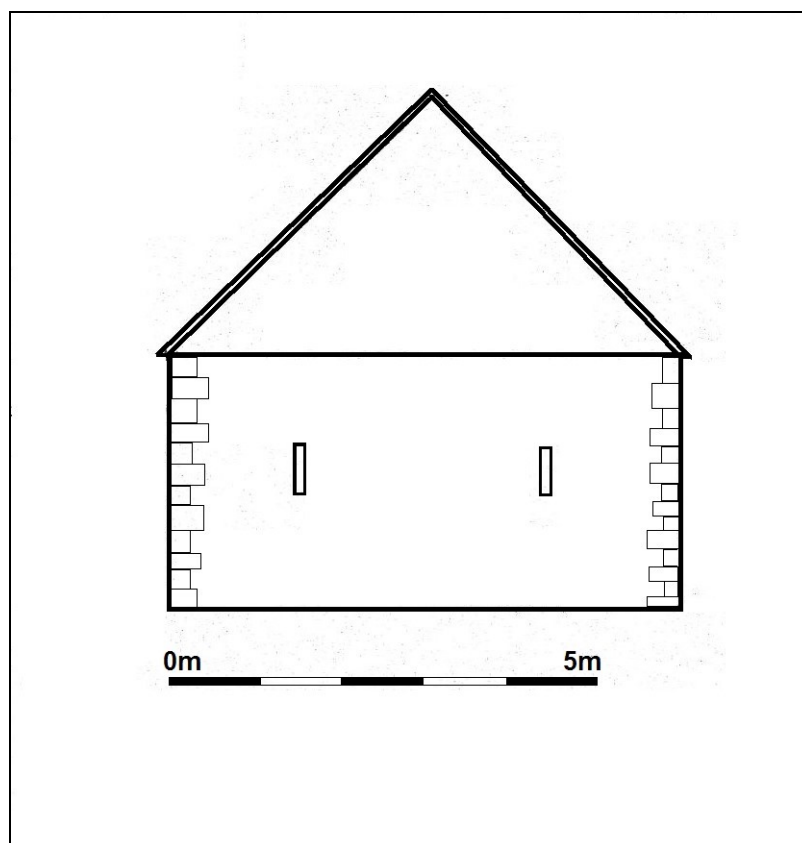
Figure 46. West elevation

The western elevation measured 6.10m in width and 6.00m in height and was plain, finished in coarse rubble-stone with flanking stone quoins (figure 46). A plinth of coarse stones appeared to support the building fabric.

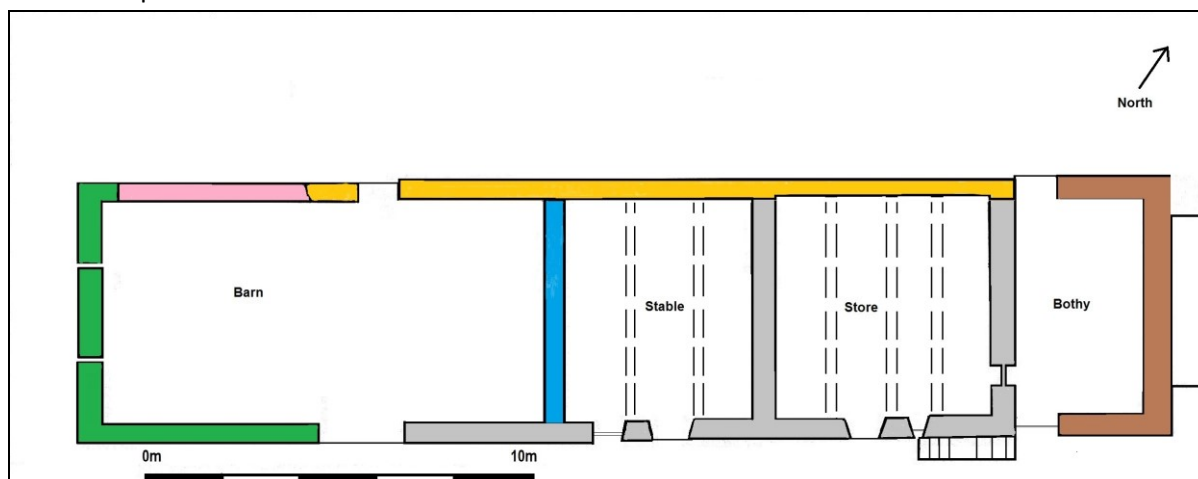
Figure 47. Phase plan of the barn complex

1. The earliest phase (grey outline) formed the original building and included a probable threshing barn and store with overhead temporary accommodation.
2. The barn may have either been rebuilt or extended (green outline) that increased the floor area. The introduction of a partition wall (blue outline) divided the barn creating a space for a stable.

3. A bothy (brown outline) was attached to the eastern end of the original barn with a flight of steps added later.

The north elevation appears to have been renovated and repointed (yellow outline) probably *circa* 1902, whilst a later further renovation occurred when a brick wall (pink outline) was introduced.
