The watching brief at the Old Fire Station, Carlisle failed to isolate deposits of any antiquity. The observed deposits were probably part of the mid-20th century reconstruction of the Fire Station demolished in 1962.

In 2014 Cumbria County Council's Historic Environment Service (CCCHES) was consulted by Carlisle City Council regarding planning permission for an extension and renovation of the former Old Fire Station, Warwick Street, Carlisle (figure 1). The planning application covering this fieldwork was No. 1/14/0129.

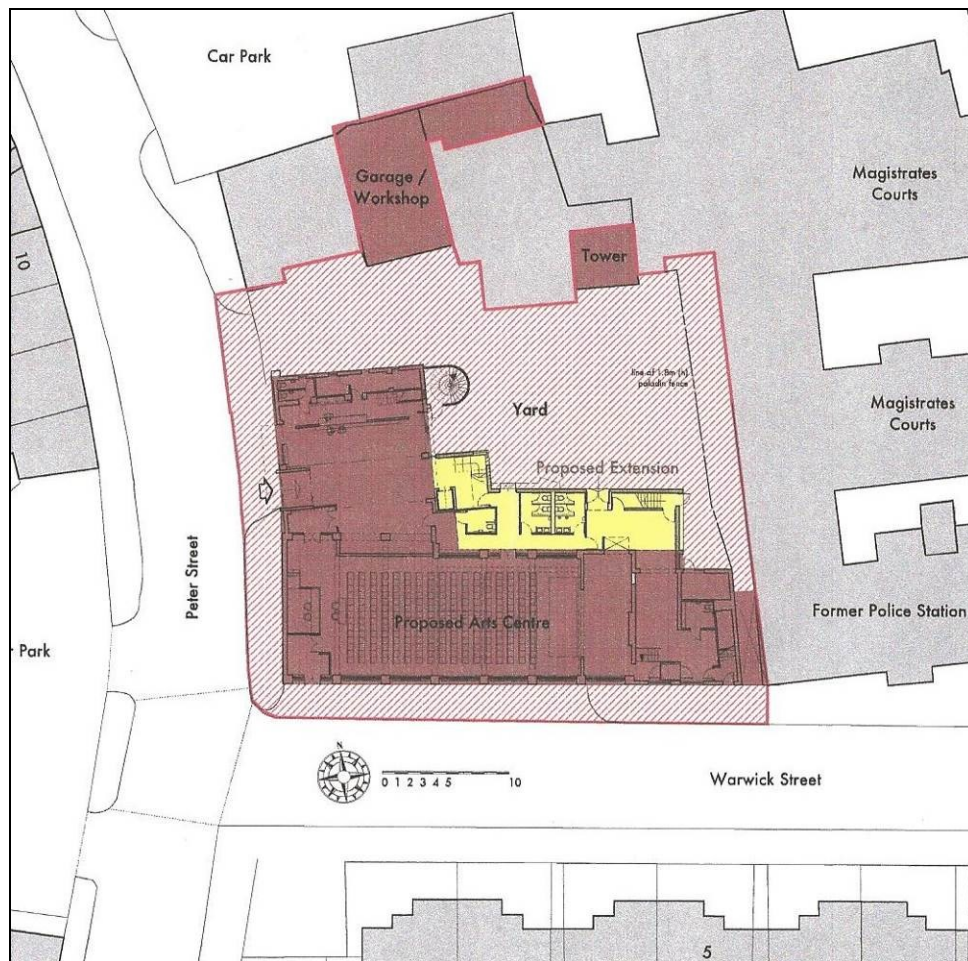
Figure 2. Location of the new development

The development of the site involved the machine removal of extraneous overburden within the proposed building footprint (figure 2, yellow shading).

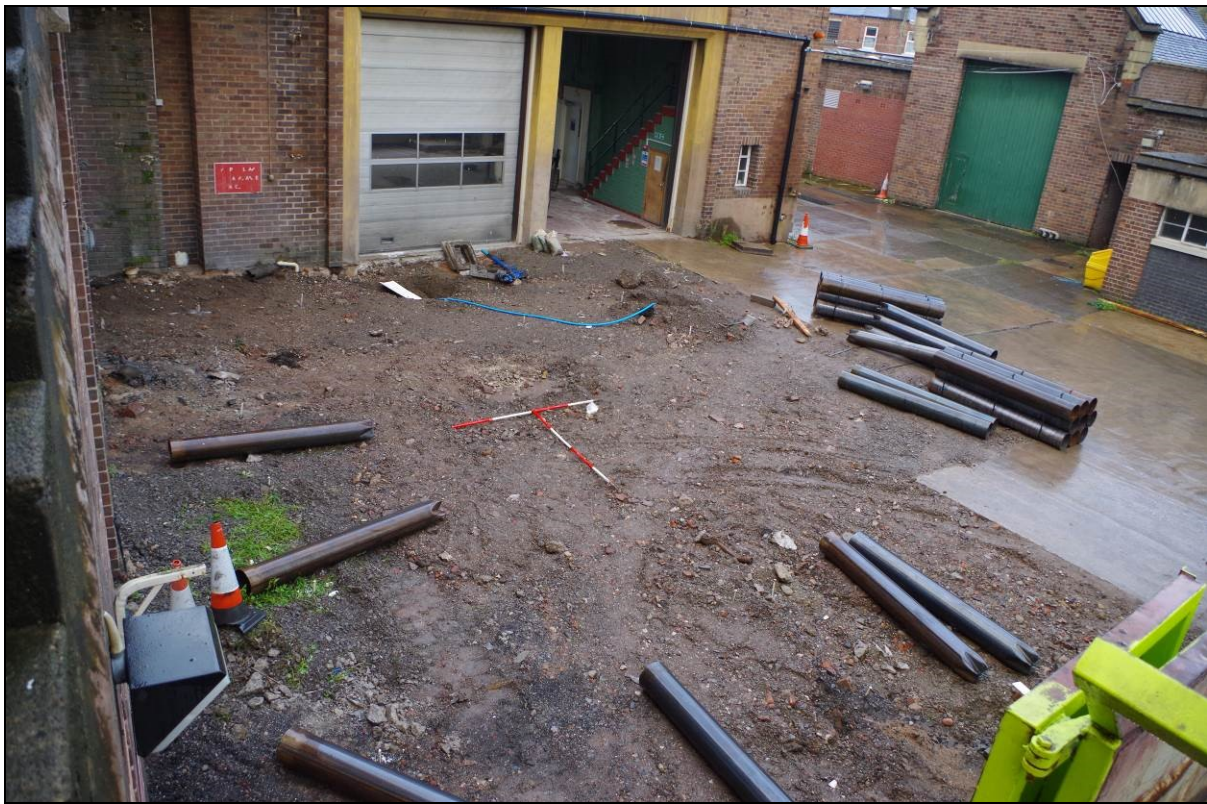
Figure 5. Study area prior to excavation

Work began on the lift shaft (figure 3) measuring 2.80m x 2.50m on October 21st 2014 at the western edge of the site (figure 5).

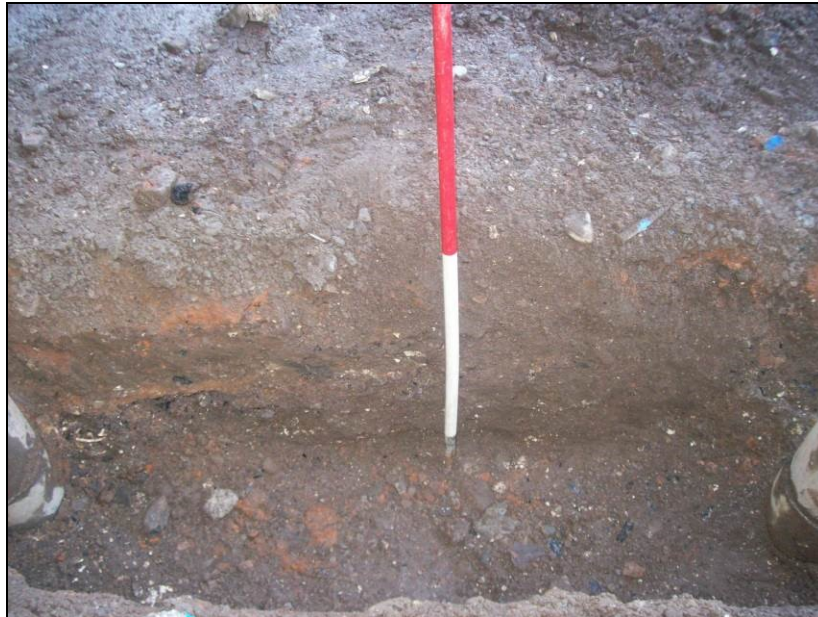
Figure 6. Section showing demolished building material

The shaft was reduced 1.67m from the concrete slab by machine excavator and then hand excavated around the piles. The excavated material comprised demolished building material mainly brick and concrete (figure 6).

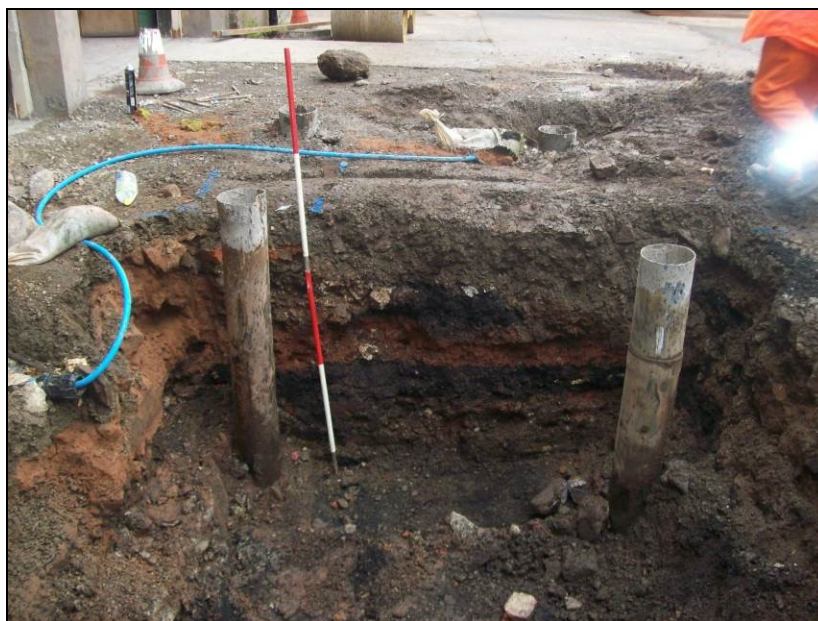
Figure 7. Modern material within the lift shaft footprint

Along the northern edge of the trench, there existed layers of rubble 0.80m in depth, sand 0.20m in thickness, dark grey industrial ash 0.20m in thickness and possibly a soil surface 0.47m in depth; all deposition of relatively recent date (figure 7).

Within the shaft footprint, a dark grey organic layer of little depth was visible that may have possibly been an original soil surface, subsequently truncated in order to provide the construction level for the mid-20th century Fire Station.

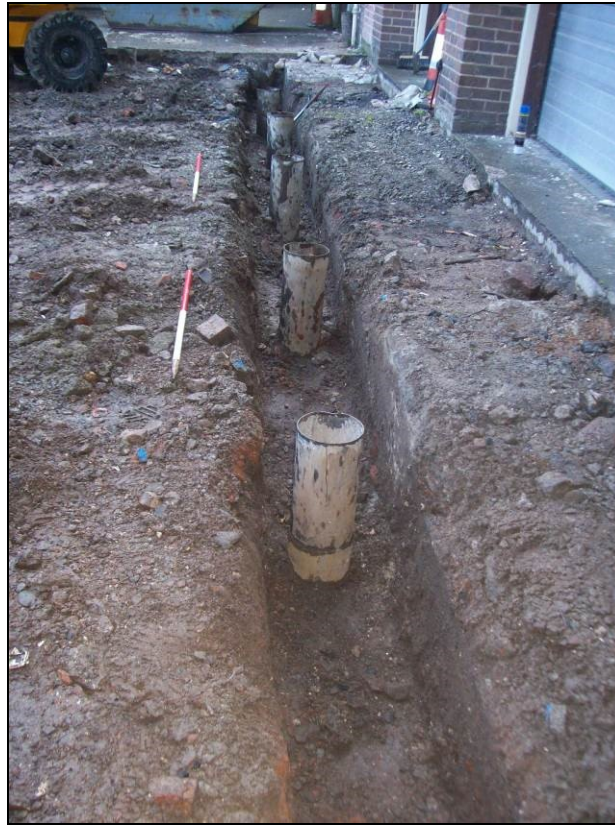
Figure 8. Trench alongside piles

An east-west aligned trench (figure 3) was also inserted beside a set of driven piles (figure 8). This trench penetrated to a depth of 0.50m but revealed only a rubble horizon 0.20m in thickness above a concrete layer 0.30m in thickness.
