A field survey was conducted to ascertain the cultural significance of a Grade II listed stone byre that collapsed during the winter of 2013-14.

The study building, a listed Grade II building, has been subject to two previous planning applications in 2005 and 2012 for conversion from a byre into part of the main dwelling that forms Skiddaw View, Bothel.

The study building was located at NY17982 38739 and is part of planning application 2/2014/0597 and 2/2014/0598.

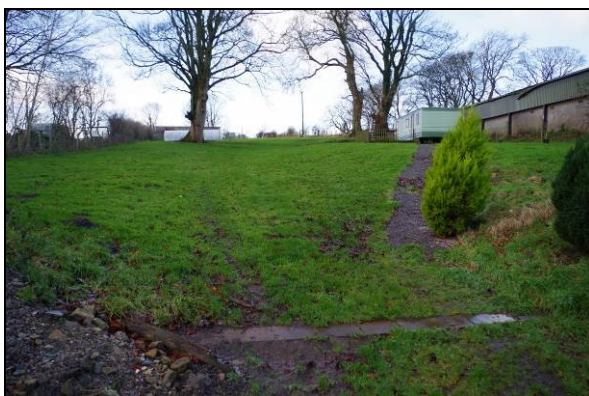
Figure 3. Looking westwards from the study area Figure 4. Looking north, adjacent farm buildings

The byre was located in a small hollow, the terrain rising westwards within a narrow property strip (figure 3) that resembled a medieval strip field.

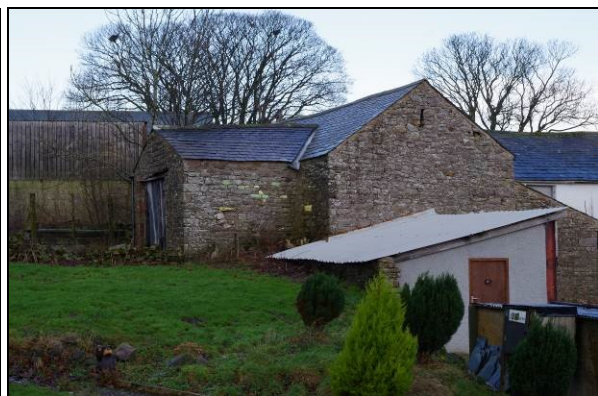
Adjacent to the study area were a suite of stone agricultural buildings (figure 4) that appeared to be contemporary to the former stone study byre. These buildings belong to Fell View Farm.

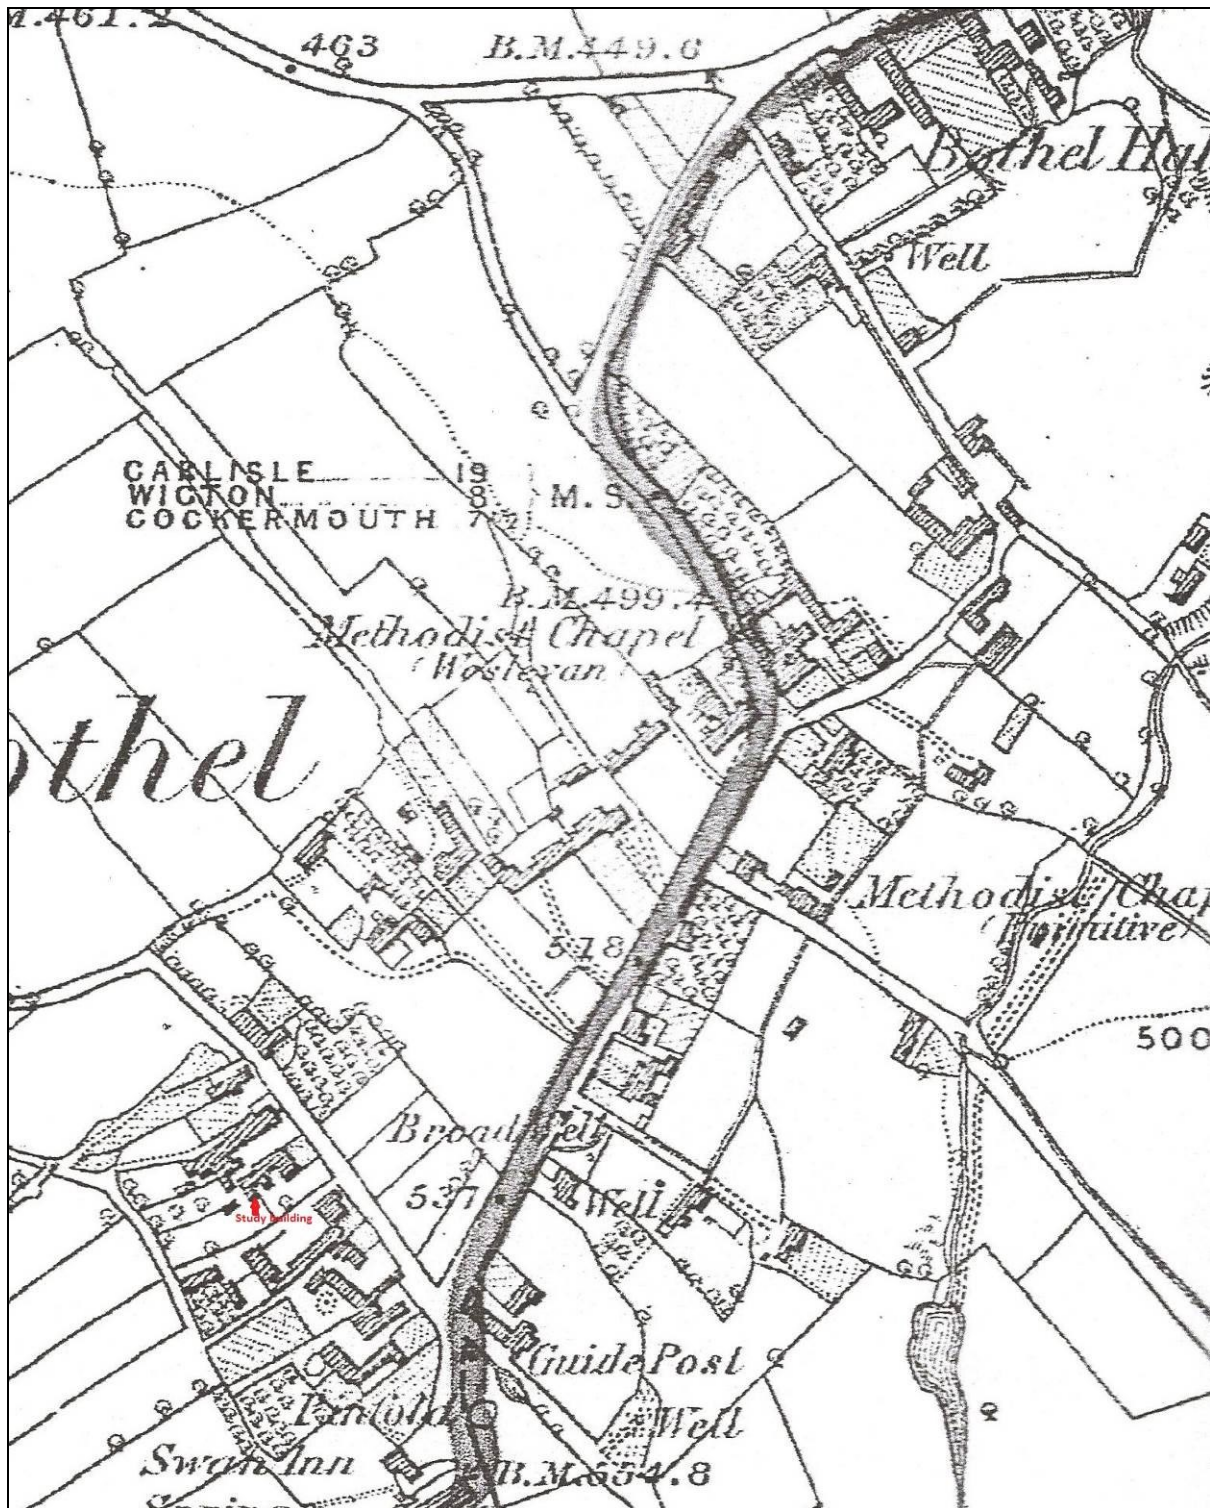
Figure 7. Location of the study building on the First Edition Ordnance Survey map 1868

Most probably, the land to the west of Skiddaw View was not subject to enclosure perhaps belonging to the Manor of Bothel. However, on the 1868 Ordnance Survey map (figure 7) each

The first edition Ordnance Survey map compiled in 1868 (figure 7) illustrates quite clearly, the recent footprint for the listed building. It depicts the main body of the house parallel to the lane with a narrow adjunct at right-angles to the main building that incorporated a byre. Other small structures that included a wash-house are also evident (figure 8). Fell View Farm, High House and Brisco House were all established.

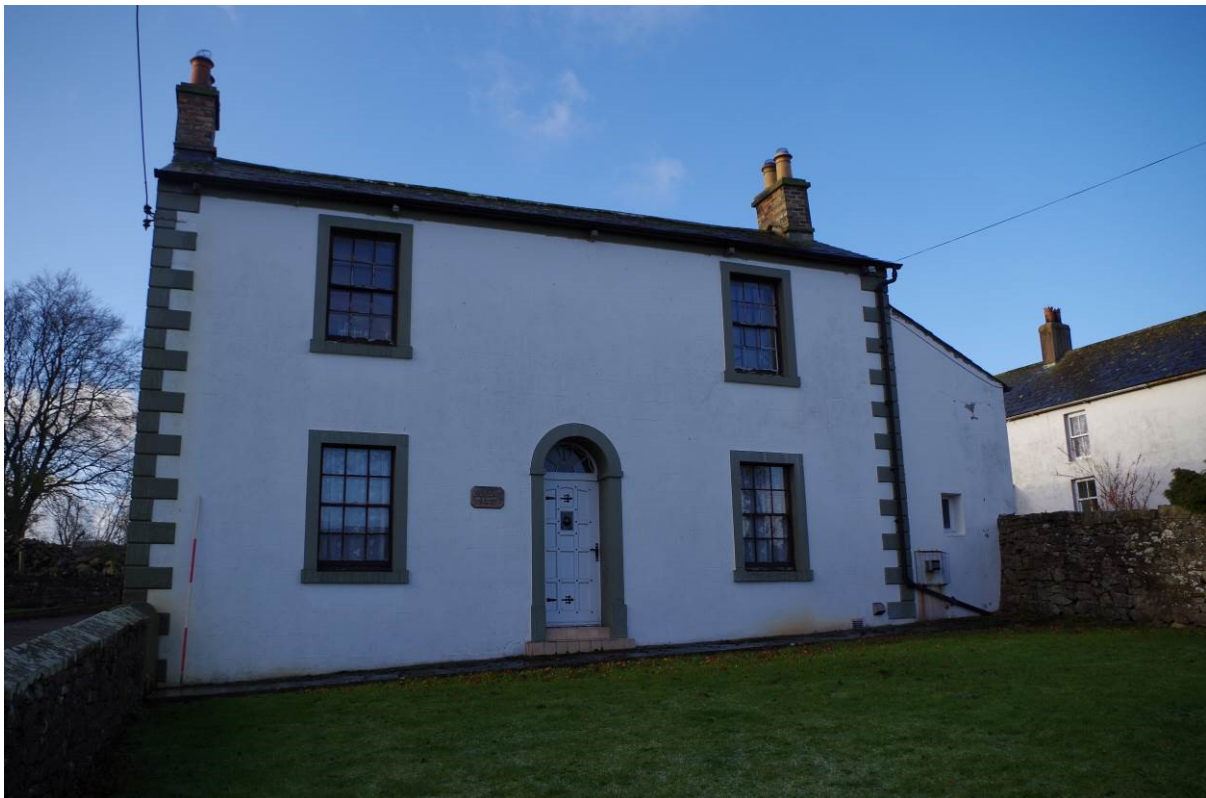
The front of the house conforms to a “Two-unit house” that was organised around two principal spaces; a general living room invariably known as the house and a second smaller room often called a parlour or bower. Above would be the sleeping quarters.

Skiddaw View would be a late version of this style as the stairwell was probably internal and the bedrooms were dedicated spaces rather than a conversion of a continuous loft.

Figure 9. Frontage of Skiddaw View illustrating the two-unit form

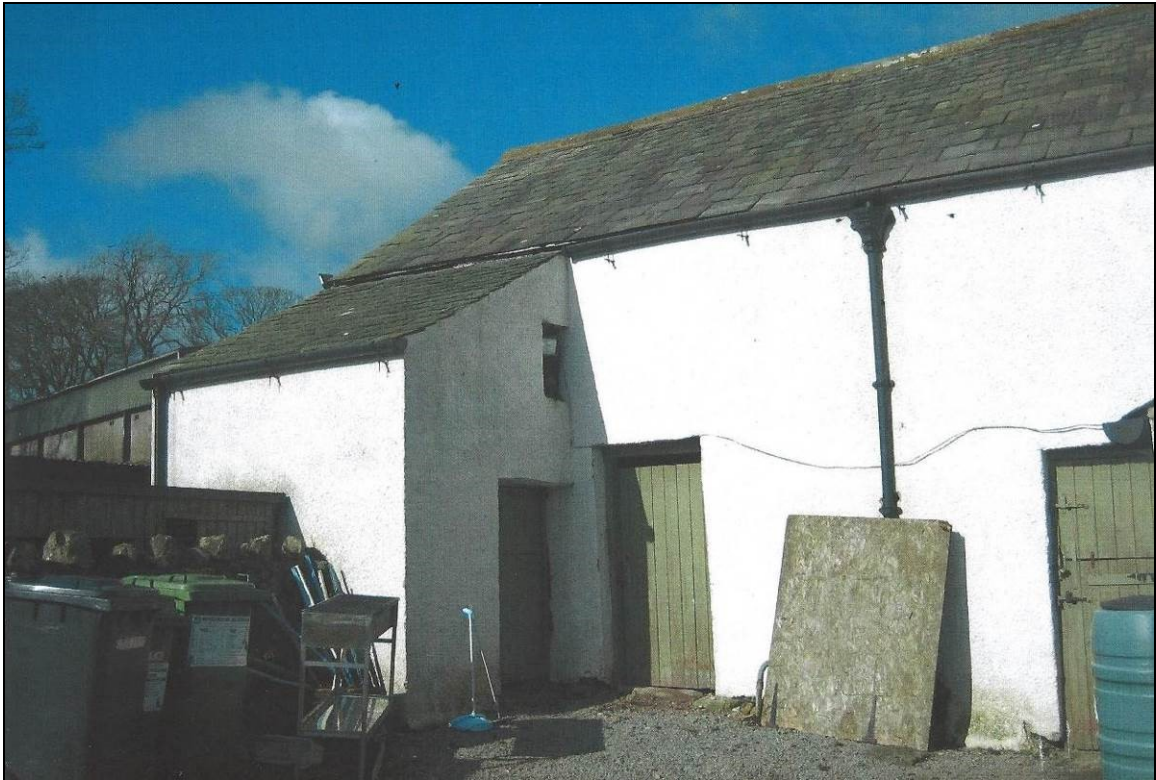
The southern elevation illustrates that the byre was finished in cement render or a form of stucco painted white and possessed a Welsh slate roof with a stone ridge (figure 12). This maintained the white finish to the rest of the house.

A small outshut of unknown function was applied to the western gable and the byre was accessed through two “tongue-and-groove” wooden doors.

Figure 12. Southern side of the former byre

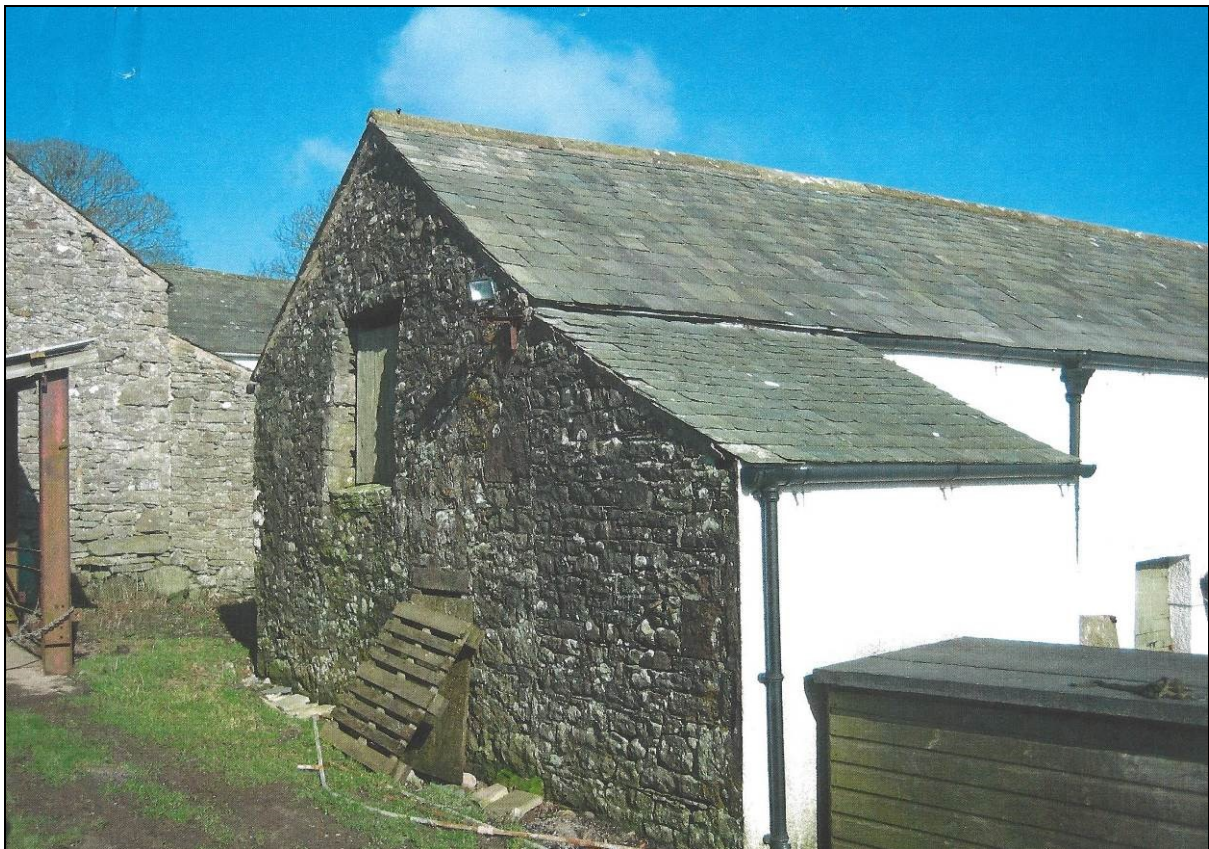
Figure 13. Western gable of the former byre

The western gable end was not finished in render and left as a rough stone finish formed from uncoursed rubble-stone. A single, central wooden door allowed access to an upper floor probably a former hayloft. A small, ground floor, filled window with red sandstone sill is just visible to the right of the hayloft door (figure 13).

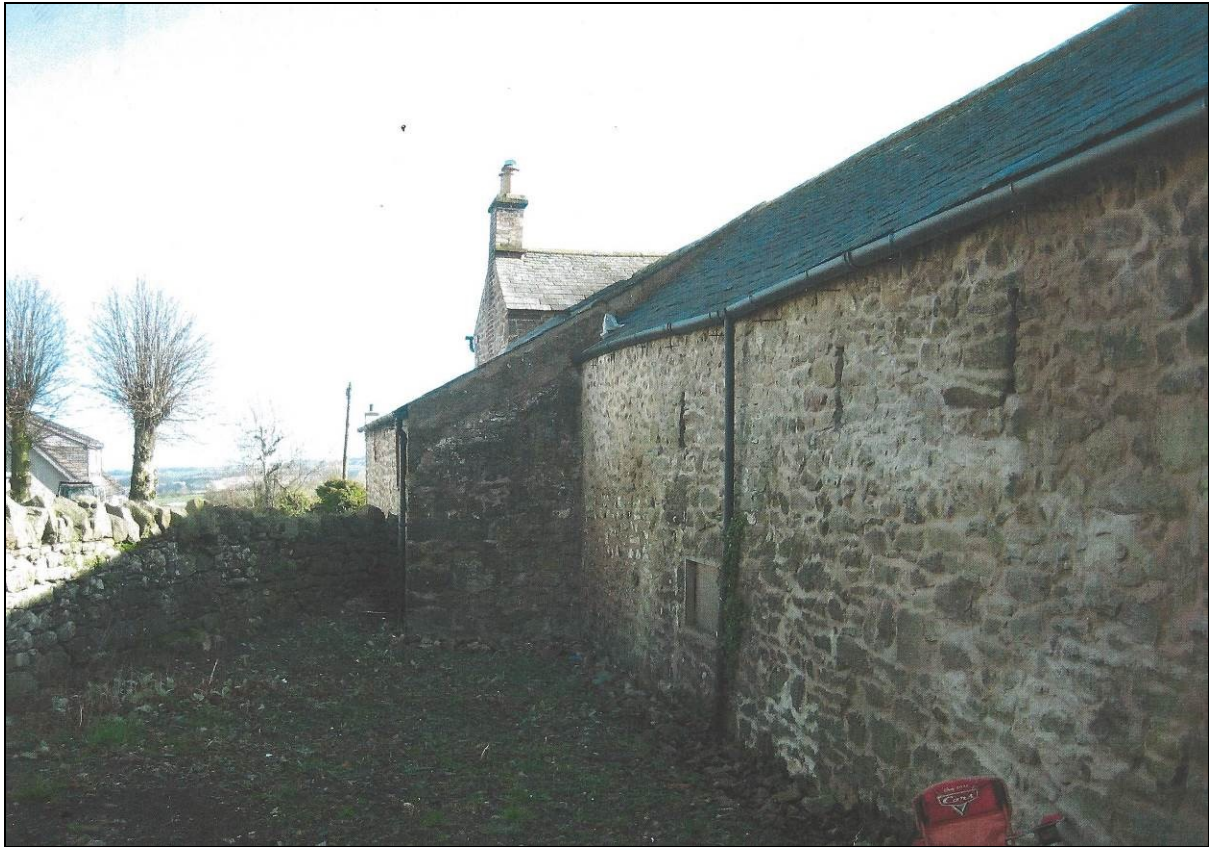
Figure 14. Northern side of the former byre

The northern elevation (figure 14) consisted of a plain rubble-stone wall with four ventilation slits on the first floor. A ground floor window appears to be boarded over.

The byre appears to sit within a foundation cut, the elevation being shorter than the internal headroom.

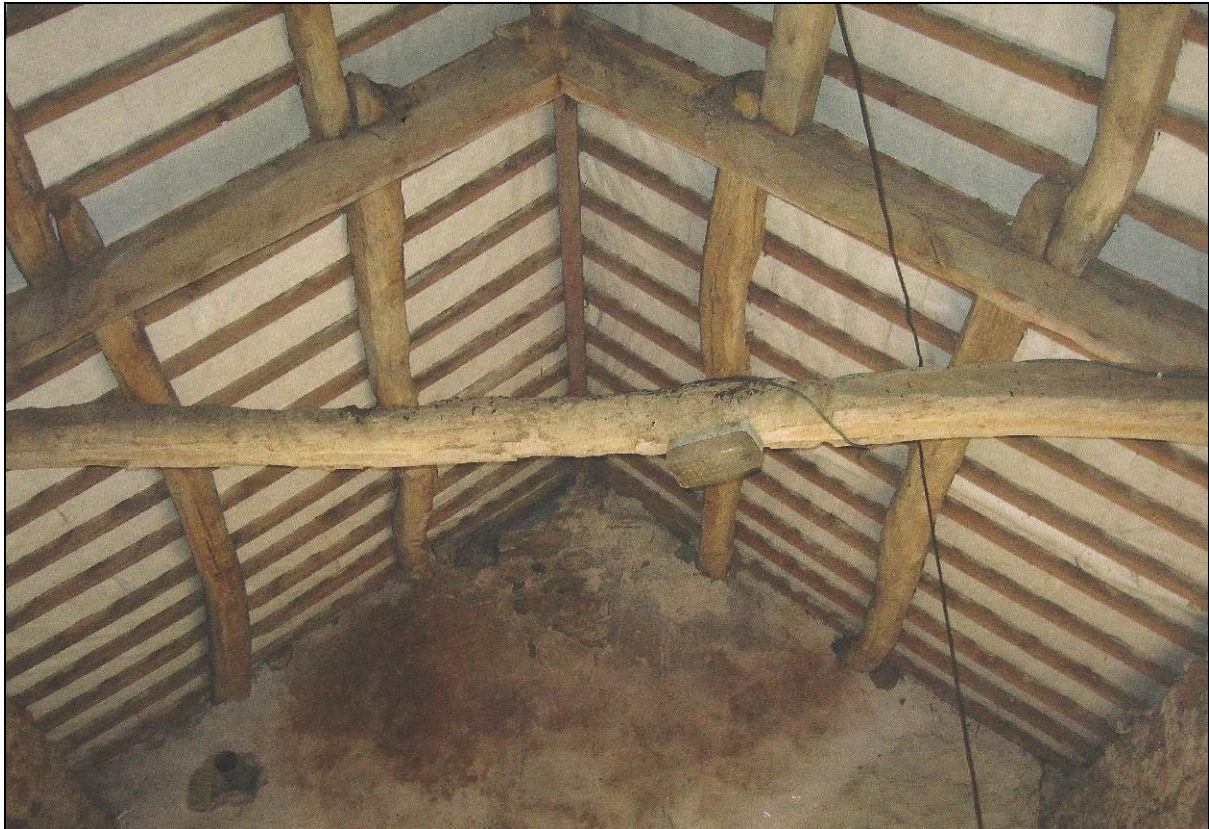
Figure 15. Eastern side of the byre with internal roof timbers

The eastern gable end appears to have been finished in plaster applied to a rough-faced rubble-stone wall.

The roof, as it served a large, open space was supported by hand finished timber purlins with a simple tie-beam truss (figure 15), common in the 18th and 19th century (Brunskill 2002, 152-153). No kingpost was present or a wrought iron central vertical tension bar, which suggests that the roof was constructed before the late 19th century.

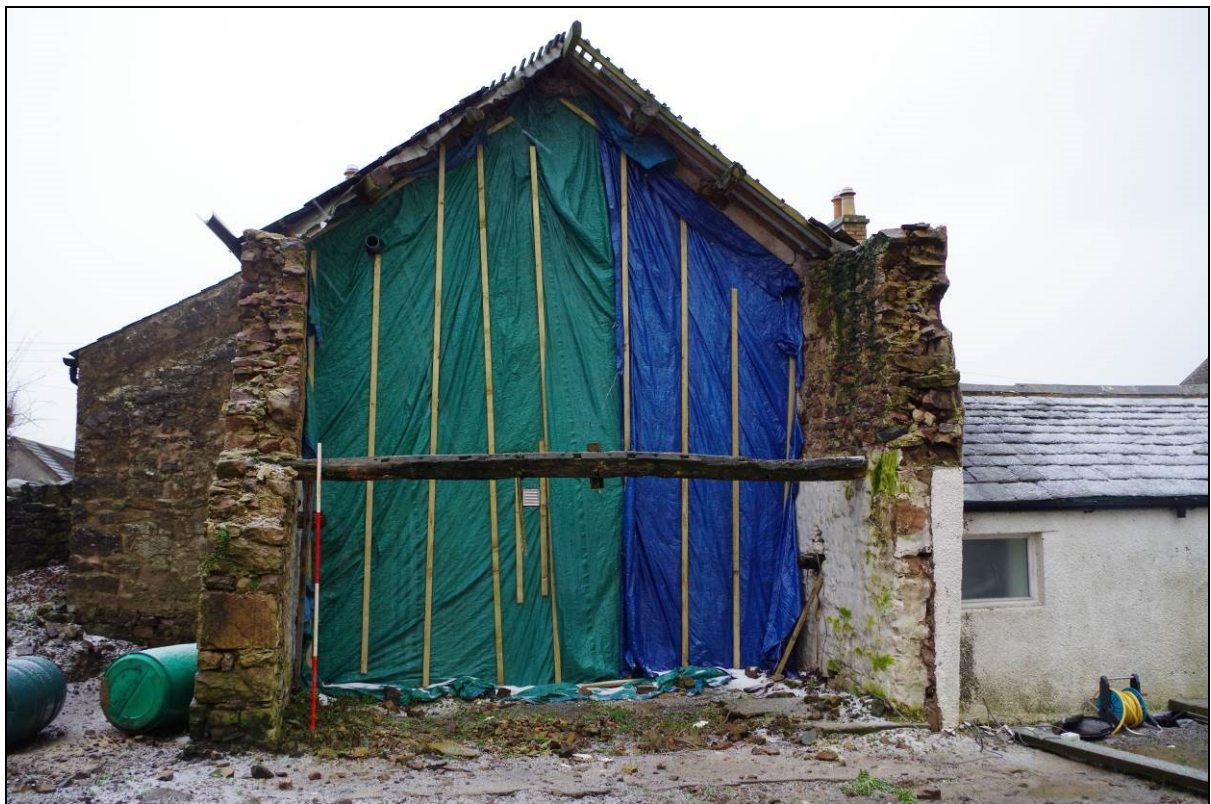
Figure 17. Gable end of former byre

The former stone byre comprising of walls, roof and floor was almost totally lost by the time of the field survey. A small part of the eastern gable end was still extant although remedial conservation meant that the stone face was not visible (figure 17).

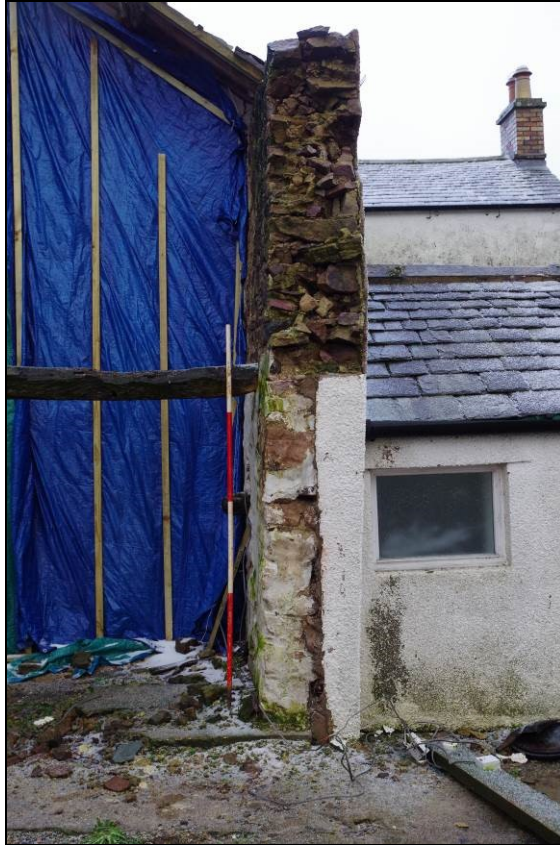
The southern wall (figure 19) was 0.52m in thickness and comprised of two faces of uncoursed rubbles-stone bound by occasional stone “throughs”.

The core of the wall made from rubble and lime mortar was supplemented by modern cement repairs.

Figure 19. Southern wall of byre

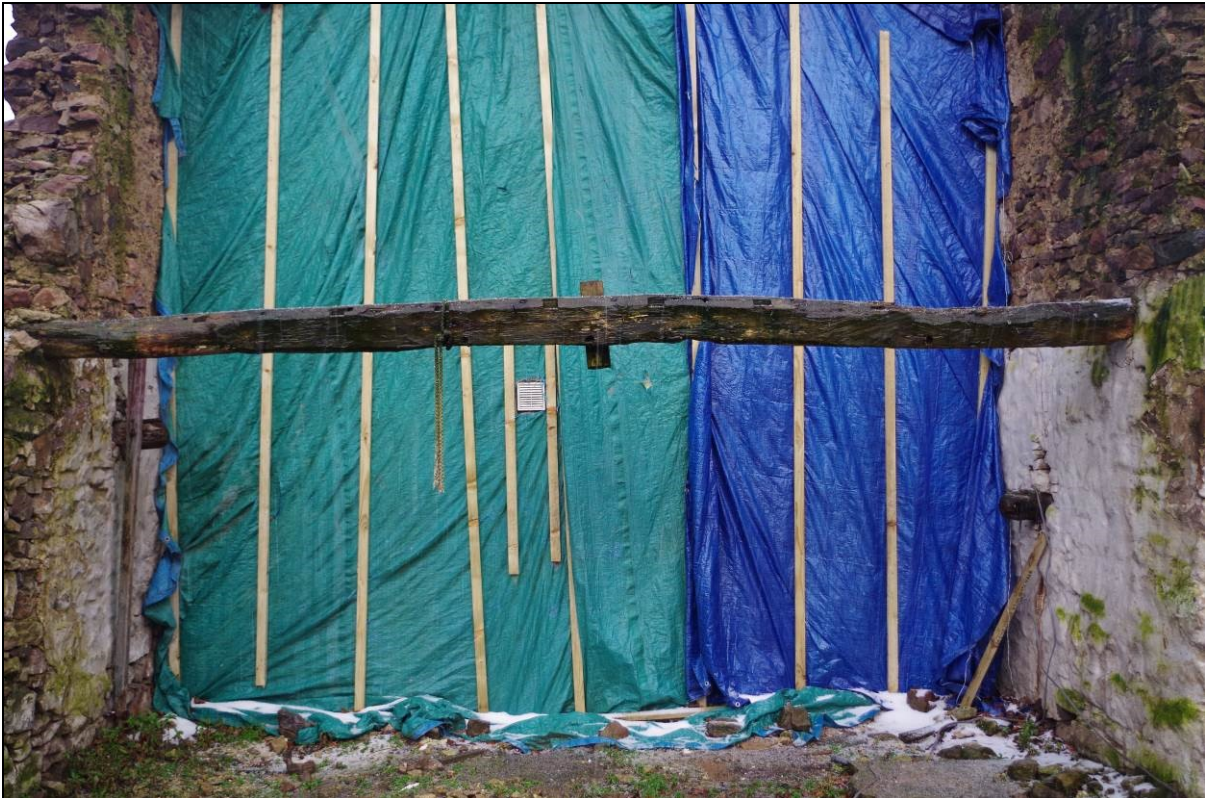
The only internal timber fixture surviving was a horizontal joist (figure 21) that formed a floor space within the building. The timber was hand-finished measuring 4.30m in length, 0.16m in height and 0.14m in width, resting 1.80m above the ground.

Eight tenons were visible on the upper face of the joist at intervals approximately 0.35m apart with perhaps a cut-down king post in the centre. Possibly, a partition existed that had been removed in antiquity or that the joist was a re-used timber.

Figure 21. Surviving joist

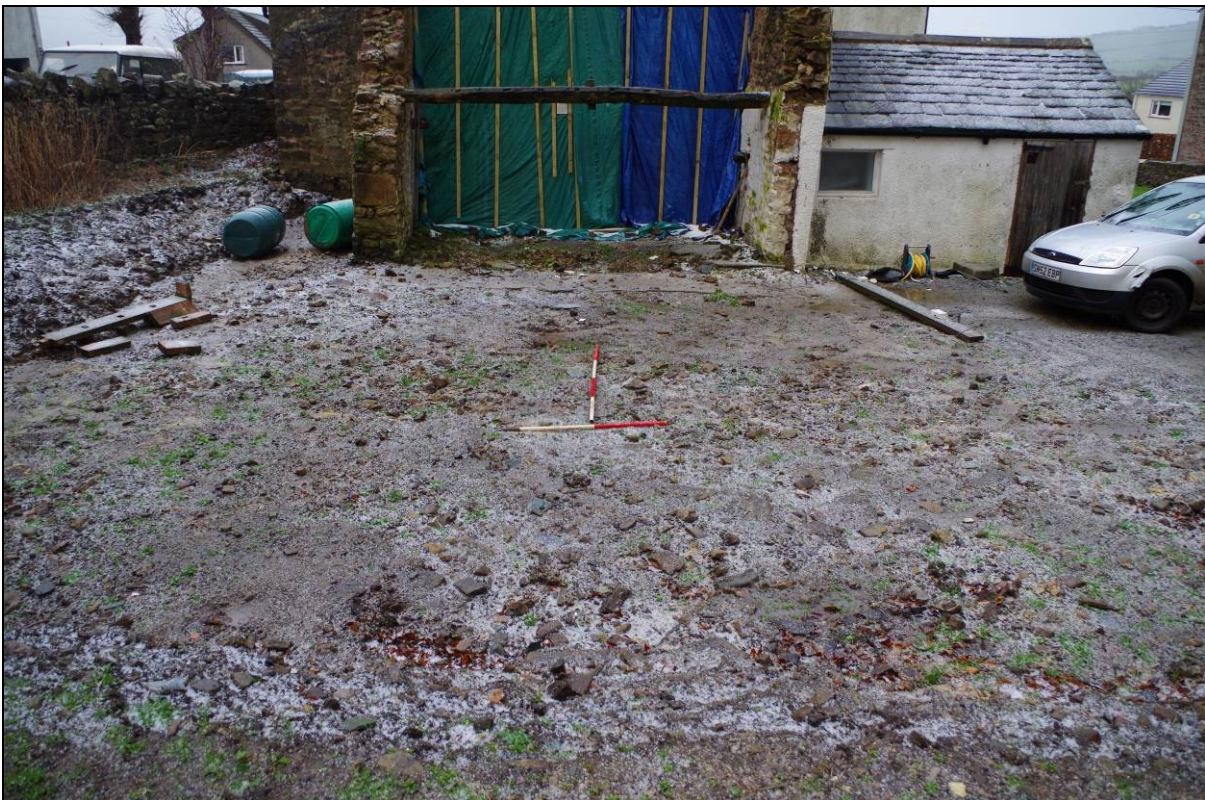
The upper floor had been left as a rough stone face whilst the ground floor was white-washed with a thin plaster render. The floor proper was made from cement and had been removed. Most probably it originally consisted of exposed stone as the byre possessed no formal foundation, built directly onto a natural stone slab. Vestiges of the wall line for the footprint of the byre were just perceptible but there was no evidence for foundation trenches (figure 22).

Figure 22. Footprint of former byre

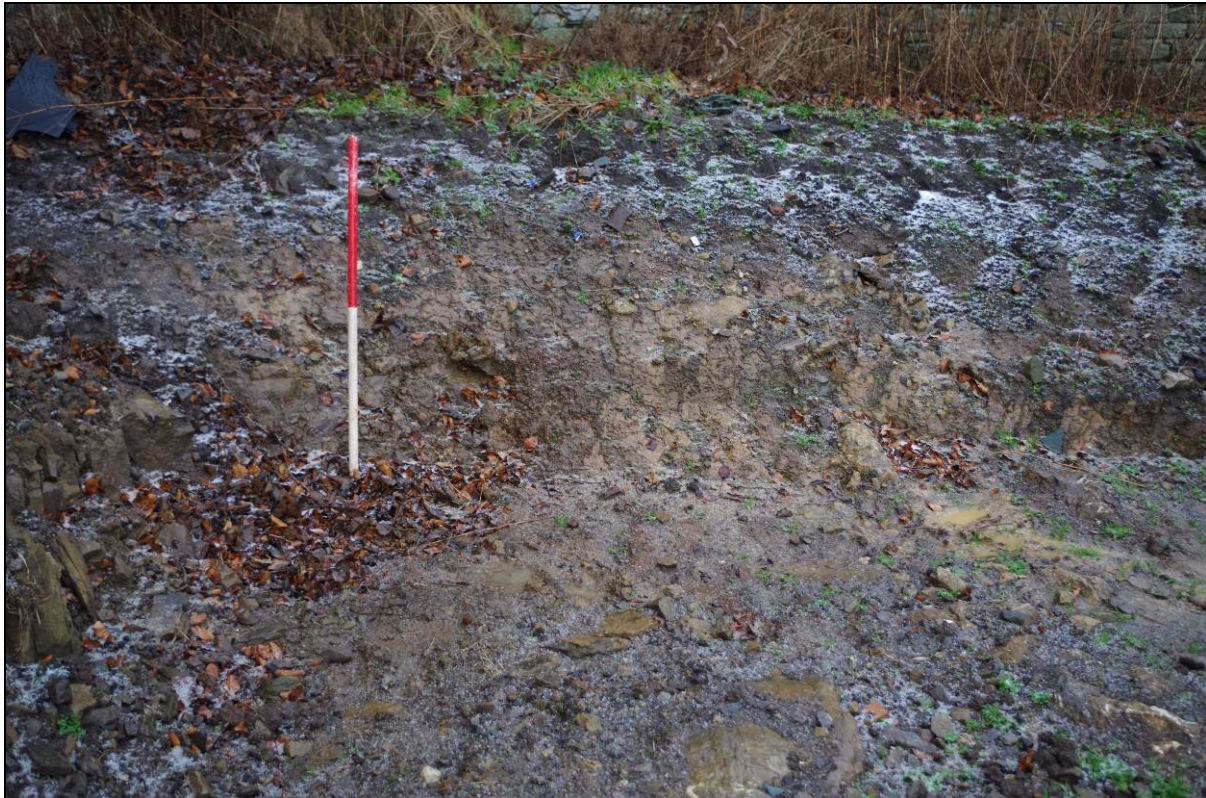
The byre had been constructed into the side of a hill reducing the external ground level on the northern side by between 0.70 and 1.00m (figure 23).

Figure 23. Construction cut for the former byre
