The watching brief at Kells Place and Church Street, Stanwix, Carlisle failed to isolate deposits of any antiquity. The only deposit observed was natural boulder clay beneath made ground, remnant of the insertion of former pipe trenches. The observed deposits were the results of a mid 20th century construction of a gas main.

Gerry Martin Associates Ltd was commissioned by Mr Stephen Miller (the client on behalf of Northern Gas Networks) to initiate an Archaeological Watching Brief Action relating to the renewal of the gas main within a Scheduled Ancient Monument (figure 1).

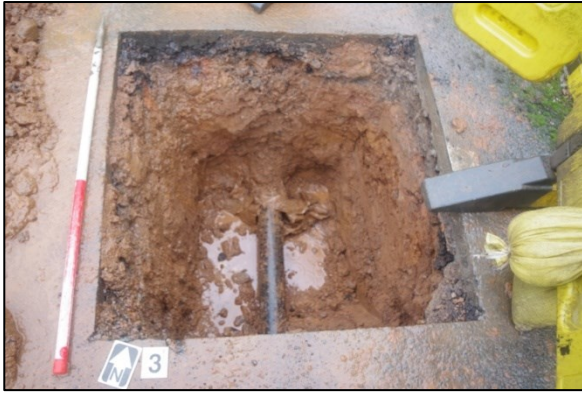
Figure 7. Intervention 3

Intervention 3: Situated outside **No.6 Knowe Terrace** @ **NY 40169 57176**. All modern clay backfill above cast iron pipe. 1.00m x 1.00m square x 1.00m deep from upper surface of tarmac road. Connection to iron pipe all pink clayey sand representing backfill to pipe. **Archaeologically Sterile.**

Intervention 3 Extended: Situated outside **No.6 Knowe Terrace** @ **NY 4021857181**. Intervention 3 was extended across pavement into garden to allow for replacing of gas services. The extension was monitored during excavation and was confined to the limits of the backfill of the cut for the original services. As such no external stratigraphy was visible. **Archaeologically Sterile.**

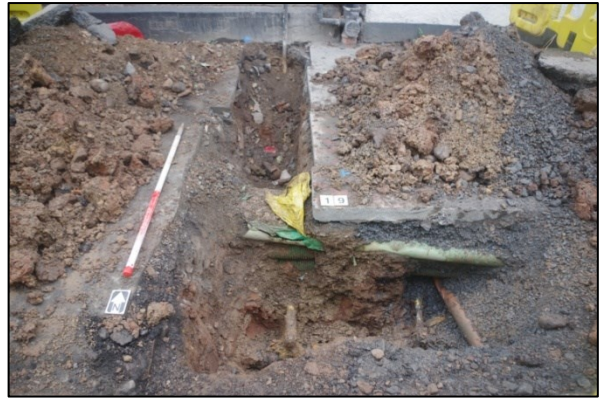
Figure 8. Intervention 19

Intervention 19: Located at **NY 40155 57117** beside the Crown and Thistle public house the intervention measured 2.80m north-south x 0.60m and 1.80m x 0.90m east-west. The northern leg was 0.50m in depth of which 0.30m in depth was modern overburden including 0.07m of tarmac. The remaining area exposed was pink sandy clay. Contains TV cable ducts with the trench continuing up to the kerb. The gas main was 0.70m in depth observed to a depth of 0.80m with 0.50m of natural pink sandy clay observed (figure 8). **Archaeologically Sterile.**

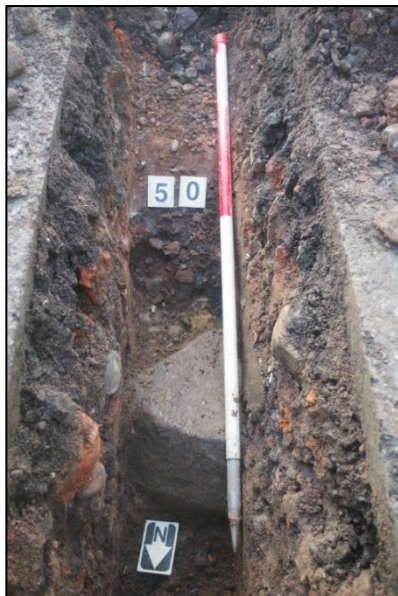
Figure 9. Trench 50 with stone

Trench 50 began at NY40141 57184 and conjoined with the gas pipe from 12 Knowe Terrace (figure 10). The trench revealed 0.60m of modern overburden within a trench 1.05m in width before a reduction of width to 0.50m at NY40140 57183 (figure 9). Measuring 0.70m in depth natural clay was visible at the base and also a cast iron water pipe or main. The trench penetrated a probable 19th century wall (figure 11) at NY 40154 57162 with tightly packed limestone, brick and boulders continuing southwards and probably representing road widening. **Archaeologically Sterile.**

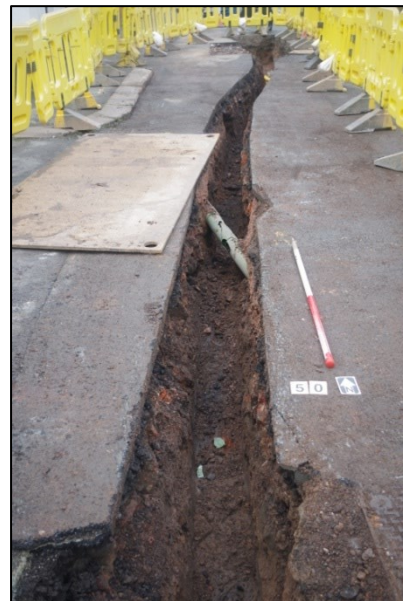
Figure 10. Course of Trench 50

Trench 50: Continued excavation of Trench 50 from the corner of Knowe Terrace @ the end of Bend, **NY40167 57144** (in the road) up to and joining @ 90° Intervention 21 located outside of No. 55, Stanwix Cottage, Church Street @ **NY40161 57133**.

9.00m (E/W) x 0.45m x 0.68m (max) deep from the upper tarmac surface of road.

The trench was monitored during excavation and was confined to the limits of the backfill for the road and pipe trench for gas main. Backfill below road make up - redeposited pink sand & pinkish/brown clay with occasional brick and tarmac fragments above cast iron Gas main. Where the trench turns at 90° to connect with Intervention 21 a single ceramic wastewater/drainage pipe is the only other service identified within this part of Trench 50. No external stratigraphy was visible. **Archaeologically Sterile**

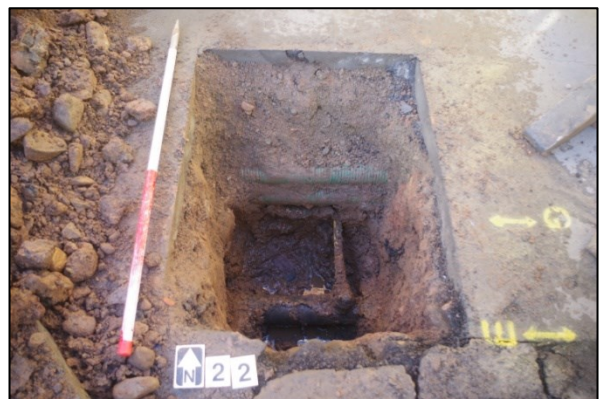
Figure 12. Intervention 22

Intervention 22: Located at **NY 40154 57115** connecting to 49 Church Street. The intervention measured 1.00m x 0.78m x 0.90m in depth. The trench cut produced only re-deposited backfill including pink sand and pinkish brown clay (figure 12). **Archaeologically Sterile.**
