As part of refurbishment of the electricity transmission system, an archaeological watching brief was requested by Historic England in order to ascertain whether sensitive past cultural features and deposits may be extant relating to the potential remains belonging to Hadrian's Wall (figure 1). This defence formed part of the Roman frontier defences; a probable turf wall, protecting the Cumbrian coast from Bowness-on-Solway to Carlisle, contemporary with the stone wall east of Carlisle.

Gerry Martin was commissioned by Scott Richardson and then later Gareth Banton, Electricity North West (the client) to prepare a Specification of Works for a Programme of Archaeological Watching Brief Action relating to groundworks along Willowholme Road, Carlisle.

Fieldwork took place between January 17th and 24th 2023.

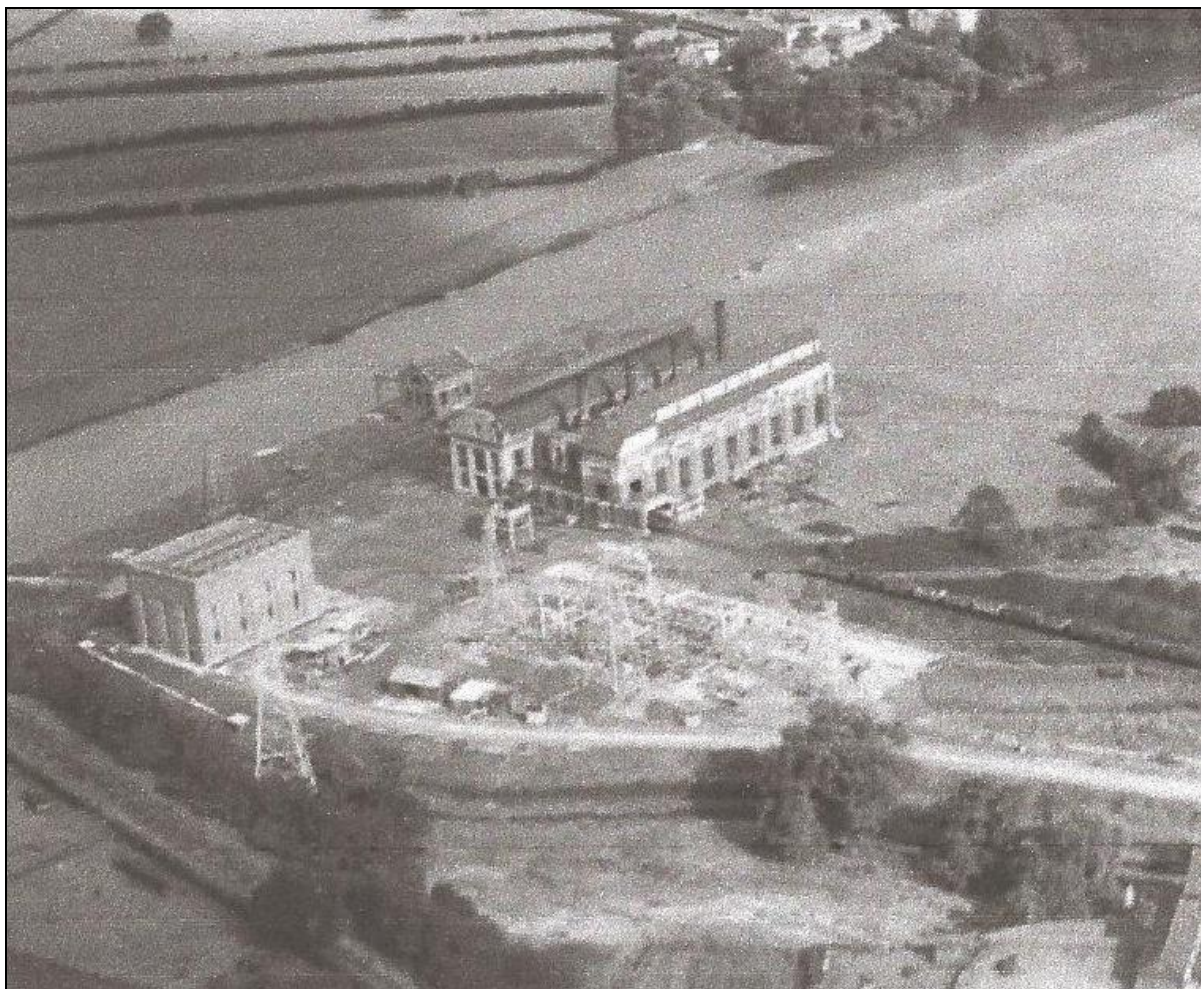
Figure 4. The power station under construction, 1932 courtesy:

The ground surface has been raised by successive dumping of household and building waste. By 1932 the existing surface appears to have been established as the present road to the old power station was extant (figure 4).

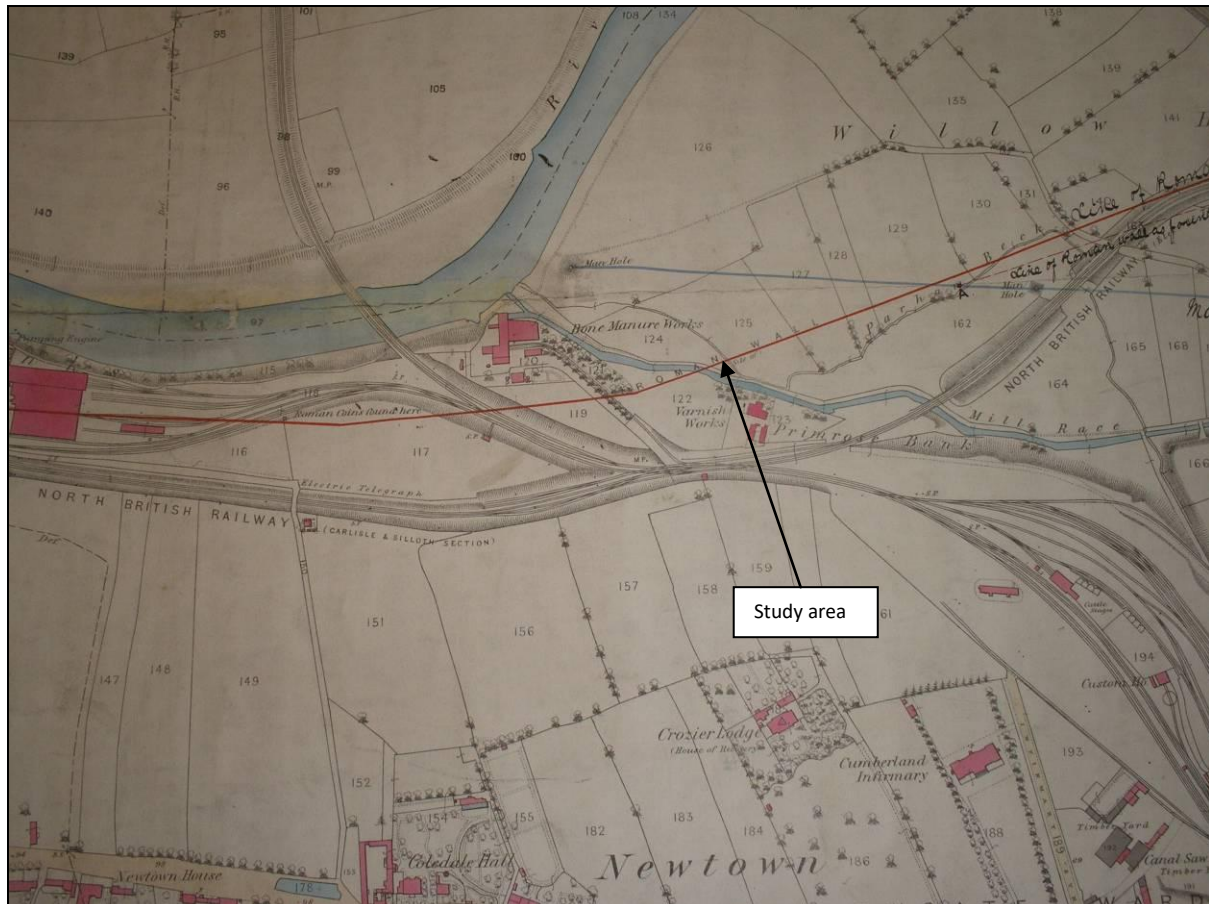
Figure 8. Asquith map of 1853 (DX 1819/1)

The 1853 Asquith map (DX1819/1) was executed on behalf of the Board of Health and led to the public health improvements that resulted in the construction of a mains sewer in 1854 which located Hadrian's Wall in close proximity to the study area.

The canal has been converted as a track bed for the Carlisle and Port Carlisle Railway but there is no access to the north of Parham Beck (figure 8).

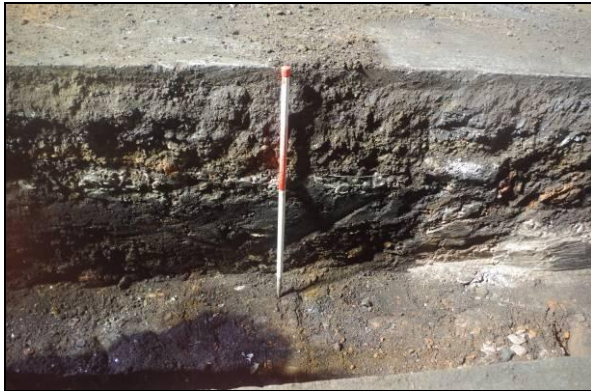
Figure 10. Section in the cable trench

The cable trench measuring 1.20m in depth and 1.00m in width was between NY 38722 56404 and NY 38703 56417, a total distance of 22.60m. After cutting the tarmac surface, 0.40m thickness of concrete road fabric was gunned out. The invert level was 1.20m, so a further 0.80m in depth of orange ash, building material and sand was removed (figure 10). This material dated to the early 20th century, as it included numerous bottles including State Management beer bottles which can be no earlier than 1916.

Natural drift geology was not observed, the dump continued in depth beyond the limit of excavation (figure 12).

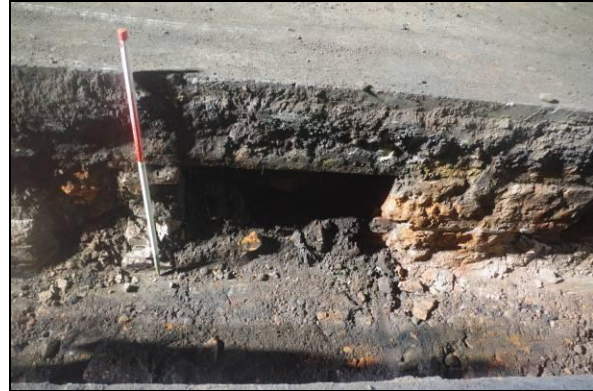
Figure 11. Sluice in the trench

of concrete road fabric was gunned out. The invert level was 1.20m, so a further 0.80m in depth of orange ash, building material and sand was removed. This material dated to the early 20th century. Located between 6.50m and 13.50m along the trench, a modern concrete and brick sluice was evident between NY 38700 56417 and NY 38696 56419 (figure 11) that probably discharged into Parham Beck.

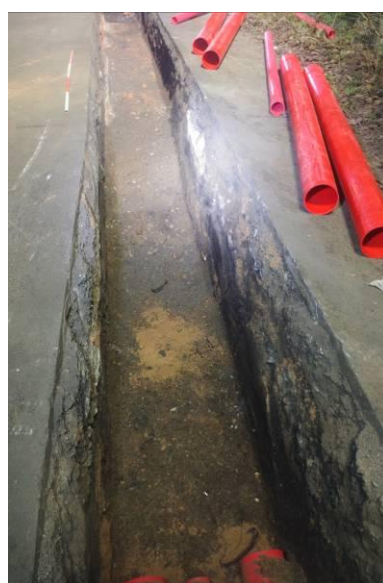
Figure 13. Trench on second night

Natural drift geology was not observed, the dump continued in depth beyond the limit of excavation (figure 13).

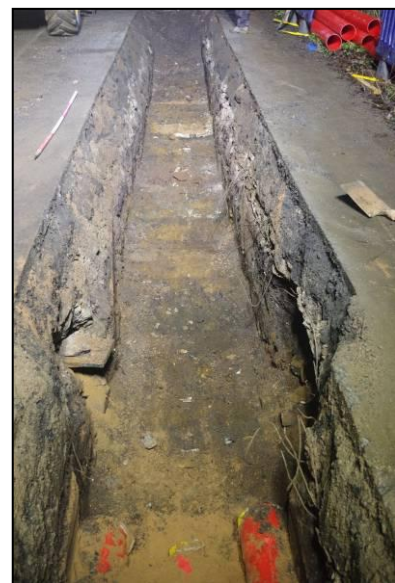
Figure 14. Third night excavation

Natural drift geology was not observed, the dump continued in depth beyond the limit of excavation (figure 14).

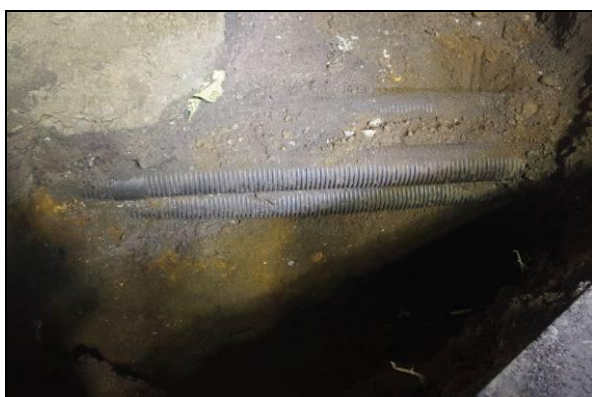
Figure 15. Depth of dumping on bend

On entry of the trench into the electricity sub-station, the trench was dropped to a depth of 2.00m yet only early 20th century rubbish was recovered (figure 15).

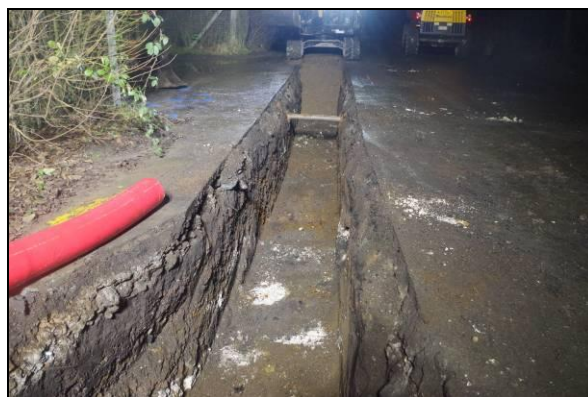
Figure 16. Excavated trench on the last night

Natural drift geology was not observed, the modern dump continued in depth beyond the limit of excavation (figure 16).
