Wiltshire Archaeological & Natural History Society 41 Long Street, Devizes, Wiltshire, SN10 1NS

SSBHC2011 STANTON ST BERNARD, HOME COWLEAZE

167.0812

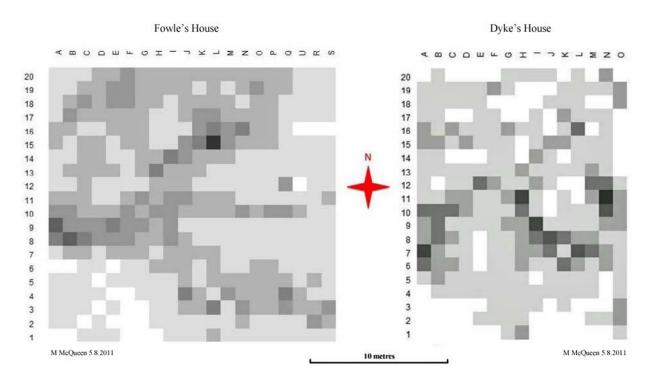
Figure 2. Resistivity Survey Results

A series of grid squares were excavated based on these results, some in areas of high resistance and others in areas where resistance was low.

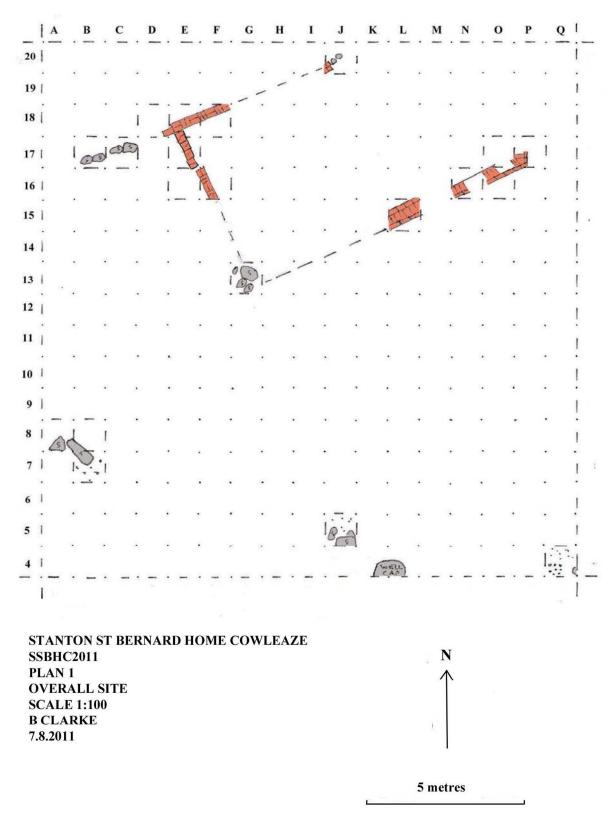
Figure 3. Overall Plan of the Excavation

Figure 3 shows the test pits excavated and the main features revealed. The lower courses of a brick wall were exposed in grid square F18 and adjacent squares were dug to establish its course.

The structure appeared to measure 5 metres front to back but its length was not determined because the eastern end was not found.

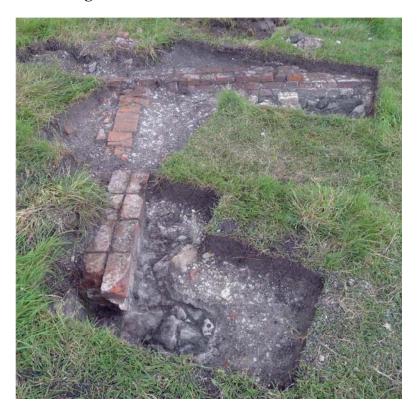
Figure 4. Northwest Corner of Structure

The northern wall of the structure was two bricks thick with no discernable bond, a stone 'pier' adjacent to its internal face may have been a support for floor joists under a wood plank floor. The western wall at right angles was also two bricks thick but here the bricks were laid header to header. A single thickness brick extension of the northern wall extended west beyond the western wall, probably part of an outhouse. An opening in the western wall at its northern end leads into the outhouse and had a threshold of reused roof tiles (Figure 4).

The bricks uncovered were probably part of foundations of mixed brick and sarsen stone as sarsen stones were found on the same alignment at the same level. Much of these foundations had been robbed out.

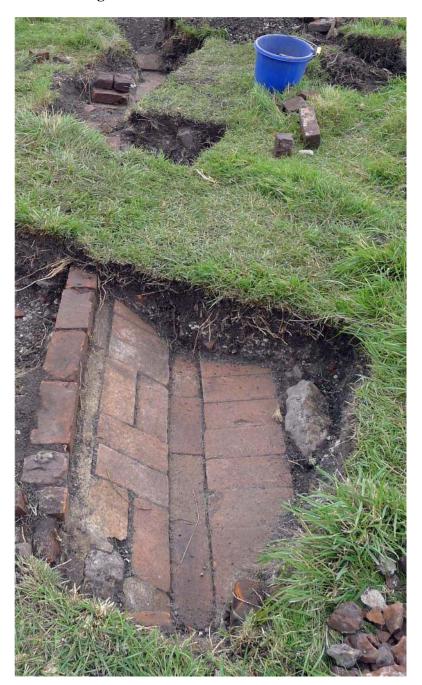
Figure 5. Southern Wall of Structure.

What appeared to be the southern wall of the structure was uncovered 5 metres to the south. In places only a single thickness of brick survived but in others two (Figure 5). Abutting this wall to the south was a brick built gully which was traced eastwards until it turned north, where the width of the building changed (see Estate map Figure App1). The purpose of this gully is unknown. Suggestions include a drainage channel or a drip gully.

The bricks used in the structures uncovered varied in size with length from $8\frac{1}{2}$ to 9 inches width from 4 to $4\frac{3}{4}$ and height from $2\frac{1}{4}$ to $2\frac{3}{4}$ which indicates they were manufactured before Parliament legislated for bricks $8\frac{1}{4} \times 4 \times 2\frac{1}{2}$ inches in 1769 (Hammond, 1998, 30).

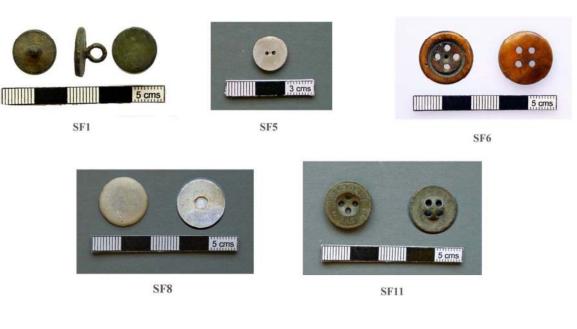
Figure 6. Buttons

Five buttons were recovered during the excavation, these are shown in figure 6 and described below.

SF1. A small copper alloy button with plain face, loop on reverse and inscibed "colour*gilt*orange*", which refers to the quality of the gilding (Cuddeford, 1992). This was probably from a blazer or something similar.

SF5. A small button made of mother-of-pearl with two holes from a shirt or blouse..

SF6. A four holed bone button of the sort used on dungarees or overalls, dating to the late 19th or early 20th century.

SF8. A mother-of-pearl button with circular recess on the reverse where a fixing stem, now missing, was attached. Most probably from an item of ladies' clothing.

SF11. A copper alloy button with an inverted-dome recess in the centre, pierced by four holes. Inscribed with makers name "J SARGENT * BATH*". Probably from an item of working clothing.

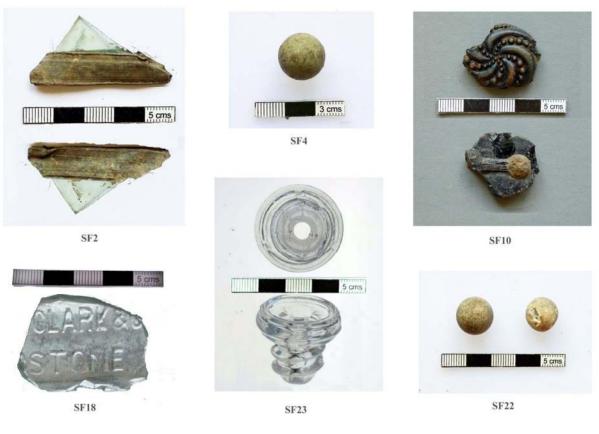
Figure 7. Glass Small Finds

Four of the glass objects are associated with bottles – glass marbles used as closures for bottles containing carbonated drinks, a bottle stopper and a fragment of bottle with a moulded inscription. The other two are a fragment of window glass still held in part of a lead window came, and a fragment of an elaborately patterned glass brooch (Figure 7).

SF4 and SF22 are glass marbles probably from carbonated drink bottles. Marble closures for mineral water bottles were introduced by Hiram Codd in 1875 and survived until c.1930 (Hedges, 1989).

SF18 is a body fragment from a bottle probably containing a patent medicine or similar with a part inscription "-CLARK & S- -STONE", which identified the maker of the contents or supplier. Moulded lettering such as this was introduced in the early 19th century (*ibid*).

SF23 is a screw threaded bottle stopper with a hole through the centre, most likely to allow the contents to be poured out gradually, probably from a baby's feeding bottle. Internal screw stoppers were introduced in 1872 (*ibid*).

SF2 is a small fragment from a leaded light window still held in part of the window came. This type of window was introduced in the late 17th century (Hall, 2005), but sheet glass such as that in this fragment didn't become available until 1840 (Brunskill, 2000).

SF10 is a moulded black glass brooch with the remains of a ferrous pin mount on the reverse. The brooch is decorated with a pattern of alternate solid and beaded curved arms radiating from the centre. This is probably Victorian imitation jet (known as French jet) mourning jewellery.

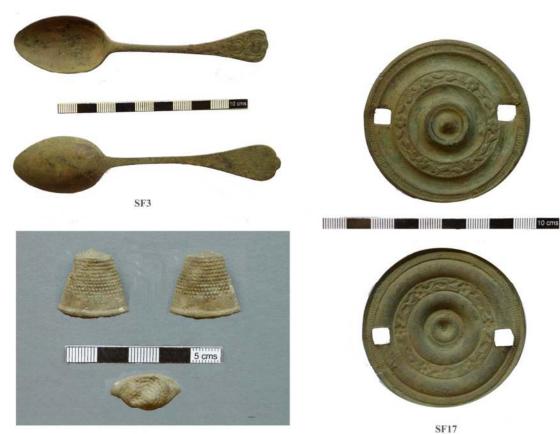
Figure 8. Copper-alloy Small Finds

SF3. A small copper alloy teaspoon with a decorated handle. This pattern on the handle is similar to 'Kings' pattern cutlery which is still made today.

SF15. A small machine made thimble with beaded rim which could have been manufactured at any time since the 19th century (Cuddeford, 1992, 48).

SF17. A machine stamped copper alloy disc, probably a decorative mount from an item of furniture.

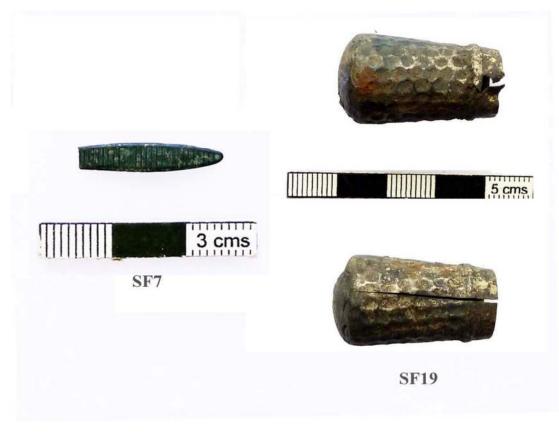
Figure 9. Other Non-ferrous Small Finds

SF7. This is a small fragment of non-ferrous metal, possibly silver, tapering to a point at one end, and decorated with close spaced lines across its width. There are no hall marks and no indication of the type of object from which it came.

SF19. The top of a swagger stick or cane found with fragments of wood inside. It is decorated with lines of adjoining indentations and a single raised ring around the circumference at the open end. The material is either nickel silver, a copper/zinc/nickel alloy, or possibly tin with a silver wash. The object is unlikely to have come from a military swagger stick as these usually bear insignia.

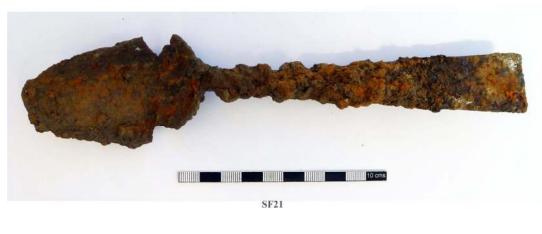
Figure 10. Ferrous Small Finds

SF9 and SF16 are four tongued rectangular buckles similar to 'stock' buckles manufactured during the 18th century which were often of silver with elaborate decoration (Whitehead, 2003, 124).

SF21 is a large spoon with no particular features to suggest a date of manufacture.

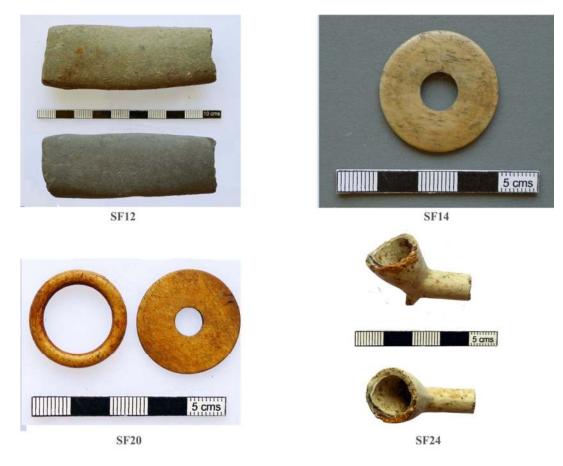
SF12 is a whetstone made from ???? of unknown date.

SF14 is a bone disc with central hole, possibly some form of washer.

SF20 comprises two objects of bone, one a disc with a hole similar to SF14, and the other a bone ring with circular cross section, possibly a curtain ring.

SF24 is part of the bowl and stem of a clay pipe. There is no makers mark to enable dating but this style with a pointed spur was not introduced until c.1690 and so this example must post date this.

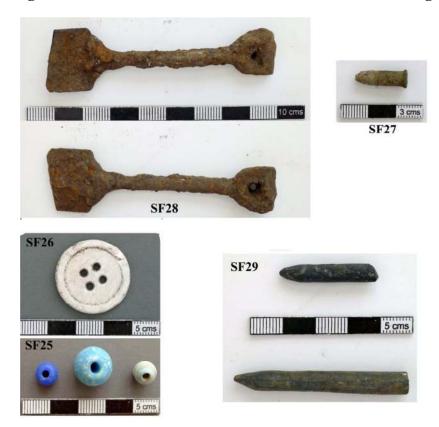
Figure 12. Additional Small Finds from Bulk Find Processing.

There were two metal finds, one ferrous and the other lead and copperalloy.

SF27. A .22 calibre bullet.

SF28. A miniture spade made of ferrous material, possibly a child's toy or a condiment spoon.

SF25. Three glass beads of different sizes and different shades of blue, probably from a bracelet or necklace.

SF26. A mother-of-pearl button with four holes.

SF29. Two pointed rods of slate most probably used for writing on slate.

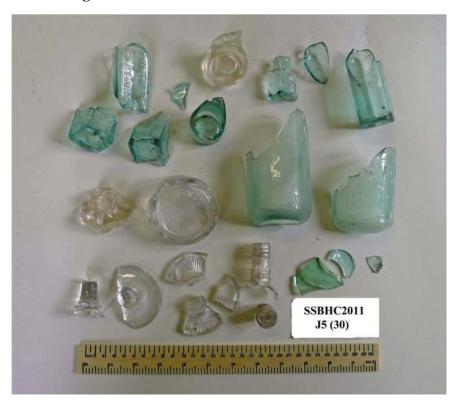
Figure 13. Glass Vessels and Other Glass Ware

The window glass recovered was all sheet glass which didn't become available until 1840, and moulded lettering was introduced in the early 19th century so, as with the pottery, it probably all dates from the Victorian period or later. There was an interesting variety of vessel shapes and patterning (figure 13), but where identifiable the contents were those expected in a domestic environment.

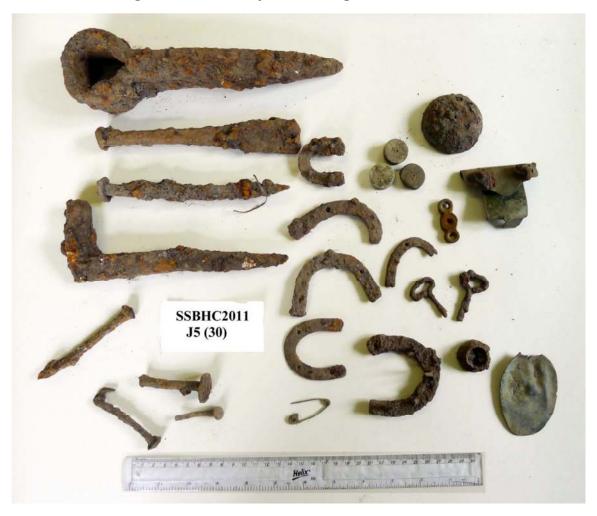
Figure 14. Metal Objects from Square J5 Context 30

The large quantity of nails found is probably from the demolition of the buildings on the site. There were a number of barns and outbuildings to the south of the house (see figure App1) and the tools and some other objects may have been associated with these. However, many of the broken objects may well have been dumped on the site post demolition.

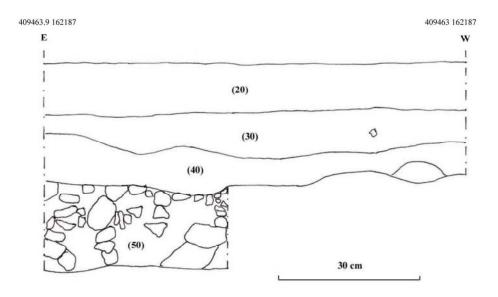
Figure App5. Section of Grid Square Q4

STANTON ST BERNARD HOME COWLEAZE SSBHC2011 GRID SQUARE Q4 NORTH FACING SECTION SCALE 1:5 L CHADD 6.8.2011
