Savernake Second World War Project: Recording Savernake's Second World War Heritage

Part 1: Iron Gates Camp

Feb 2017

**AFG2017.1:
Sav2016**

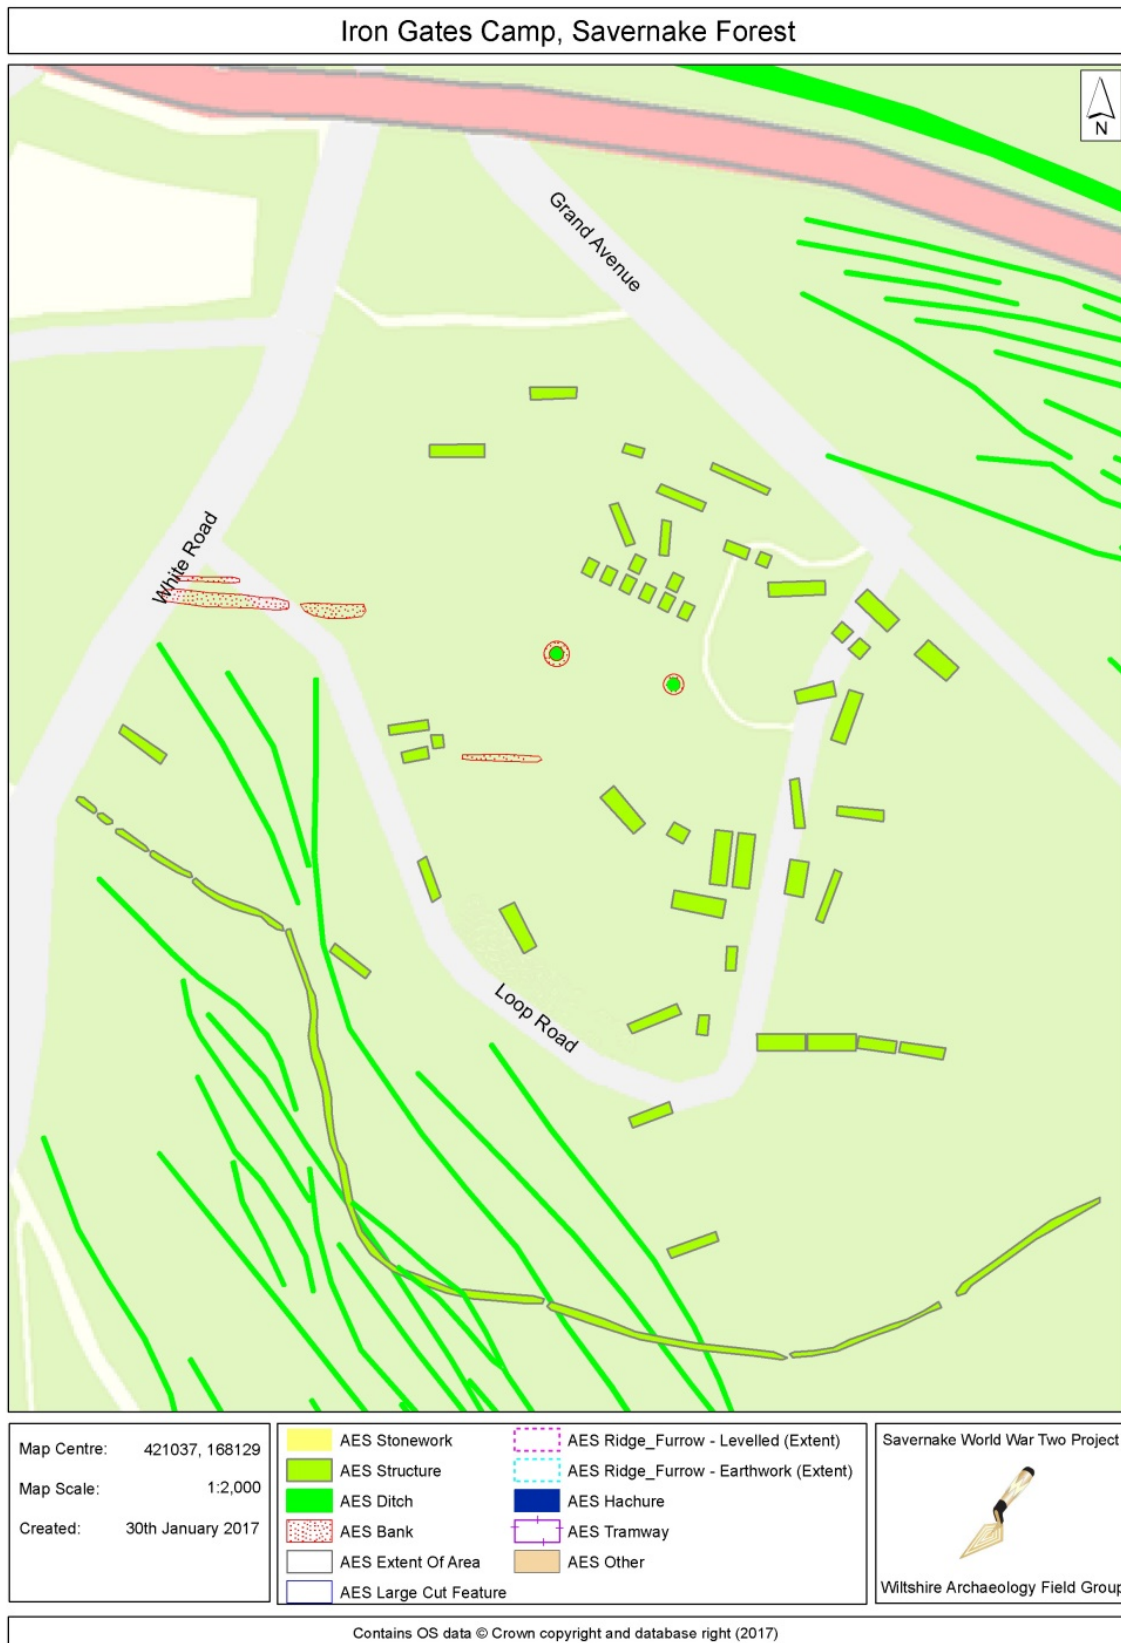
The survey mapped 51 individual features (Fig. 2) including different sized and shaped huts and buildings, tents, a boundary bank or barbed wire entanglement that defined the southern edge of the camp and two circular earthwork features that have been interpreted as gun or mortar emplacements. The results of the survey were used to create a Wiltshire Historic Environment Record monument record MWI44966 and a National Record of the Historic Environment (NRHE) monument record, No. 1471538.

Fig. 2. Features mapped from the English Heritage National Mapping Project 2007-8. See appendix 1 for a larger image.

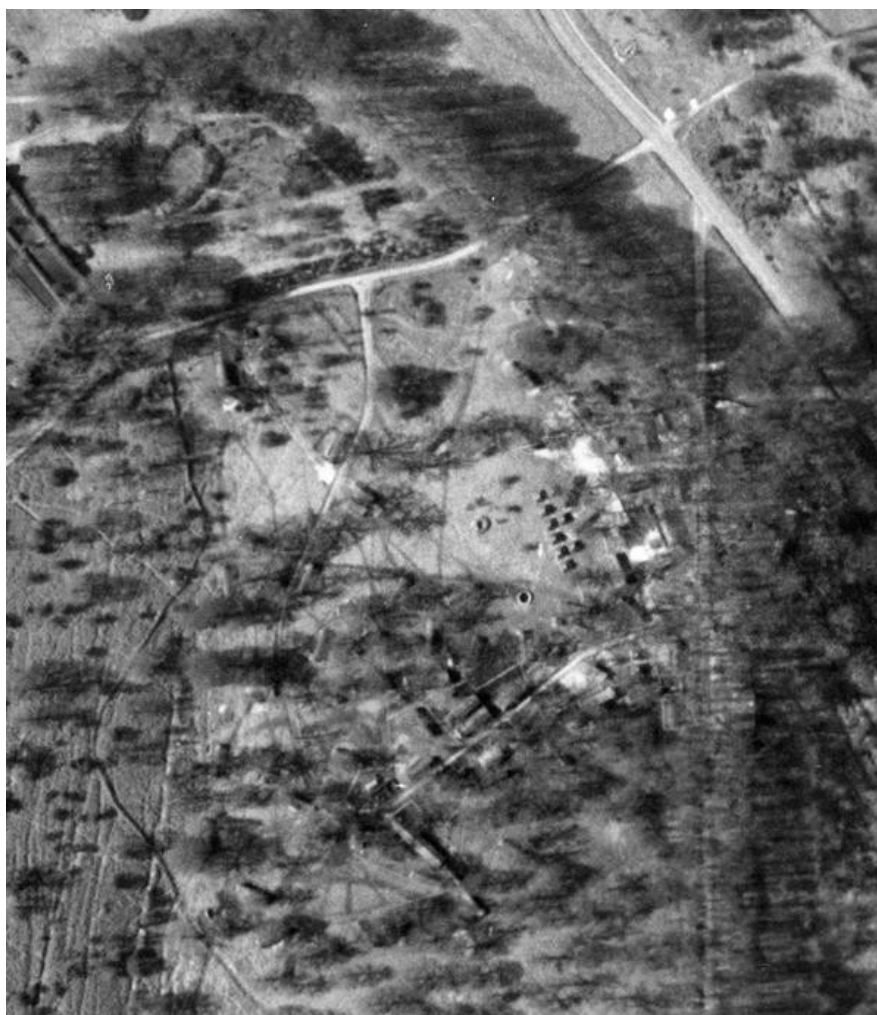
Fig. 4 Aerial photograph of Iron Gates taken by the US in 1944
(US_7PH_GP_LOC209_V_5010 (6887 8 March 1944) Historic England USAAF
Photography.

Unlike today, where the camp area is covered with thick undergrowth; brambles, ferns and smaller trees, mixed with a few larger older trees, the area during the Second World War was cleared of undergrowth with just the larger, predominately beech, oak and horse chestnut trees, providing cover. This made for a relatively cleared and open area within which to construct an army camp, though with the added protection of the large tree canopies to provide camouflage from the air.

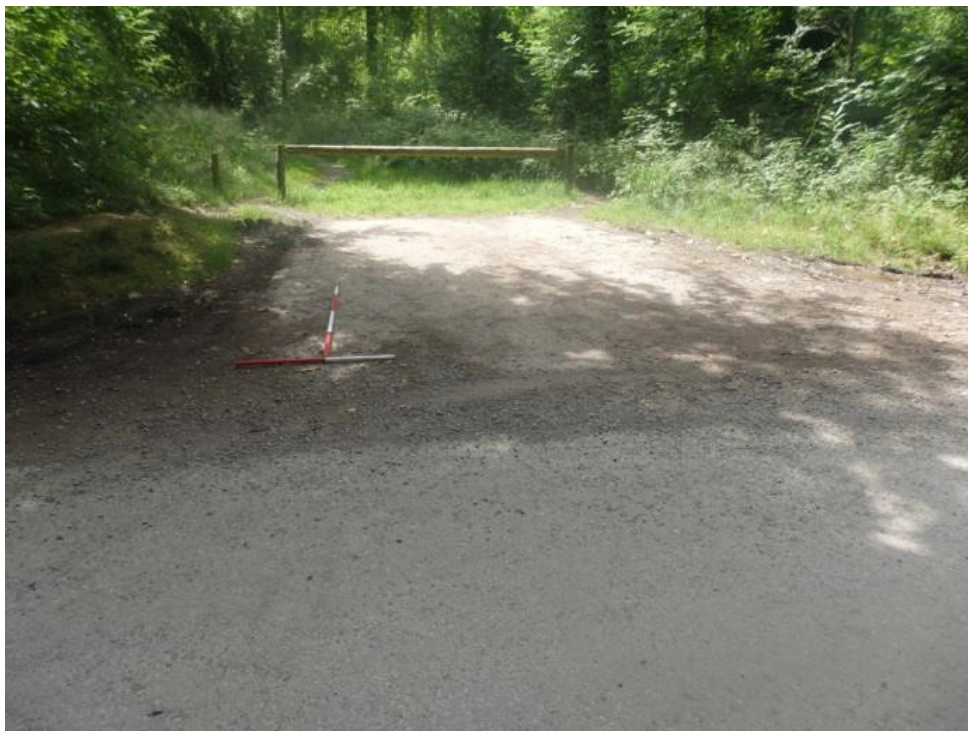
The metalled inner Loop Road was the main arterial access of Iron Gates camp, running from the Grand Avenue to White Road and was the focus for many of the communal huts in the camp.

Fig. 5 Entrance to the inner circular road from the Grand Avenue

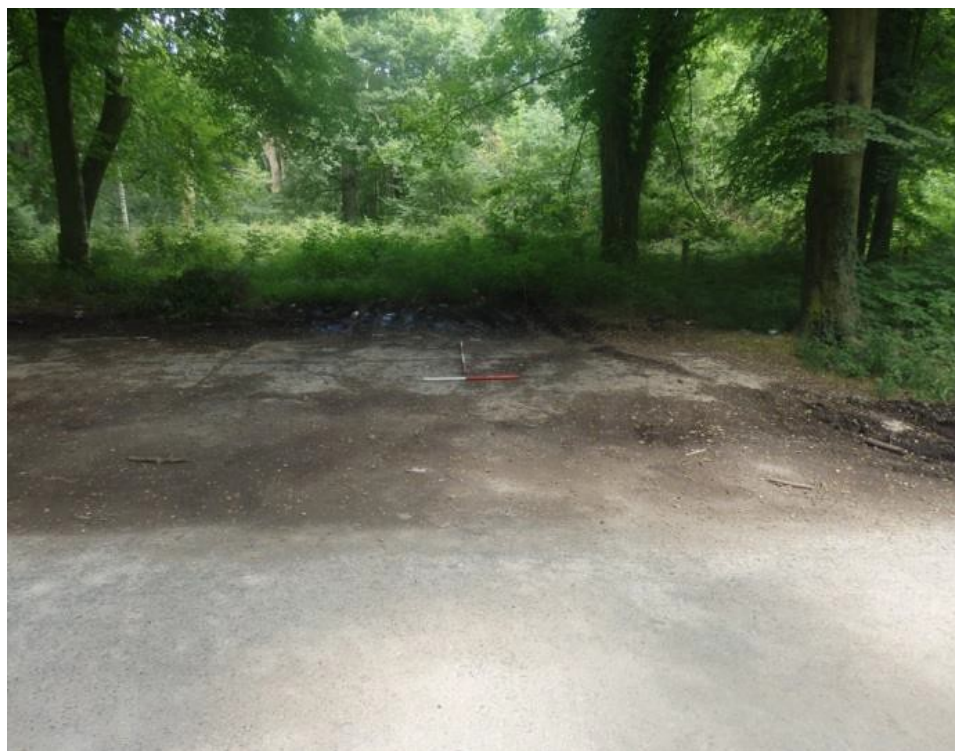
A large concrete hardstanding is still visible at SU2117068182. This was used as a vehicle park and a vehicle inspection pit, associated with the park, was visible until it was filled in sometime around 2000.

Fig. 6. Hardstanding of the vehicle park.

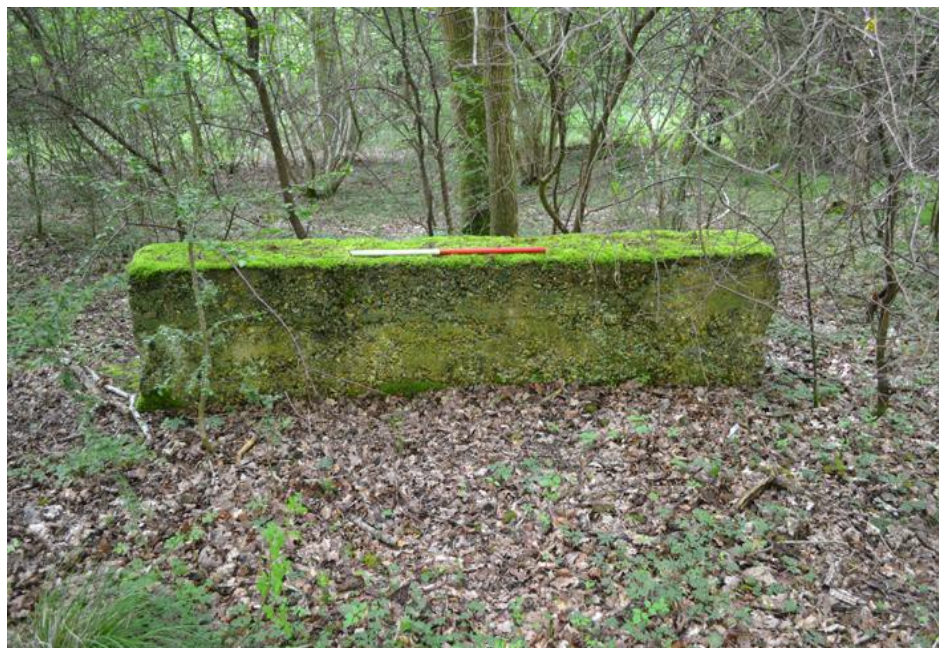
Pairs of standard dimension (3.0 – 3.10 metres length by 0.45-50 metres width) concrete blocks both ends of the railway carriages. The blocks were shuttered made using a high pebble and aggregate ratio to cement. They differ in height depending on the gradient of the slope. On a flat piece of ground they average between 0.45 and 0.50 metres high. However, on steeper ground one of the pairs of blocks was significantly higher. An example is at SU2112367913 with the block on the downslope measuring 0.76 metres high. The different heights of the blocks indicate that they were made in situ dependant on the local topography. The concrete blocks were positioned between 10.6 and 11 m (c. 36 ft) apart, most likely supporting the area of the carriage which would have originally been connected to the bogey assembly.

Fig. 7 Concrete block used to support each end of the railway carriage accommodation huts.

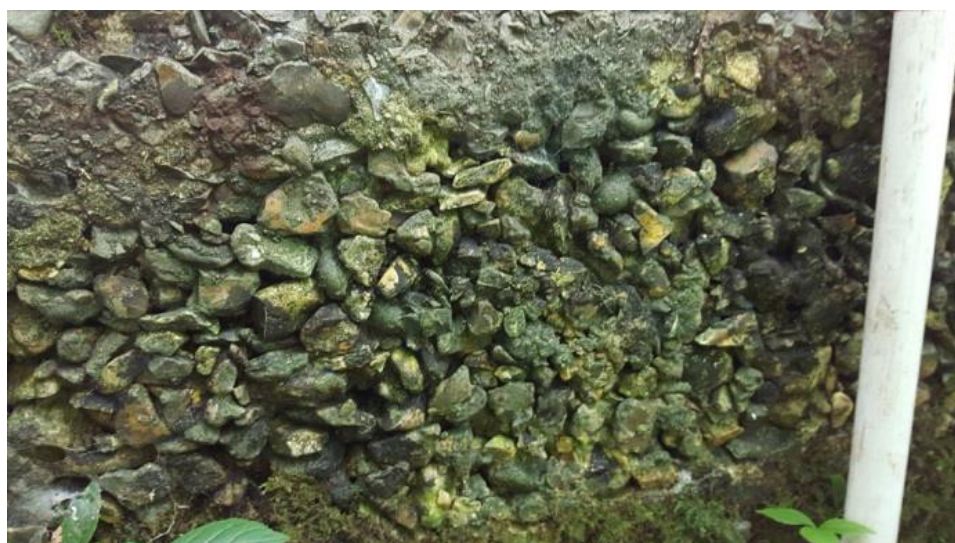
Fig. 8 High ratio of aggregate to cement mix of concrete support blocks.

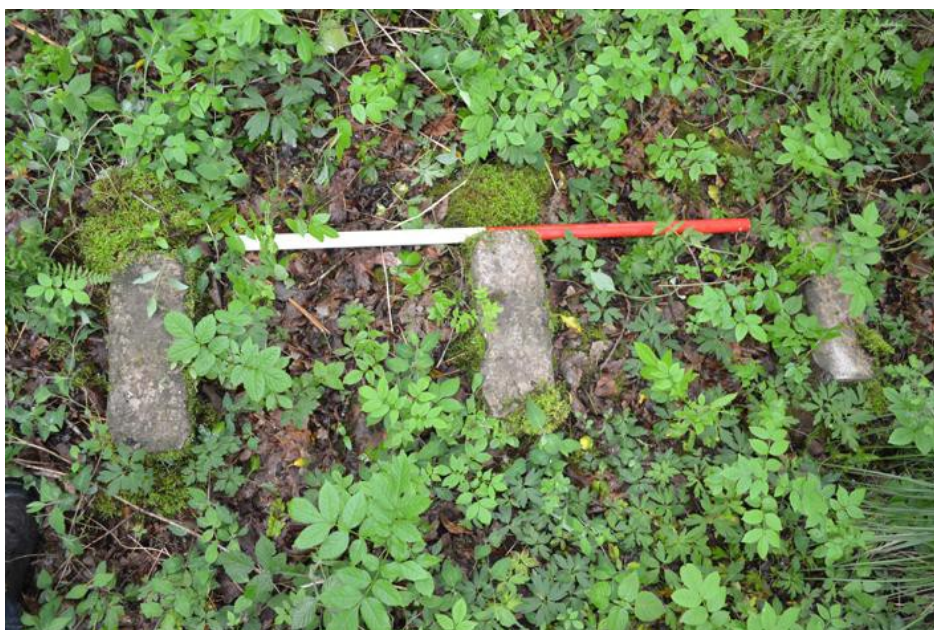
The foundations of steps have been found associated with a number of the railway carriages, indicating the entrances to the carriages. One example has steps at both ends of the carriage, which may indicate that the carriage had been internally divided to create two separate compartments, accessed individually.

Fig. 9 Carriage step foundations

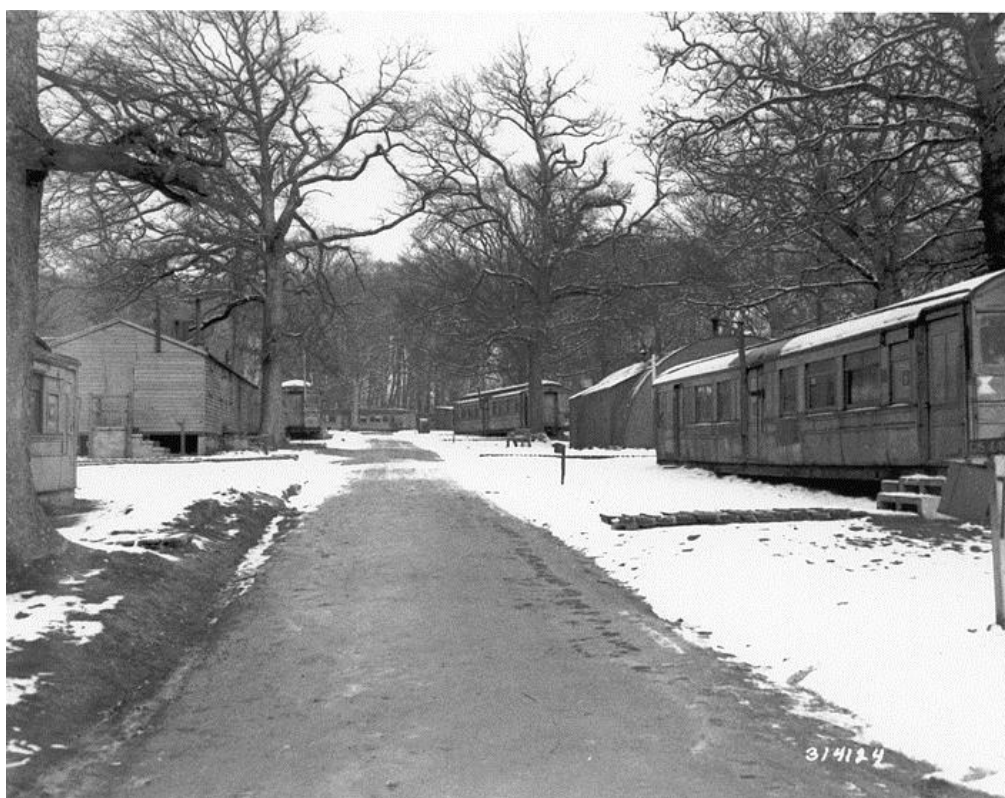
Fig. 10 Contemporary photographs show these huts supported by the concrete blocks and with steps leading to the entranceways. Copyright US National Archives (public domain).

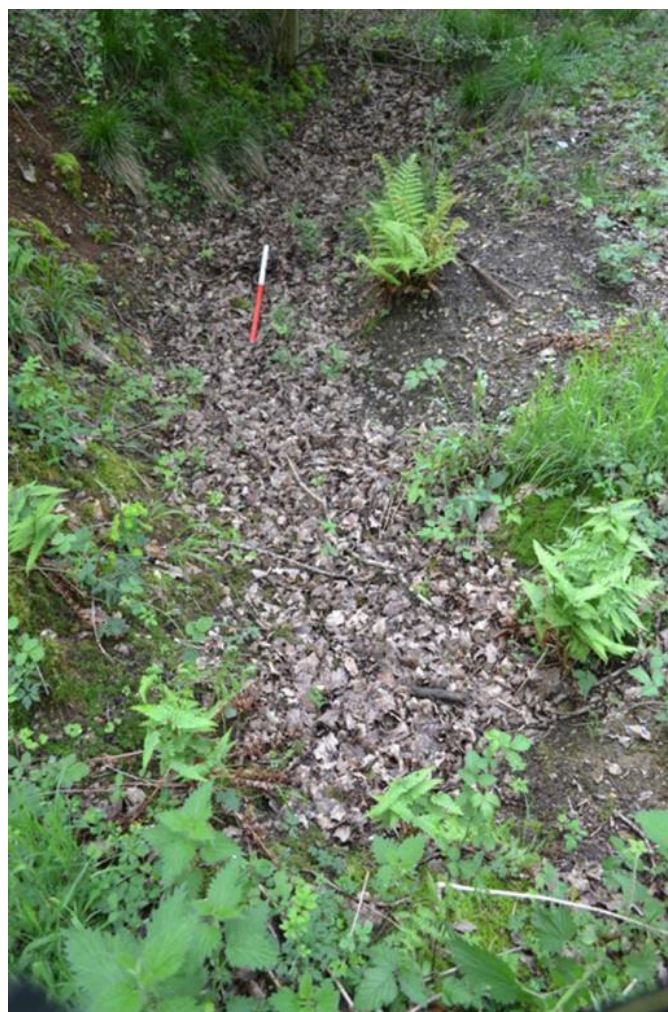
Linear or V-shaped slit trenches have been found associated with the majority of railway carriages. They are positioned directly underneath or part-underneath where the railway carriages would have been, and some have survived up to 1 m in depth. Their shape and length differ – from a classic V- shaped slit trench to linear trenches, and from c.3 m to 8 m. These trenches have now been interpreted as air raid trenches, known as Passive Air Defences (PADs).

Fig. 11. V-shaped slit (passive air defence) trench running under the carriage.

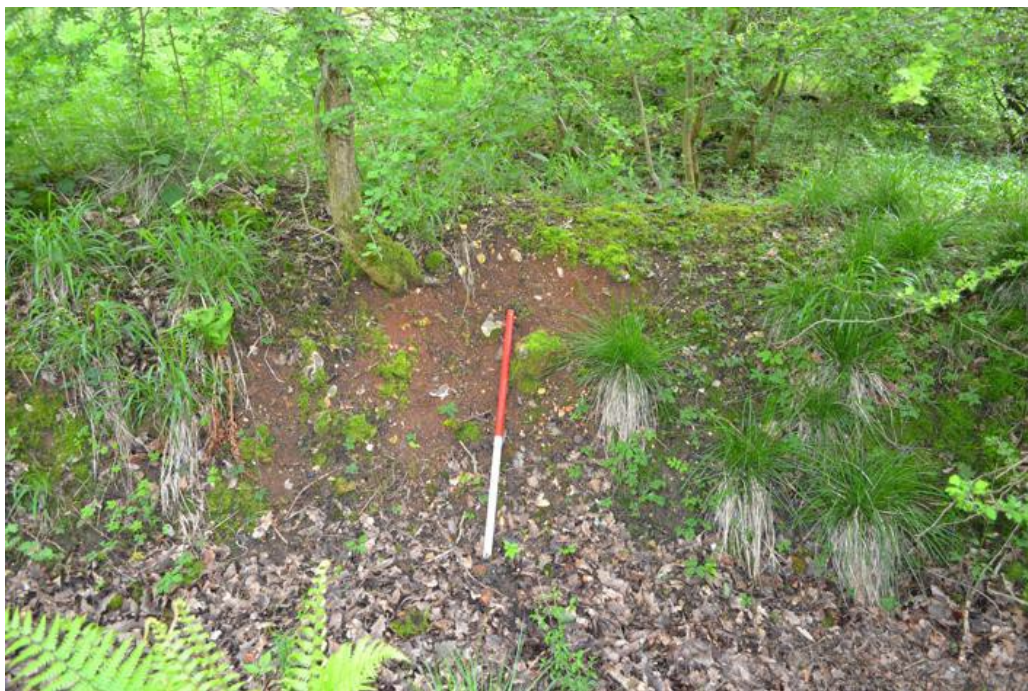
Fig. 12. Dug out earth piled above the air raid trench over 1 metre high in some examples.

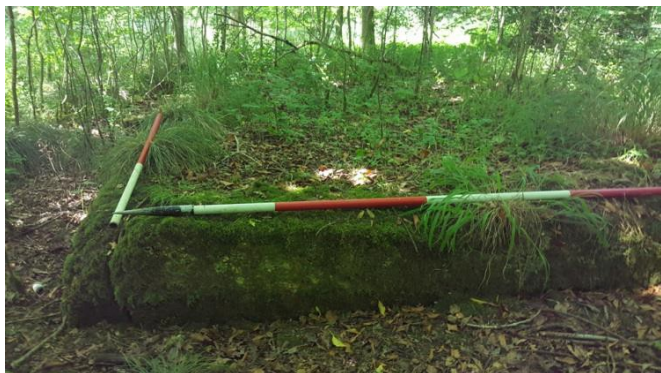
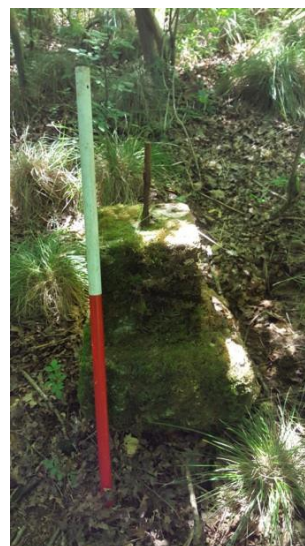
This large hut base measures 21 m x 8 m and in its southern end measures 0.30 m thick to provide a level surface. It has three steps at its southern end indicating an

entrance and is surrounded by a ditch, potentially a roof drip trench. There are a number of concrete blocks with iron bars which may have been used to tie down camouflage netting. The hut has been identified as a nissen type hut from the aerial photographs, and due to its size –the largest in the camp and its central position has been identified as potentially being the camp's mess.

Fig. 13 & 14 Concrete base of the large nissen hut in the centre of the camp and one of the concrete blocks with iron bar, possibly to hold down camouflage netting.

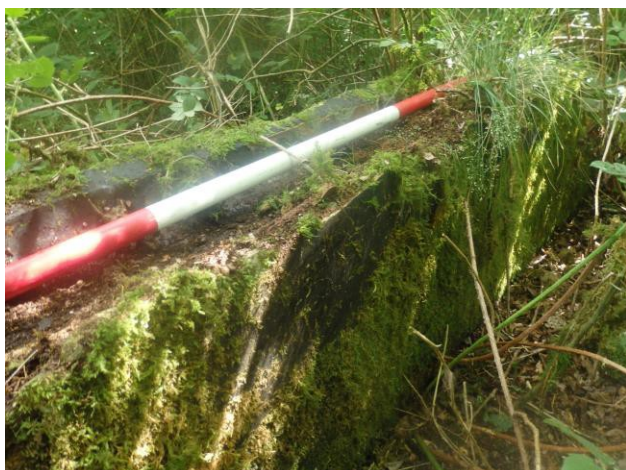
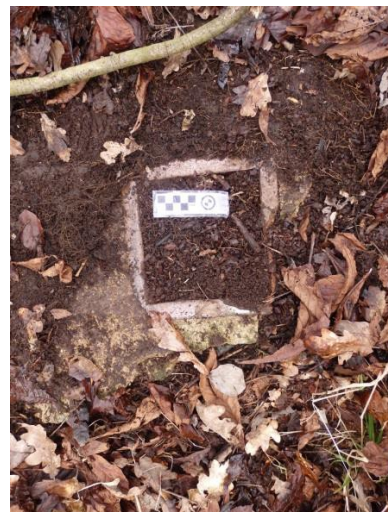
A rectangular feature was identified by the English Heritage aerial mapping survey in an area that is badly overgrown and which has been significantly disturbed leaving a jumbled mess of broken concrete and brick debris. However, two sections of concrete found have been identified as two urinals measuring c. 3 m in length, 1m in height and 0.5 m wide. These have a distinctive tarred splash back, open half drain pipes and down pipes. A small rectangular drain was identified next to one of the urinals. These have been identified as two urinals probably situated at either end of a rectangular latrine block.

Figs. 15 & 16 Urinal splash back and associated drain for latrines.

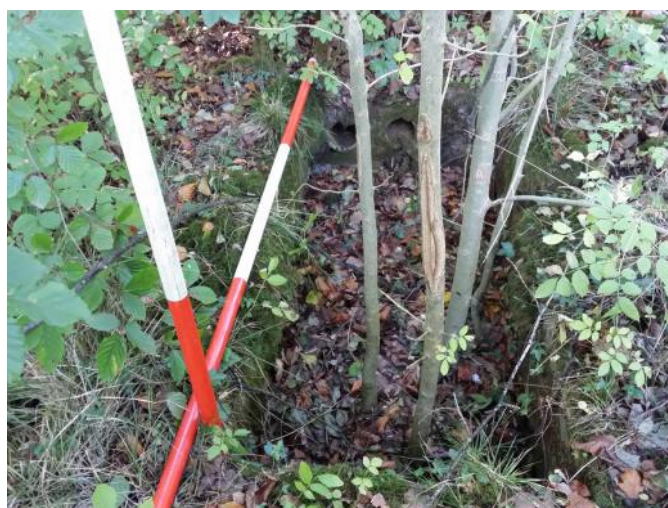
A number of drains of differing size and construction and some broken ceramic drain pipes have been found in the camp. Nearly all of these have been found associated with the remains of wooden or nissen huts. The size of the drains differ from smaller soakaways measuring 0.50 m by 0.25 m to larger drains with ceramic pipes leading into them 1.5 m by 0.7 m - for example the one associated with the two huts alongside the Grand Avenue at SU2110068203. Although the majority of the drains have been interpreted as soakaways, there are a number of larger ones with ceramic drainpipes leading from buildings into them. These drains and soakaways would have been for draining dirty water from washing or cooking facilities, rather than for sewage as the camp did not have mains sewers.

Fig. 17 Large drain with two ceramic pipes entering it from the huts adjacent to the Grand Avenue at SU 2110068203.

soakaways found during the survey are associated with these huts, indicating that there was some sort of water use in these huts – for example sinks, basins, or showers. The large drain (alongside a smaller one) located next to the large hut bases along the Grand Avenue at SU 2110068203, has two ceramic drainpipes entering the drain from the direction of the huts. This established drainage system could suggest a large use of water, possibly a shower or ablution block.

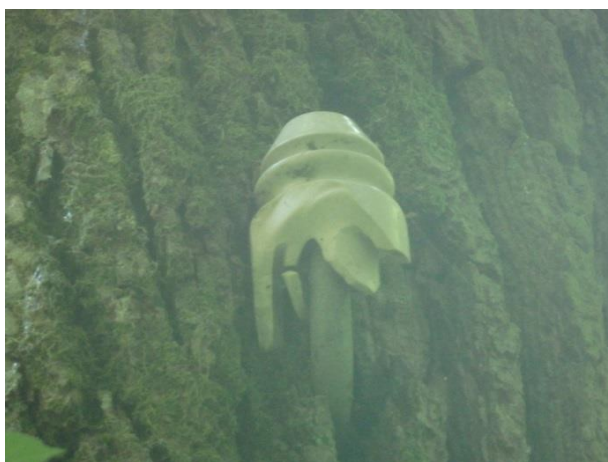
Two ceramic insulators have been found during the survey. The first is still in situ in one of the beech trees (Forestry Commission tag 5340) along the Loop Road at SU2110668026 are of the telephone/telegraph type. The second large electrical type insulator was found close to the large nissen hut located in the centre of the camp at SU2106568080. Cabling for electricity has also been found at various places within the camp area.

Fig. 18 Ceramic telephone/telegraph insulator in situ on a tree on the Loop Road 2016.

The documentary evidence of a telephone exchange being located at Iron Gates is supported by the finding of a ceramic telegraph/telephone insulator still in situ on a tree on Loop Road. An electricity supply at the camp is confirmed by the finding of an electrical insulator near the large nissen hut in the centre of the camp, and various findings of insulator wire. The contemporary photograph of the entrance to Iron Gates (see cover photograph of the report) also shows clearly a number of telegraph poles and electricity and telephone wires criss-crossing the entrance to the camp.

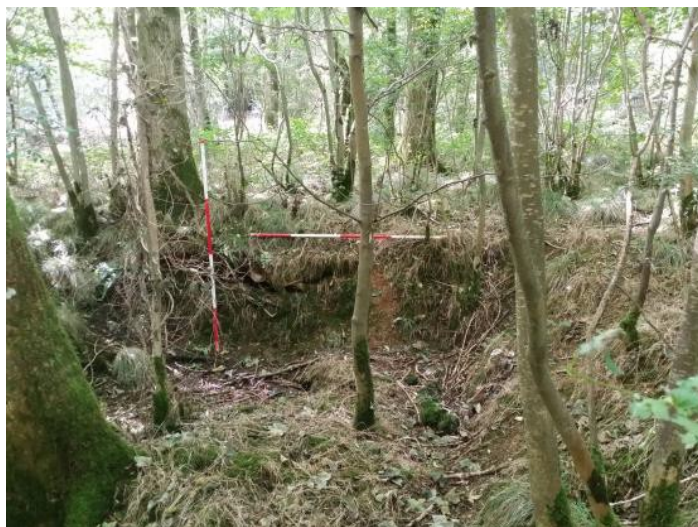
Three large pits have been found in the northern part of the camp around SU20950 68210 and one very large pit is located in the south western part close to the most southern carriages at SU 2111067894. These pits range in size from 4.6 m x 4.6 m to over 8 m x 8 m in size. They seem to have been dug as rectangular pits though appear curved due to infill and collapse. They have been filled with domestic waste from the camp, including large amounts of clinker, probably from domestic stoves, pottery and glassware – from containers and crockery, used personal items, as well as structural waste – barbed wire, rubble etc.... The material culture from these rubbish pits (though not examined in detail) indicate that the pits were used as domestic rubbish pits whilst the camp was in use and then as clearance pits when the camp was dismantled and abandoned. Large amounts of burnt material (including burnt white War Office crockery) was found in the largest pit in the south western part of the camp. It appears that some of the domestic waste was set alight as part of its disposal.

Fig. 19 Large rubbish pit at SU20950 68210.

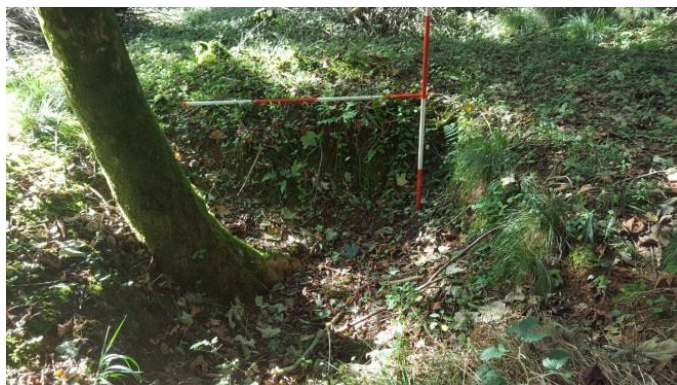
There is an enigmatic set of eight small rectangular shaped pits (2 x2 and 2 x1 metre) in three groups of 4, 2, and 2 respectively around SU20976824 in the north west corner of Iron Gates, close to White Road and the entrance to the Loop Road. Although some rubbish has been deposited in the bottom of some of these, they seem to be too small for rubbish pits. Their size and dimensions are also uniform and correspond roughly to the size of two-man slit trenches and have been interpreted as potential firing points or defensive positions in case of ground attack.

Figs. 20 & 21 Small pits possibly used as defensive firing points at SU2092668197.

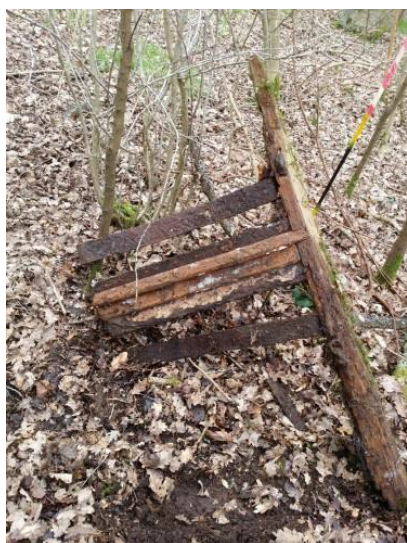
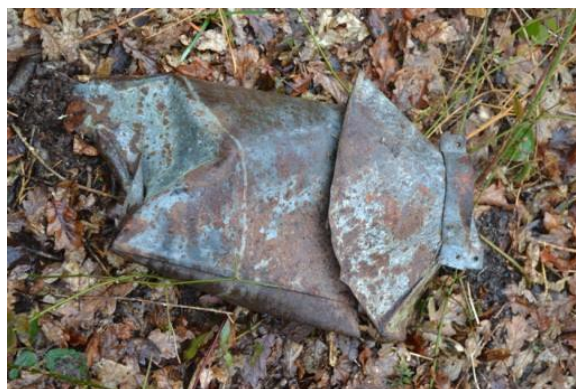
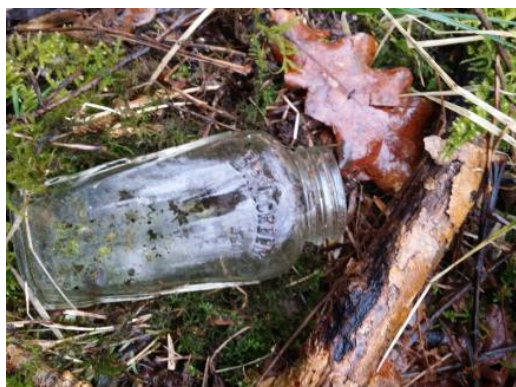
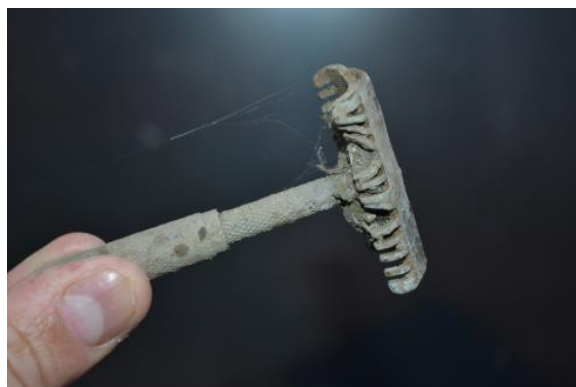
Figs 22-25 Material culture remains found within the camp area, associated with the carriages. a. end part of a railway carriage, b. stove hood, c. razor, d. brylcreem bottle

Some material culture remains were found associated with the camp. This comprises predominantly of two types of material culture; that associated with the railway carriage structure and components and the other as domestic waste. The remains associated with the railway carriages includes structural components, such as iron braces, front end of the carriage, window glass, pieces of carriage wood and bolts. Internal components of the carriages include a flue pipe and parts of a belly-stove. The majority of the domestic waste found is clinker from the stoves, followed by standard War Office white glazed ceramic, bottle glass, and other ceramic and waste. Most of this has been found in the rubbish pits, but much is also scattered on the forest floor with significant spread suggesting that it was scattered in order to dispose of it during the life of the camp, or was dispersed during the demolition and clearance period post war.

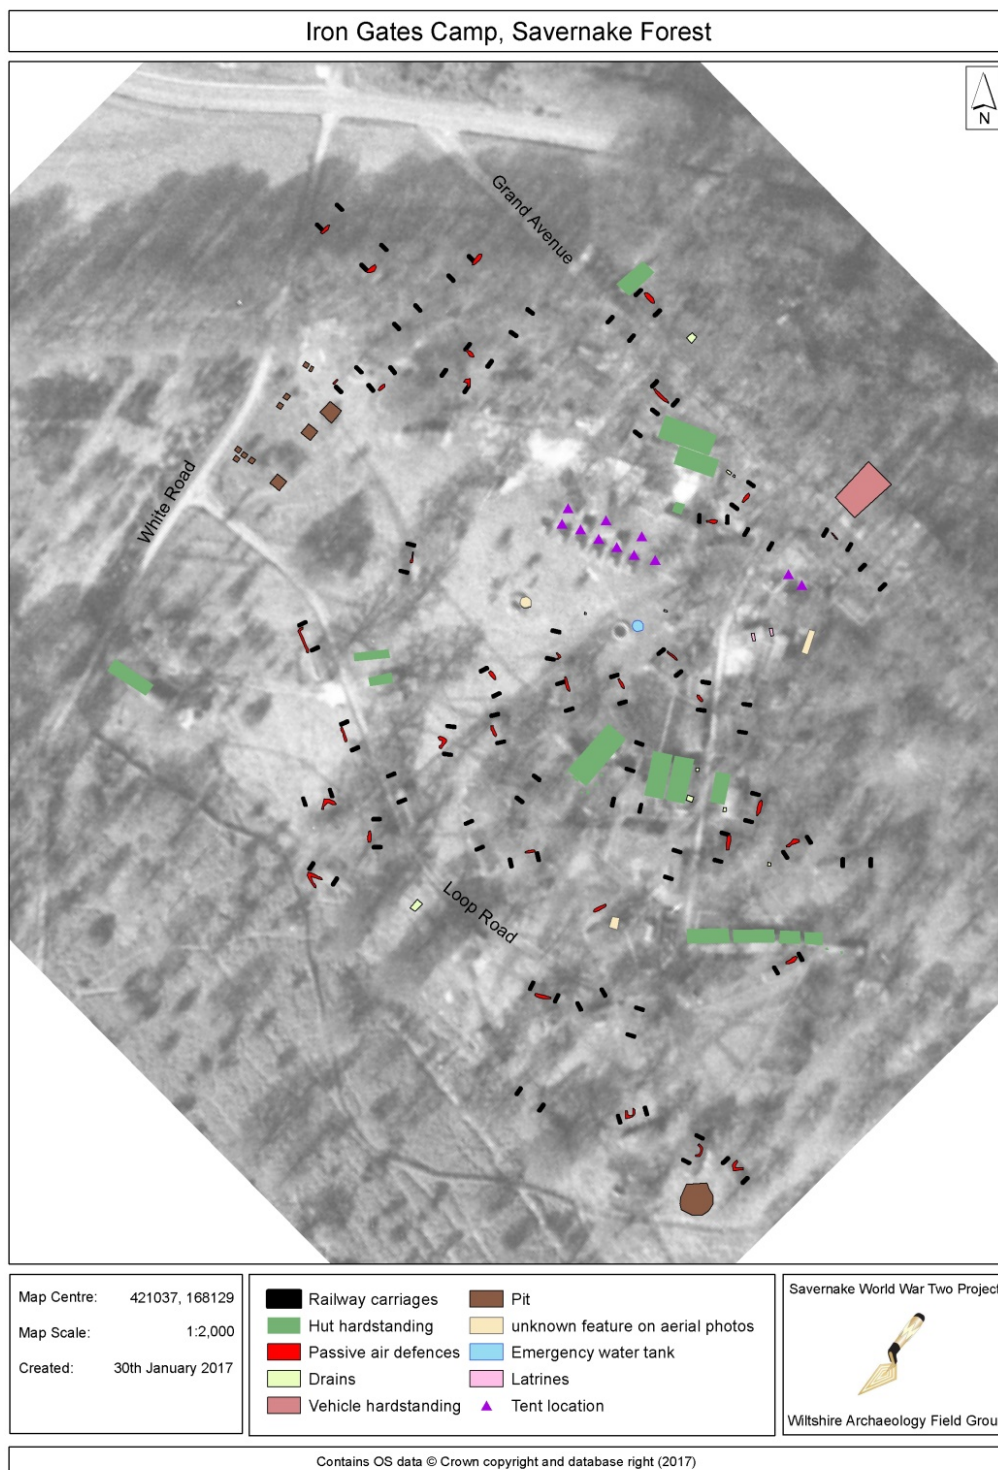
Fig. 26 Mapped features of Iron Gates Camp (2016) transcribed on the .1944 USAAF aerial photograph (US_7PH_GP_LOC209_V_5010 (6887 8 March 1944) Historic England USAAF Photography. See Appendix 2 for larger image.
