Report 1062

Archaeological building recording of the Chapel at the Royal South Hants Hospital, Fanshawe Street, Southampton, SOU 1570

Client: NHS Southampton City

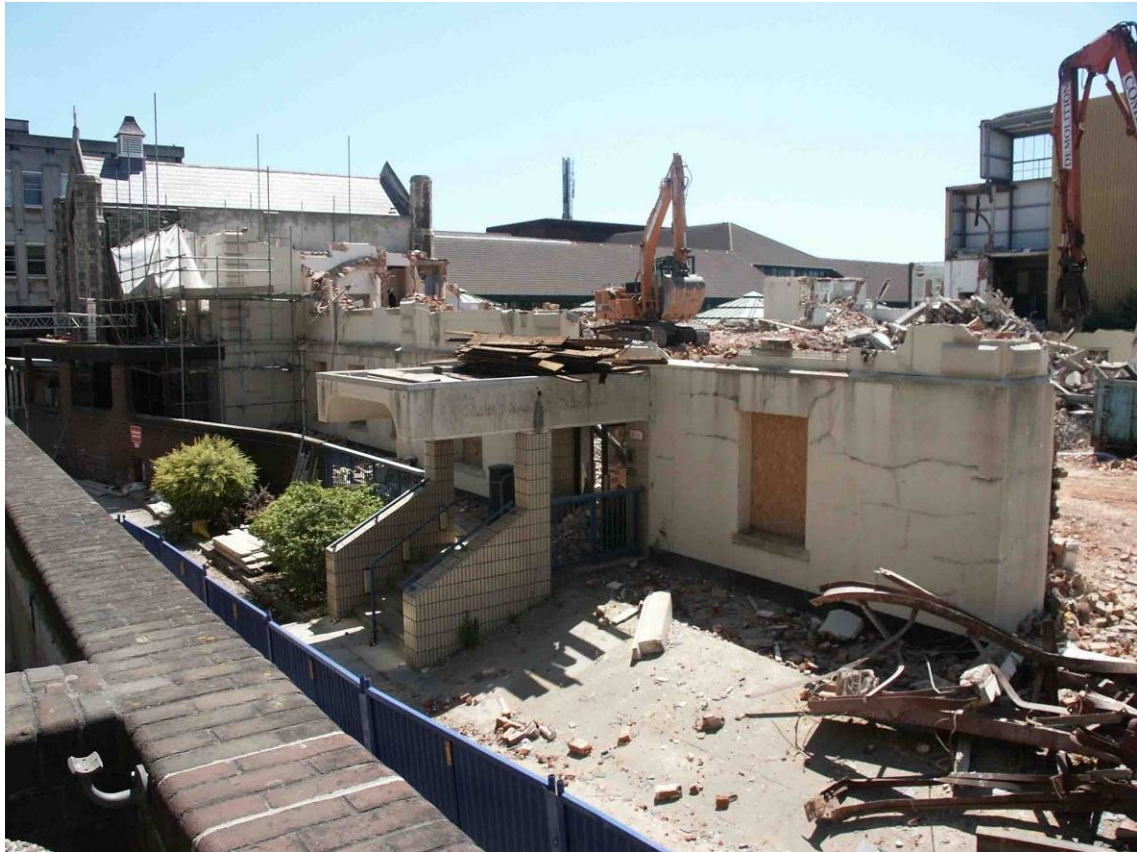
Figure 3. West elevation of the Chapel in relation to the 19th century hospital buildings, looking south-east.

Part of the SOU 1314 archive, showing the hospital buildings in an advanced state of demolition, but with the linking corridor still in place.

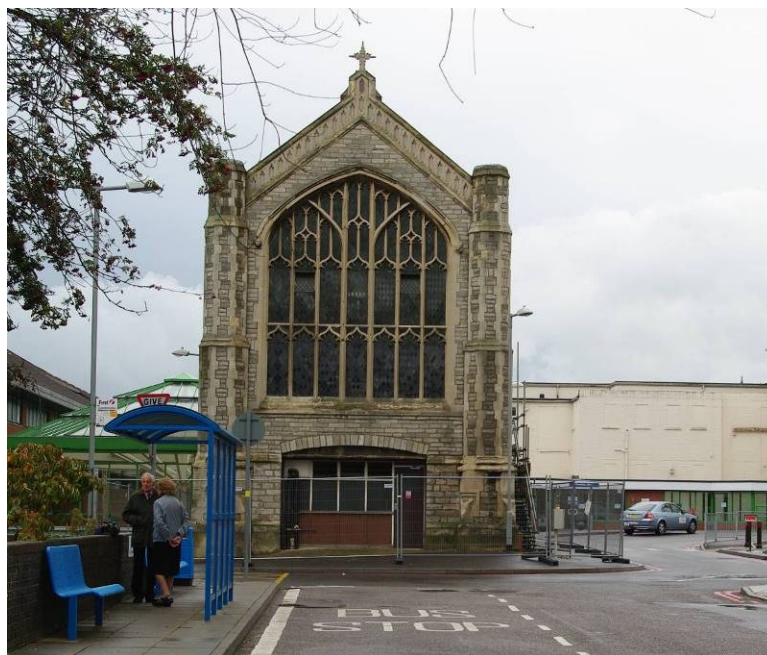
Figure 4. The north elevation, looking south.

The north elevation formed a gable end (figure 4). As built, it formed the main façade, facing the public street immediately adjacent to the principal frontage of the hospital buildings to the west. The gable had a pinnacle supporting a cross. The gable was defined by a frieze of trefoil-headed recesses, forming a parapet to the roof-line. The undercroft had a large opening with a low-centred arched head. The arch was defined by stone voussoirs. The infilling was modern. There was a stone string course at the level of the arch springing. The Chapel was lit by a large window with Perpendicular tracery. The window was protected by a drip mould. It had sculptured corbel heads at its terminal. That to the east was a female head, whilst that to the west was male. No images of Dowling and Oke (the benefactor and her administrator) have been found, but it is tempting to see these as possibly being their portraits.

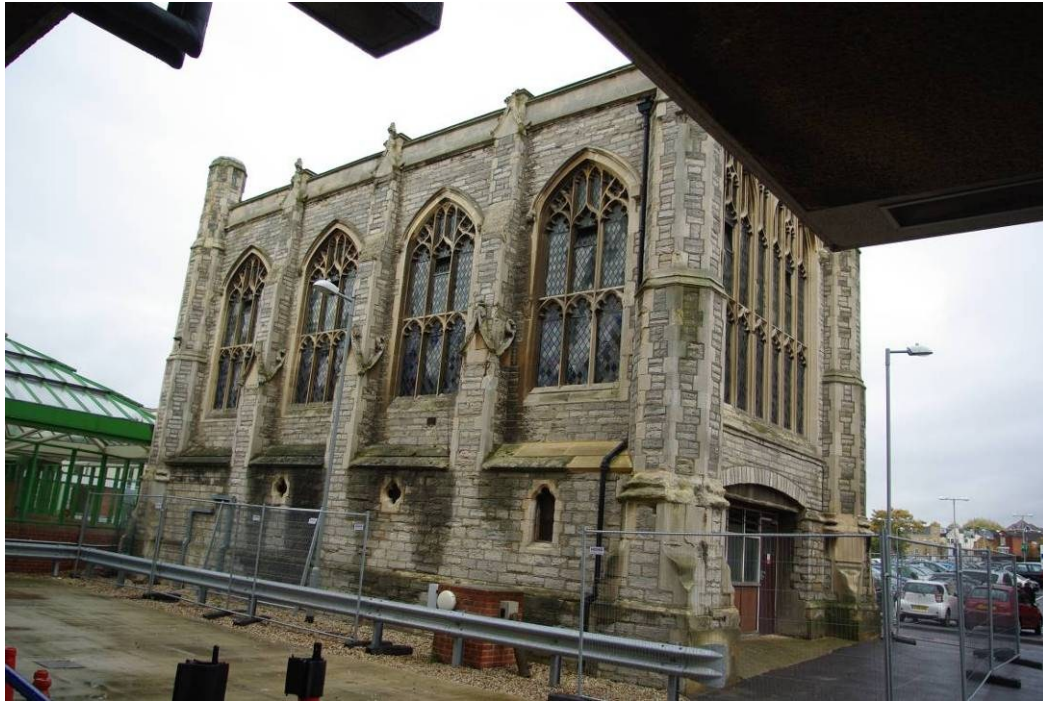
Figure 5. The east elevation, looking south-west.

When first built, the east elevation would also have faced a public street, Exmoor Road (figure 2). The upper storey was set back slightly from the undercroft, the gap being capped by sloping stone slabs (figure 5). The undercroft was lit by a small window with a trefoil head near its north end. There were two quatrefoil openings to its south.

The Chapel storey was divided into four bays by three buttresses rising from the undercroft wall. The buttresses rose in three stages. The lower stage had pedimented tops, the terminals of which originally had sculptured human heads, but only the northern head of the southern buttress survived (a moustachioed male). The return faces had half pediments with crouching beasts at their apexes. The second stages were thinner and their east faces sloped in at the level of the window arch springings (see below). The top of the buttresses were also pedimented with sculptural decoration at their terminals, now very eroded.

The buttresses divided the Chapel storey into four bays. Each bay contained a large window with Perpendicular tracery. The terminals of each drip mould was decorated with a sculptured human head. The heads were in varying degrees of decay, some being in good condition. The northernmost head had been replaced by a modern, unsculptured, block. Each bay was surmounted by an ashlar parapet.

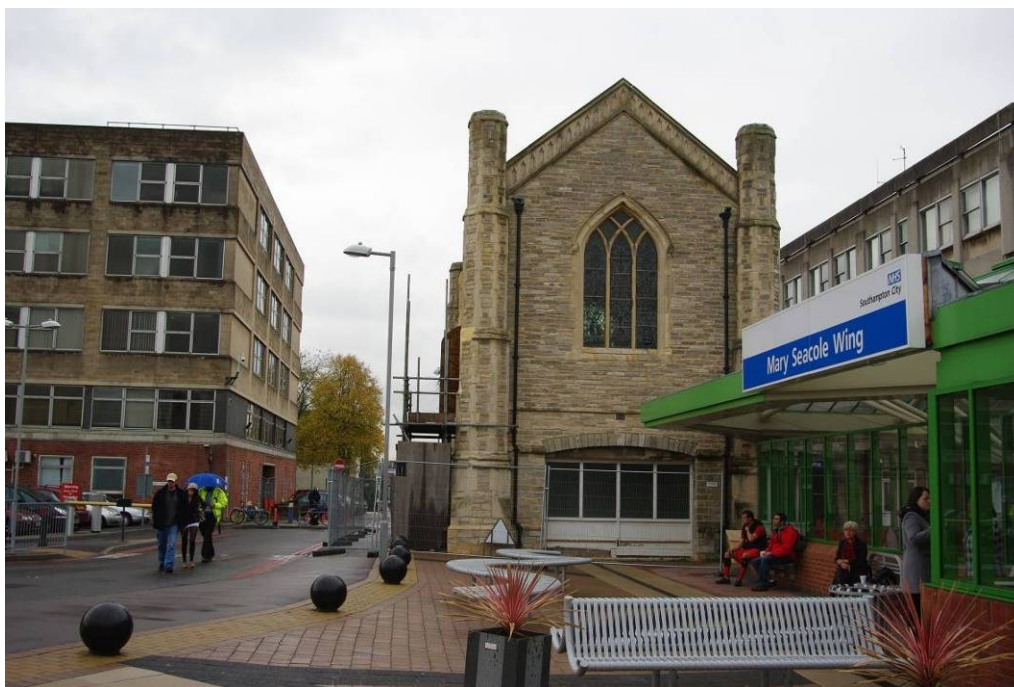
Figure 6. The south elevation, looking north.

The south elevation (figure 6) was similar in form to the north elevation. The main differences were the absence of a cross at the apex, and the smaller size of the window.

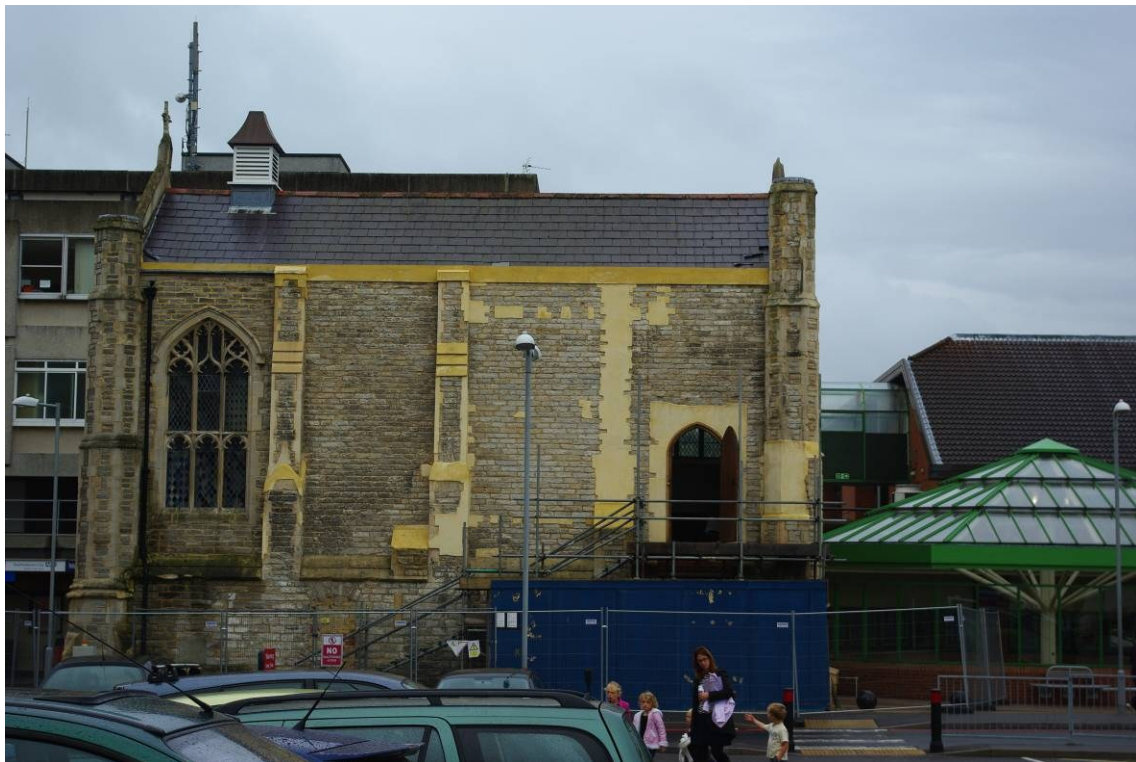
Figure 7. The west elevation, looking east.

The west elevation, as built, would have been largely obscured by the earlier hospital buildings, except the northern bay which projected slightly beyond them (figure 2). The basic form of this elevation was the same as that of the east elevation, with the Chapel being set back from the undercroft, and the four Chapel bays defined by two buttresses. The southern buttress was originally replaced by the north wall of the link to the hospital buildings (figure 3). This had been removed by the time of the present survey, its scar being made good by a line of yellow cement render above a stump of wall (figure 7). The render present on the walls of the three southern bays in 2004 had been removed.

The detail of this elevation was very different from that of the east elevation. The undercroft had no windows. There was a blocked door near the south end (figure 8, hidden behind the hoarding in figure 7). This was flanked and surmounted by modern bricks and may not have been original. There was another blocked opening below the second bay from the north (figure 9). It

The décor of the upper Chapel storey was much plainer than that of the east elevation, except for the north bay which had the same type of window (figure 7). The three bays to the south did not have windows, though there was an arched door opening in the southern bay. This would have opened onto the first floor of the hospital building. The buttresses lacked the sculptural detail of those of the east elevation. The west elevation also lacked the parapet, leaving the slope of the roof exposed.

The roof was slate clad with ceramic ridge tiles (figure 7). There was a small turret ventilator above the ridge of the northern bay. It had louvered openings in its faces.

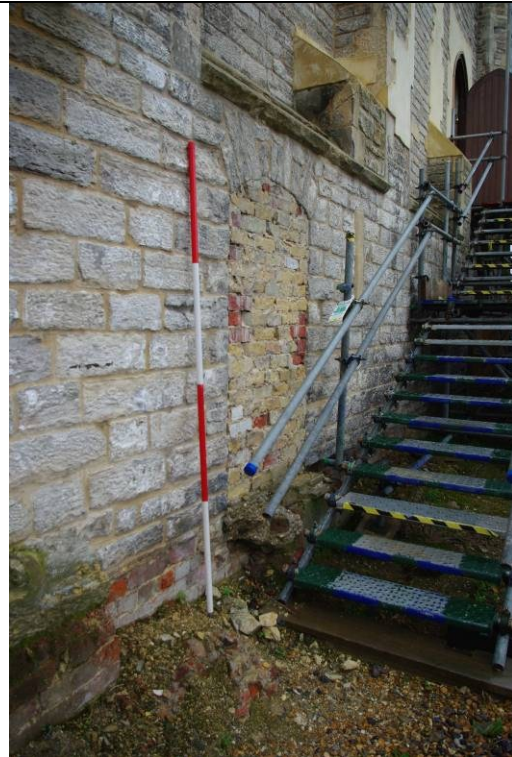
Figure 9. The northern door to the undercroft and possible flue, looking south-east.

had an arched head. It was 1.66m (5ft 5in) high and 0.90m (2ft 11in). It opened onto the narrow passage between the Chapel and the hospital building, and its function is uncertain. A small structure above the undercroft coping butted against the base of the north face of the central buttress. It had a sloping top of yellow cement, which was probably a post-2004 alteration.

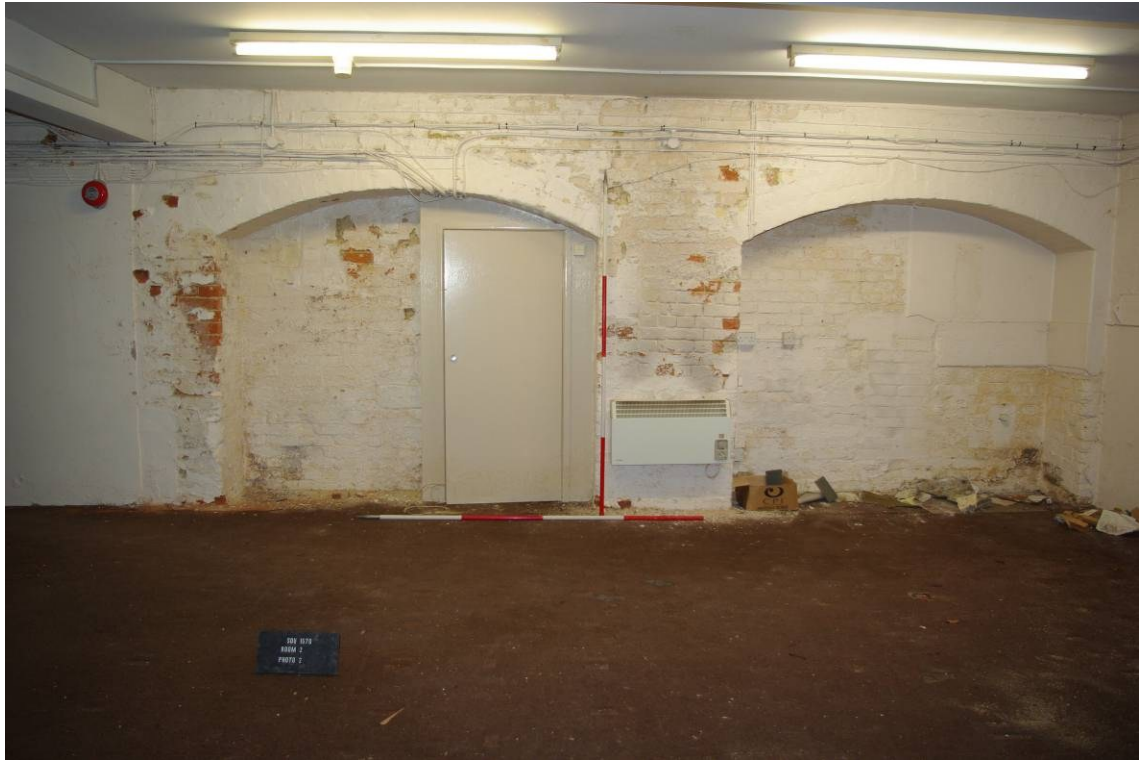
Figure 11. The west wall of room 2, looking west.

The north end of the undercroft was occupied by a large room (2). The east and west walls had a pair of arched recesses in them. The southern recess in the west wall contained the blocked opening noted externally (figure 11). The opening had been converted into a cupboard that contained part of the distribution equipment for the hospital radio system dating from the 1970s. A scar in the brickwork to its south was of uncertain function. Externally, a small structure rose above the coping above the undercroft wall (figures 7 and 9). It may originally have been a flue, perhaps for a boiler.

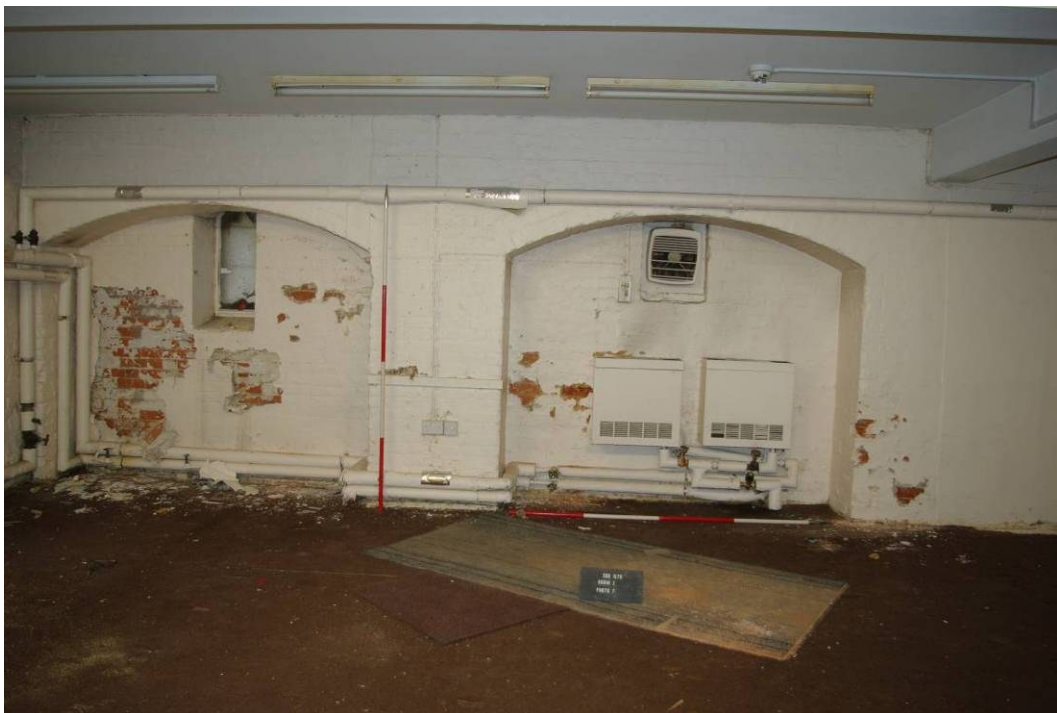
Figure 12. The east wall of room 2, looking east.

The northern recess in the east wall contained the trefoil headed window noted externally (figure 12). The southern recess had one of the quatrefoil windows, though it was obscured by a modern ventilator.

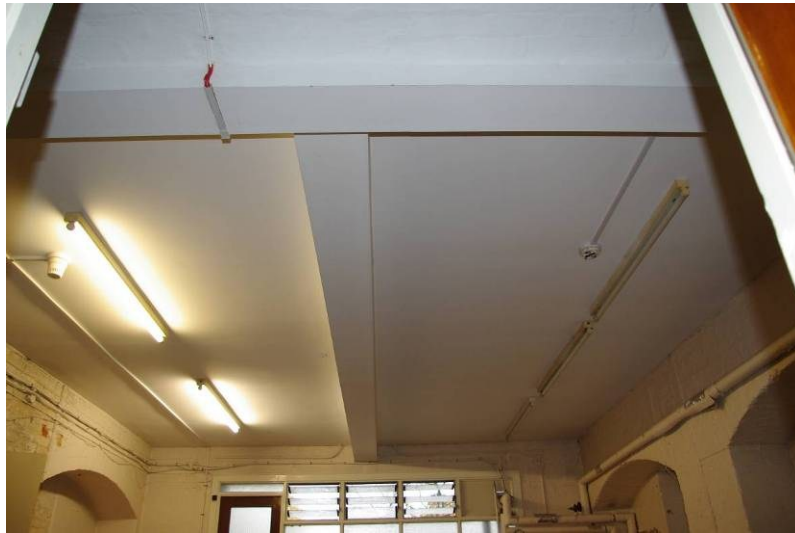
Figure 13. Room 2 ceiling, looking north.

There was a transverse boxed-in beam across the ceiling about 6m to the south of the north wall of room 2. There was a scar in the east wall below it, but not in the west wall. It is possible that this represents an original division of the undercroft, perhaps with a doorway at its west end. The ceiling to the south of the beam was formed by part of an east to west aligned barrel vault, whilst that to the north was flat with a longitudinal boxed-in joist (figure 13).

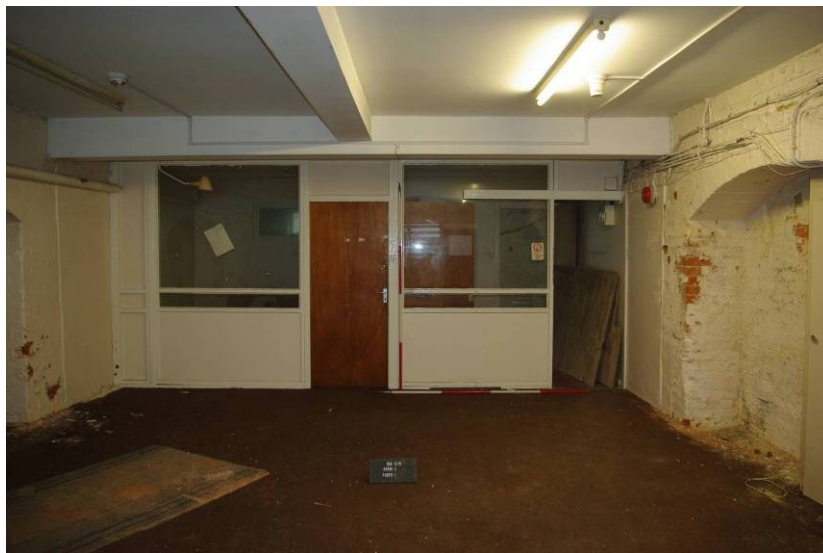
Figure 14. The partition wall between room 2 and rooms 3 and 4, looking south.

Two interconnecting rooms (3 and 4) were present to the south of room 2. They were divided by plasterboard partitions with large windows (figure 14). Their east wall was formed by a modern brick wall (figures 15 and 16).

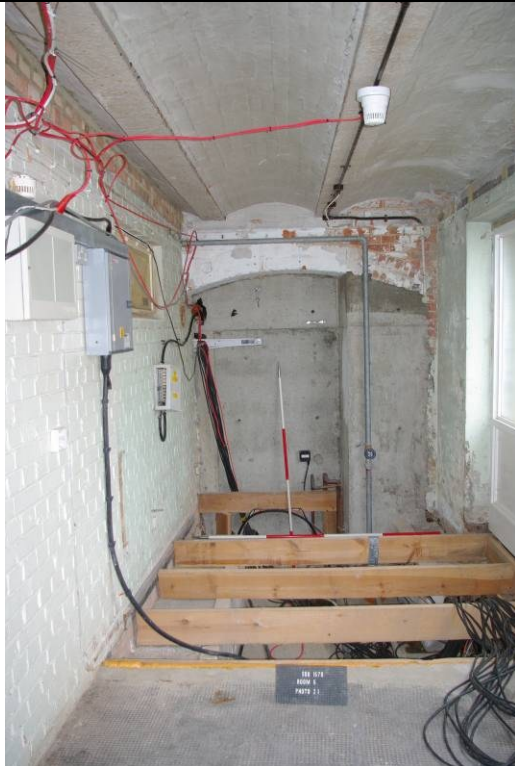
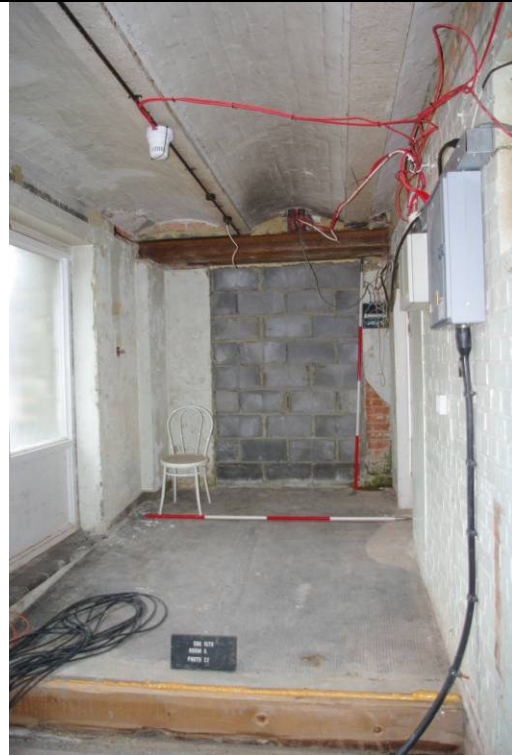
Figure 15. Room 5, looking east.

A narrow service room (5) was present to their south (figures 15 and 16). It had a service pit at its east end, and a blocked doorway in its west wall. The south end of room 2 and rooms 3 to 5 had a sequence of six, shallow, transverse barrel vaults laid on 200mm (8in) iron joists.

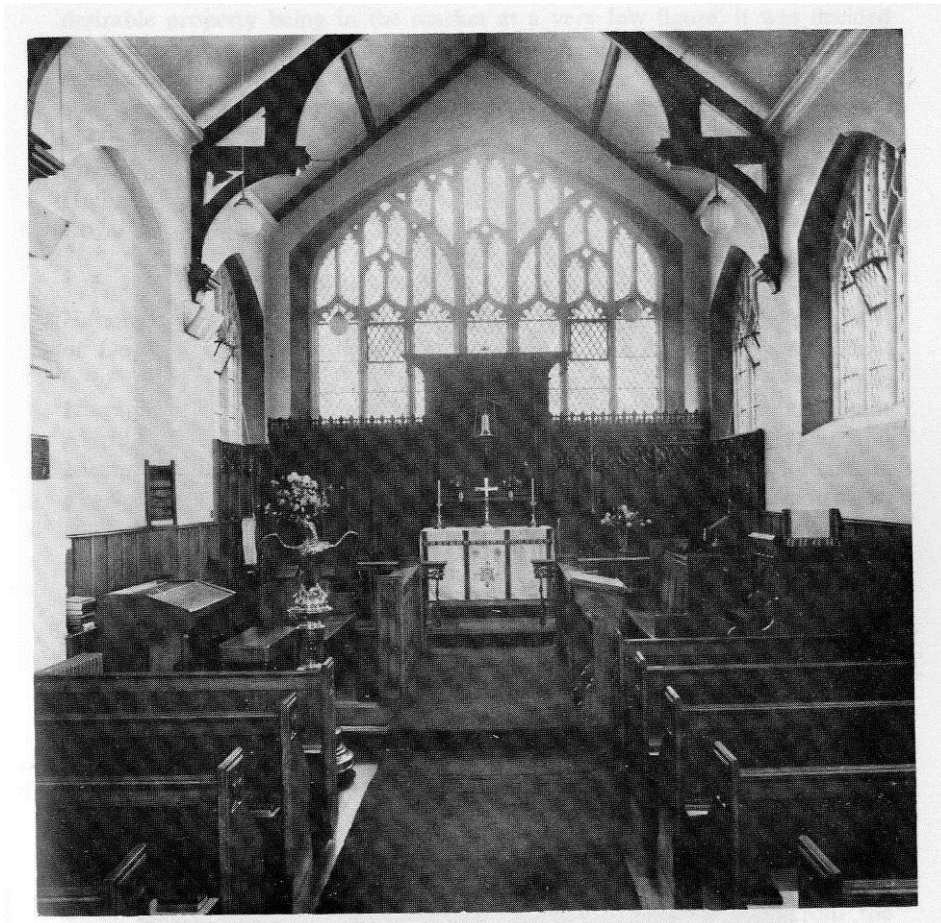
Figure 18. The interior of the Chapel in the 1970s? Looking north.

The upper storey of the building was entirely occupied by the Chapel (room 1 – figure 17). An undated photograph published in Watson (1979, facing p80 – figure 18) shows the interior of the Chapel after the additions of the 1920s. It probably dates from the 1970s when her book was published. It shows the fittings in the Chapel when it was still in use. Much of the furnishings were still present at the time of the survey. Significant details that have since been removed included a harmonium on the west side of the choir (second bay from north), dado panelling on the west wall of the choir, a hanging chandelier

in front of the altar, and globe lamps hanging from the ends of the hammer-beams. The altar cloth may have been one of the textiles contained in vestment chest (item 35) but this was not checked on site. The altar crucifix and candlesticks were not present either.

modesty panel 21. The Watson photograph (figure 18) shows the now missing harmonium in this position, with the brass eagle lectern (item 20) to its east. The lectern had formed a series of scars in the floor surface of this area. At the time of the survey, the lectern had been moved to the upper step, and there was a vestment chest of uncertain provenance (item 35) in the place of the harmonium. There were two north to south aligned benched choir stalls of four panels (items 11 and 12) fronted by a modesty panel (item 13) at the north end of bay 3. They had more carved decorative detail than the pews in bays 1 and 2.

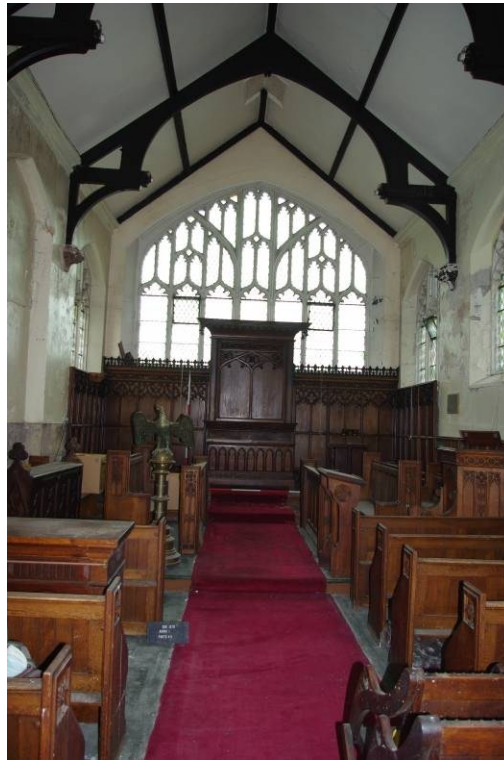
Figure 19. General view of the Chapel in 2011, looking north.

The chapel was divided into four bays defined by three hammer-beam roof trusses. Each bay was lit by a large window in the east wall. The walls were generally rendered in plain white render, apart from oak panelling against the base of the walls in the northern two bays (figure 19 - see below for details). The two southern bays (1 and 2) formed the nave, the second bay from the north (bay 3) the choir, and the northern bay (4) the chancel. There was no physical barrier, such as choir screens, between the bays, but there were 150mm (6in) steps between bays 2 and 3, and 3 and 4, producing a progressive rise in height to the altar.

The furniture and many of the fittings had been moved around prior to the present survey. They were moved back to their approximate original positions before the photographs were taken by reference to stains and scars in the floor surface and the Watson photograph (figure 18). Each item was assigned a reference number, and a list is provided in appendix 1. There were a number of items that did not originate from the Chapel. A photograph of the chapel in the Fred Woolley convalescent home found in the Chapel (item 47) showed that several of the items had been moved from there. They are also listed in appendix 1. A list of the memorial plaques, with transcriptions, is given in appendix 2. They were also given reference numbers. The location of the plaques on the sketch elevations is indicative only.

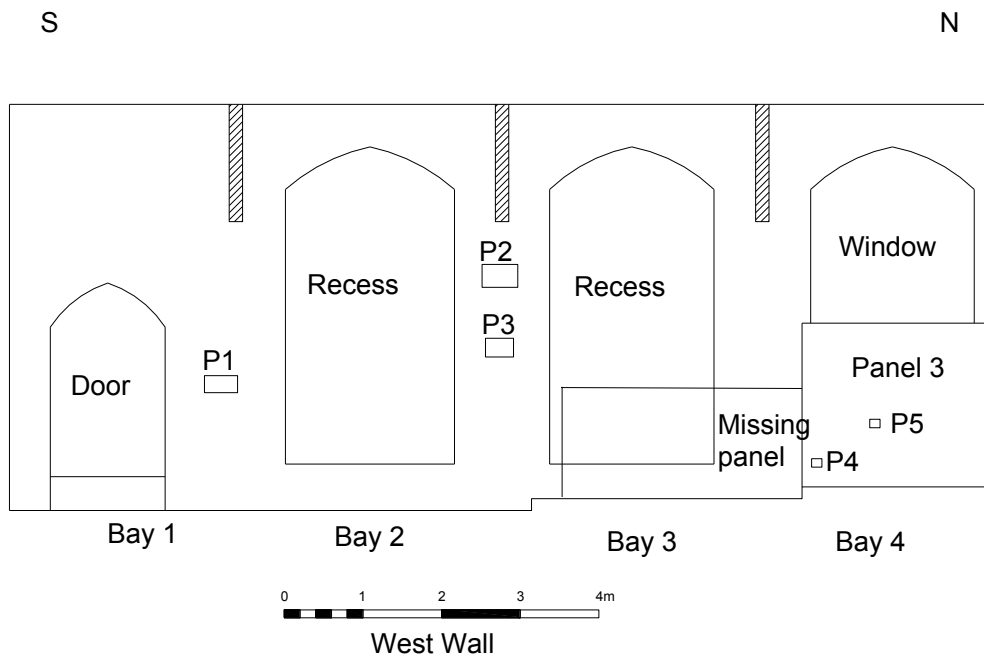
Figure 20. Dimensioned sketch elevation of the west wall.

Bay 1, at the south end of the Chapel contained the entrance door from the main hospital block in its west wall (figures 17, 20 and 22). The door was of plank and batten construction. It opened outwards, that is onto the former linking corridor to the east. The memorial plaque (plaque 1) to Nurse Norman was located to the north of the door.

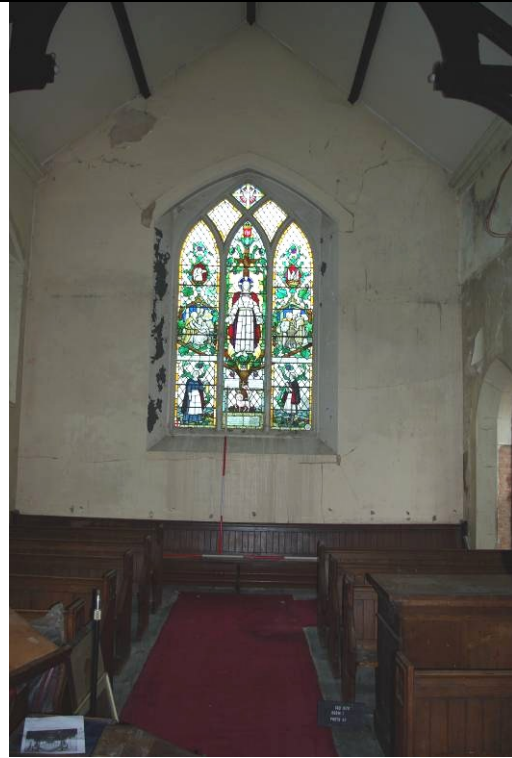
Figure 24. Fred Woolley window in south wall of bay 1.

The south wall of bay 1 had a full length bench running along its base (item 25). A memorial to an anonymous “wife and mother” (plaque 10) was attached to the east end of the bench. She may have been Mrs Perkins, whose husband, Colonel Perkins, donated the pews in 1923. There was a large window rising slightly into the gable. It had a much plainer tripartite tracery that contained the Fred Woolley stained glass window of 1955 (figures 24 and 25).

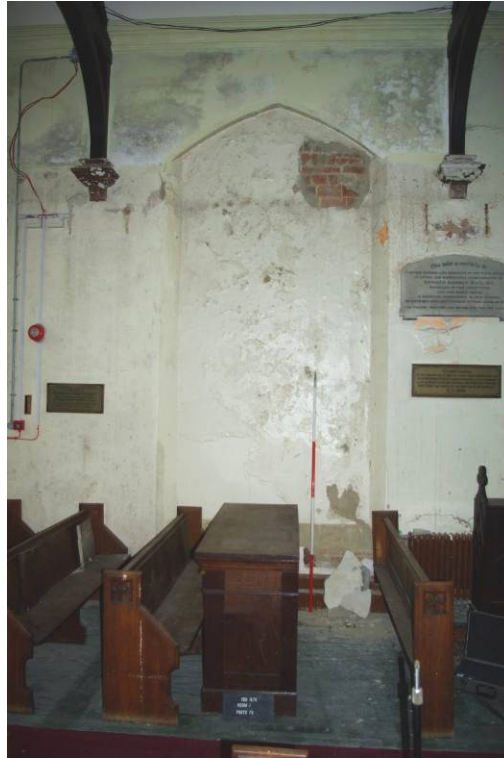
Figure 26. West wall of bay 2, looking west.

Bay 2 formed the northern end of the nave. The west wall had an arched recess in it, rising to 4.66m (15ft 4in) above the floor level (figures 21 and 26). Its base sloped out to form a cill at a height of 0.59m (1ft 11in). The Maul and Dowling memorials (plaques 2 and 3) were located on the boundary between bays 2 and 3.

The large chest is the altar from the Fred Woolley chapel (item 34) and is in the position of a missing pew.

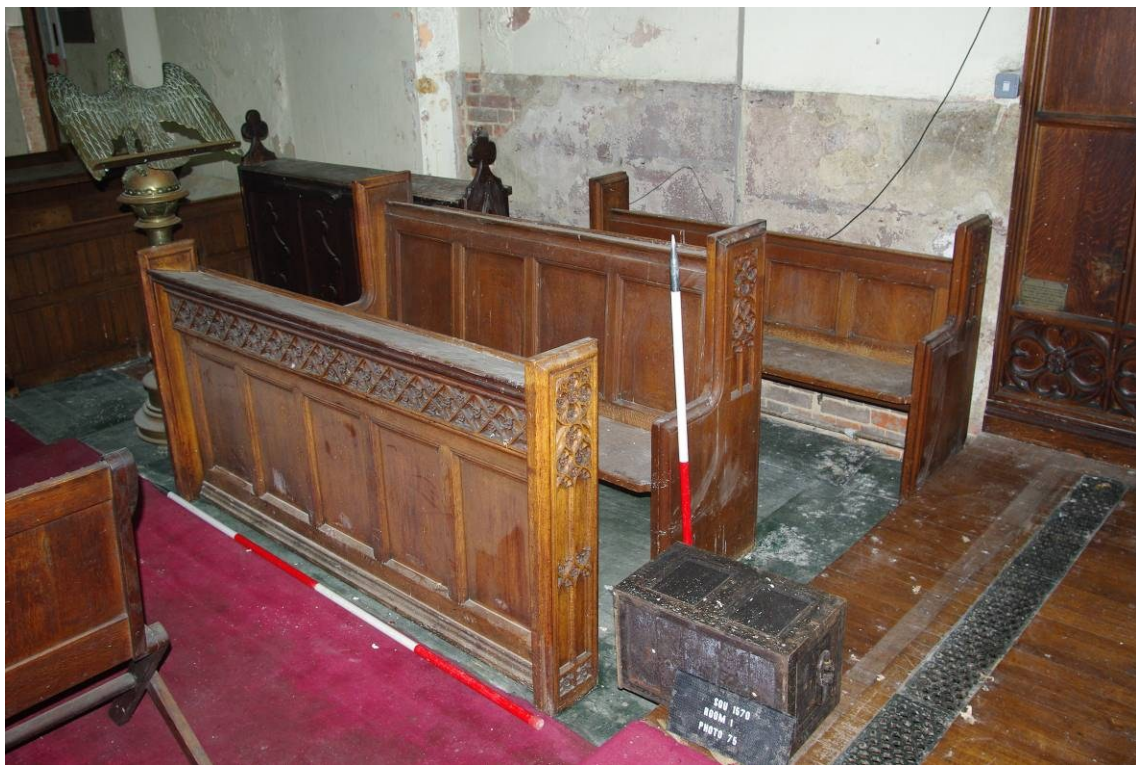
Figure 27. The furnishings on the west side of bay 3, looking south-west.

Bay 3 formed the choir. The basic structure of the east and west walls was the same as in bay 2. The west wall originally had an approximately 1.4m (4ft 7in) high dado panel, but this had been removed, exposing rough plaster over brickwork (figure 27). The floor level was 0.15m (6in) higher than that of bays 1 and 2. There was an open space between the step and the western

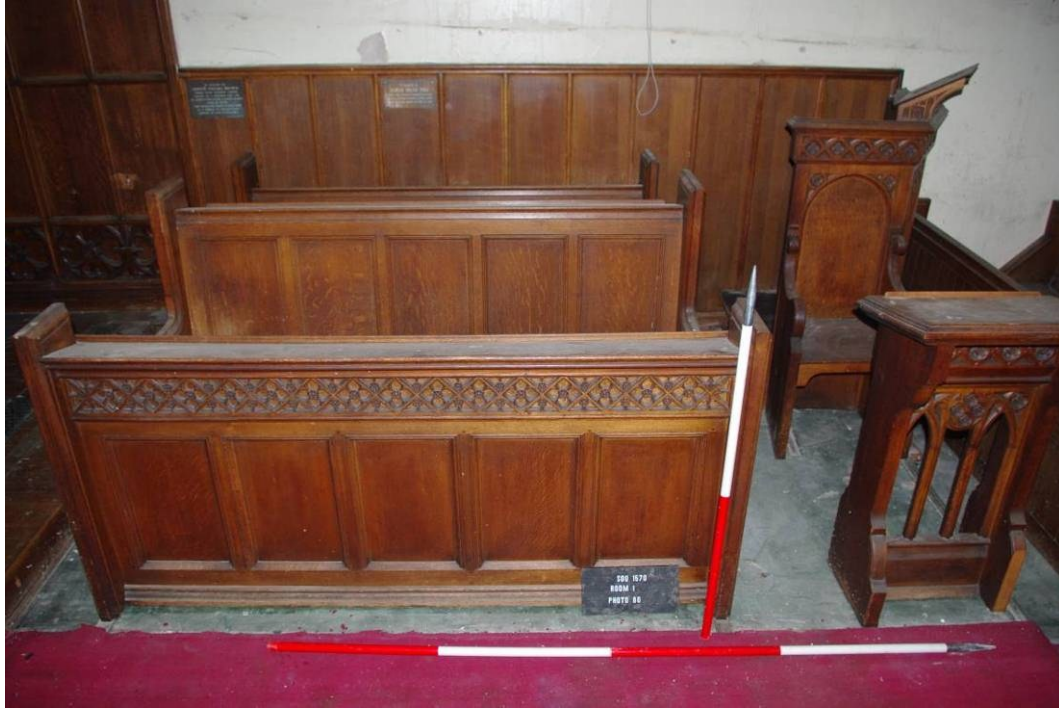
Figure 28. The furnishings on the east side of bay 3, looking east.

The dado panel survived on the east wall of bay 3 (figure 28). It was of plain plank construction. The Brown and Pike memorials (plaques 7 and 8) were attached to it. The Watson memorial (plaque 6) was attached to the wall above the panelling. There were two benched choir stalls (items 15 and 16) and a modesty panel (item 14) on this side as well. They had the same decorative treatment, but were somewhat longer, at five panels. A curved pulpit (item 17 – figure 29), with Early English style decoration, was present at the south end of the choir stalls. A reader's chair (item 18) fitted into the west

face of the pulpit. The chair bears a brass plaque that reads “Presented by the medical men at Southampton July 1898. Carver HG Boniface.” There was a reader’s desk (item 19) to the west of the chair.

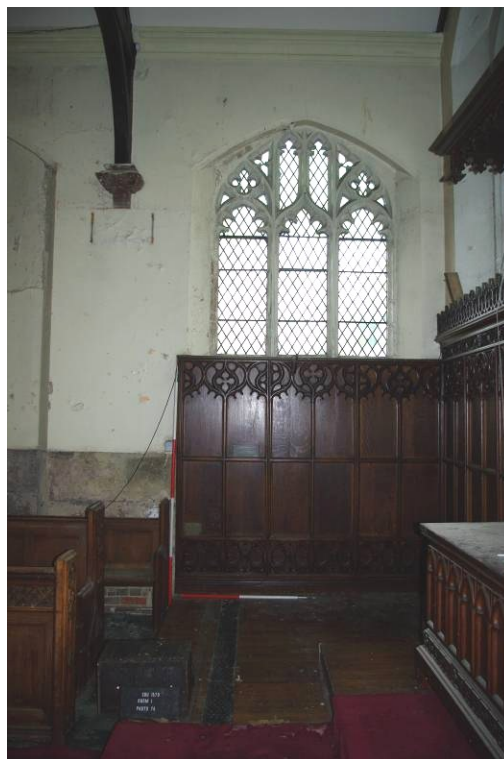
Figure 30. West wall of bay 4, looking west.

Bay 4, at the north end of the Chapel, contained the chancel. Its floor was 0.15m (6in) higher than that of bay 3. Its west and east walls had the same type of traceried windows as in the east wall of bays 1 to 3. Oak panelling, 2.8m (6ft 10in) high, was placed over the base of both walls (Items 3 and 4 - figure 30). Their tops obscured the bases of the windows. They were divided into six vertical panels with a floral roundel frieze at the base and scrolled friezes at the top. The west panel had a bracket of uncertain function at its top, and the Shettle and Hasset memorials (plaques 4 and 5). The Shettle plaque indicates that these panels were inserted in 1920, though there is a problem with the orientation (see section 6). It also had a door in one of the panels which presumably opened onto a cupboard.

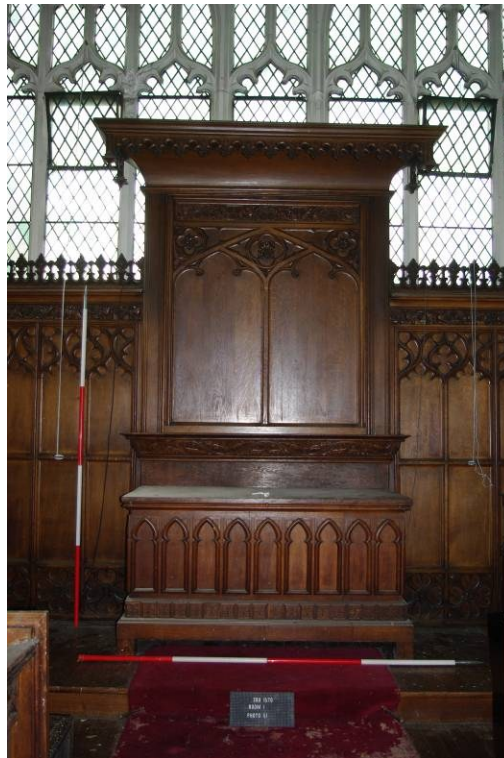
Figure 31. The reredos in front of the north window, looking north.

The north wall had a large Perpendicular window that occupied most of the wall. It had the same sort of glass as in the east wall windows. Oak panelling was placed in front of the base of the window (figures 18, 19, 31, 33 and 34). The panelling consisted of a central, canopied reredos (item 7) that rose to a height of 3.2m (10ft 6in) above the floor level. It had a projecting shelf, with a

foliated frieze, at a height of 1.38m (4ft 6in). The base of the reredos was open giving access to a radiator (item 52) in front of the window (figure 32). An oak altar table, with arcaded moulding (item 1 – figures 31 and 33), was placed in front of the reredos thus hiding the radiator. It was placed on a 0.14m (5½in) high plinth. The Watson photograph (figure 18) shows two filigree altar rails in on either side of the altar step. These were probably the lengths of iron railing and oak rails (item 2) stored behind the reredos at the time of the survey. It was not possible to access them.

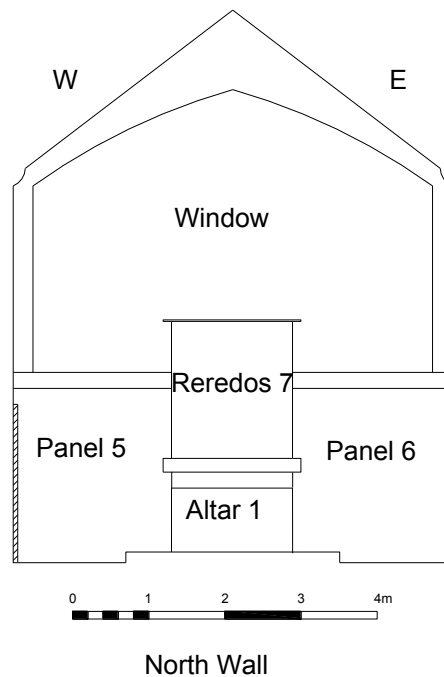
Figure 33. Dimensioned sketch elevation of the north wall.

Six frame panels (items 5 and 6 – figures 18, 19 and 33, and 34) were present on either side of the reredos. They were of the same design as the panels on the east and west walls. Both panels were surmounted by a pediment with floriate frieze at their base and a spiked rail on top.

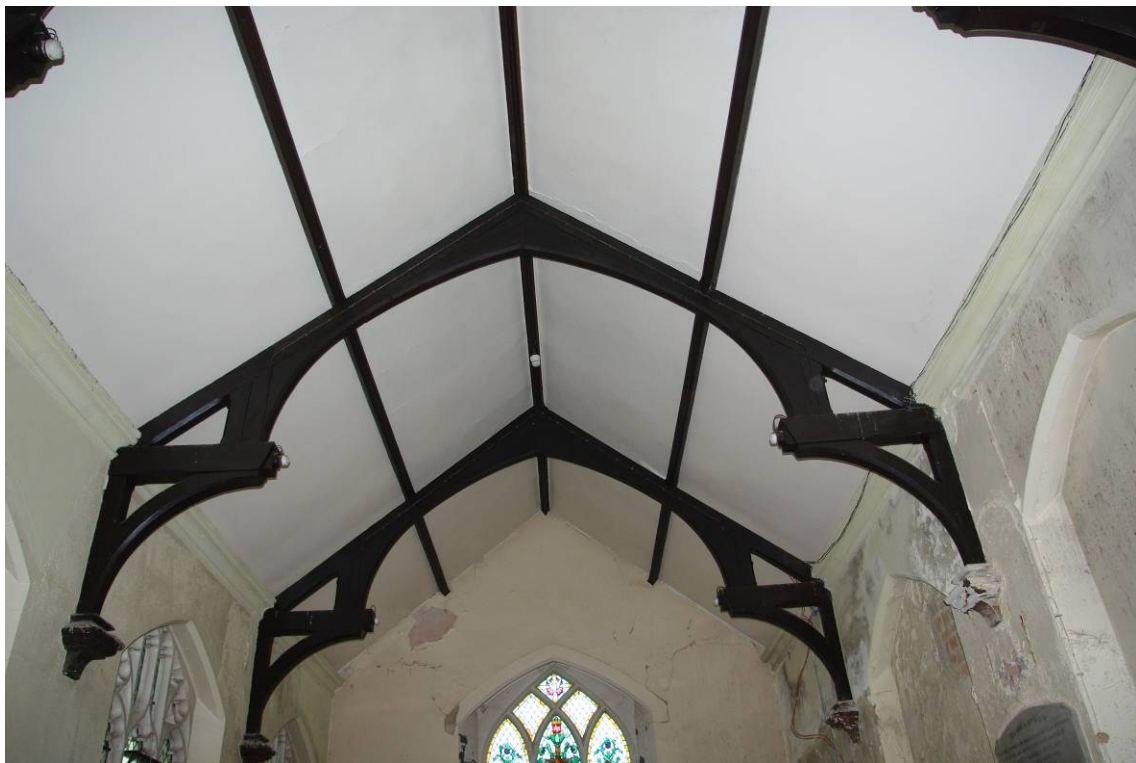
Figure 35. The roof looking south.

The roof was supported on three, undecorated, hammer beam trusses (figure 35). They were supported on stepped corbels set into the walls. The hammer-beams terminated in white electrical roses, that Watson's photograph (figure 18) show supported suspended globe lamps. The principal rafters supported a single butt purlin on either side, and met at a ridge pole. The common rafters were hidden by a plaster ceiling. The ridge pole was broken above bay 4 by the insertion of a grill that followed the slope of the roof, below the external turret (see section 7.2). The cut ends of the ridge pole were very rough.
